National Transportation Safety Board

WPR22FA160

ACCIDENT SITE EXAMINATION

Location: Sylmar, California
Date: April 20, 2022
Time: 1226 Pacific daylight time (PDT)
Airplane: Textron Aviation Cessna 337; N13JB

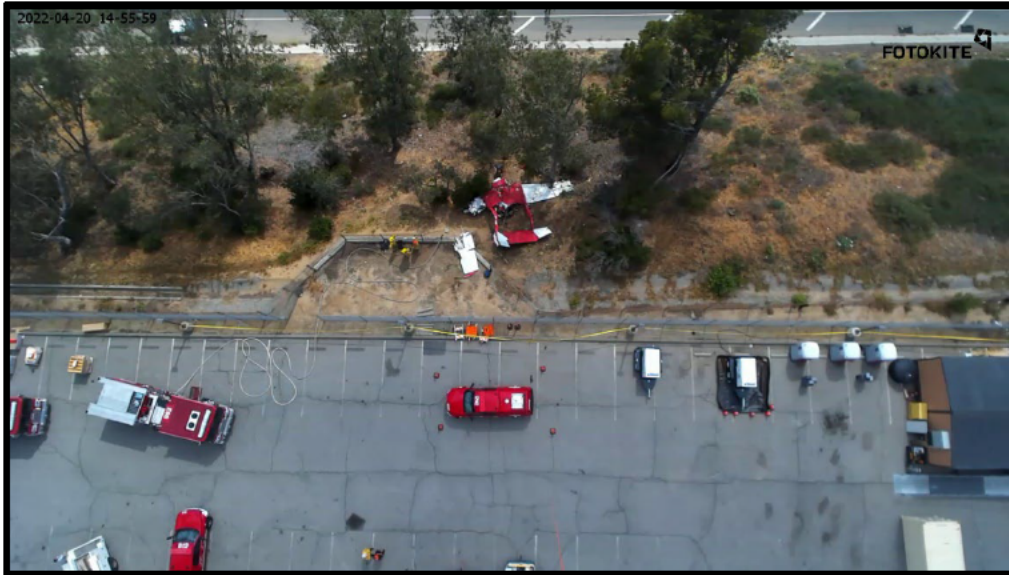
The accident site was in an urban industrial area adjacent to a Southern California Edison (SCE) substation. The airplanes' left wing clipped a perimeter fence and separated from the airplane and remained near the top of the embankment. The entire airplane came to rest on a sandy embankment wedged in between two trees, in an upright, nose-low attitude about 80 ft from the westbound lanes of Interstate 210.

Figure 2 - Aerial View of Accident Site (Photo Courtesy of LAFD)

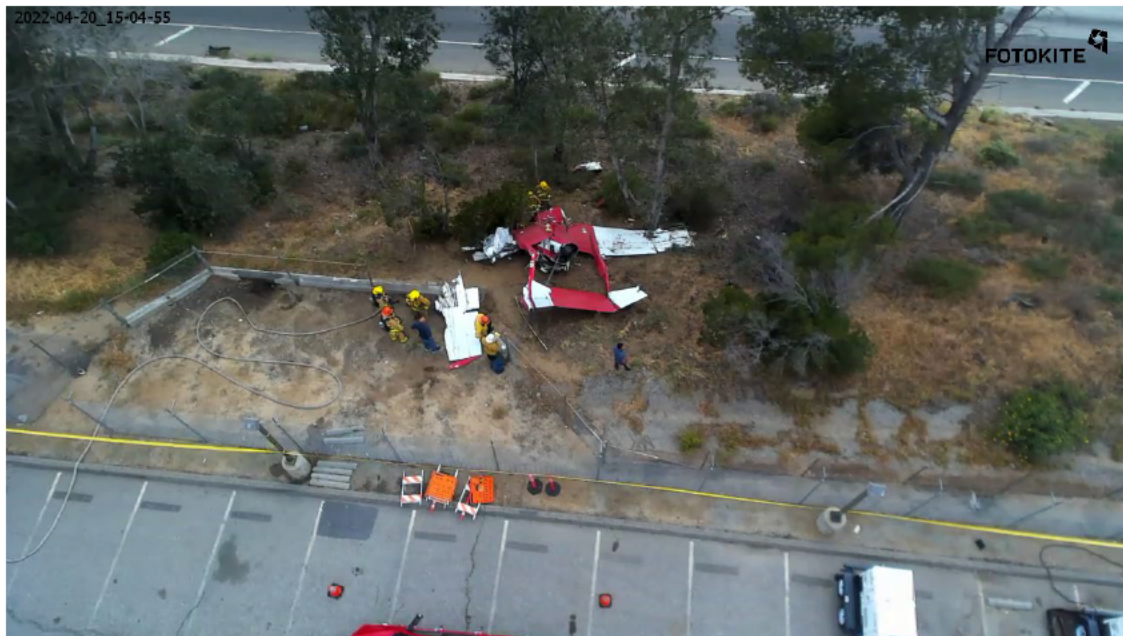
Figure 3 - Close-up Aerial View of the Accident Site (Photo Courtesy of LAFD)

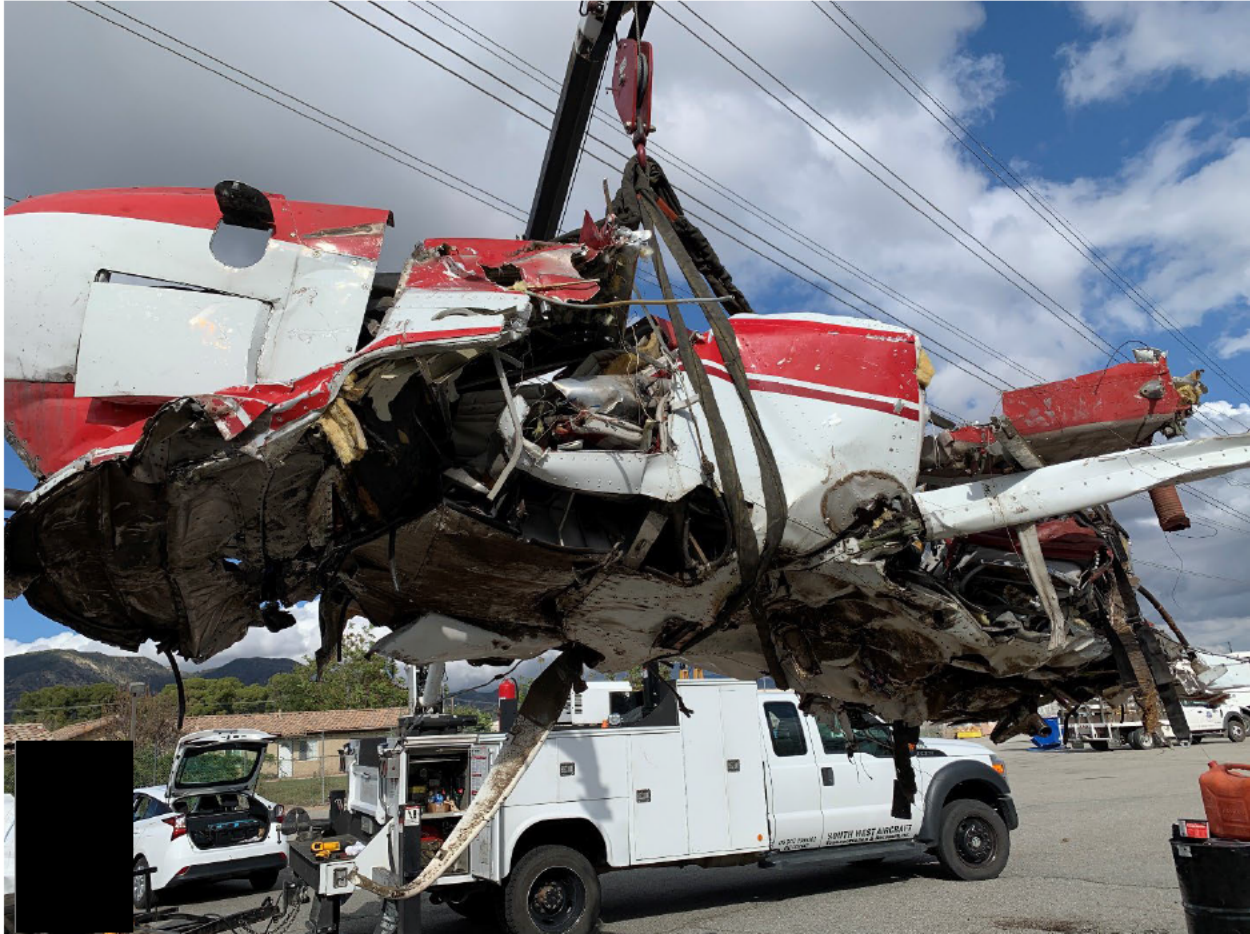
The entire airplane came to rest mostly intact at the accident site. The left outboard portion of the wing struck a perimeter fence during the accident sequence, separated, and remained near the top of the embankment, above the main wreckage. Flight control continuity was established from the cockpit to each flight control surface either from movement of each control cable, or

visually. The smell of fuel was present at the accident site; the left outboard wing and inboard fuel tanks had been breached. The right-wing inboard fuel tank had not been breached and fuel was observed in the fuel tank. The right outboard fuel tank had been breached.

Figure 4 - Recovered Main Wreckage at Accident Site

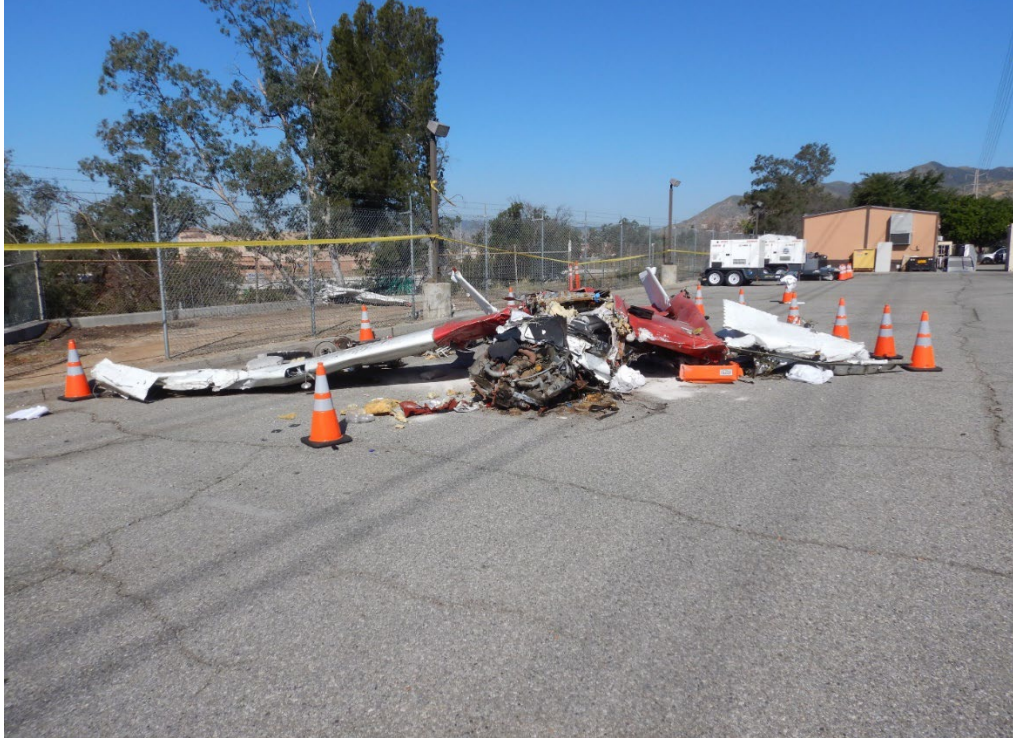
The undercarriage sustained crushing damage the entire length of the fuselage.

Figure 5 - Front View of the Accident Airplane (Photo Courtesy of Textron Aviation)

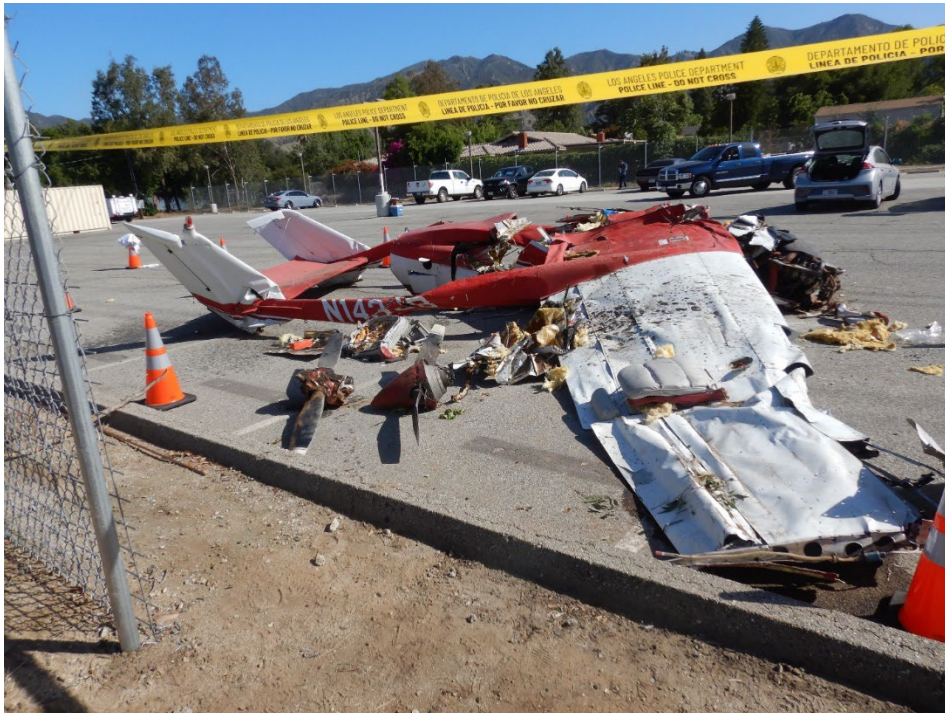
Figure 6 - Right View of Accident Airplane (Photo Courtesy of Textron Aviation)

Most of the right wing remained attached to the airframe; the tip separated. The wing was crushed and sustained leading to trailing edge damage. The right tailboom was buckled and crushed to the right.

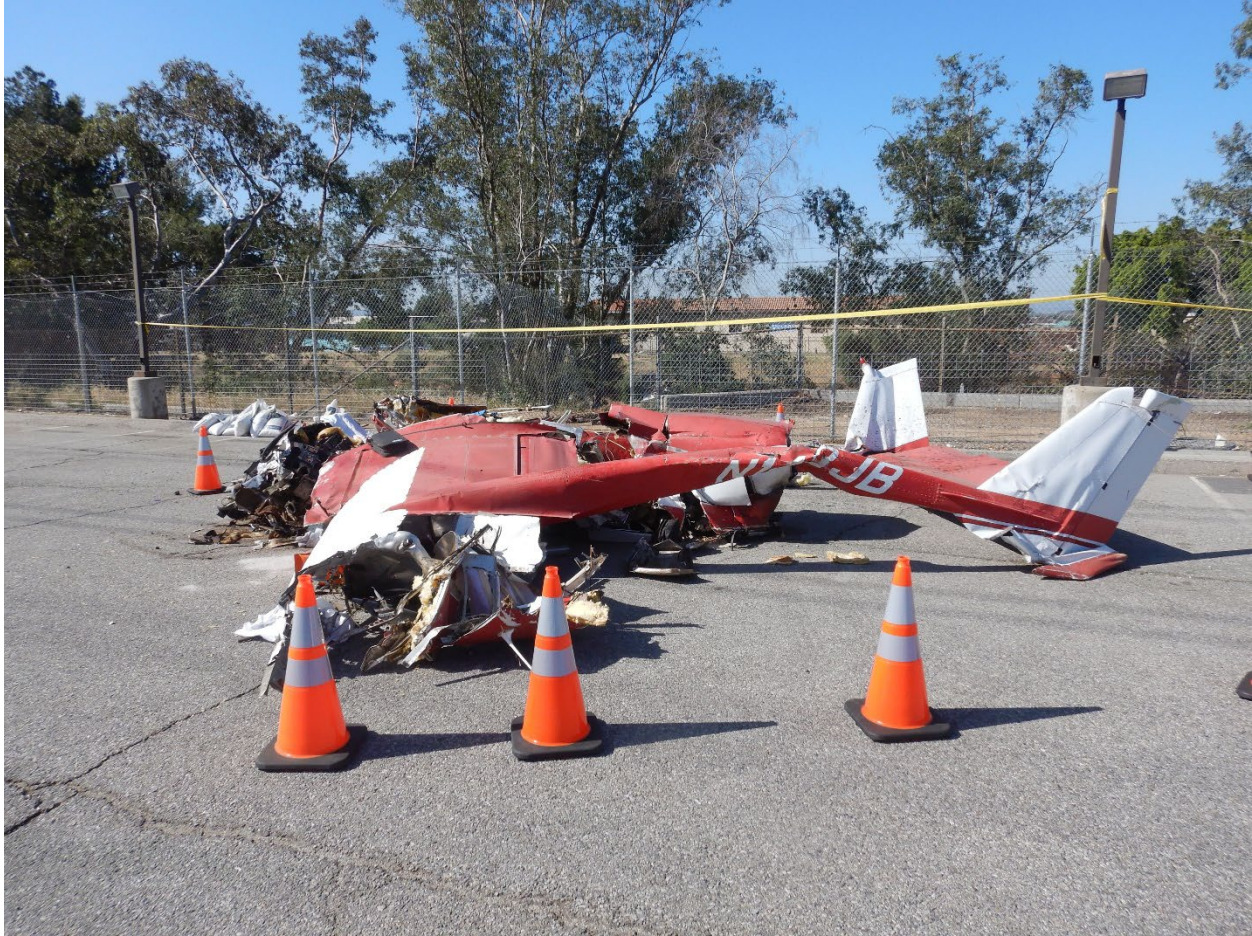
Figure 7 - Left View of Accident Airplane (Photo Courtesy of Textron Aviation)

The left tailboom remained attached to the fuselage and was buckled up and toward the right.

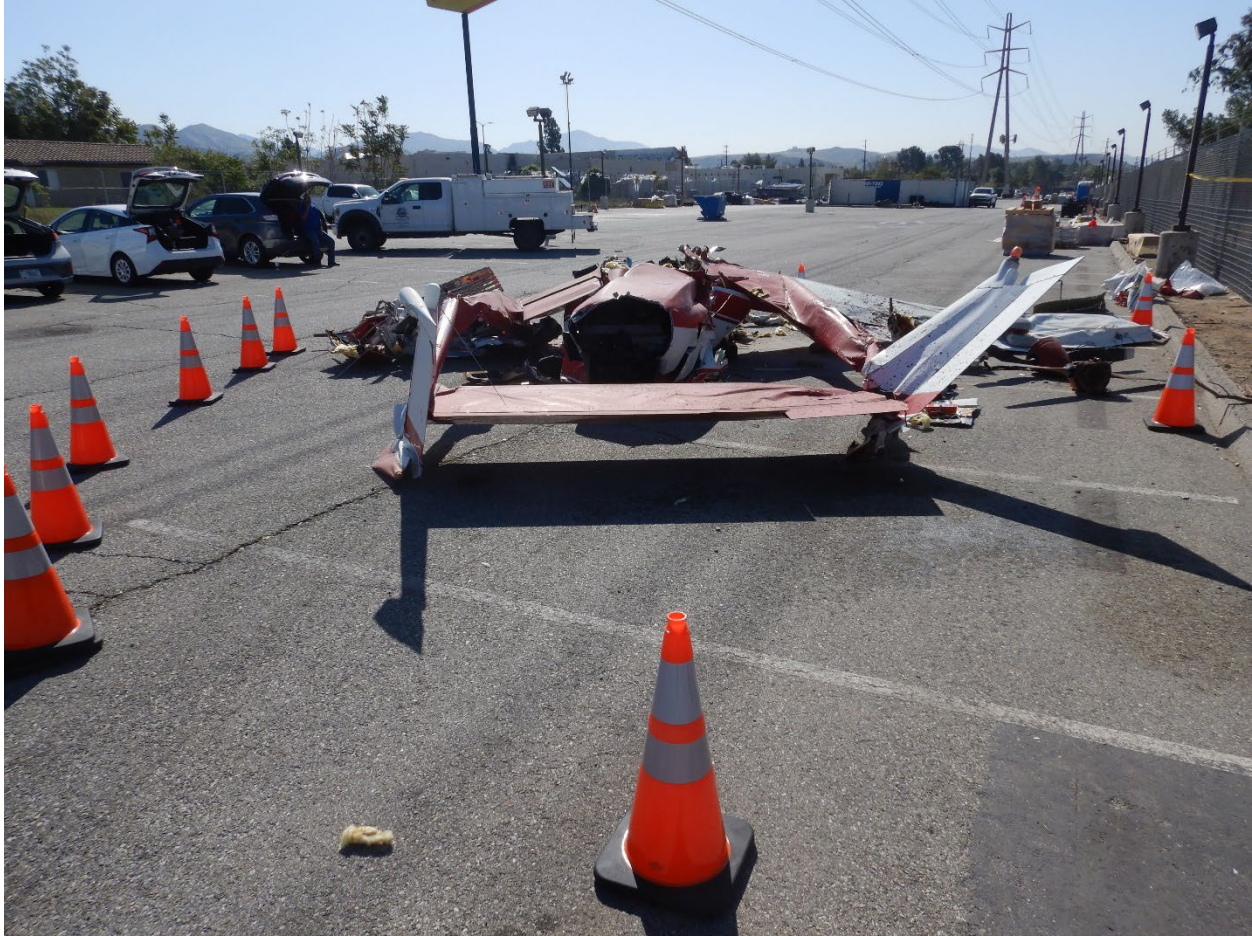
Figure 8 - Rear View of Accident Airplane (Photo Courtesy of Textron Aviation)

Both left and right vertical stabilizers remained attached but were canted toward the right.

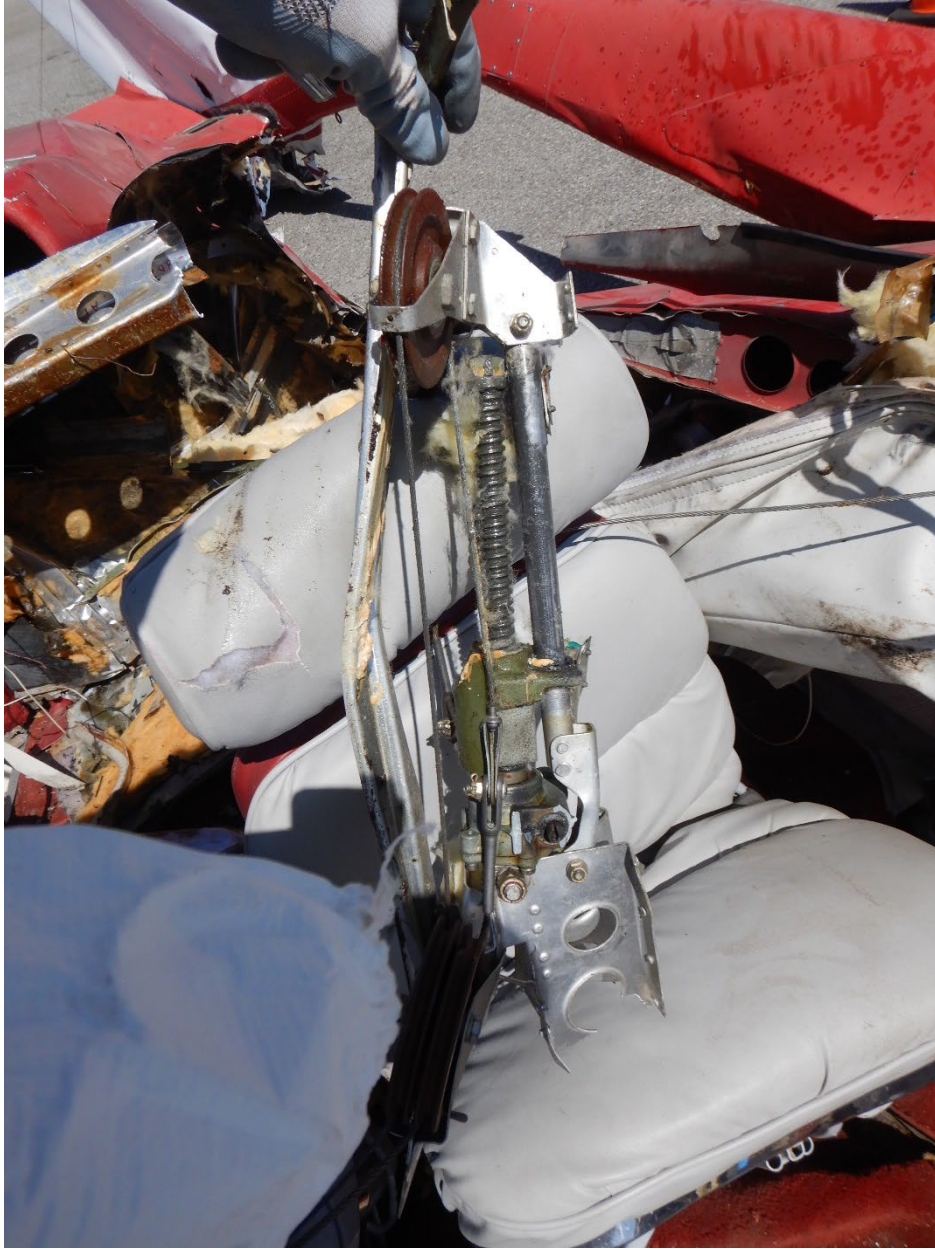
Figure 10 - Flap Motor/Actuator - Full Retracted Position - Flaps up (Photo Courtesy of Textron Aviation)

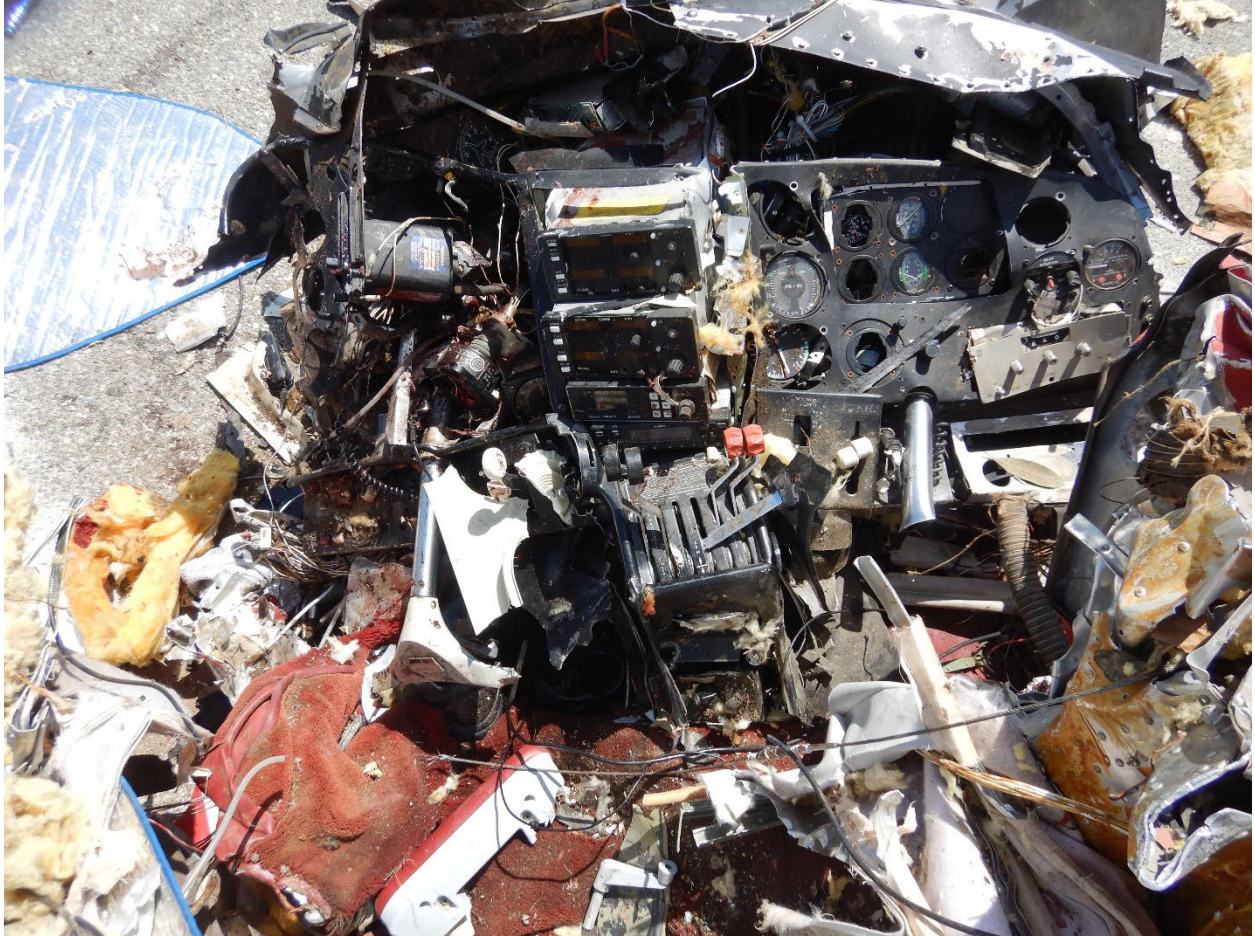
Figure 14 - Instrument Panel (Photo Courtesy of Textron Aviation)

Instruments panel was destroyed during impact sequence.

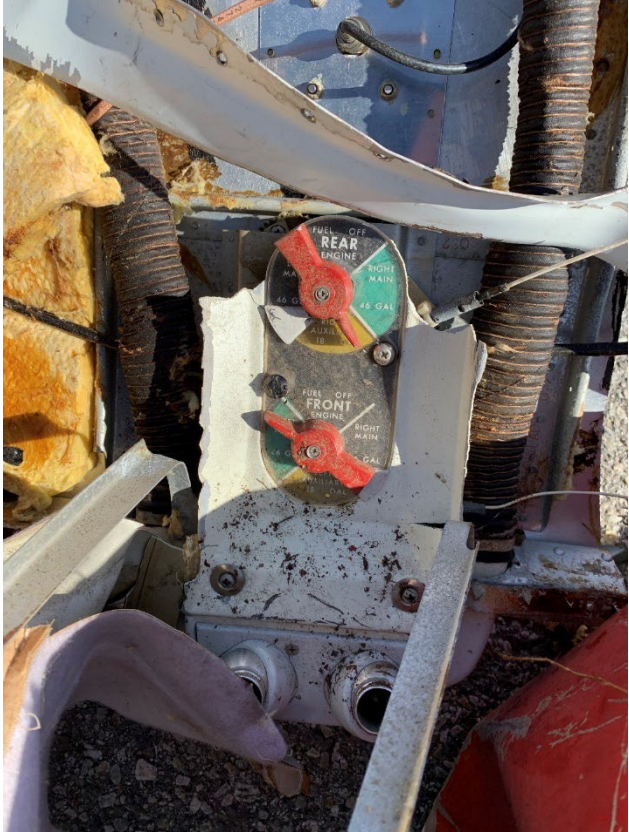
Figure 16 - Fuel Selector Handles

The fuel selector handles were positioned:
Front Engine - Left Main
Rear Engine - Auxiliary tank

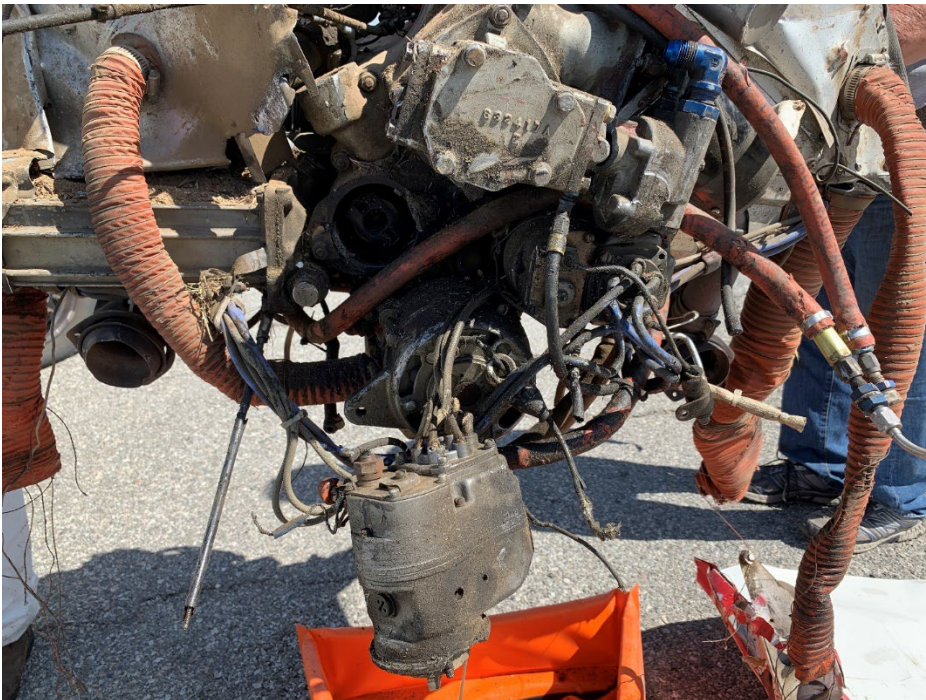
Figure 20 - View of Accessory Section of Forward Engine

The left magneto separated from its mounting pad but remained attached via the ignition harness.

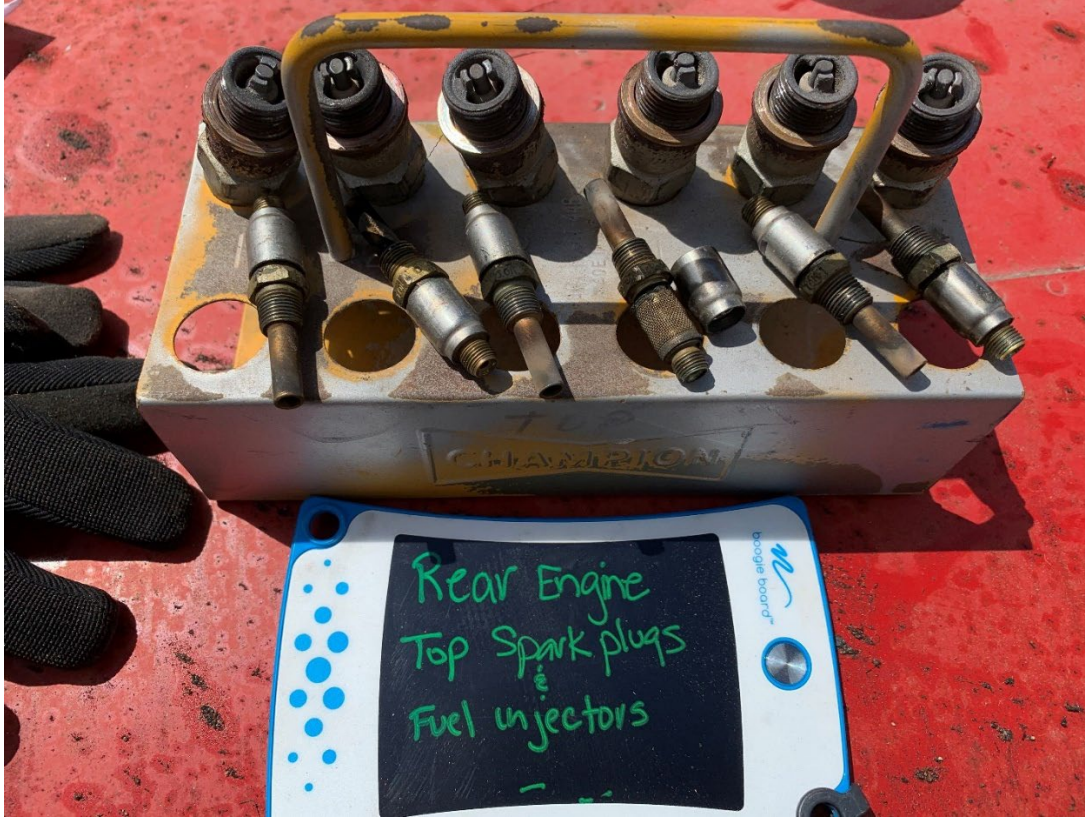
Figure 23 - View of Rear Engine Top Spark Plugs and Fuel Injectors

The top spark plugs for the rear engine were removed, and they were the massive electrode type. According to the Aviation Check-A-Plug Chart AV-27, the spark plug electrodes exhibited a normal worn-out appearance and were carbon and oil fouled. The fuel injector screens were free of debris.

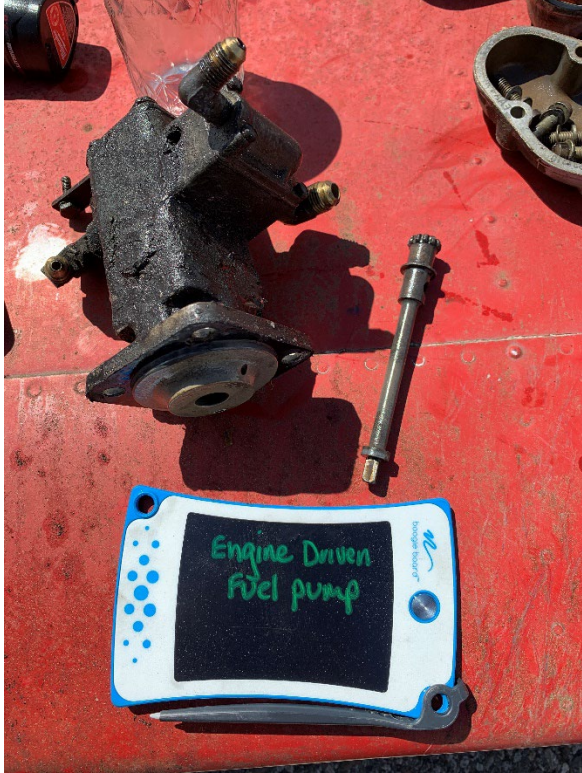
Figure 24 - Rear Engine Driven Fuel Pump

The rear engine driven fuel pump drive shaft remained intact. A residual amount of a blue colored liquid was removed from the fuel pump.

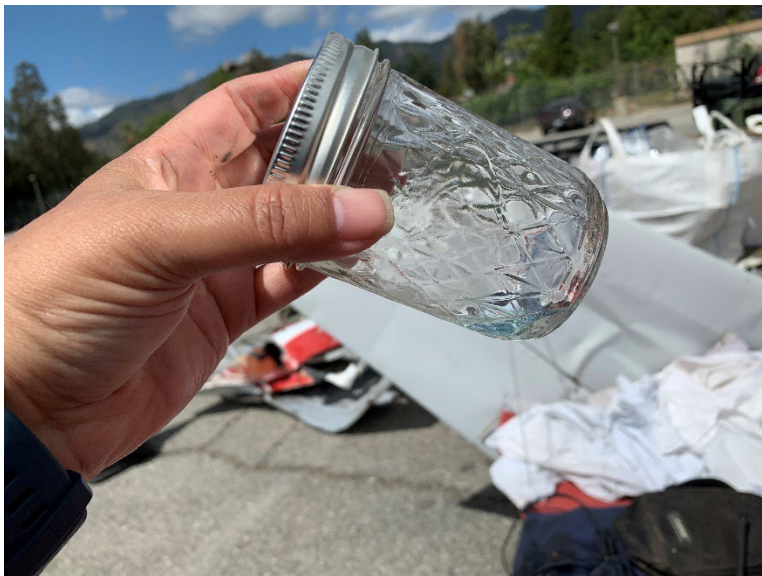
Figure 25 - Residual Fuel from Fuel Pump

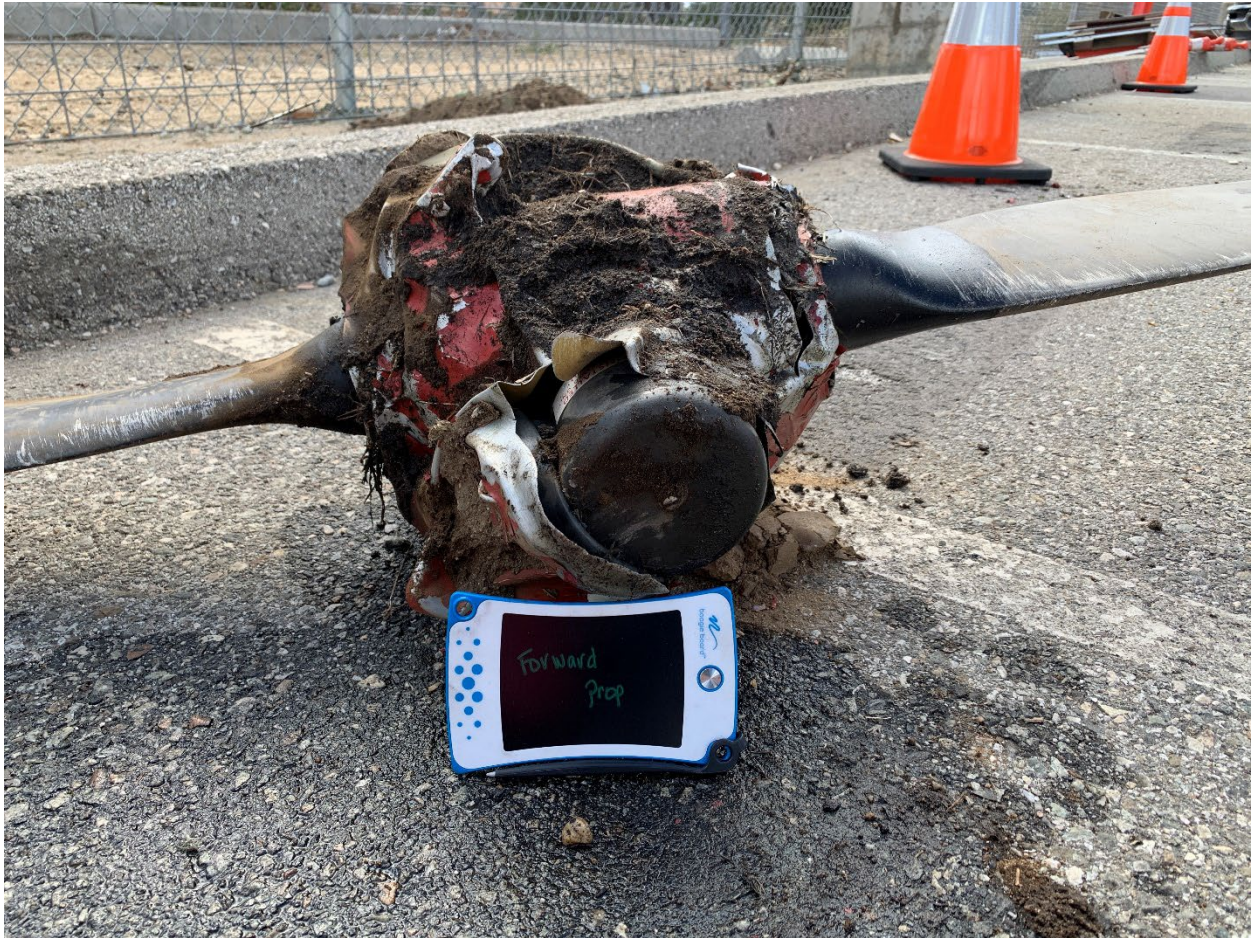
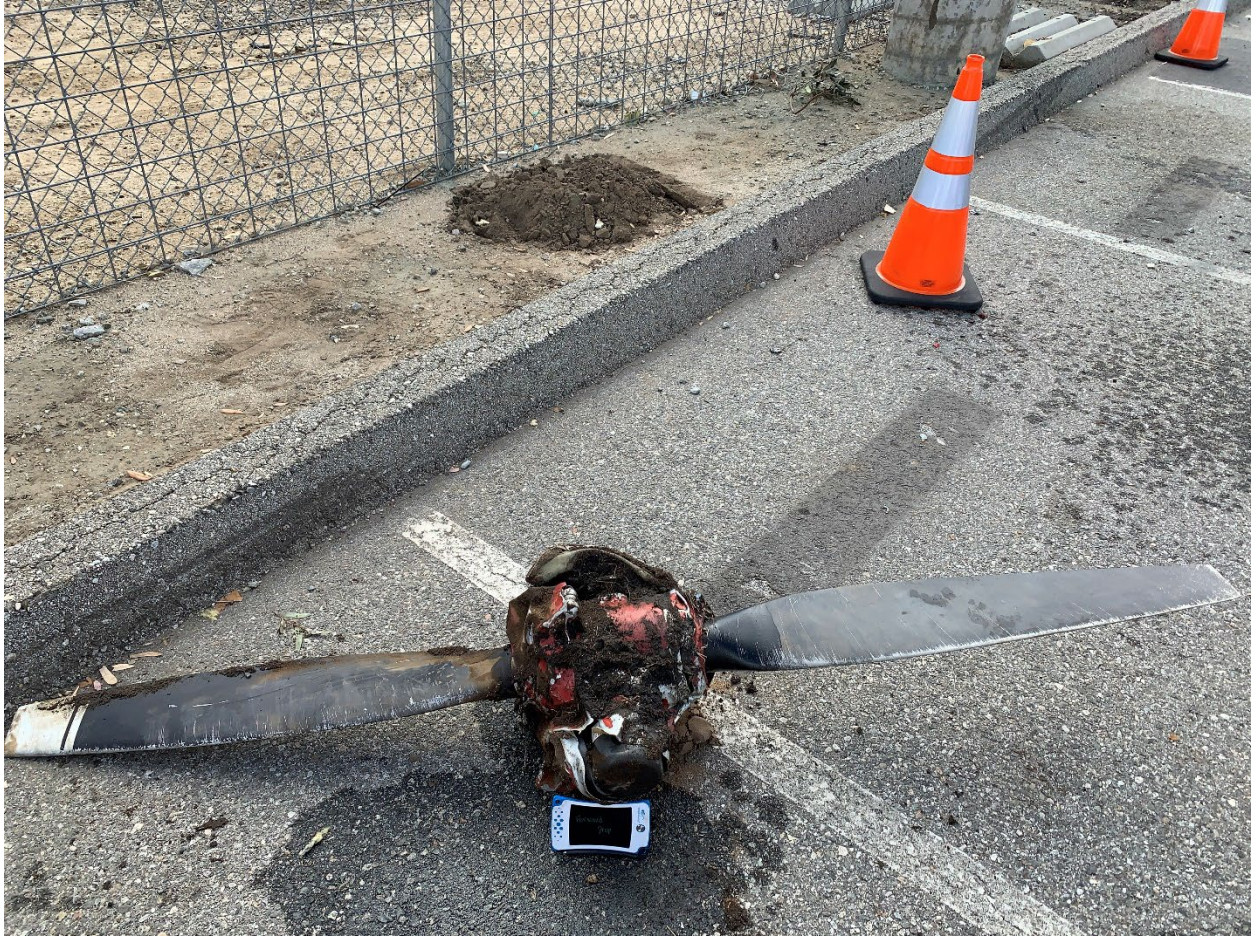
The forward engine propeller assembly had separated at the engine crankshaft propeller flange, with the propeller blades remaining attached at the hub. It was located underneath the engine in its relative normal position. The propeller blades were relatively straight with chordwise scratching the full length of the blades to include the cambered and face sides. The spinner showed rotational damage. The tip section of one of the propeller blades had separated.

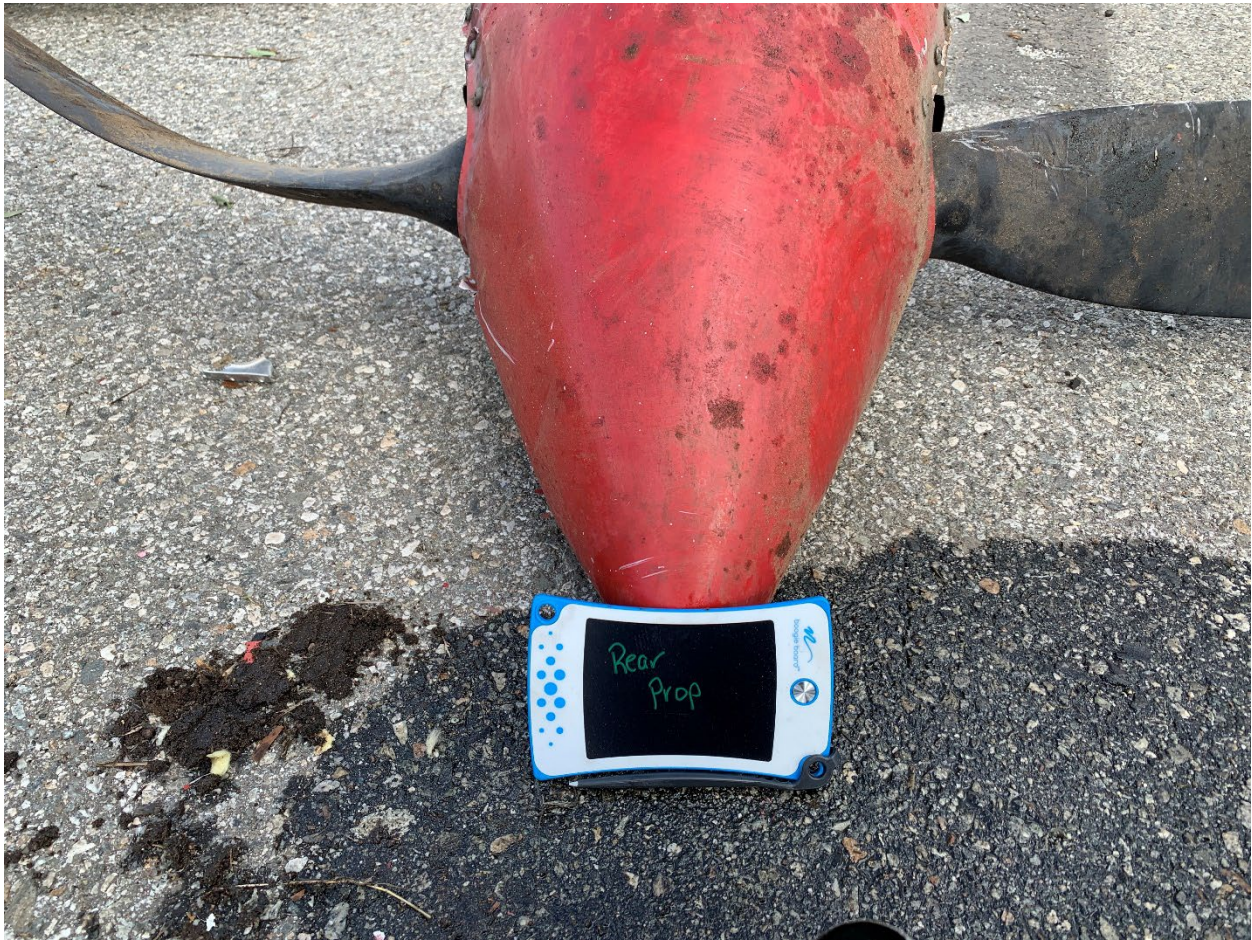
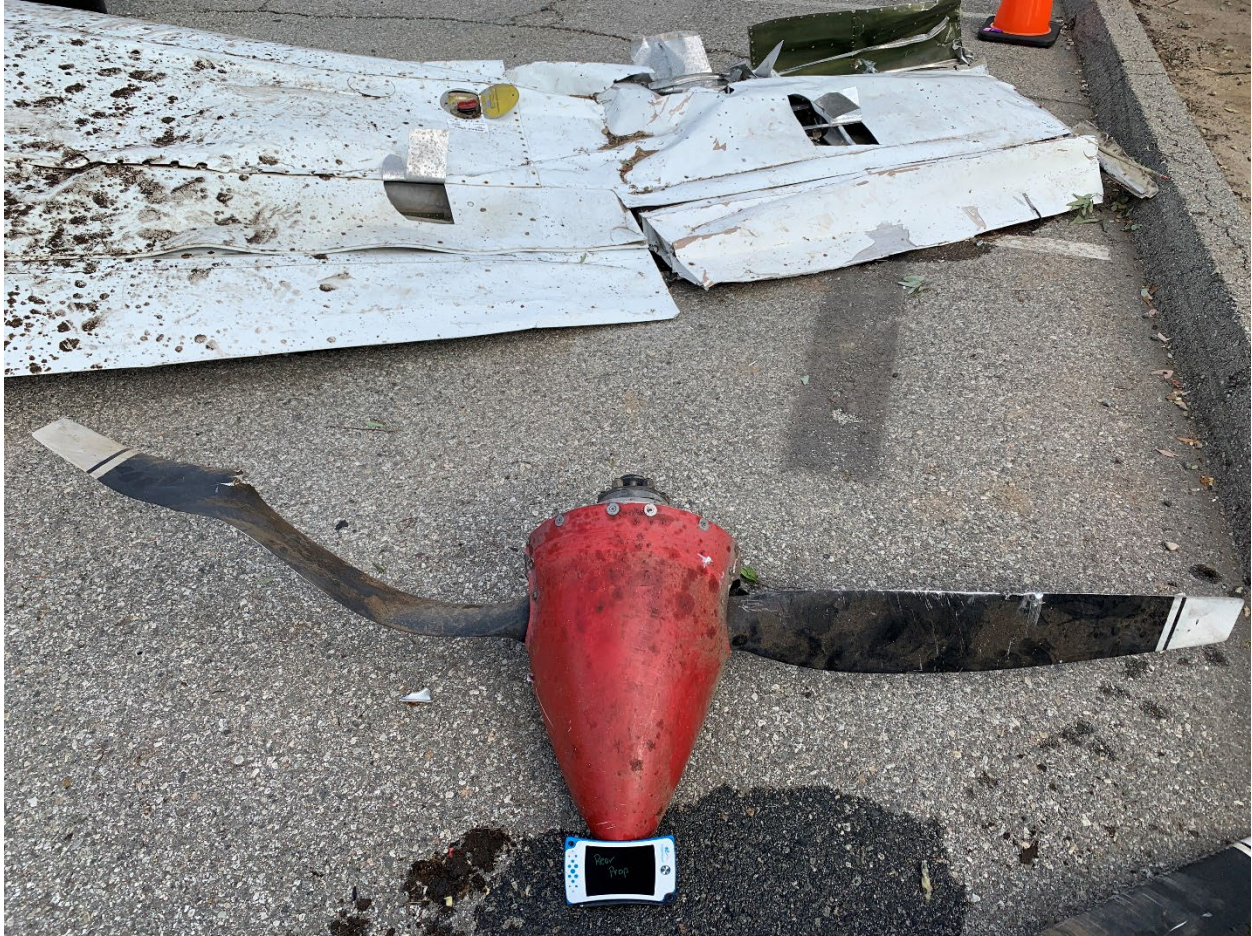
The rear engine propeller assembly separated at the engine crankshaft propeller flange, and the spinner remained intact with minimal postcrash damage. It came to rest just forward of the right wing. The propeller blades remained attached at the hub. One propeller blade exhibited S-bending and was bent aft about mid-span; the remainder of the blade was bent forward with a tear at the leading edge.
