## **NATIONAL TRANSPORTATION SAFETY BOARD**

# **ACCIDENT SITE EXAMINATION SUMMARY**

**WPR22FA164**

Location: Cedar City, Utah  
Date: April 23, 2022  
Aircraft: Diamond, DA 40, N321PF  
NTSB Investigator-in-Charge: Eric M. Gutierrez

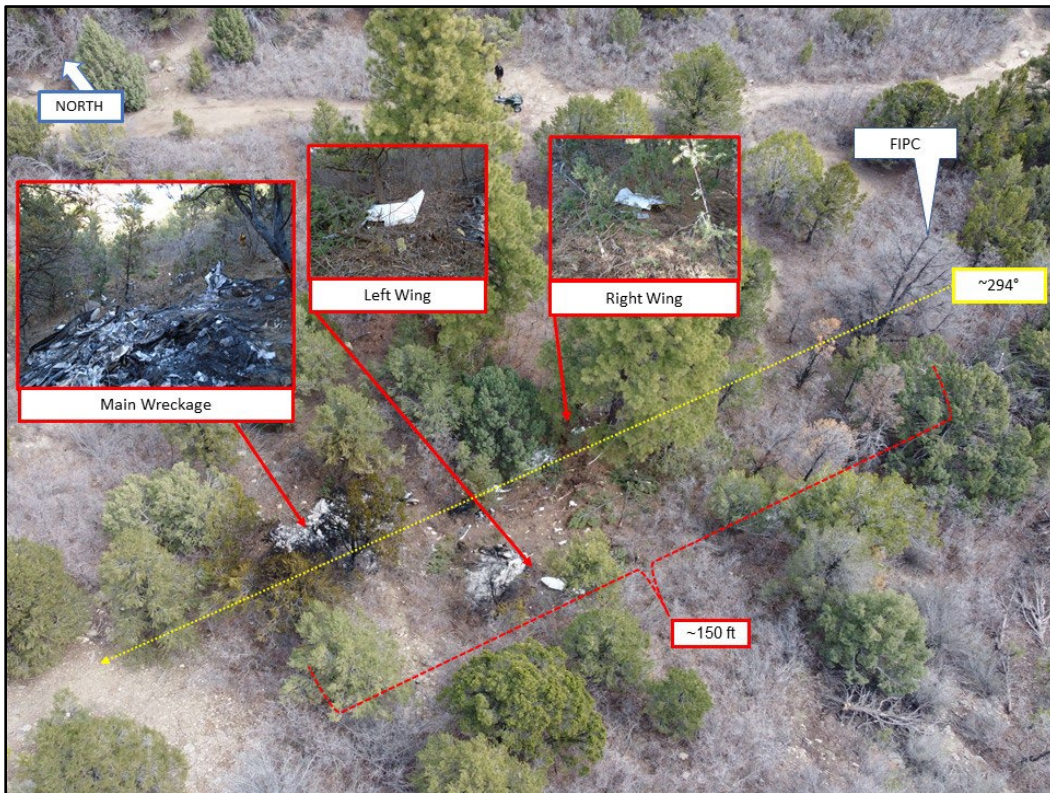
Examination of the accident site revealed that the airplane impacted mountainous terrain along the southern edge of a canyon about 7 miles southeast of the CDC. The airplane came to rest inverted, on a magnetic heading of about 289°, at an elevation of 6,583 ft mean sea level. The first identified point of contact (FIPC) was a tall tree that had damaged limbs near the top of the tree. The debris path was oriented on a magnetic heading of about 294° and was about 150 ft in length from the FIPC to main wreckage. All major structural components of the airplane were located throughout the debris path.

Figure 1: View of accident site diagram (photo courtesy of the NTSB)

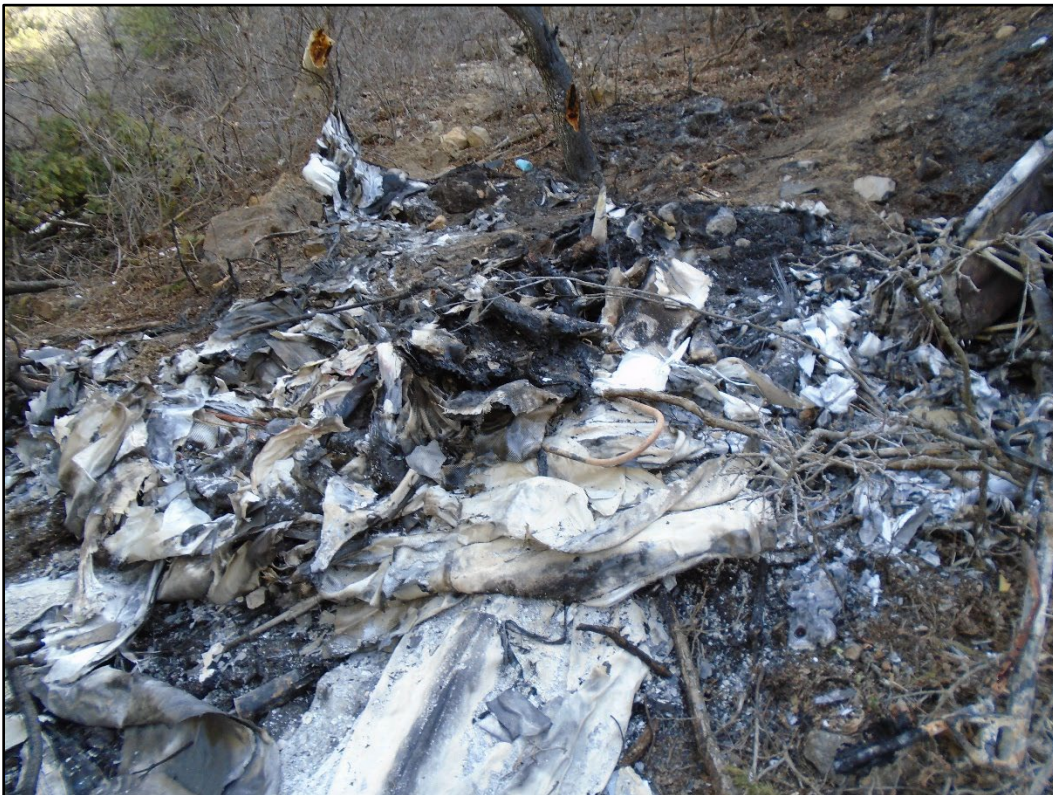
Examination of the fuselage revealed that it was mostly destroyed by thermal and impact damage. Both wings, center section, left and right horizontal, elevators, vertical stabilizer, and rudder were separated. The fuselage came to rest inverted against uneven mountainous terrain on a magnetic heading of about 289°. The instrument panel was thermal and impact damaged with instruments separated. The nose landing gear was separated from the fuselage.

The forward section of the fuselage was heavily impact and thermal damaged. The cockpit, flight controls, and seats were separated and located within debris field. The cabin area was heavily impact and thermal damaged. The instrument panel was recovered with various instruments separated. The engine mount had several fractures, consistent with impact damage. The aft section of the fuselage exhibited thermal damage throughout.

Figure 2: View of airplane fuselage (photo courtesy of the NTSB)

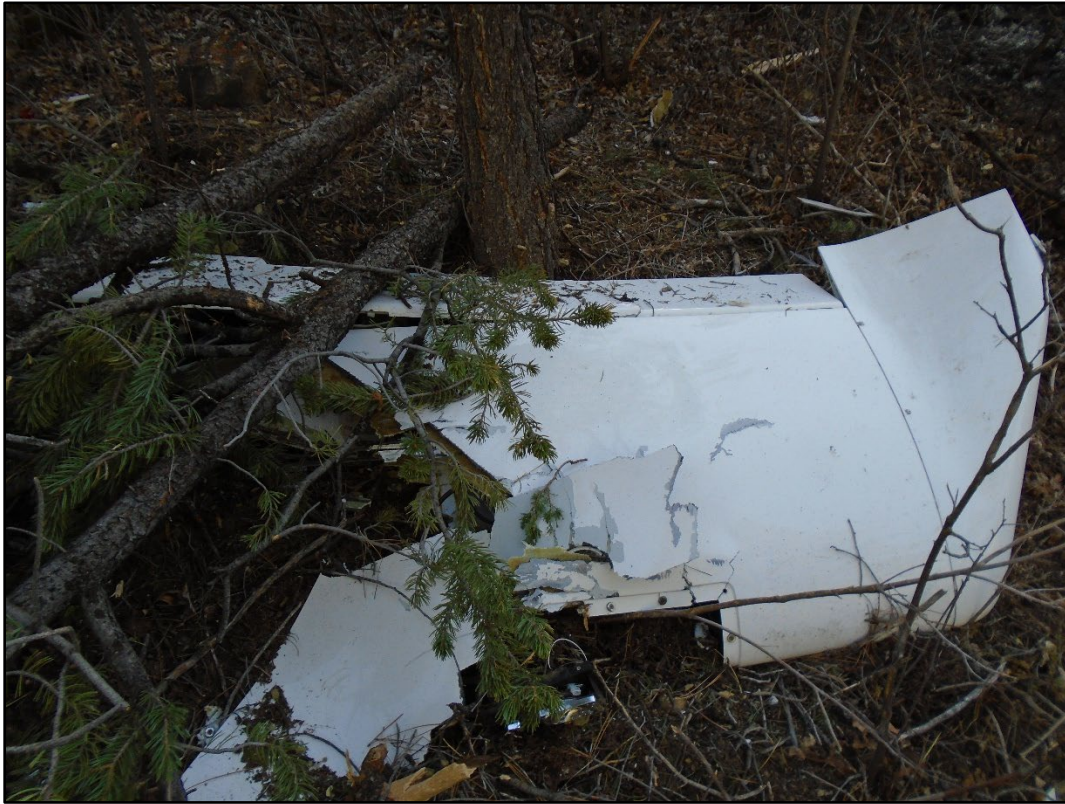
The left wing separated from the fuselage at the wing root and fragmented into numerous sections. The fragmented left wing sections were scattered throughout the debris field and

thermal damaged. Near the FIPC a 5 ft left wing outboard section with the aileron attached to the wing attachment points was observed. The left main landing gear strut separated from the fuselage and was located in the debris field.

**Figure 3: View of left wing fragment (photo courtesy of the NTSB)**

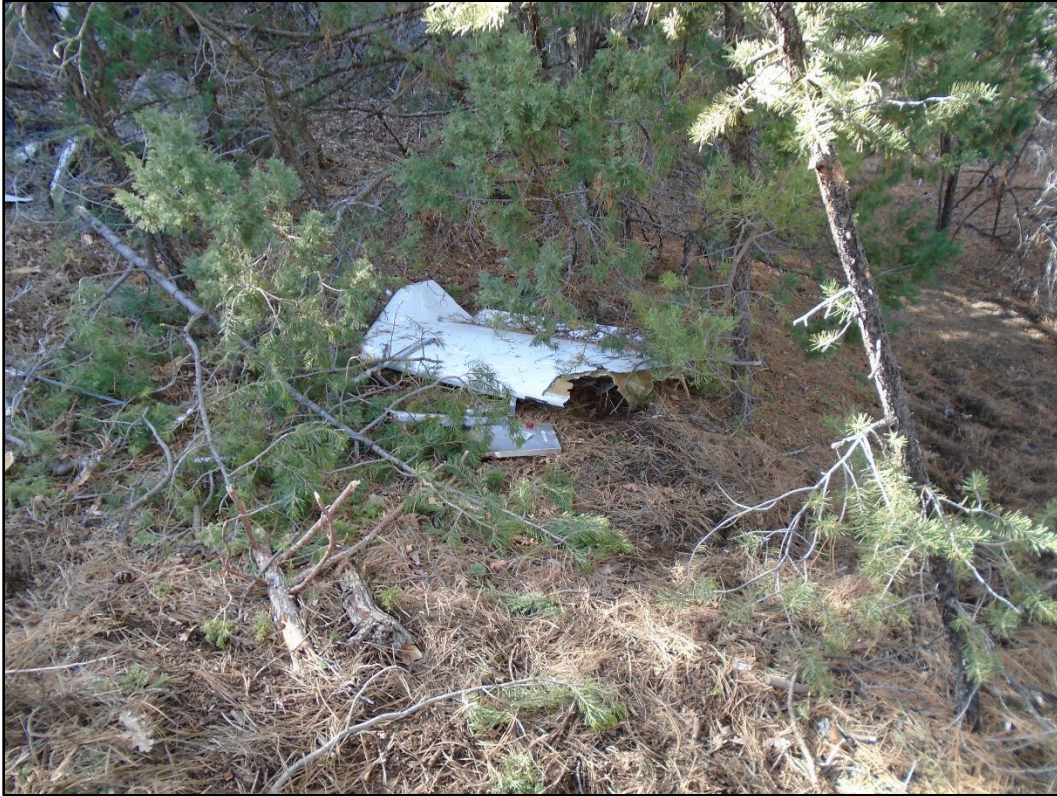
The right wing separated from the fuselage at the wing root and fragmented into numerous sections. The fragmented right wing sections were scattered throughout the debris field and thermal damaged. Near the FIPC a 5 ft right wing outboard section with the aileron attached to the wing attachment points was observed. The right aileron inboard section of about 1 ft was separated and located in the debris field. The right main landing gear strut separated from the fuselage and was located in the debris field.

Figure 4: View of right wing fragment (photo courtesy of the NTSB)

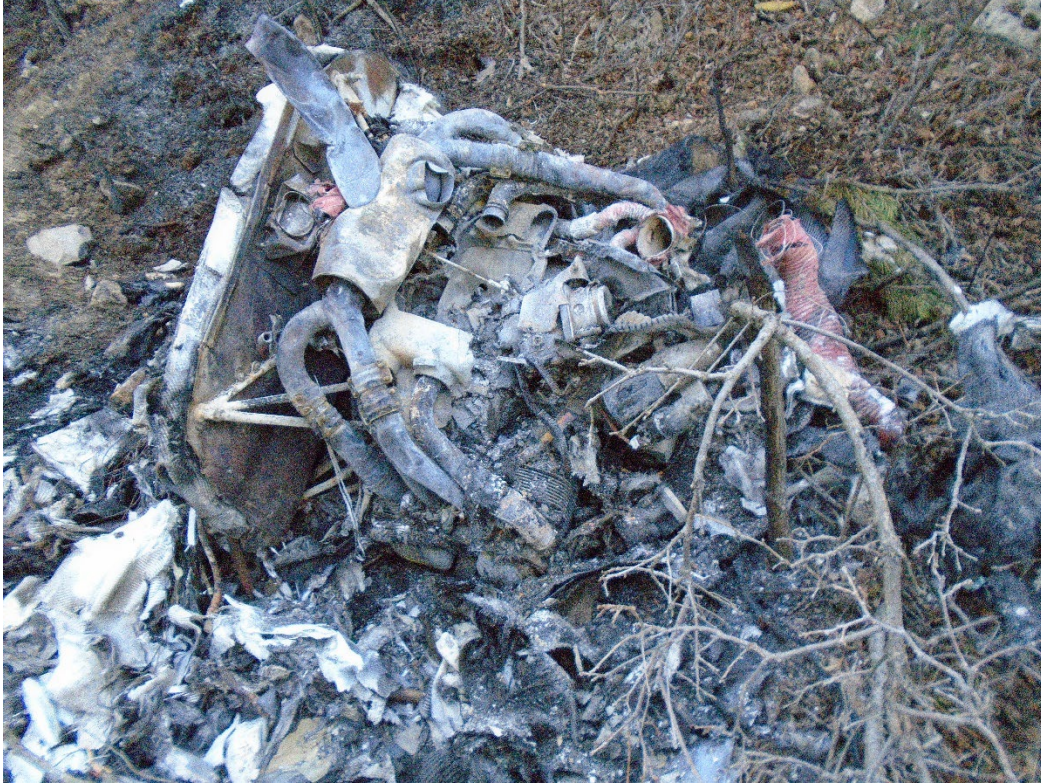
The engine remained attached to the engine mount and came to rest adjacent to the main wreckage. All four cylinders remained attached and exhibited impact and thermal damage. The throttle body was observed in the open position and exhibited impact damage. The mixture control cable remained attached to the throttle body. The throttle control cable separated at the throttle arm. The intake and exhaust remained attached and exhibited impact damage throughout. The engine starter and propeller governor were separated from the engine, exhibit impact damage and located in the debris field.

Figure 5: View of airplane engine (photo courtesy of the NTSB)

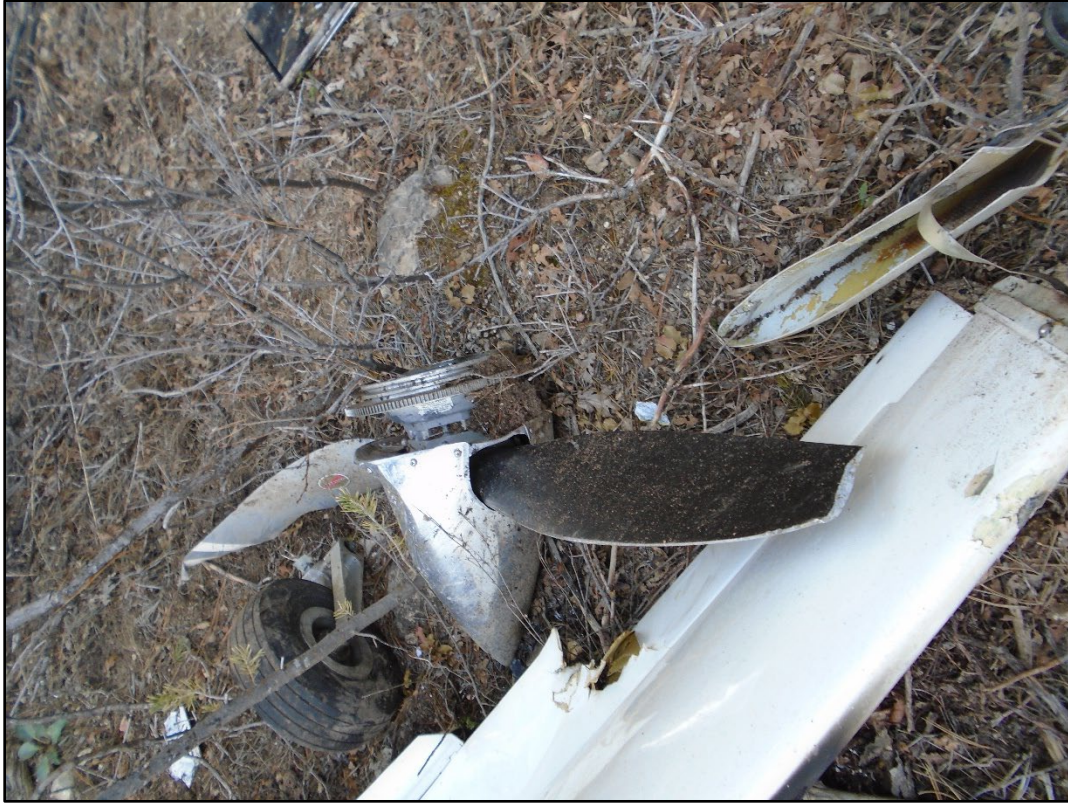
The airplane was equipped with a two blade Hartzell propeller. The propeller and attached crankshaft flange separated from the engine at the crankshaft. Both blades remained attached to the propeller hub. Propeller blade A exhibited polishing along the leading edge, along with unidirectional striations on the cambered side of the blade. Additionally, the propeller was fracture separated about near the propeller tip. Propeller blade B exhibited bending forward about mid span, with unidirectional striations on the cambered side of the blade. Additionally, about 5 in of the propeller tip was fracture separated.

**Figure 6: View of airplane propeller (photo courtesy of the NTSB)**
