NATIONAL TRANSPORTATION SAFETY BOARD

AIRFRAME AND ENGINE EXAMINATION

WPR22FA164

Location: Cedar City, Utah
Date: April 23, 2022
Aircraft: Diamond Aircraft, DA 40, N321PF
NTSB Investigator-in-Charge: Eric M. Gutierrez

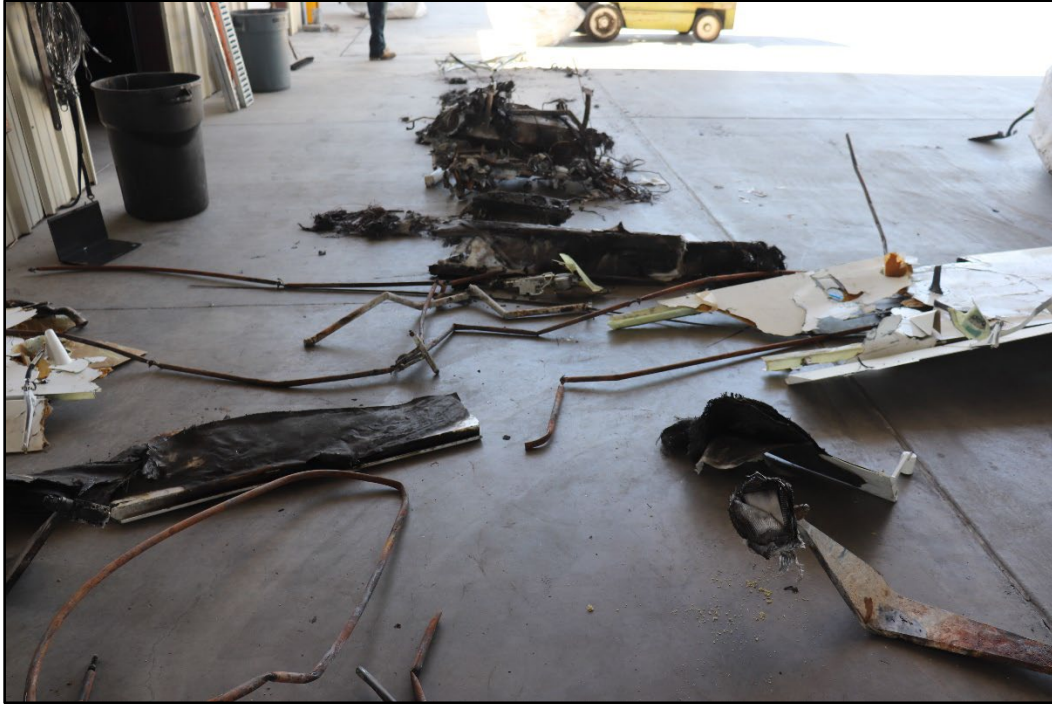
Flight control continuity was established from the primary flight controls to the primary flight control surfaces. The cockpit flight controls were separated and exhibited thermal and impact damage throughout. The rudder pedals remained attached to the firewall with heavy impact and thermal damage. All areas of separation were consistent with overload or were cut by recovery personnel.

Figure 1: View of flight control torque tubes.

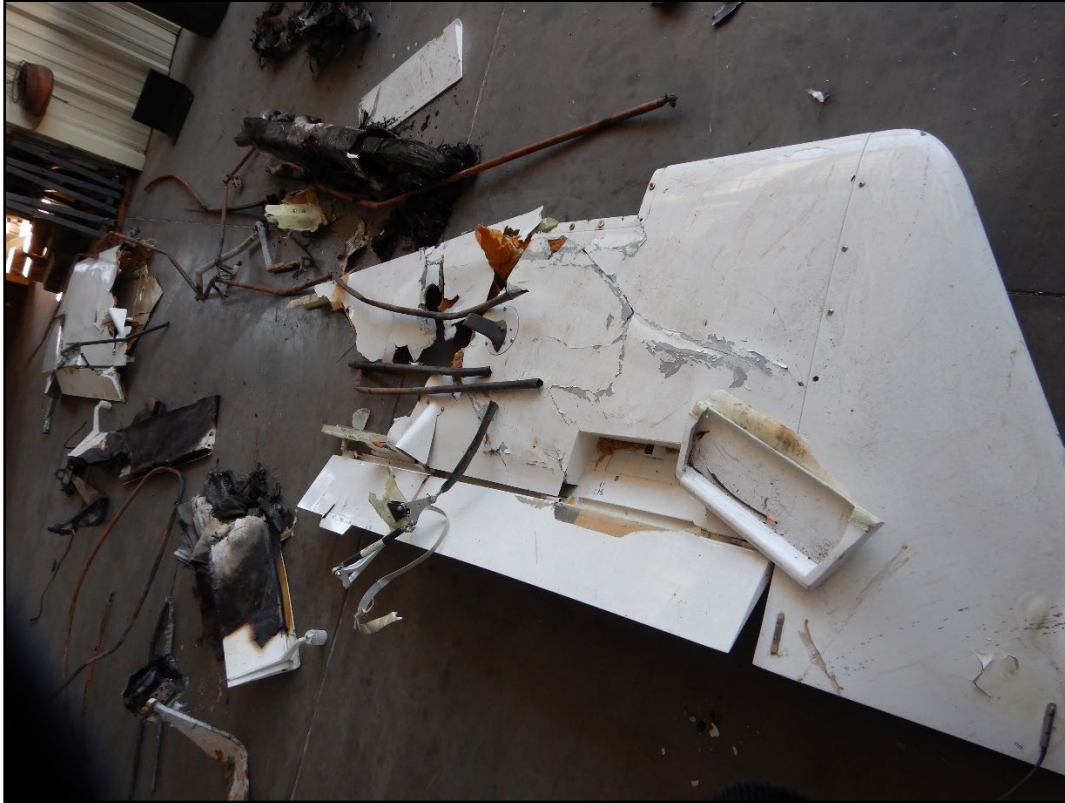
The left wing from the wing root to about midspan was destroyed fire. A 5 ft left wing outboard section with the aileron attached to the wing attachment points was observed. The left wing flap was separated, thermal and impact damaged was observed throughout. The left main landing gear strut separated from the fuselage and was thermal damaged.

The right wing from the wing root to about midspan was destroyed fire. A section of about 5 ft of the right wing outboard section with the aileron attached to the wing attachment points was observed. The right wing flap was separated, thermal and impact damaged was observed throughout. The right main landing gear strut separated from the fuselage and was thermal damaged.

Figure 2: View of left- and right-wing tips.

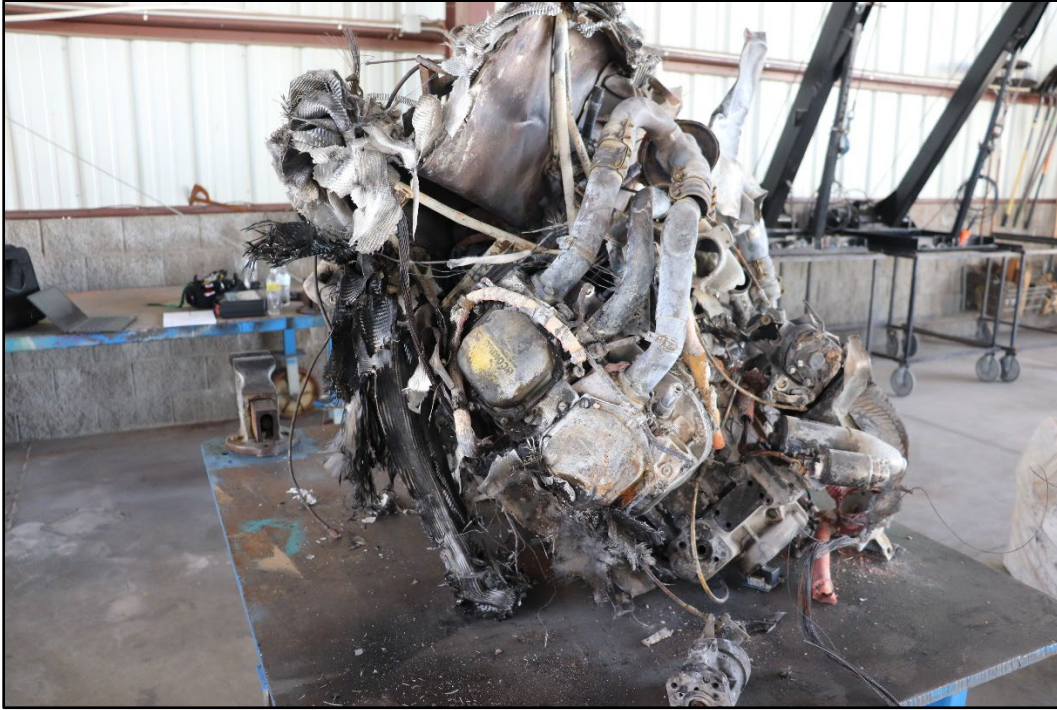
Examination of the recovered engine revealed that the engine remained attached to the engine mounts, impact and thermal damage was observed throughout. All four cylinders remained attached to the engine. The oil sump and intake plenum were mostly destroyed, consistent with impact and thermal damage. No evidence of any mechanical damage was observed to the engine crankcase. The propeller and propeller flange separated from the engine crank shaft. The exhaust remained attached, bending and crushing was observed throughout.

Figure 3: View of recovered engine.

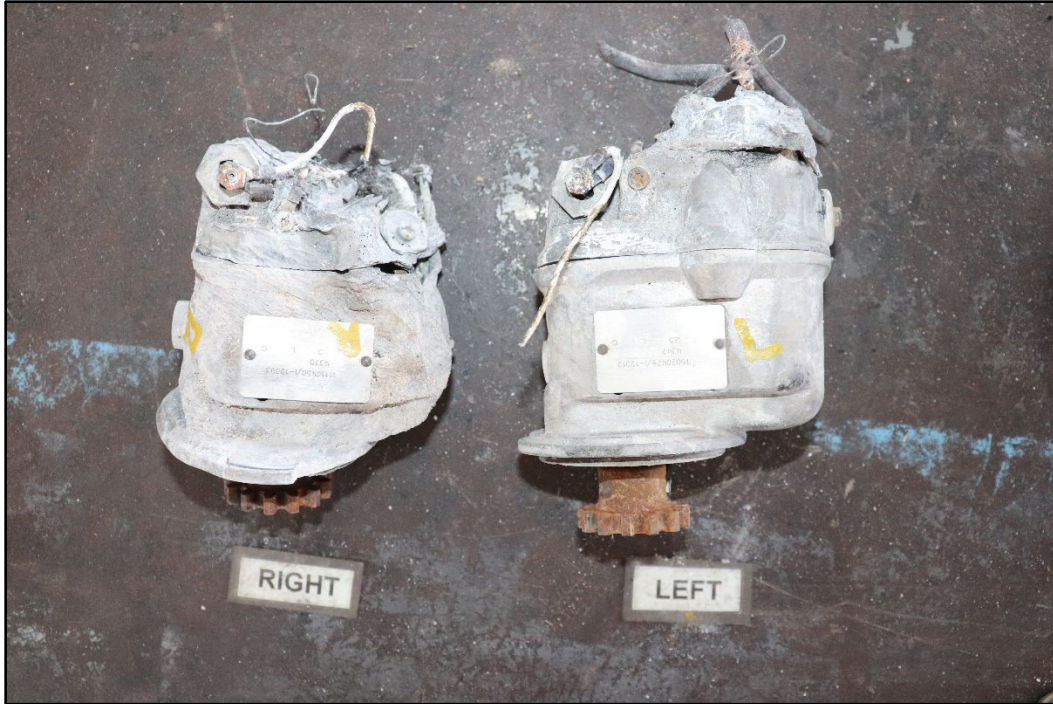
The left and right magnetos remained attached to the engine accessory case, extensive damage thermal damaged was observed on both. Due to extensive thermal damage, a functional test could not be performed.

Figure 4: View of left and right magnetos.

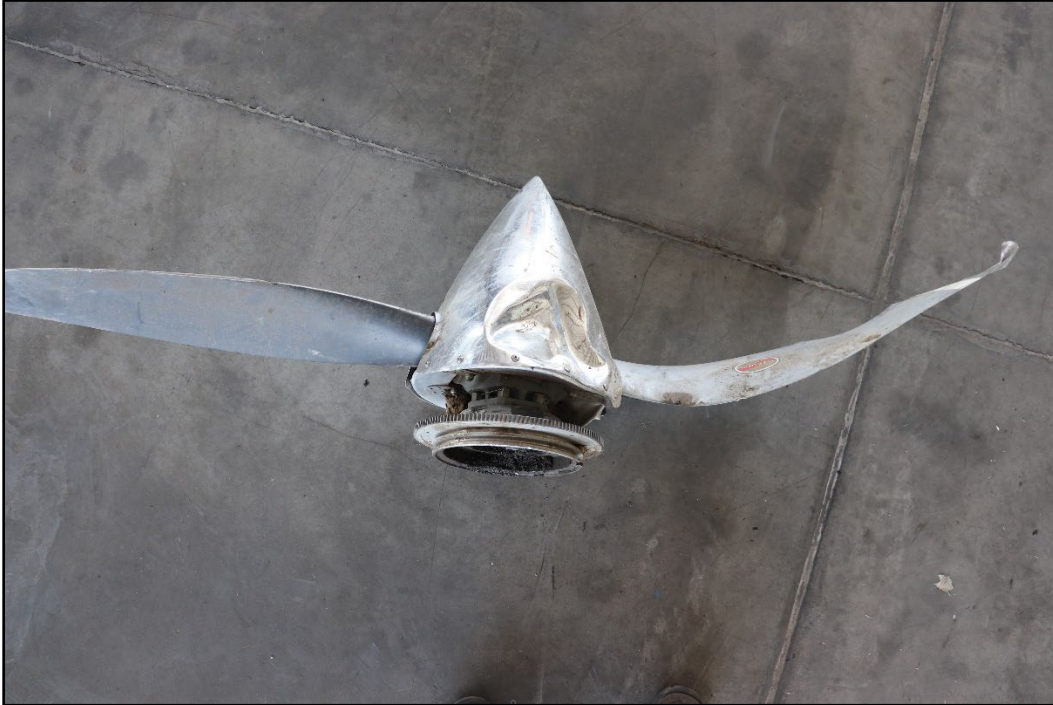
The airplane was equipped with a two blade Hartzell propeller. The propeller and attached crankshaft flange separated from the engine at the crankshaft. Both blades remained attached to

the propeller hub. Propeller blade A exhibited polishing along the leading edge, along with unidirectional striations on the cambered side of the blade. Additionally, the propeller was fracture separated about near the propeller tip. Propeller blade B exhibited bending forward about mid span, with unidirectional striations on the cambered side of the blade. Additionally, about 5 in of the propeller tip was fracture separated.

Figure 5: View of propeller.
