# National Transportation Safety Board

WPR22FA229

## **ENGINE EXAMINATION**

Location: Kerrville, Texas  
Date: June 25, 2022  
Time: 1823 LCL  
Airplane: Mooney M20J, N4267H

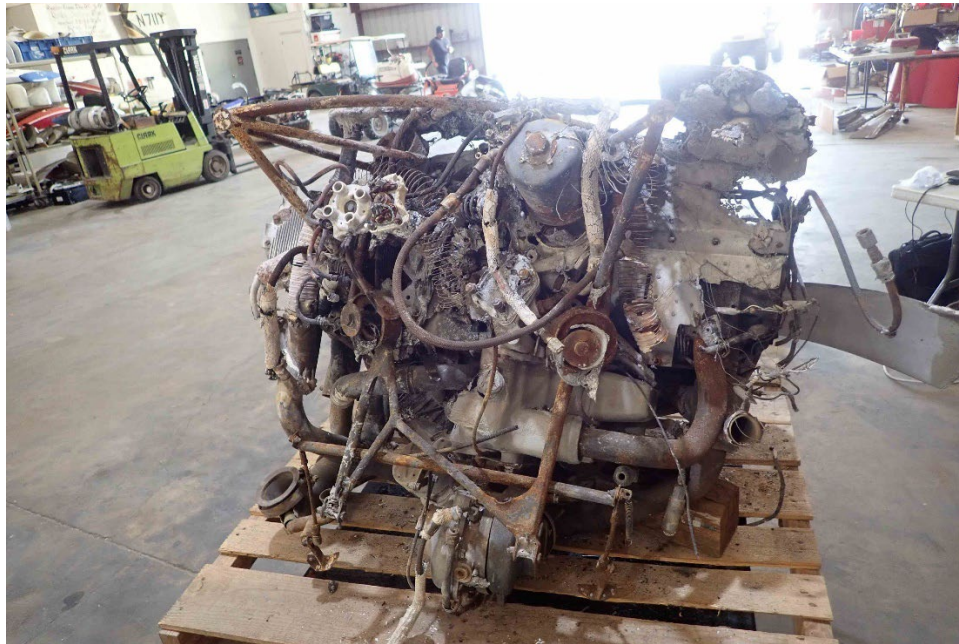
**Figure 1 - Engine before examination**

The engine sustained extensive thermal damage, and remained partially attached to the mount, which had detached from the firewall (figure 1). There was no evidence of catastrophic internal failure such as case perforation. All fuel and oil lines sustained extensive thermal damage, but the remaining line fittings were still tight at their respective attachment points.

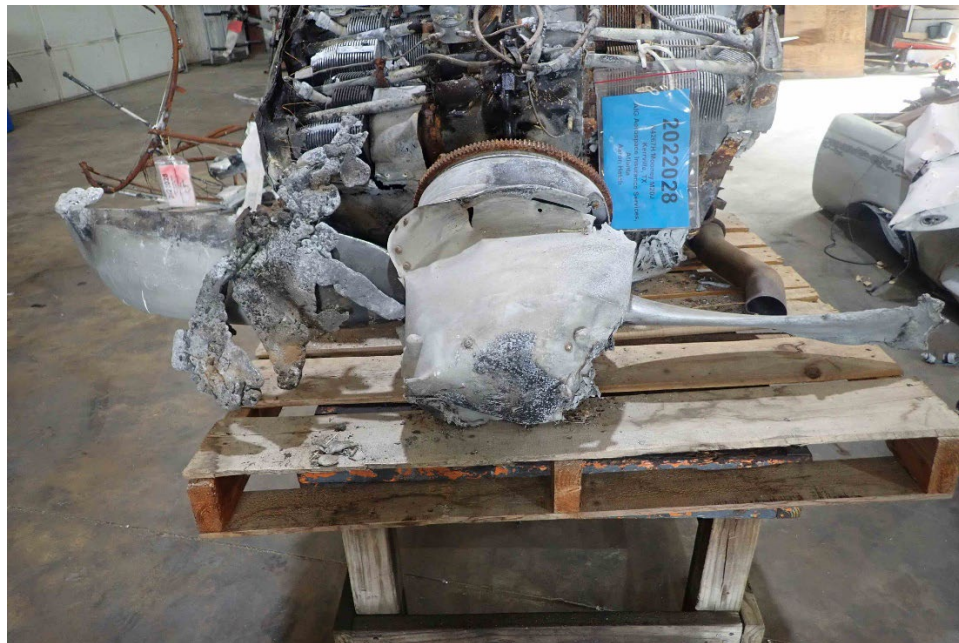
**Figure 2 - Propeller and hub/spinner**

The propeller remained attached at the hub (figure 2), both blades sustained thermal damage melting one blade outboard about midspan; this blade had partially detached from the hub, was loose within the assembly, and displayed about 45° of pitch in the direction of flight within the hub. The 12-inch section of the other blade had melted, and the blade was bent progressively about 30 degrees aft, with a similar 45° pitch angle. Neither blade remnant exhibited any leading edge nicks, dents or

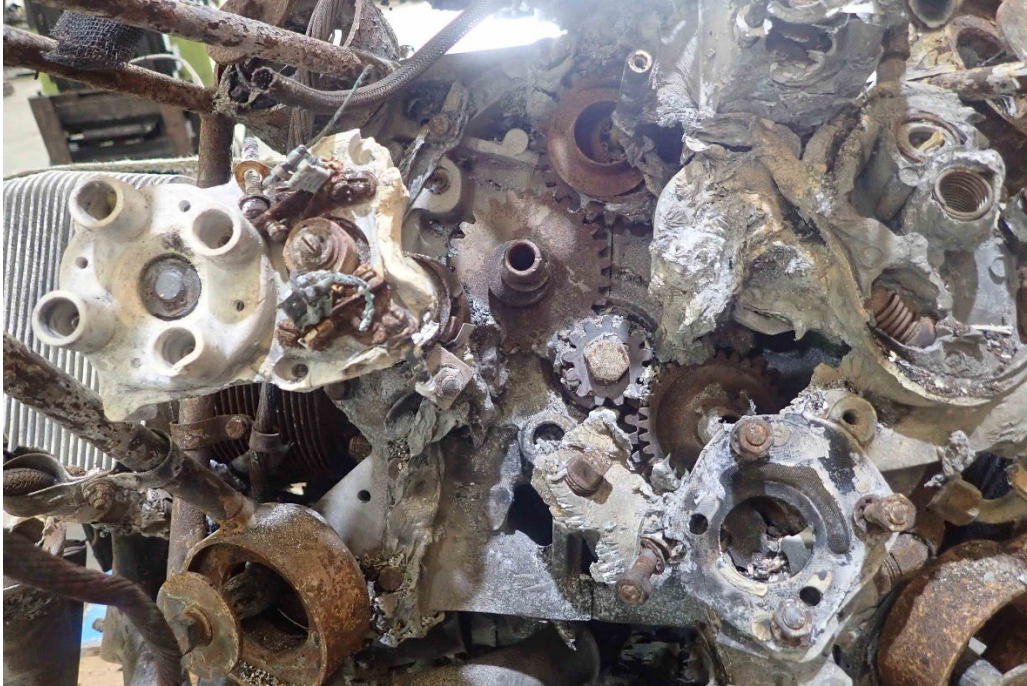
**Figure 3 - Accessory case remnants**

The accessory case had melted, exposing the accessory gear idler drivetrain (figure 3). The engine driven fuel pump had melted, revealing the inner spring, shaft, and diaphragm plate. The right side of the dual magneto had burnt away; the left side was still partially attached to the accessory case through its center drive shaft, which was still attached to the drivetrain (figure 4). Remnants of the vacuum pump mounting plate remained attached to the accessory case, but the pump appeared burnt and its remnants were not located. A burnt secondary vacuum pump assembly was observed within the airframe debris. The propellor governor case had melted, revealing the fly weights and the oil screen which was free of debris.

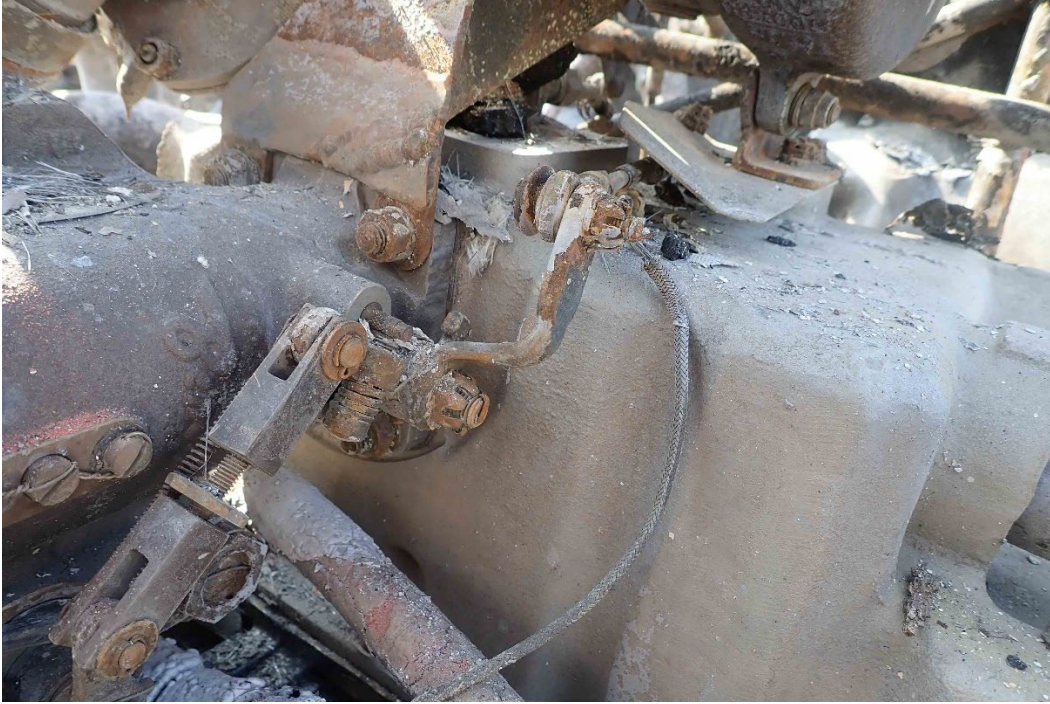
**Figure 5 - Throttle control**

The inlet manifold/oil sump had partially melted on the left side, the fuel servo remained attached to the remnants. Both the throttle (figure 5) and mixture (figure 6) linkages were still attached to the servo. The mixture arm could be moved, the throttle arm was frozen in the closed position, and the butterfly valve was in the closed position.

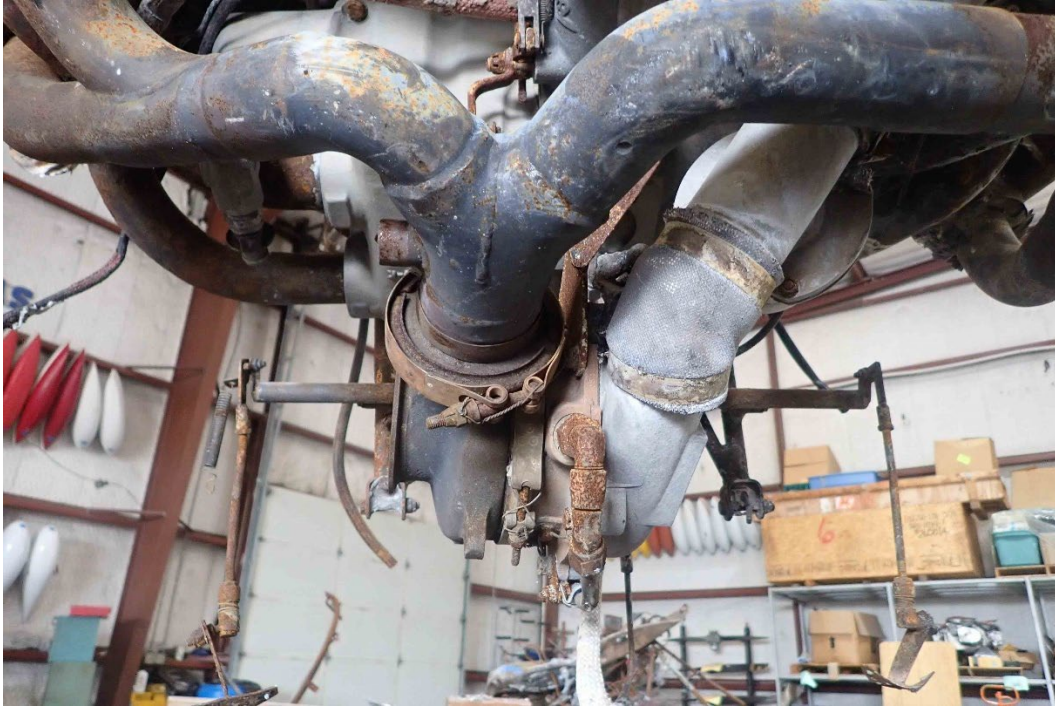
**Figure 7 - Turbocharger**

The turbocharger assembly remained partially attached to the engine. The air inlet tube had burnt away, the outlet tube was still attached to the intercooler, and the intercooler tube was still attached to the inlet of the fuel servo (figure 7). The exhaust pipes remained attached to each cylinder and were continuous to the turbocharger manifold; each slip joint was intact. The turbocharger exhaust inlet, outlet and center V-band clamps were intact (the exhaust pipe outlet clamp was disconnected by the NTSB IIC to facilitate inspection at the accident site). The exhaust fixed orifice tube

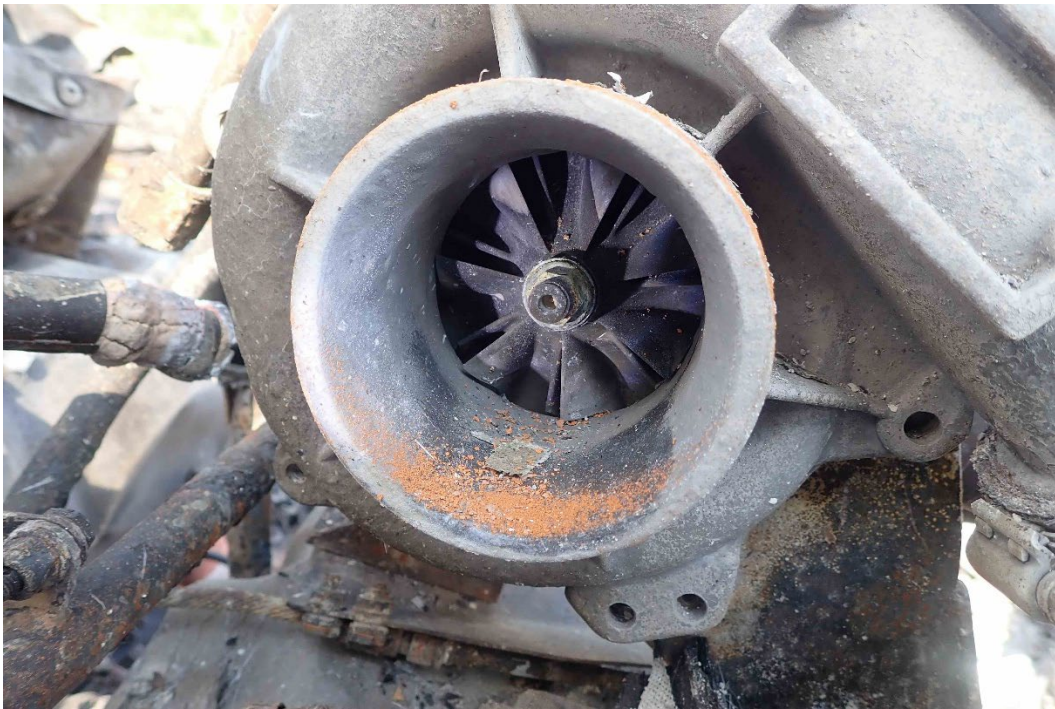
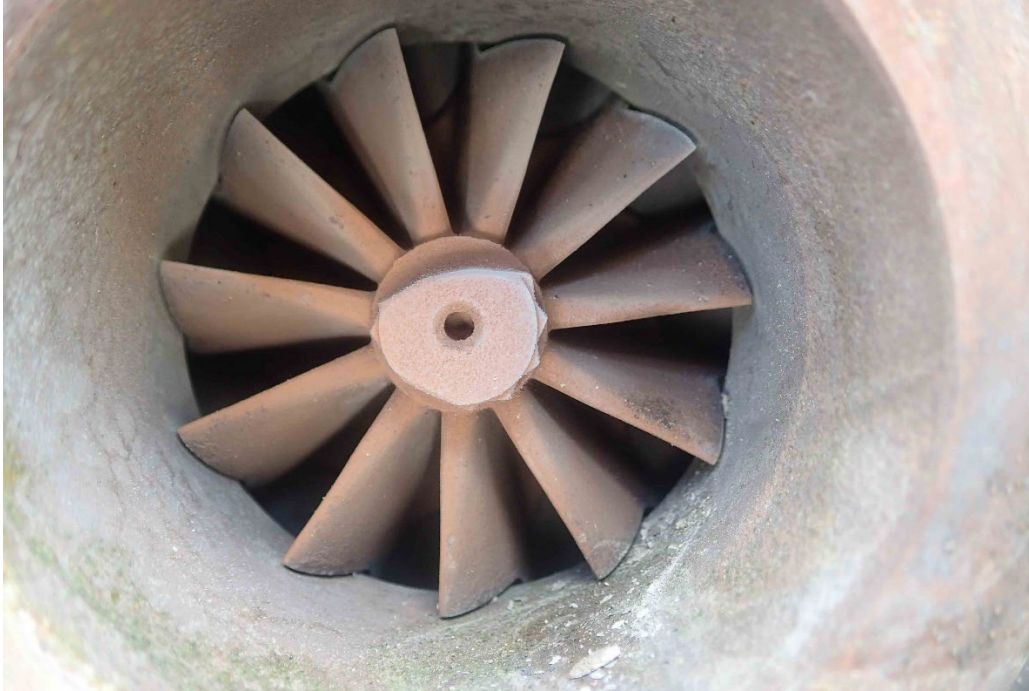
had partially broken away from the exhaust pipe. The turbine and compressor wheels could not be rotated, and there was evidence that the compressor housing had partially melted and was sagged against the turbine. The blades of both wheels were intact and undamaged (figure 8, 9). The oil drain line was removed and the center bearing area could be viewed through the opening. The area had sustained thermal damage similar to that observed externally, and there was no evidence of localized heating or debris.

**Figure 8 - Turbocharger compressor wheel**

**Figure 9 - Turbocharger turbine wheel**

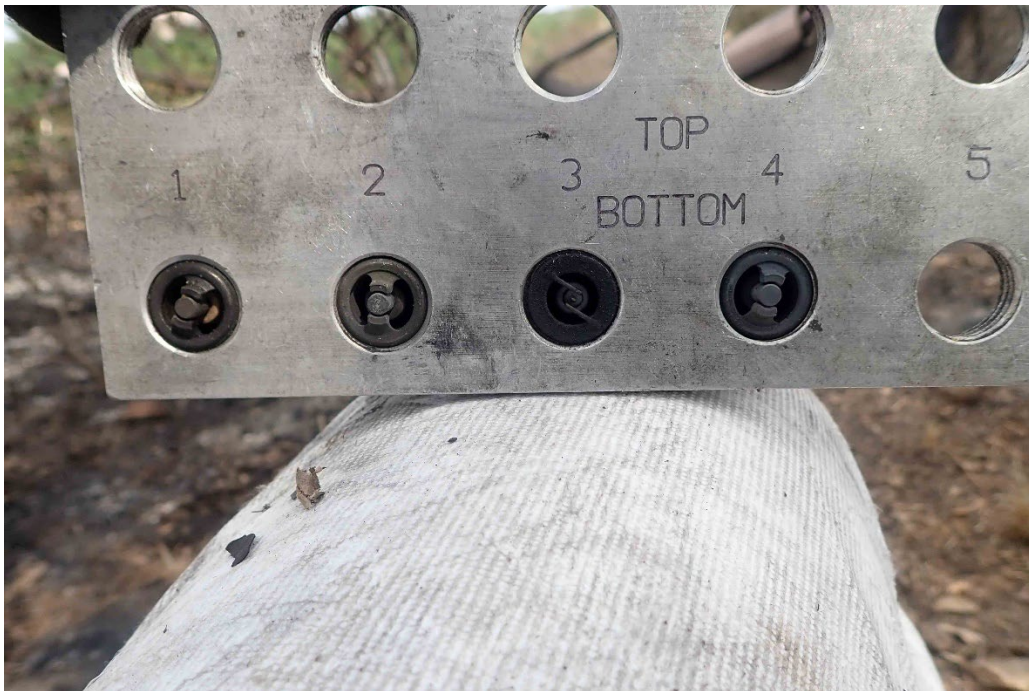
**Figure 10 - Bottom spark plugs at accident the site**

The spark plugs were removed, all were the massive electrode type except for the bottom cylinder 3 which was the fine wire type. All appeared to be new with minimal wear signatures. All plugs exhibited varying degrees of black and grey sooting, along with oil deposits (figure 10).

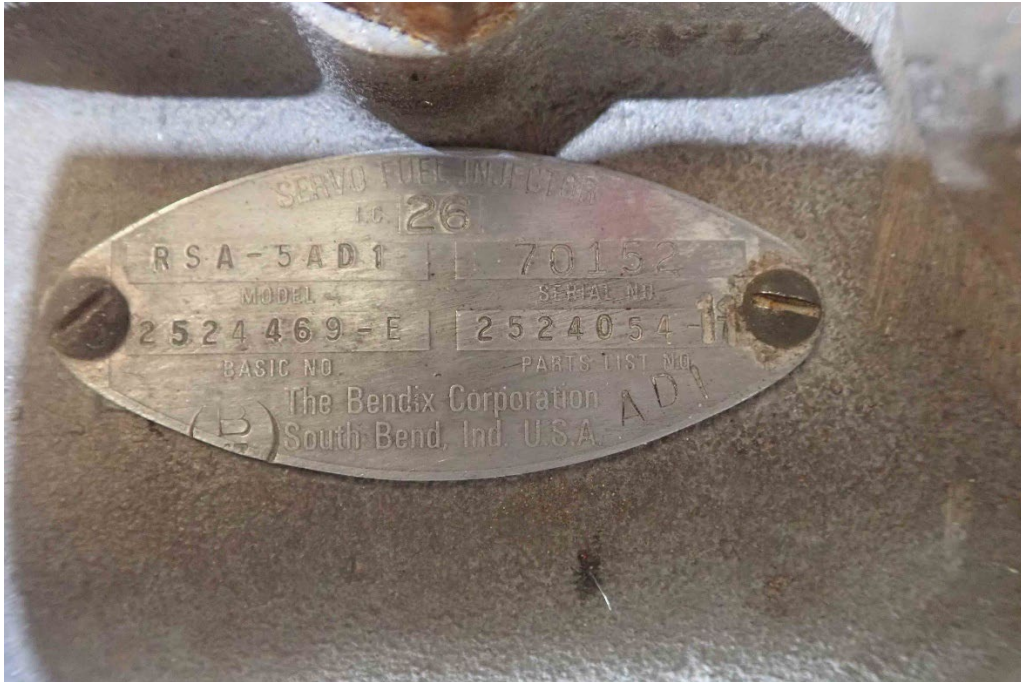
**Figure 11 - Fuel servo data tag**

The fuel servo had a Bendix data tag, rather than the Precision Airmotive tag (figure 11). Precision Airmotive purchased Bendix in 1988 and have since required the servo type be overhauled every 12 years. The overhaul kit contains a replacement Precision Airmotive data tag that should be installed at overhaul.

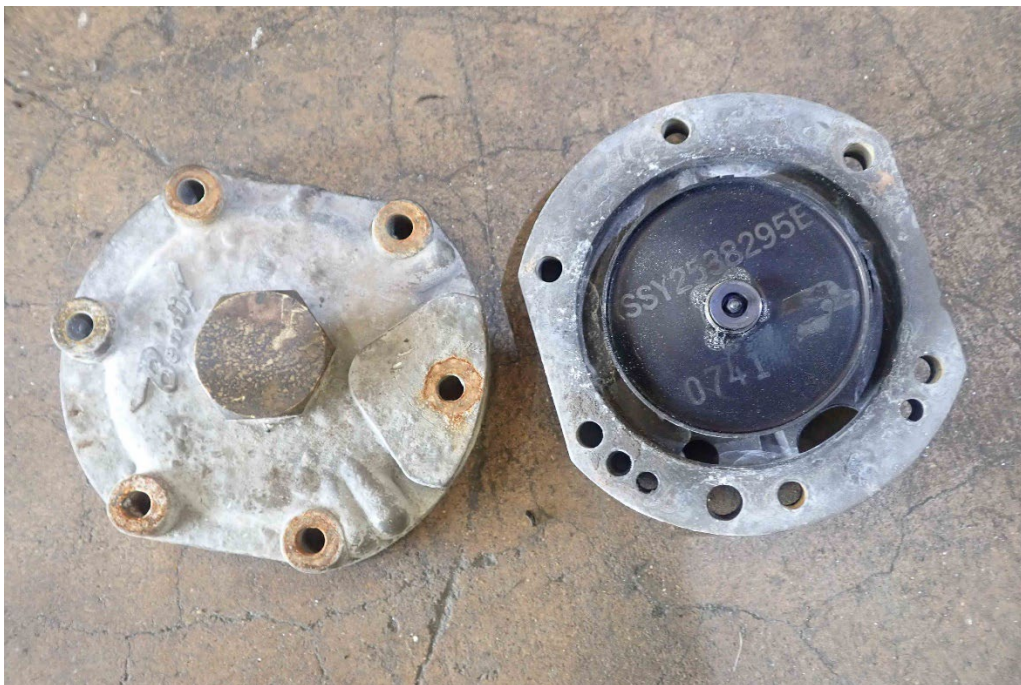
**Figure 12 - Fuel servo hex plug and diaphragm plate**

The servo was disassembled, and all internal diaphragms were burnt and black. A Precision Airmotive manufacturing mark was observed on one of the internal components figure 12. Therefore, without maintenance logs, it could not be determined who installed the Precision Airmotive components, and when.

FAA airworthiness directive (AD) 2009-02-03, applicable to the RSA-5AD1 fuel injection servo requires the compliance with Precision Airmotive Service Letter RS-87, issued July 14, 2008. The AD warns that a loose regulator hex plug can cause a lean fuel mixture, and possible loss of engine power. If during the inspection the hex plug was found loose, it is required to be removed and replaced with an alternate gasket, then retightened and a "G" be stamped into the regulator hex plug. If looseness was not observed, no stamp was required, however a 50 hour re-examination was.

No "G" was observed on the accident plug; the hex plug was tight, but the surrounding aluminum housing displayed evidence of distortion and thermal damage (figure 12). Due to the maintenance logbooks being destroyed in the fire, it could not be determined if the AD had been complied with.
