# National Transportation Safety Board

WPR22FA229

## **ONSCENE EXAMINATION**

Location: Kerrville, Texas  
Date: June 25, 2022  
Time: 1823 LCL  
Airplane: Mooney M20J, N4267H

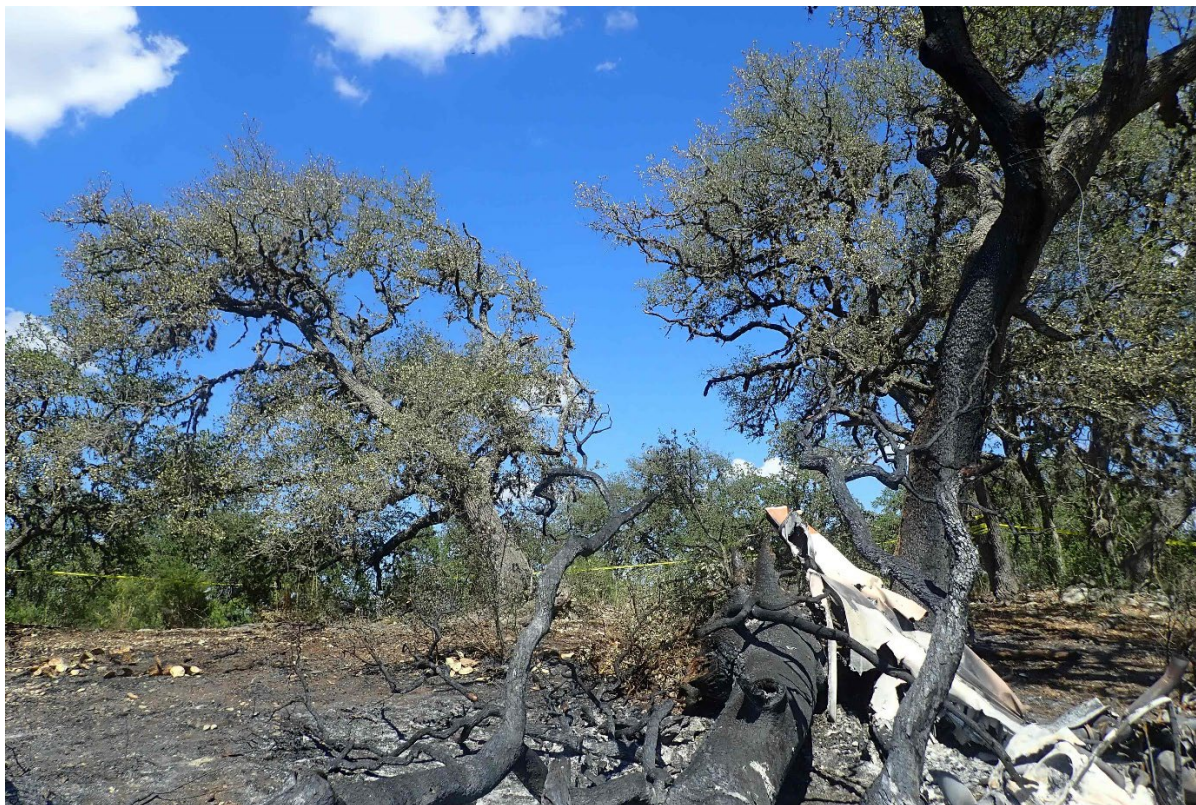
**Figure 1- Accident site with cut tree swath**

The airplane came to rest at an elevation of about 1,600 ft on the slope of a hill, about 4,200 ft beyond the runway 12 threshold, and 20° offset the runway centerline. The first identified point of impact was a cleanly cut swath of tree branches and limbs, at an angle of about 60° relative to the horizon (figure 1). The airplane was located about 30 ft southwest of the swath, at the base of a felled 50-ft tall oak tree (figure 2). The tree exhibited impact damage along its north face.

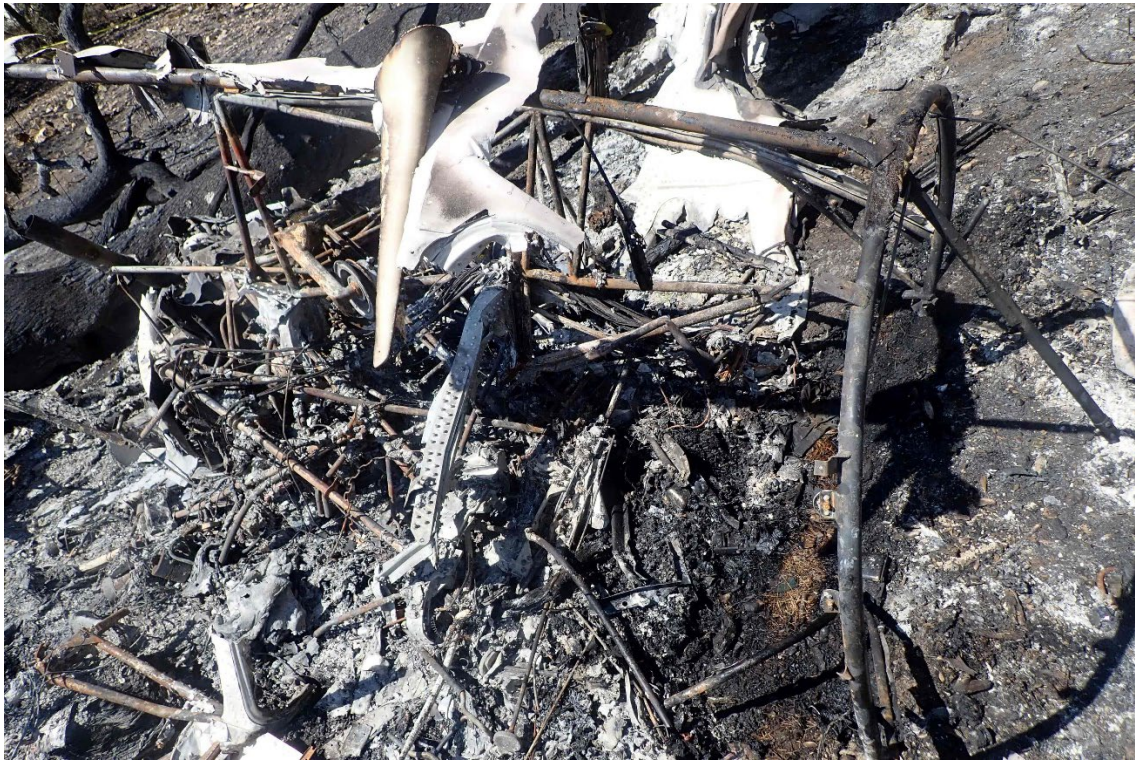
**Figure 3 - Forward cabin**

The cabin skins were consumed by fire, with only crushed and bent steel frame members remaining (figure 3). The instrument panel, flight instruments, control switches and circuit breakers were consumed by fire, such that their operation and position at the time of the accident could not be determined.

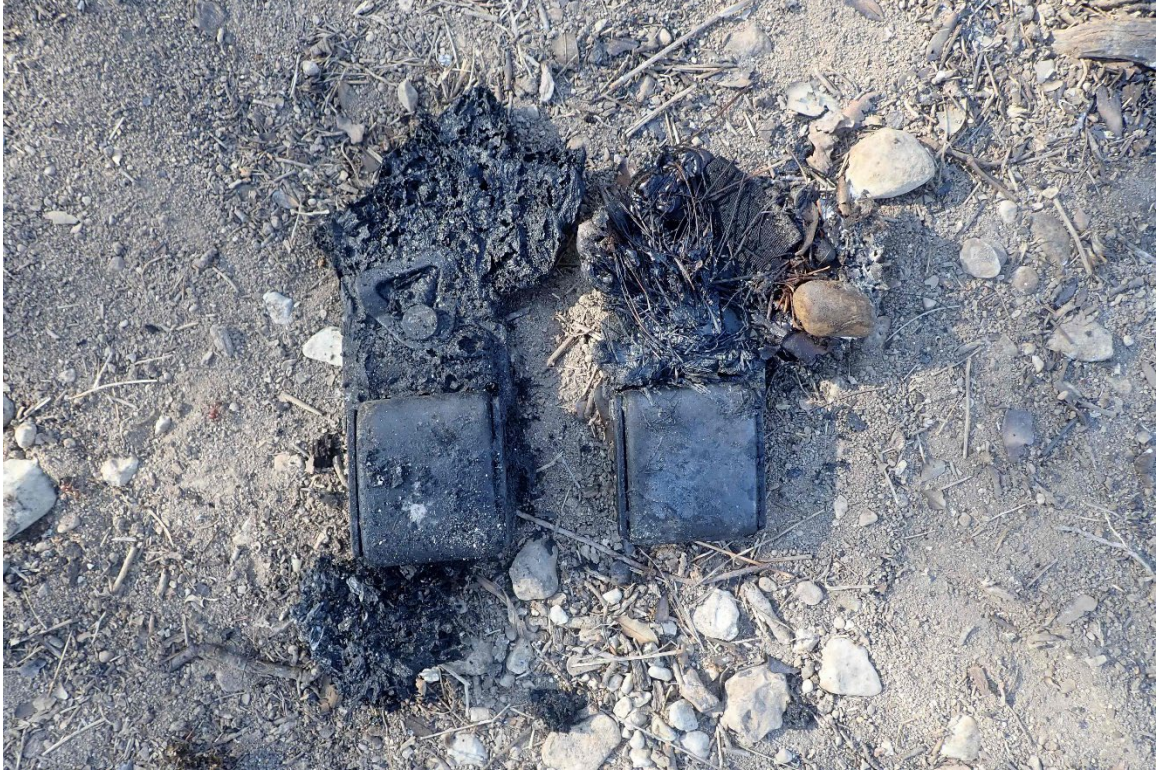
**Figure 4 - Front seatbelts**

All seatbelts sustained thermal damage, destroying their webbing. Both forward seat latches were located, and were in the locked position, with their shoulder strap buckles still attached (figure 4).

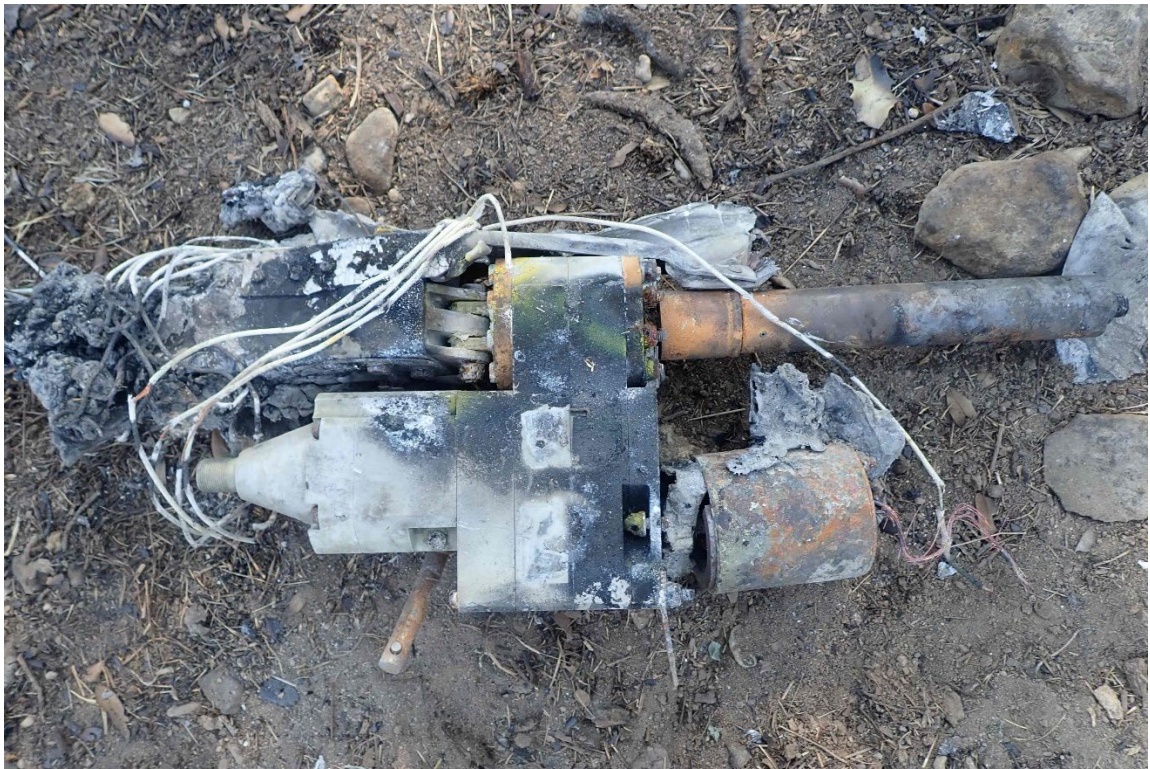
**Figure 5 - Landing gear actuator**

The landing gear actuator assembly had partially melted, and its jack screw appeared to be fully retracted, consistent with the landing gear being extended at impact (figure 5). The remaining landing gear components and assemblies had sustained such extensive damage during the accident and subsequent fire, that the systems operational viability during the flight could not be determined.

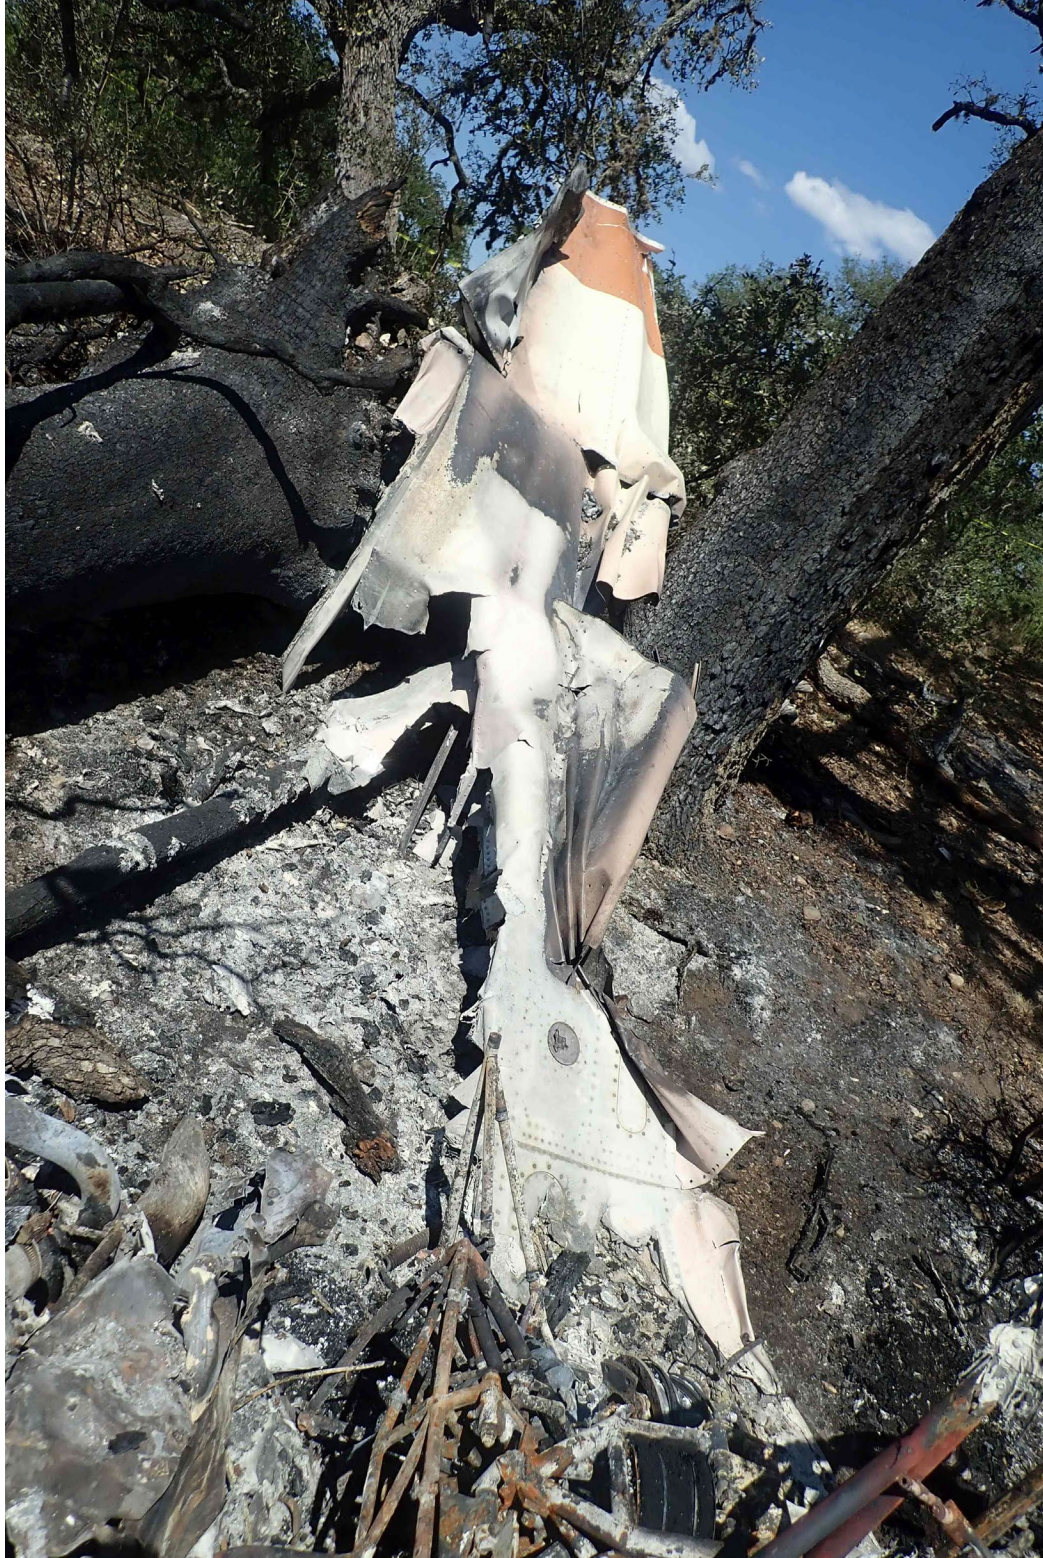
**Figure 6 - Left wing**

The left wing came to rest against the tree (figure 6). The inboard section of the aileron was attached by its hinge, and most of the inboard skins along with the main and aft spar were consumed by fire. The outboard aileron and wing tip had separated and were found in the debris field about 40 ft downrange from the impact site. Remnants of the fuel tank remained, and the fuel cap was securely in place at its filler neck.

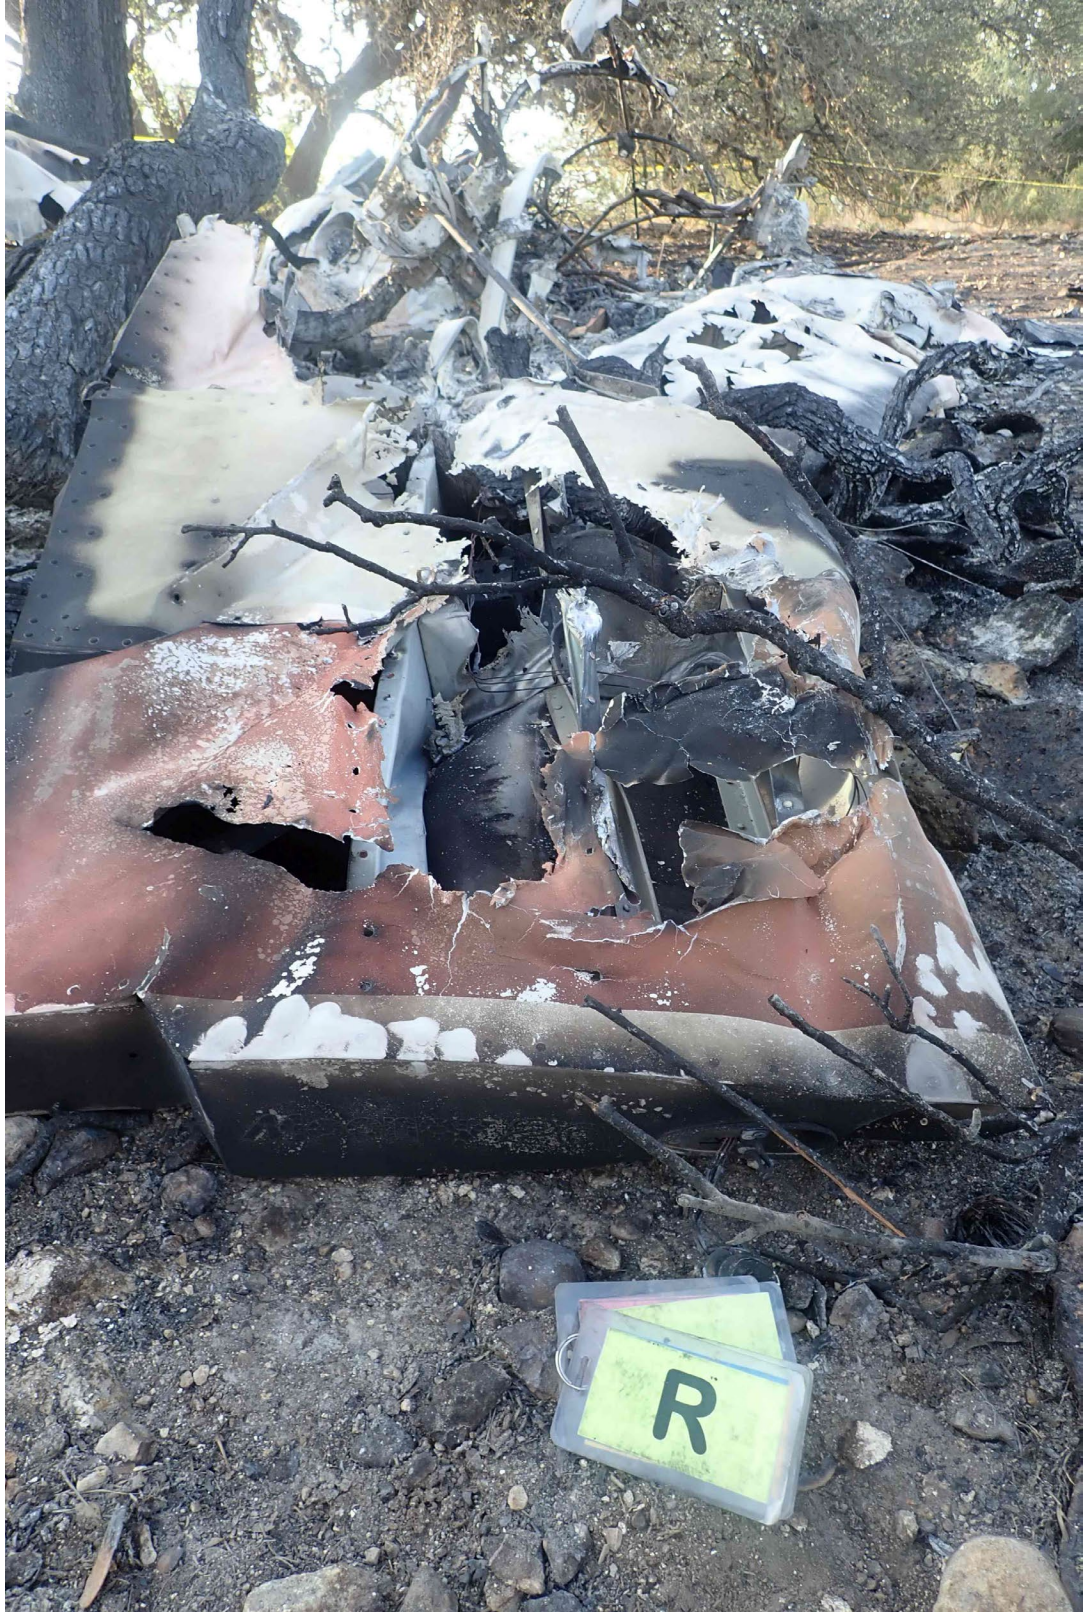
**Figure 7 - Right wing**

The leading edge of the right wing was adjacent to the remnants of the cabin. The trailing edge sections were almost completely consumed by fire (figure 7).

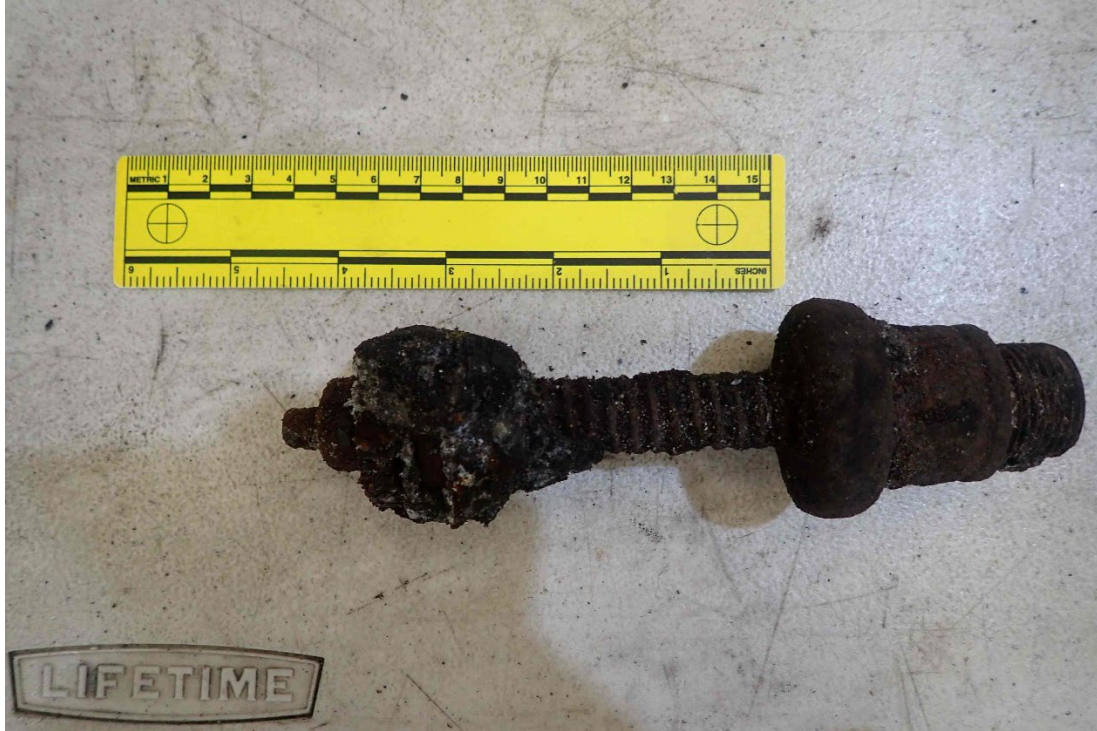
**Figure 8 - Flap actuator jackscrew**

The flap actuator was consumed by fire, with only the steel remnants of its jack screw and barrel end remaining. The jack screw extension was about 2.6 inches, which corresponded to a flaps up position (figure 8).

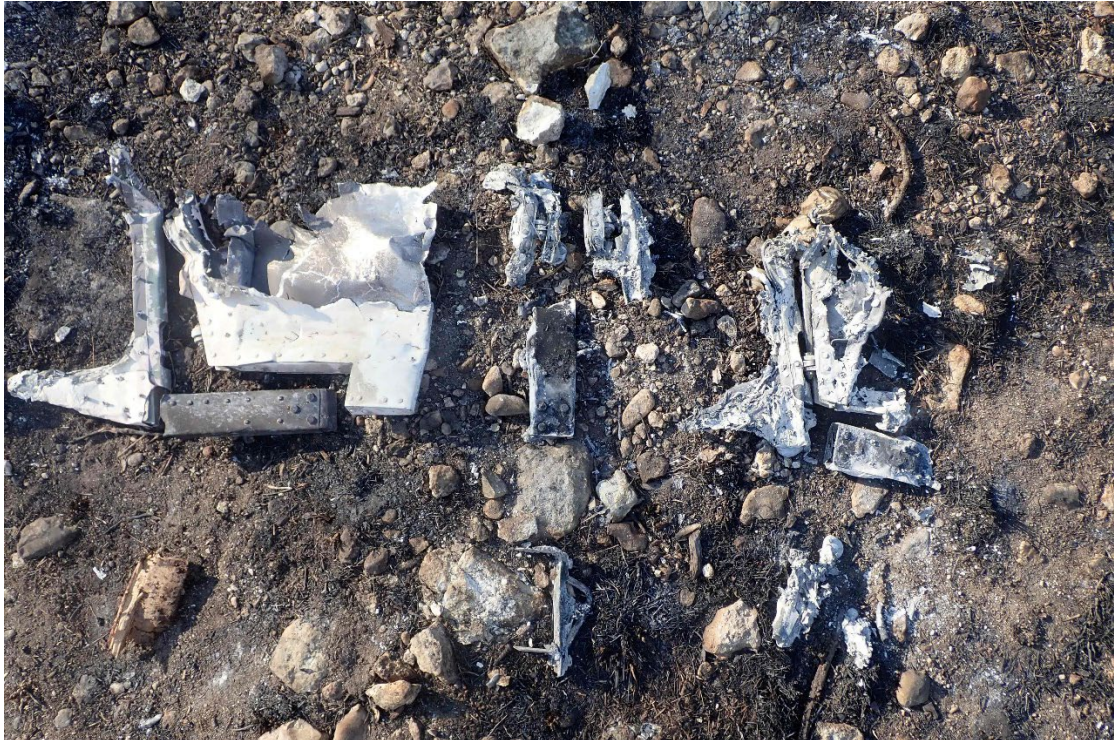
**Figure 9 - Tail section balance weights and hinges**

Fire damaged empennage remnants were found comingled in the aft cabin. The steel elevator and rudder control system assembly could be identified, along with both elevator tips and remnants of the rudder tip and their respective balance weights (figure 9).

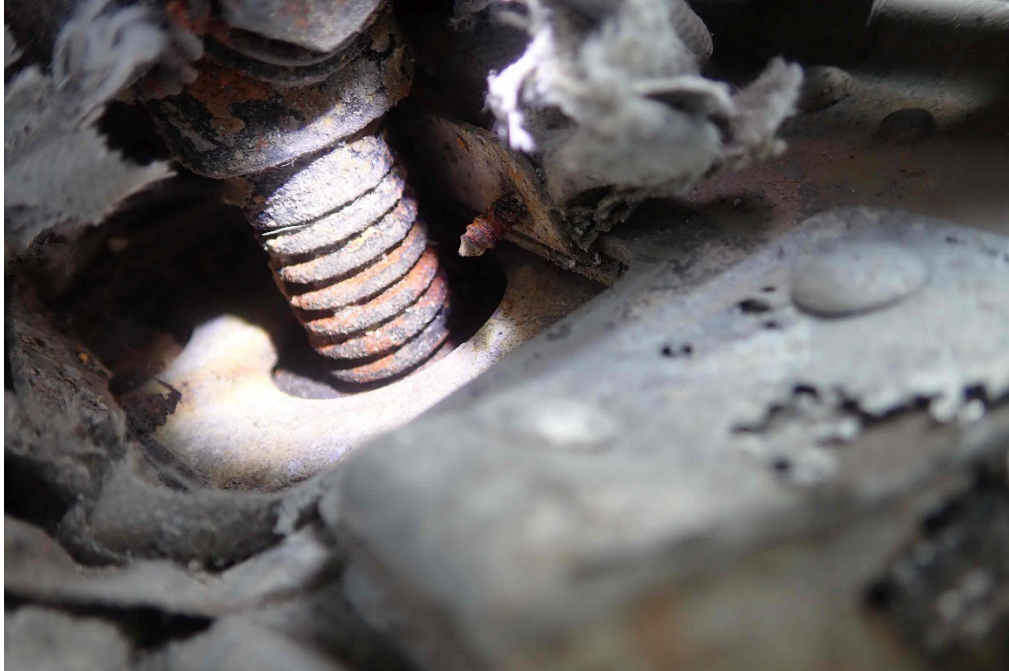
**Figure 10 - Moving tail aft assembly jack screw threads**

The aft moving tail assembly jack screw exhibited 6 exposed threads, which corresponded to the takeoff trim position (figure 10). The cabin center-mounted elevator trim assembly exhibited an extension dimension of 1.2 inches from the trim stop to the aft jam nuts, which also corresponded to a takeoff trim position (figure 11).
