# National Transportation Safety Board

WPR22FA254

## **ACCIDENT SITE EXAMINATION**

Location: Topeka, Kansas  
Date: July 16, 2022  
Time: 1153 central daylight time  
Airplane: experimental amateur-built, RV-7, N283S

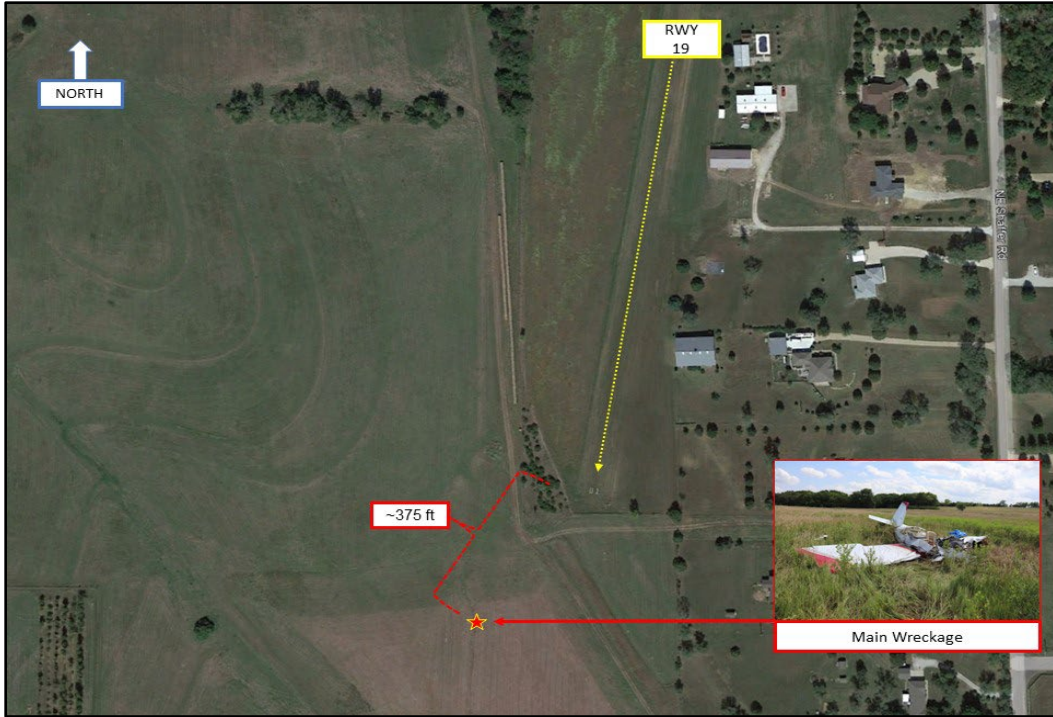
Examination of the accident site revealed that the airplane came to rest upright in an open grass field about 375 ft southwest of the departure end of runway 19, at Buena Terra Airport, Topeka Kansas. The wreckage came to rest on a heading of about 340° magnetic, at an elevation of 1,023 ft mean sea level. All major structural components of the airplane were located at the accident location. No visible ground scars were observed in the area near the wreckage.

**Figure 1: View of the accident site diagram.**

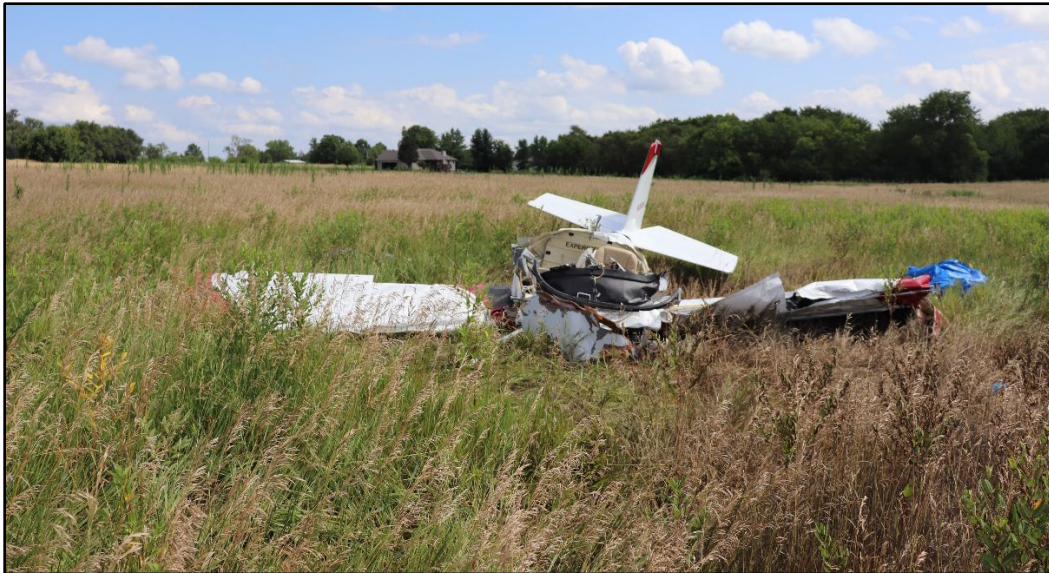
The fuselage was mostly intact. The engine and forward portion of the fuselage were impact damaged and displaced to the right. The engine cowling was fragmented consistent with impact damage but remained attached to the fuselage. The engine mount had several fractures, consistent with impact damage.

**Figure 2: Front view of accident airplane.**

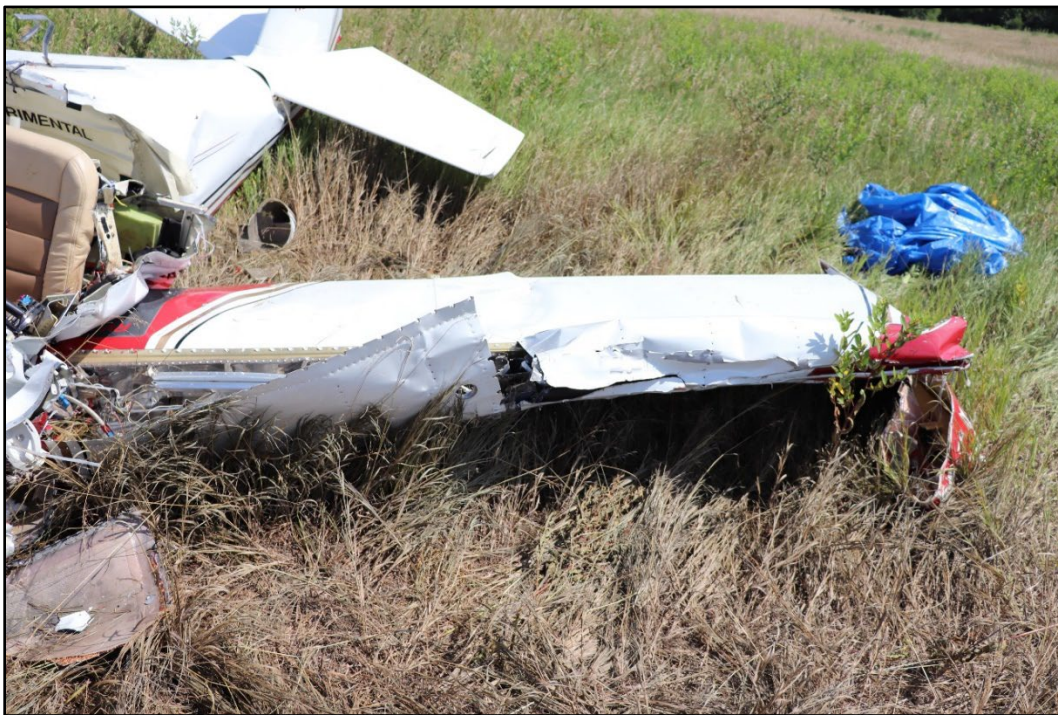
The left wing remained attached to the fuselage. The leading edge fragmented from the wing root to about mid span. Crushing and bending was observed throughout the wing. The left-wing tip was separated from the wing and was tethered by various wires. The left flap and aileron remained attached via their mounts. The left aileron was moved by hand, the flight control stick was observed to move in the corresponding direction. The flap was observed partially extended and would rotate freely when moved by hand. The main fuel tank fuel cap location was in the fragmented section of the wing and separated from the filler neck.

**Figure 3: View of left-wing.**

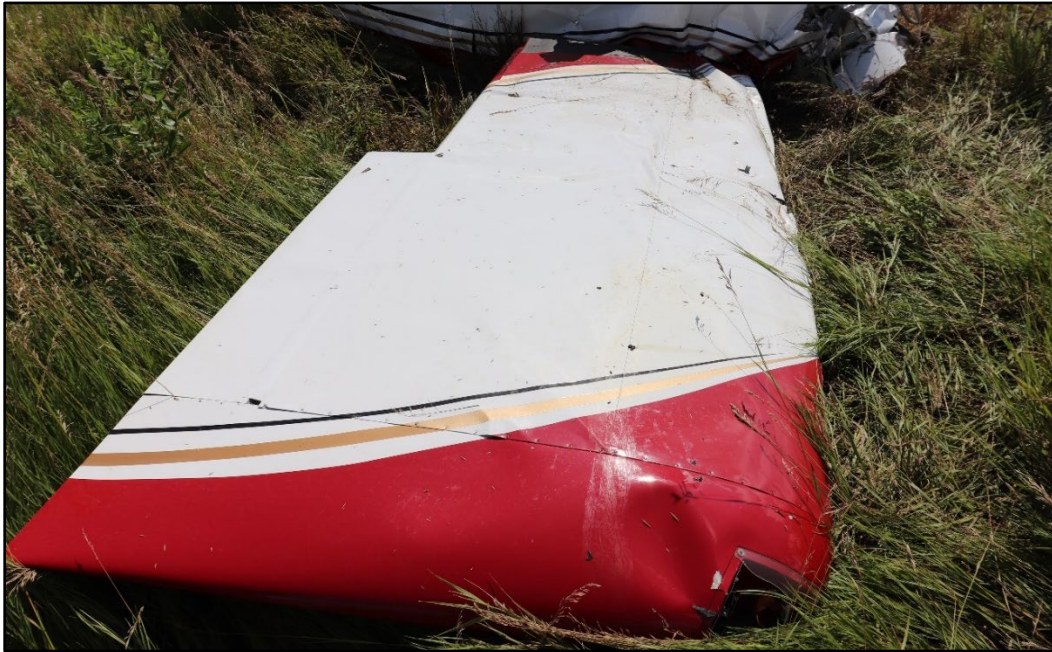
The right-wing remained attached to the fuselage. Crushing was observed on the leading edge from the wing root to about mid span. The right flap and aileron remained attached via their mounts. The right aileron was moved by hand, the flight control stick was observed to move in the corresponding direction. The flap was

observed partially extended and would rotate freely when moved by hand. The main fuel tank fuel cap was observed in place and secure. No fuel was observed in the fuel tank.

**Figure 4: View of right-wing.**

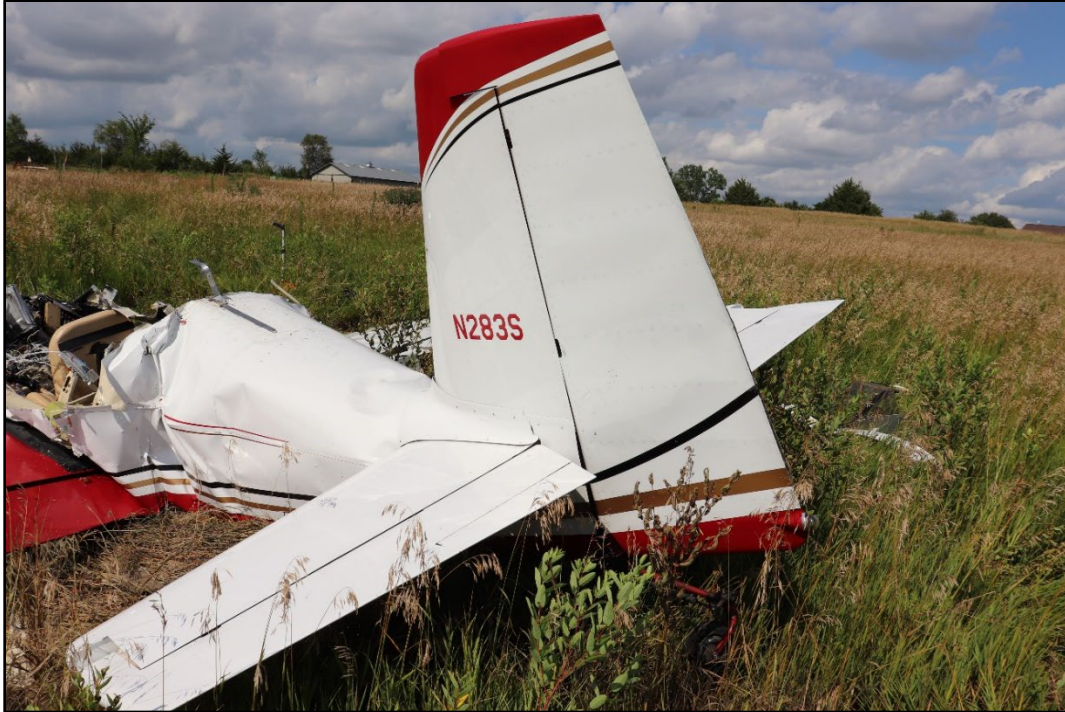
The empennage remained attached to the aft fuselage. Crushing and bending was observed throughout. Both vertical and horizontal stabilizer attached. The rudder and elevator attached to their respective mounts. The rudder cables were observed attached to the rudder and the rudder pedals, no separations in the cables were observed. The trailing edge of the rudder surfaces separated, from the bottom to about mid span. The elevator torque tube remained attached and was traced to the center of the fuselage, where it had separated from the flight controls.

**Figure 5: View of empennage.**
