Dan Baker
Senior Air Safety Investigator
AS-WPR

Date: August 23, 2022

Subject: WPR22FA312, Wreckage Examination Notes

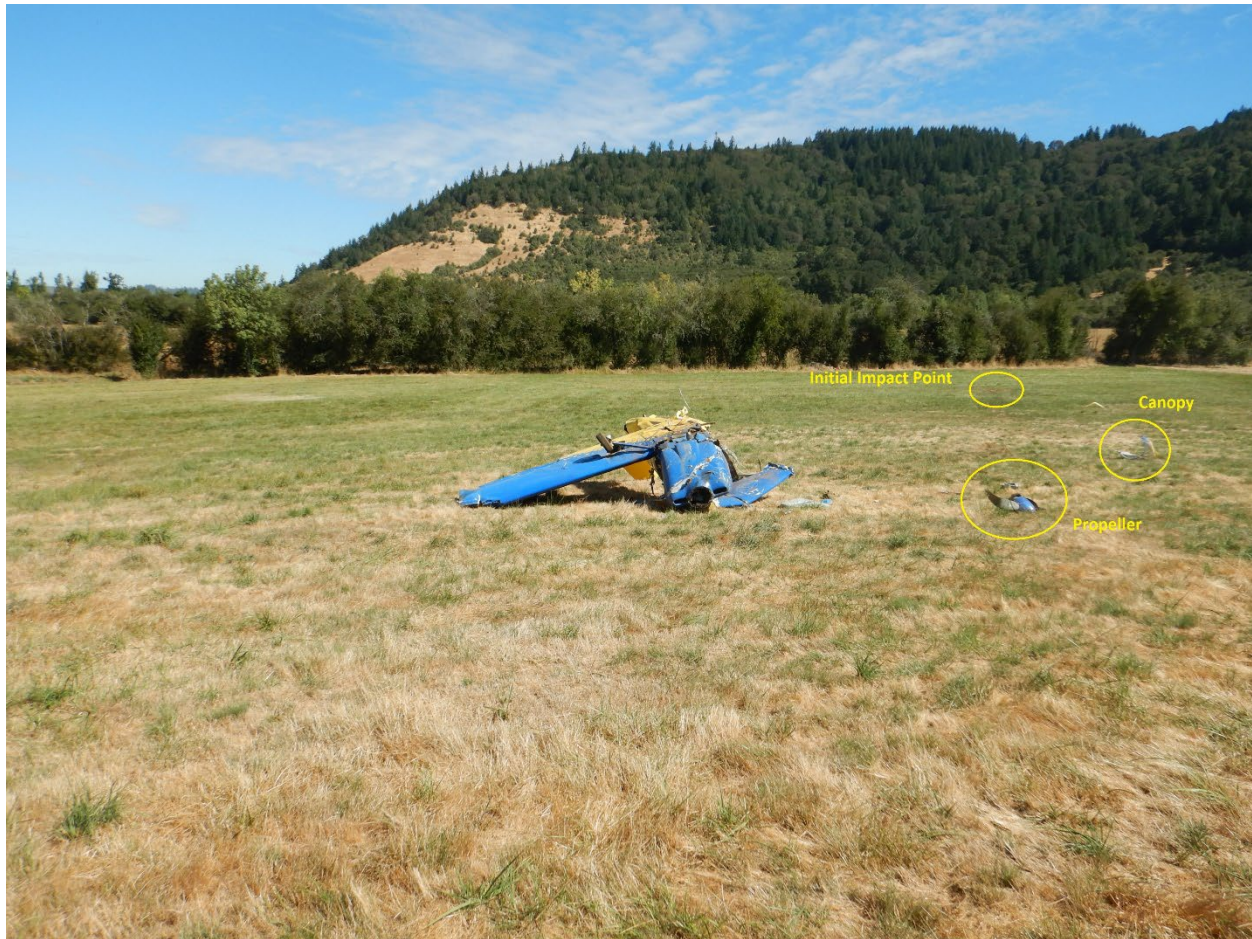
The main wreckage came to rest inverted on about a 180 heading. The right wing was mostly separated from the fuselage and folded underneath the fuselage. The left wing remained attached to the fuselage. The tail section and empennage exhibited bending and disfiguration but remained attached to the fuselage.

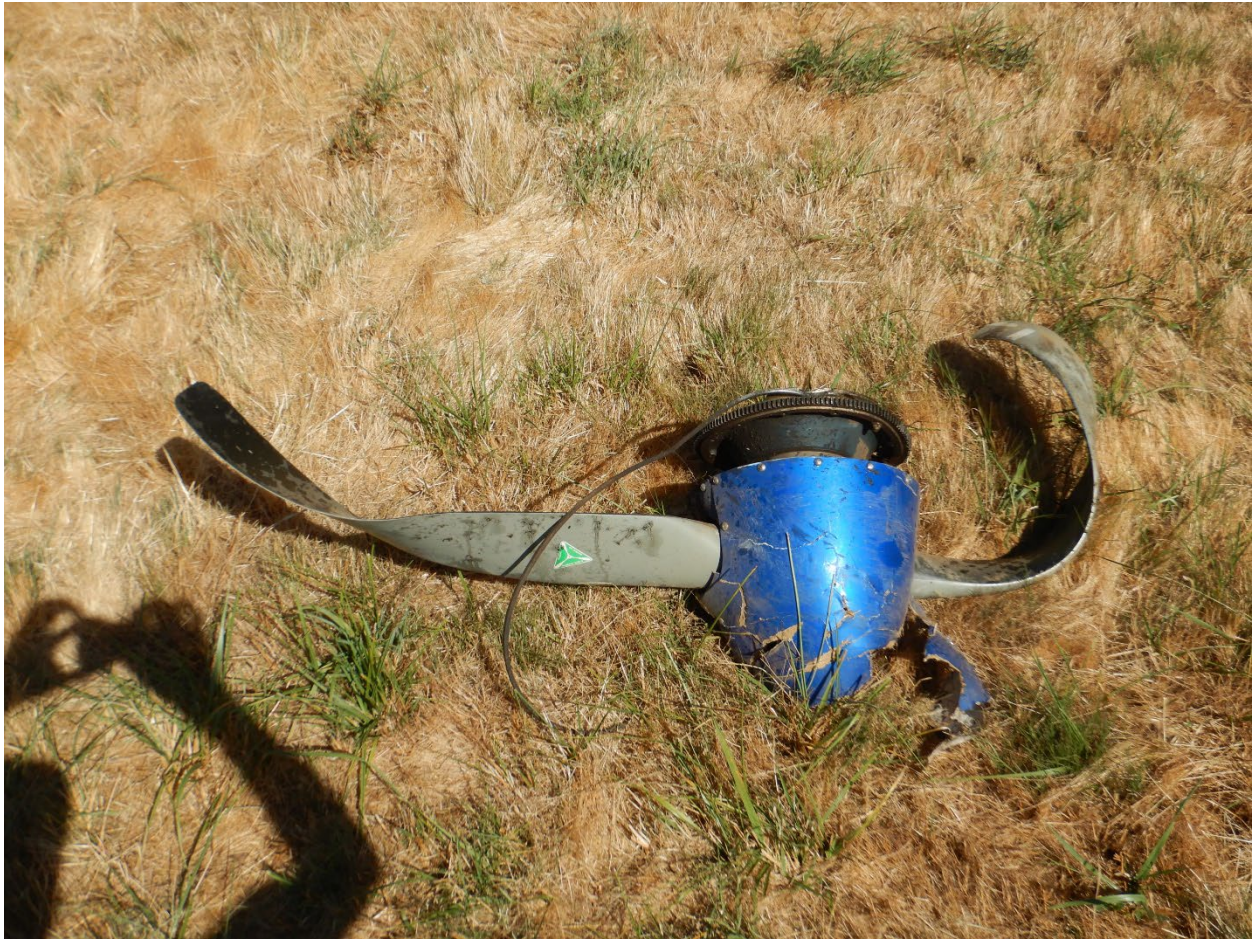
The engine and engine cowling remained attached to the fuselage. The propeller was separated from the engine at the propeller shaft and was located about 10 feet from the main wreckage. Both metal propeller blades exhibited twisting and S bending, chord wise scratching, and leading edge gouging.
