NATIONAL TRANSPORTATION SAFETY BOARD

AIRFRAME AND ENGINE EXAMINATION

WPR22LA083

Location: Williams, Arizona
Date: January 26, 2022
Aircraft: Beech, F33A, N1HH
NTSB Investigator-in-Charge: Eric M. Gutierrez

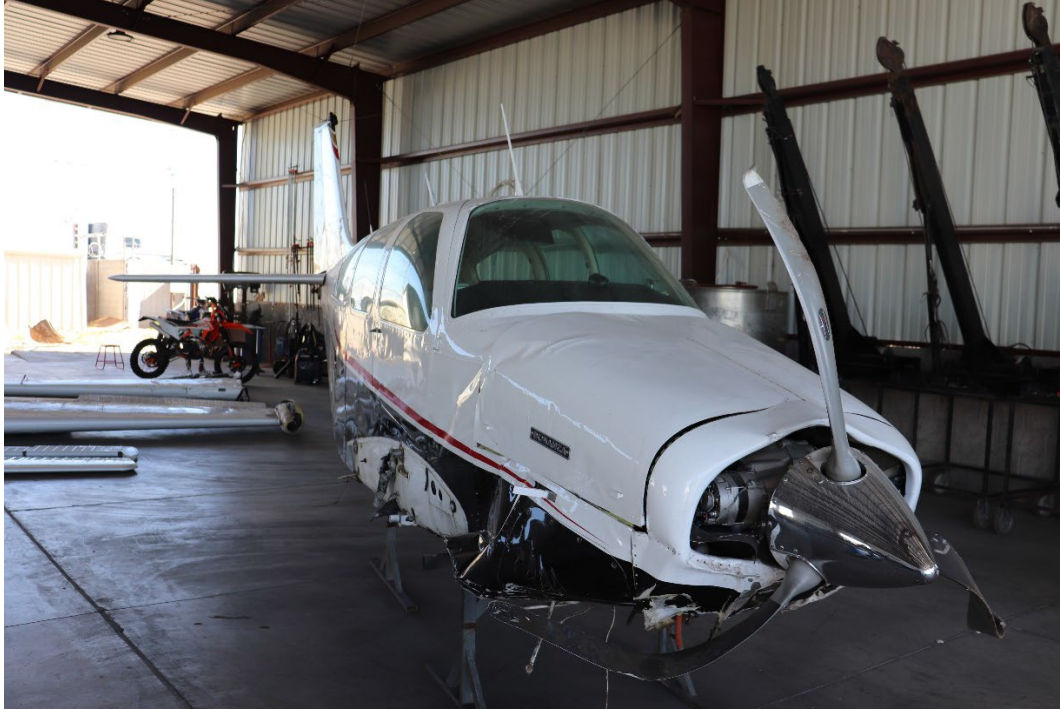
Examination of the recovered airframe revealed that the recovery organization had removed both wings, left horizontal stabilizer and both elevators for transport. The forward section of the fuselage, near the cockpit was impact damaged. Additionally, the recovery personnel had drained about 20 to 30 gallons of fuel from the left tank. The fuel selector lever was in the right fuel tank position and the master switch was off. The observed tachometer time was 4160.9 hours.

Figure 1: View of airplane during examination (photo courtesy of the NTSB)

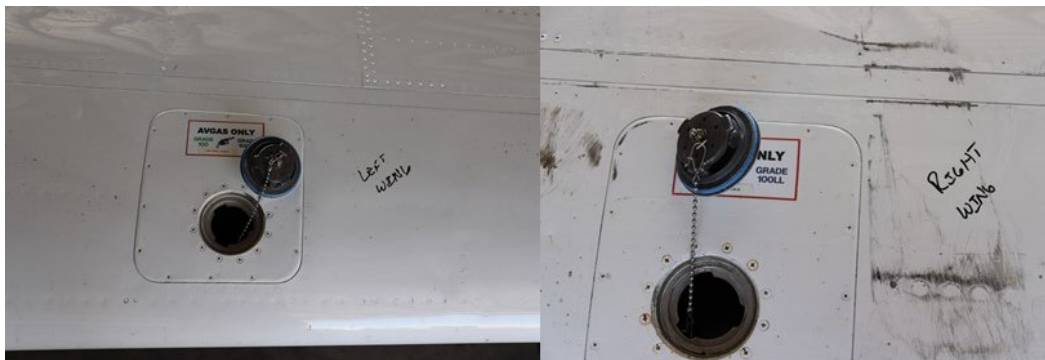
The left and right wings exhibited impact damage. The airplane was equipped with bladder fuel tanks and composite auxiliary tanks. Visual inspection of the right and left fuel caps revealed that the rubber seal appeared normal and unremarkable. Both fuel filler ports were normal and unremarkable.

Figure 2: View of airplane left and right fuel caps (photo courtesy of the NTSB)

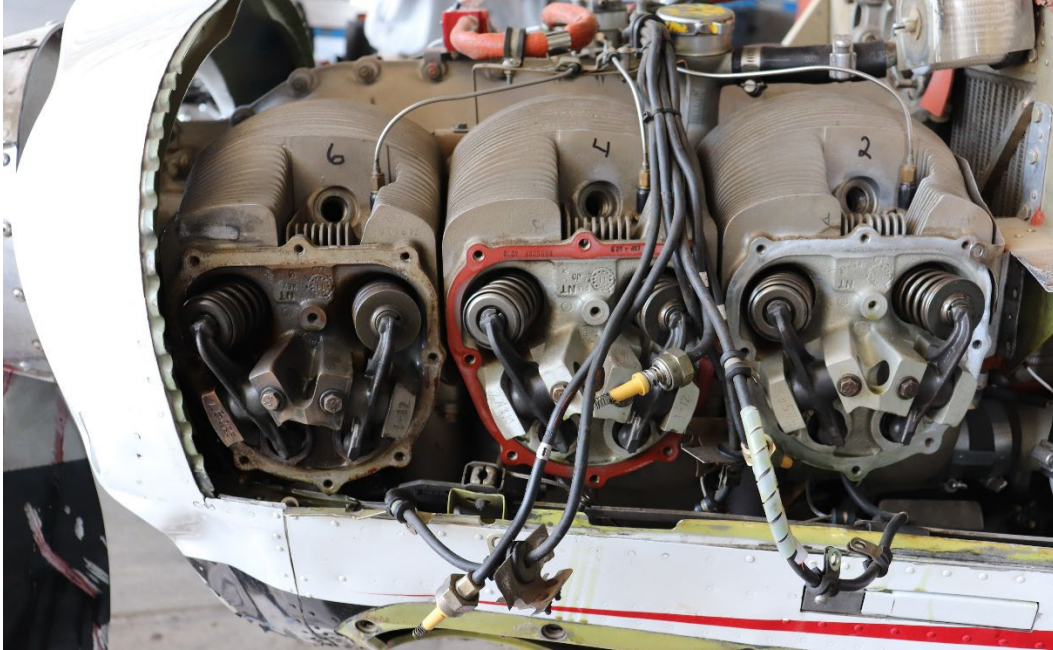
Examination of the recovered engine revealed that the engine remained attached to the airframe via the engine mounts. All six cylinders and all engine accessories remained attached. All fuel and oil lines that were removed were tight. No evidence of any mechanical damage was observed to the engine crankcase.

Figure 3: View of left side of the engine (photo courtesy of the NTSB)

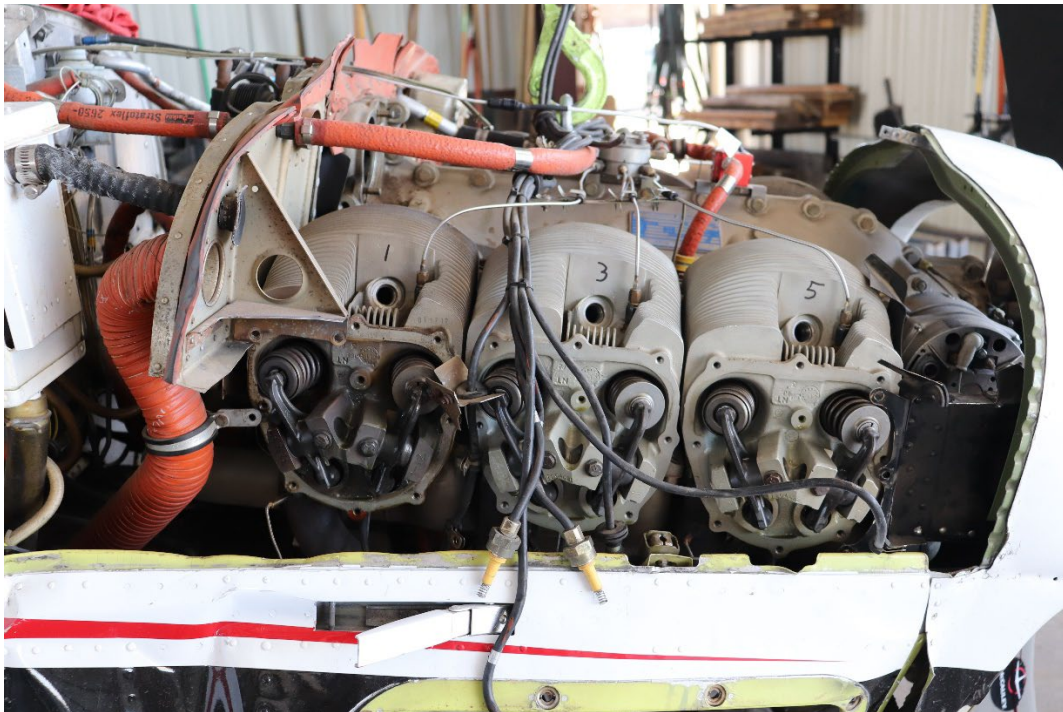
Figure 4: View of right side of the engine (photo courtesy of the NTSB)

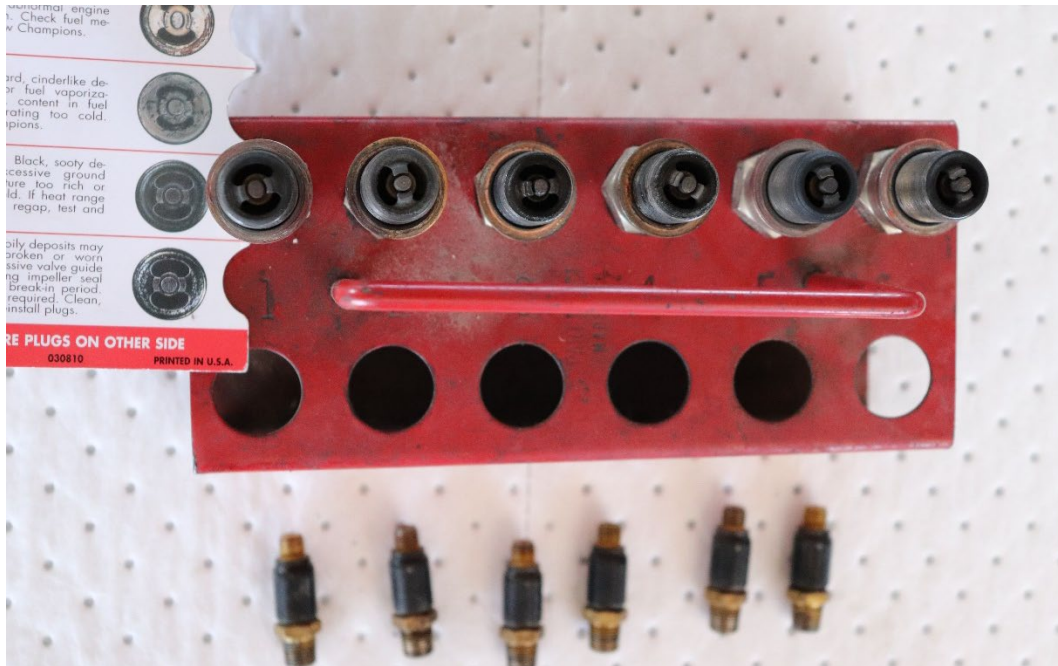
Examination of the recovered airframe and engine revealed no anomalies that would have precluded normal operation and the production of power. However, the upper spark plugs electrode areas were black in color, consistent with a rich fuel/air mixture.

The top engine spark plugs were removed from the engine, and they were the massive electrode type. The sparkplugs exhibited black deposits within the electrode area. All of spark plugs exhibited signatures consistent with CARBON FOULED when compared to the Champion Check-A-Plug comparison chart.

Figure 5: View of top engine spark plugs (photo courtesy of the NTSB)

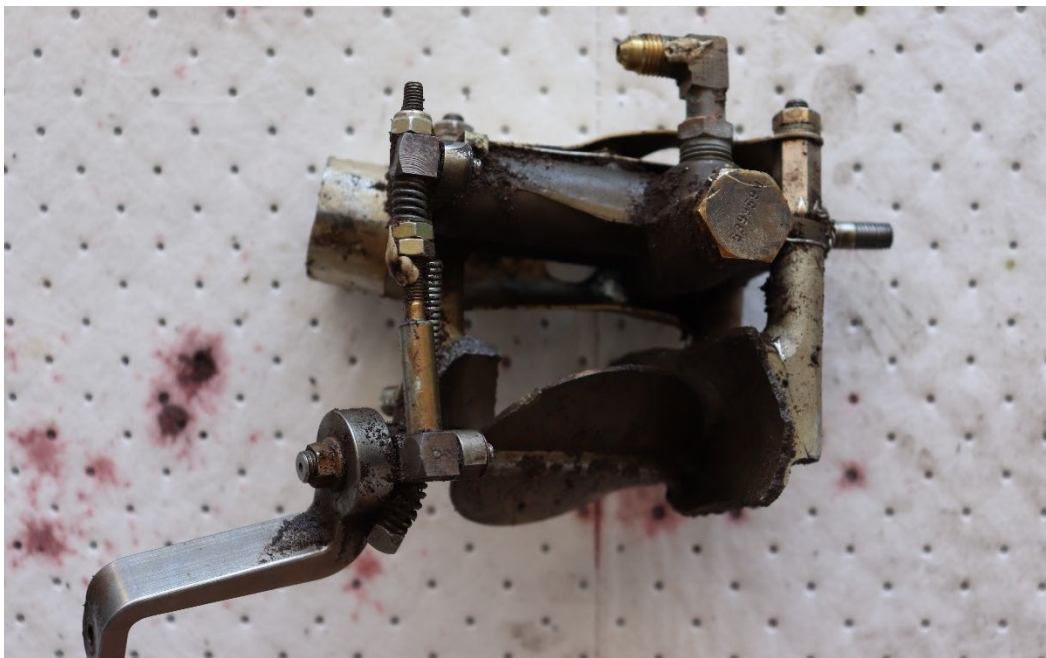
The throttle body was separated from the engine and impacted damaged. The throttle control cable remained attached to the throttle body and unremarkable. The mixture control cable remained attached to the throttle body and unremarkable. The throttle and mixture control moved the available length. The fuel servo inlet screen was removed, and a slight amount of debris was observed.

Figure 6: View of throttle body (photo courtesy of the NTSB)

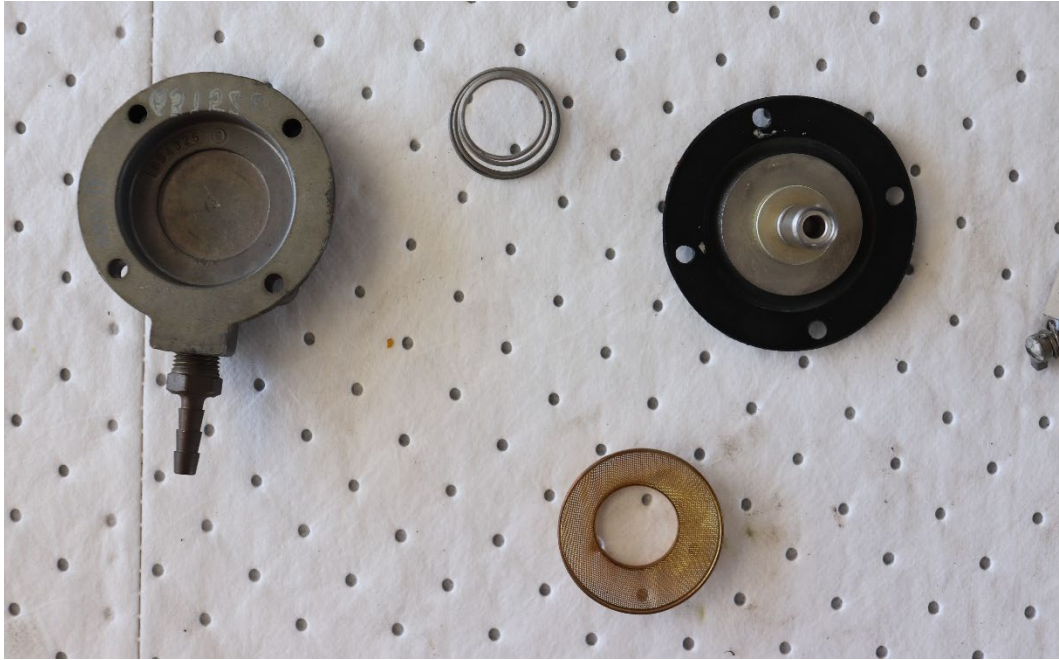
The fuel flow manifold valve was intact, undamaged, removed and disassembled. The screen was clear and free of debris. The spring and diaphragm were intact and undamaged.

Figure 7: View of fuel flow manifold spring and diaphragm (photo courtesy of the NTSB)

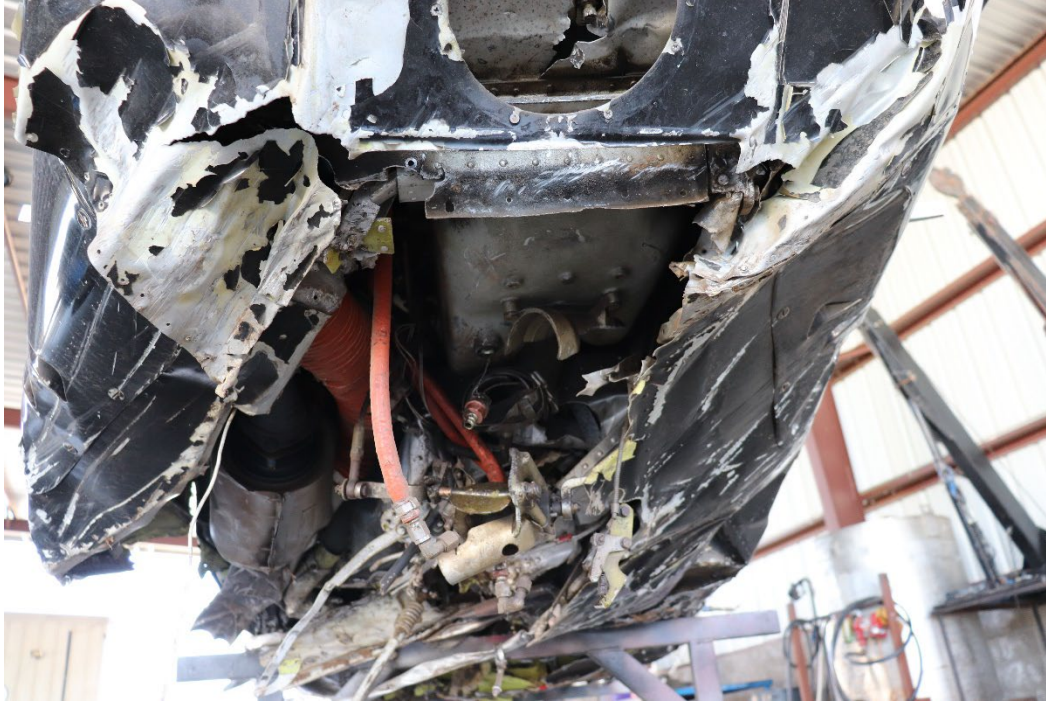
The engine oil sump had impact damage and the oil quick drain was partially separated.

Figure 8: View of oil sump damage (photo courtesy of the NTSB)
