NATIONAL TRANSPORTATION SAFETY BOARD

LANDING GEAR EXAMINATION SUMMARY

WPR22LA228

Location: Palm Springs, California
Date: June 4, 2022
Aircraft: N4752K, Cessna P210N
NTSB IIC: Albert Nixon

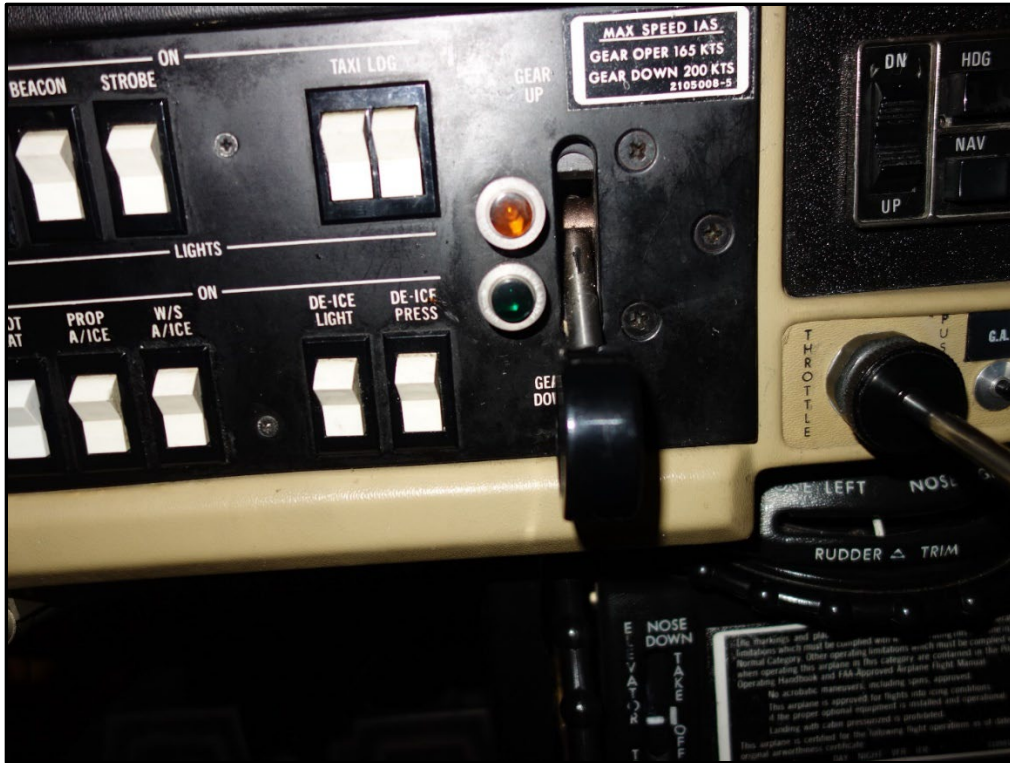
Figure 1: Land Gear Lever and Landing Gear Position Indicator Lights.

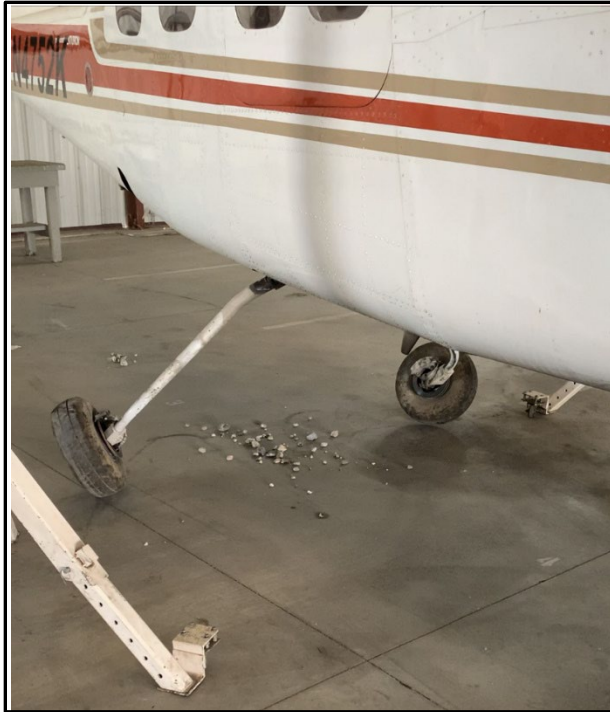
- The hydraulic fluid maintained its level and the LDG GEAR and GEAR PUMP circuit breakers remained in during the examination of the landing gear.
- The landing gear lever was examined, and its movement and detent were appropriate, with no anomalies noted.
- It was noted that during gear extension, the nose wheel locked into place first, and the main landing gear pivoted and moved to the locked position a few seconds later.
- During the transient interval, the main landing gear struts were angled such that if contact were made with the ground, the top outer edge (side) of the tire would make contact.
- Examination of the main landing gear tires revealed that both tires had obvious markings on the outer edge (side) consistent with ground contact. These marking were noted at the start of examination before the gear swings were accomplished.

Figure 2: Main Landing Gear in transient for extension (note outer edge of tire).

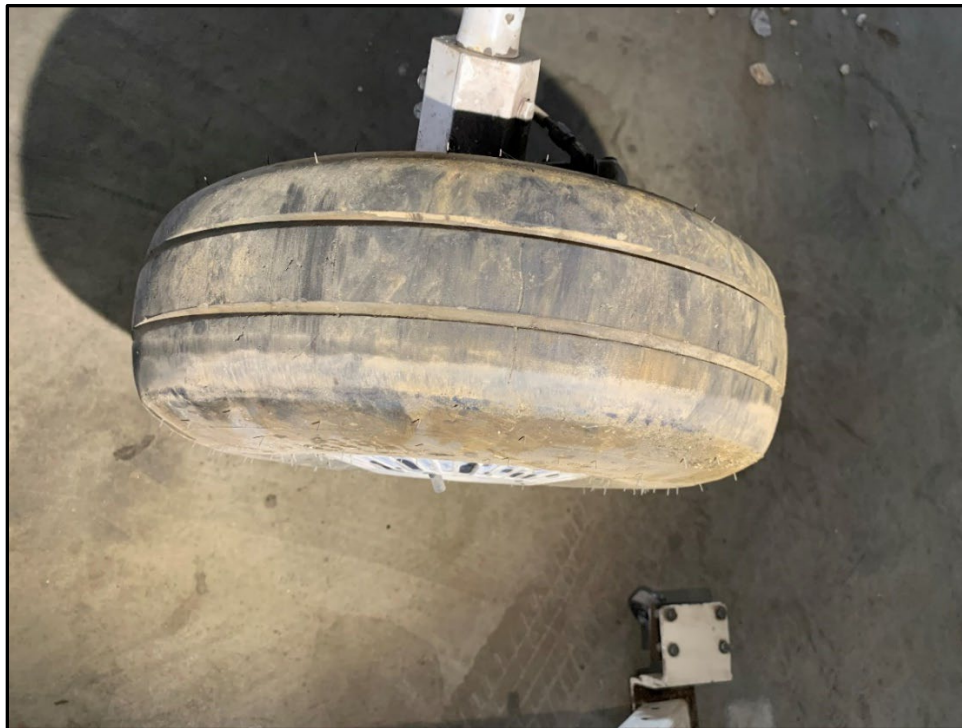
Figure 3: Main Landing Gear Tire as viewed from the top side (note markings on outer edge).
