National Transportation Safety Board

WPR22LA238

AIRFRAME AND ENGINE EXAMINATION

Location: Challis, Idaho
Date: June 26, 2022
Airplane: Piper, PA-20-135, N1231C

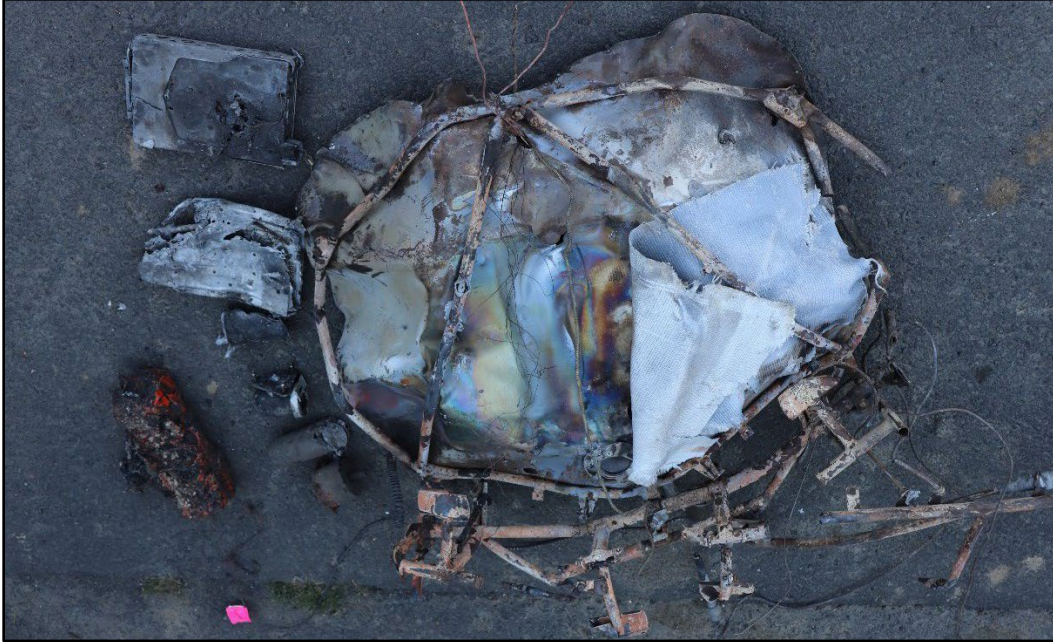
Examination of the recovered wreckage revealed that the cockpit, both wings, and fuselage structure was mostly destroyed by thermal and impact damage. The instrument panel was consumed by fire. Multiple instruments were separated from the instrument panel and exhibited thermal and impact damage. The left main landing gear was separated from the fuselage and was impact and thermal damaged. The right main landing gear remained attached to the fuselage and was impact and thermal damaged.

Flight control continuity was unable to be established due to multiple separations, consistent with impact, and thermal damage. The cockpit flight controls were separated and exhibited thermal and impact damage throughout. The rudder pedals were observed in the cockpit area with heavy impact and thermal damage. All areas of separation were consistent with overload or were cut by recovery personnel.

Figure 1: View of airplane cockpit area with impact and thermal damage.

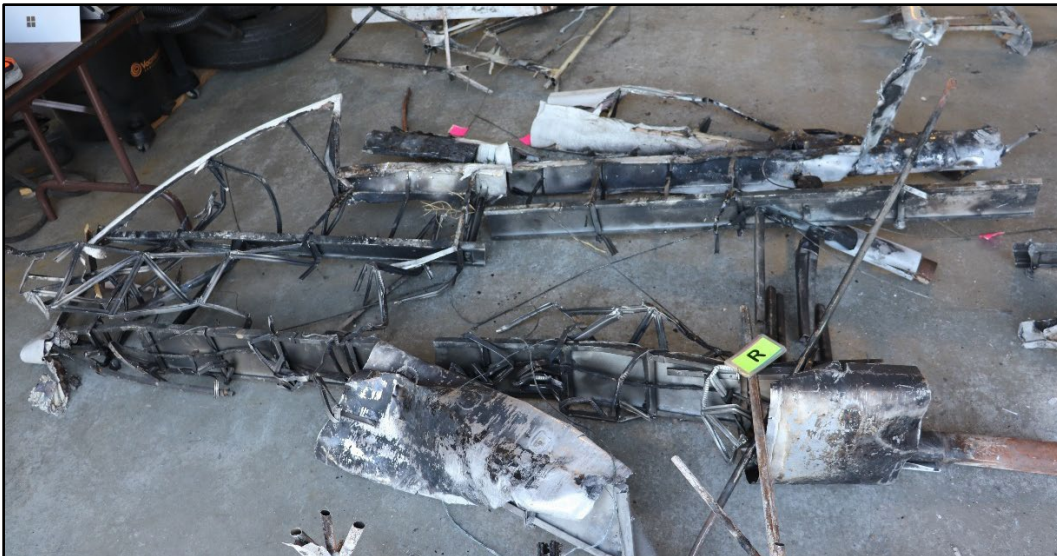
The right wing was separated from the fuselage at the wing root, was impact and thermal damaged. The wing was cut into numerous sections by recovery personnel. A center section of right wing aileron remained attached to the wing attachment point. The wing flap was separated from the wing and was thermal and impact damaged.

Figure 2: View of right wing thermal damage.

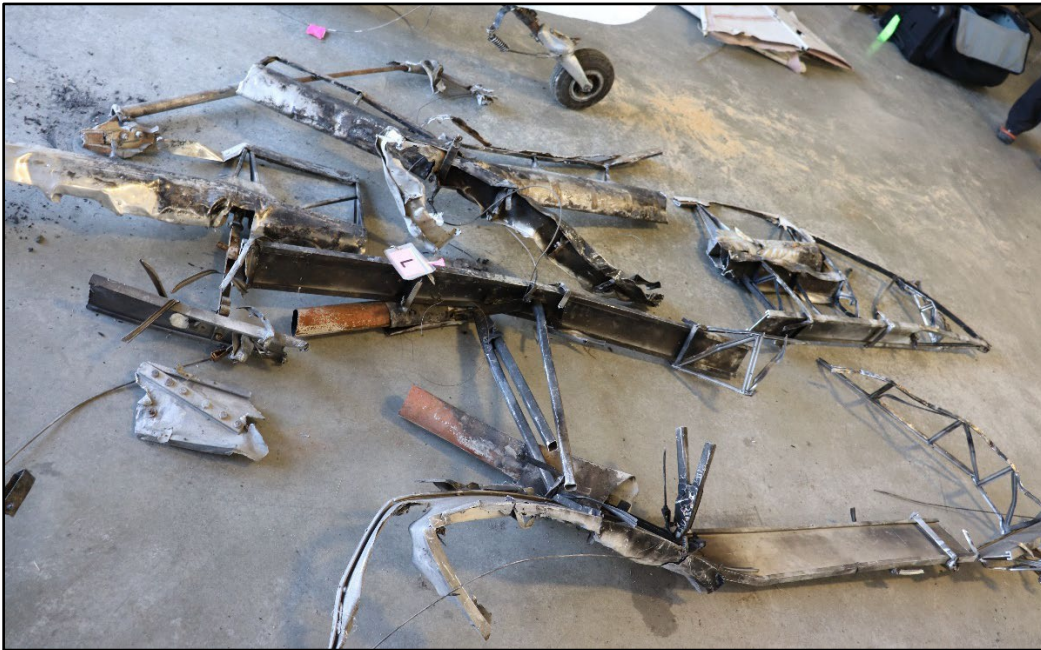
The left wing was separated from the fuselage at the wing root, was impact and thermal damaged. The wing was cut into numerous sections by recovery personnel. A

center section of left wing aileron remained attached to the wing attachment point. The wing flap was separated from the wing and was thermal and impact damaged.

Figure 3: View of left wing thermal damage.

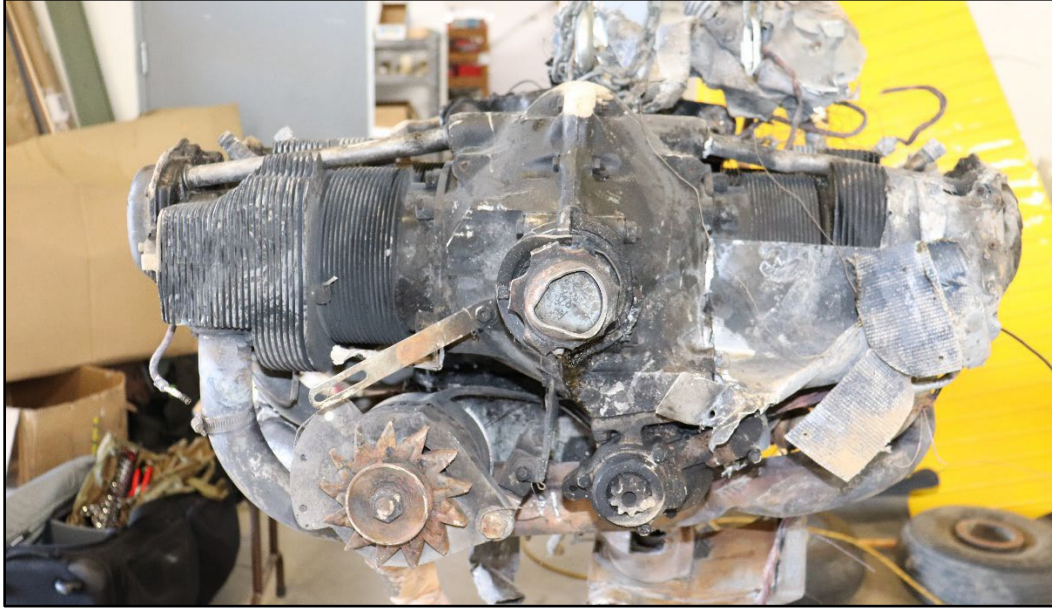
Examination of the recovered engine revealed that the engine remained attached to the engine mounts, impact and thermal damage was observed. The engine mount was cut by recovery personnel. Impact damage was observed to the number 1, 2, & 3 cylinder rocker box covers. A crack was observed on the engine crank case, near the propeller seal, consistent with impact damage. No evidence of any internal mechanical damage was observed to the engine crankcase. All four cylinders remained attached. Extensive thermal damage was observed to the engine accessories case. The carburetor separated, impact damaged, was deformed, consistent with thermal damage. All fuel lines near the engine's accessories case were thermal damaged and various fuel lines were loose.

Figure 4: Front view of engine.

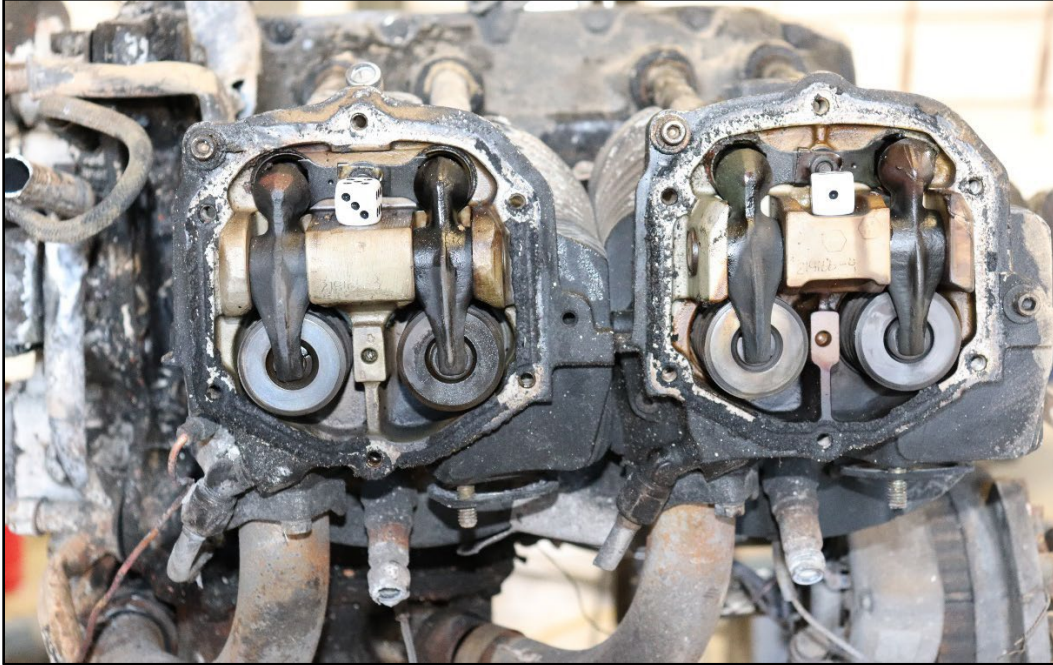
Figure 5: View of the right side of the engine.

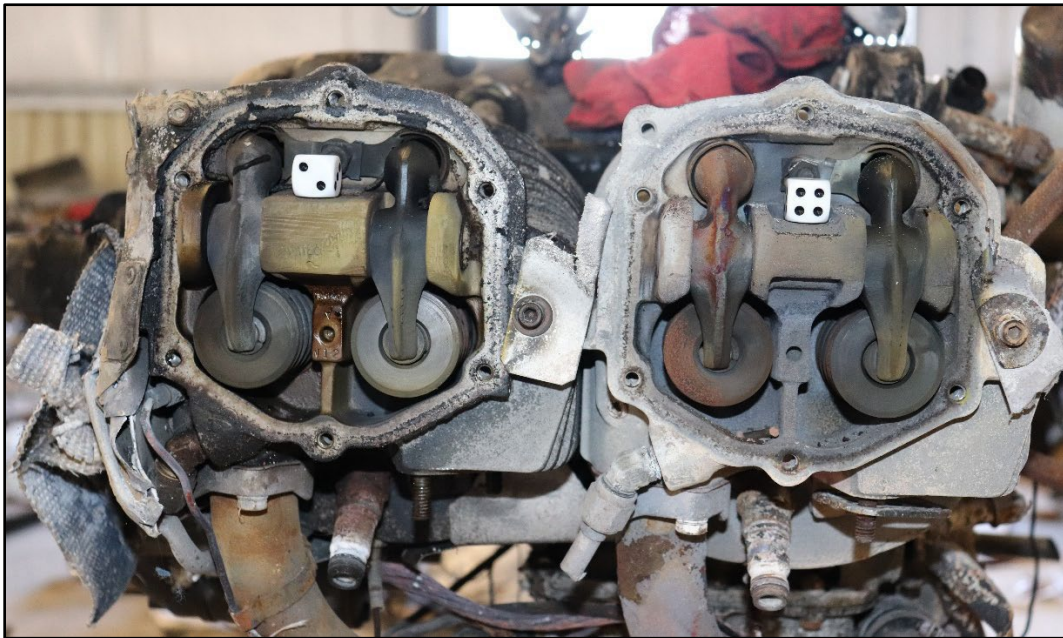
Figure 6: View of the left side of the engine.

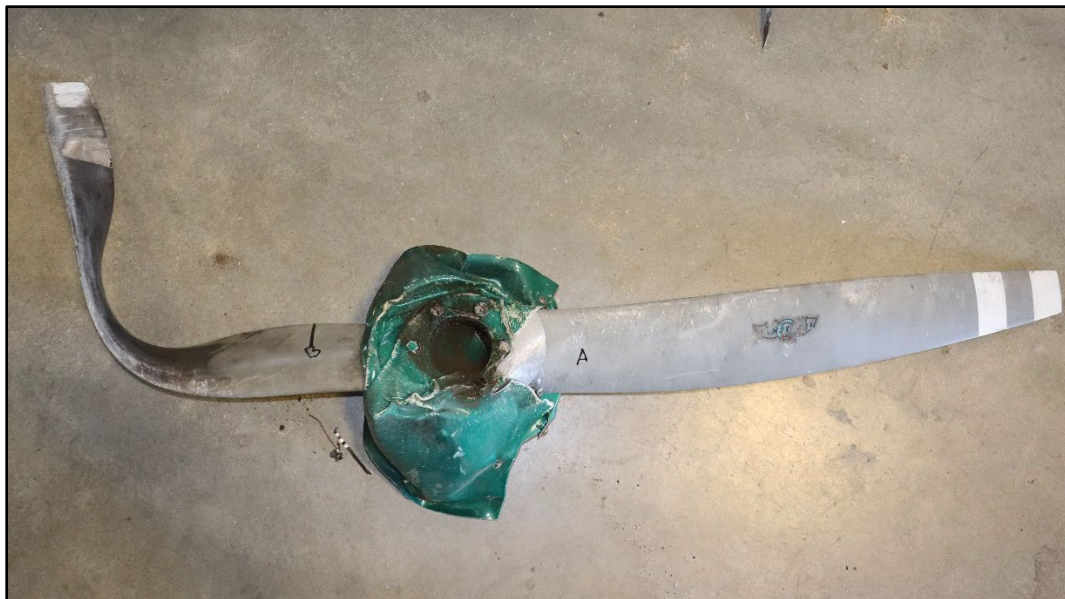
The airplane was equipped with a two blade Sensenich propeller. The propeller separated from the engine at the crankshaft. Both propeller blades remained attached to the propeller hub. Propeller blade A exhibited polishing along the leading edge with unidirectional striations on the cambered side of the blade. Propeller blade B exhibited bending forward, about mid span with unidirectional striations on the cambered side of the blade.

Figure 7: View of propeller.
