National Transportation Safety Board

WPR23FA034

STRUCTURES

Group Chair's Factual Report

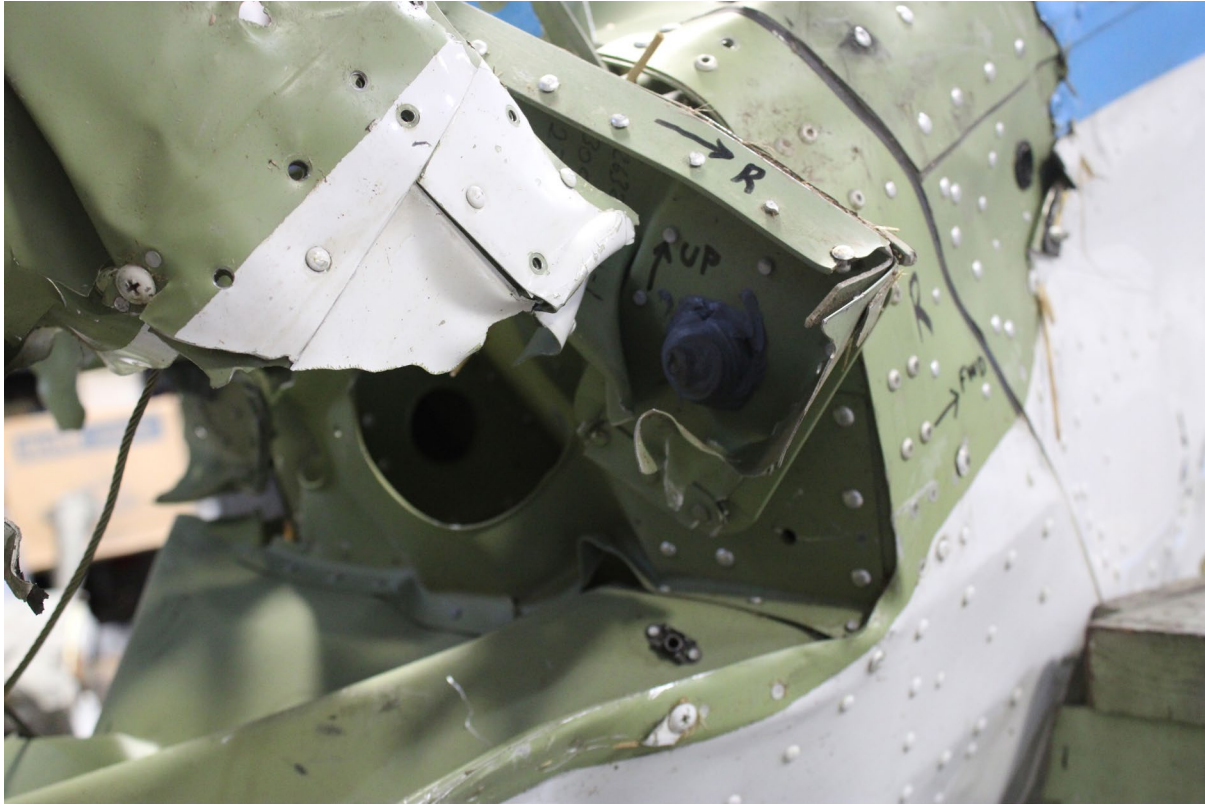
The forward horizontal stabilizer attach points were intact with the bolts installed and sealant covering the aft ends. About 8 inches of the horizontal stabilizer forward spar remained attached at the right attach point and it was rotated down about 45° (Figure 3). The upper spar cap was partially attached, and the lower spar cap was separated. About 5 inches of the horizontal stabilizer forward spar remained attached at the left attach point and it was rotated down about 45° (Figure 4). The upper and lower spar caps were separated. The horizontal stabilizer rear spar right attach point remained attached to the aft fuselage and the spar was fractured immediately outboard of the fitting. The horizontal stabilizer rear spar left attach point was separated from the aft fuselage and remained with the left stabilizer and the rear spar fractured immediately inboard of the fitting. The center portion of the horizontal stabilizer with the trim cable and pulleys was present with significant crushing damage.

Figure 3. Horizontal stabilizer forward spar right attach point, looking forward (NTSB photo)

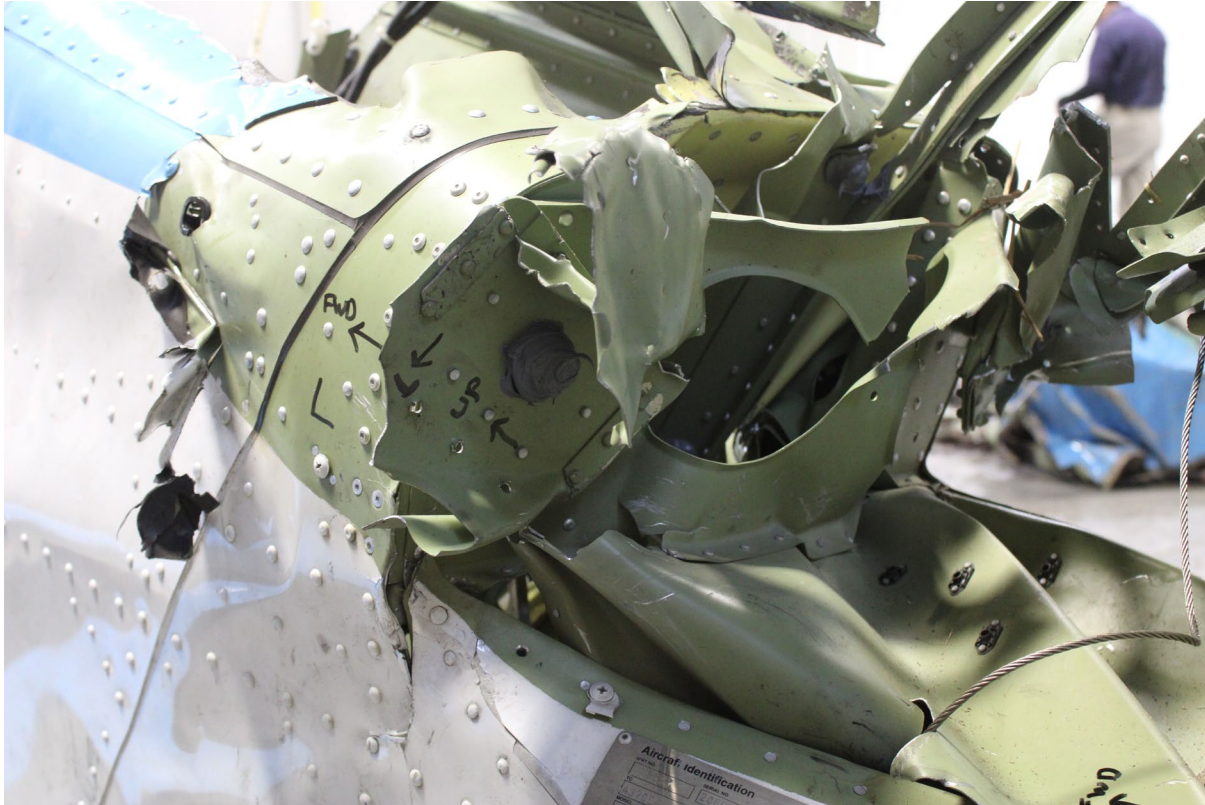
Figure 4. Horizontal stabilizer forward spar left attach point, looking forward (NTSB photo)

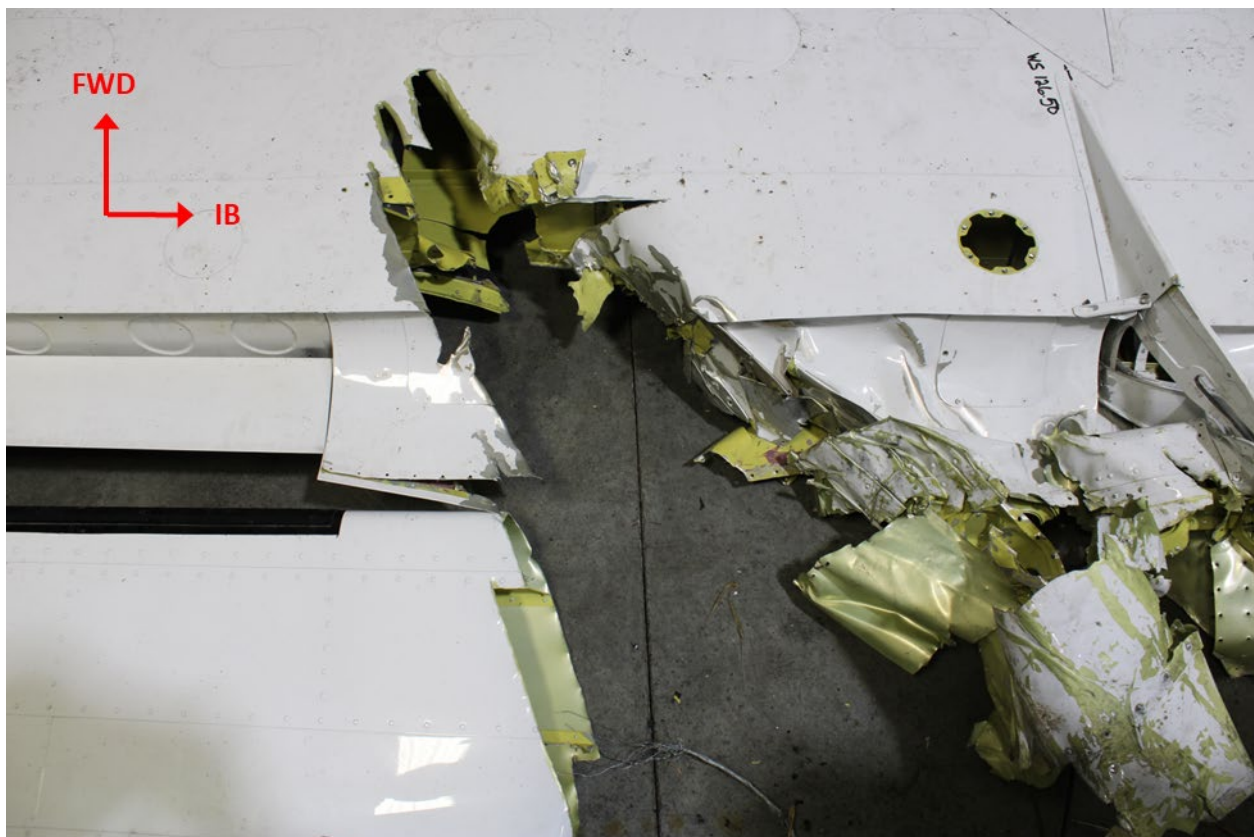
deformed consistent with the inboard end of the flap section rotating upward. About 32 inches of damaged and deformed flap remained attached to the center flap track and the center track was deformed inboard. There was significant crushing and multiple mechanical cut areas noted with the cut ends curled upward. There was no flap structure attached to the inboard flap track. The inboard flap track was deformed in a u-shape. Two additional sections of flap were identified, one about 6 inches wide and one about 39 inches wide, each with diagonal mechanical cuts on each end. The cuts were oriented about 25° from the longitudinal axis and the cut ends were curled upward. There were 4 distinct parallel diagonal mechanical cuts noted to the wing between WS 141 and WS 170 that cut the skins and aft wing spar (Figure 5). The cuts were oriented about 25° from the longitudinal axis. The cut edges all had upward curling, and there was some black paint transfer noted.

Figure 5. Right wing lower surface diagonal cuts WS 141-170 (NTSB photo)

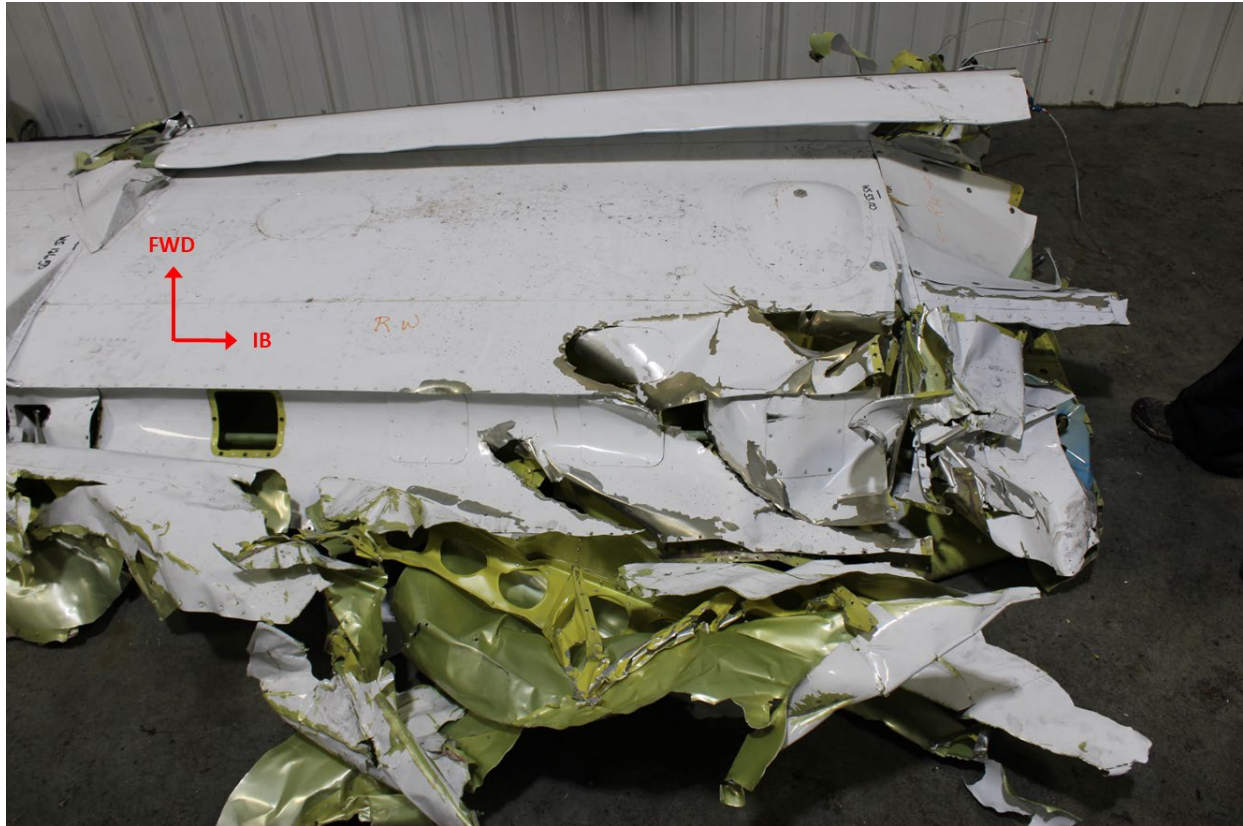
There were 4 distinct parallel diagonal mechanical cuts noted in the wing root area between the root (WS 35) and WS 84. The cuts were oriented about 60° from the longitudinal axis. The cut edges all had upward curling, and there was some black paint transfer noted.

Figure 6. Right wing lower surface diagonal cuts WS 35-84 (NTSB photo)

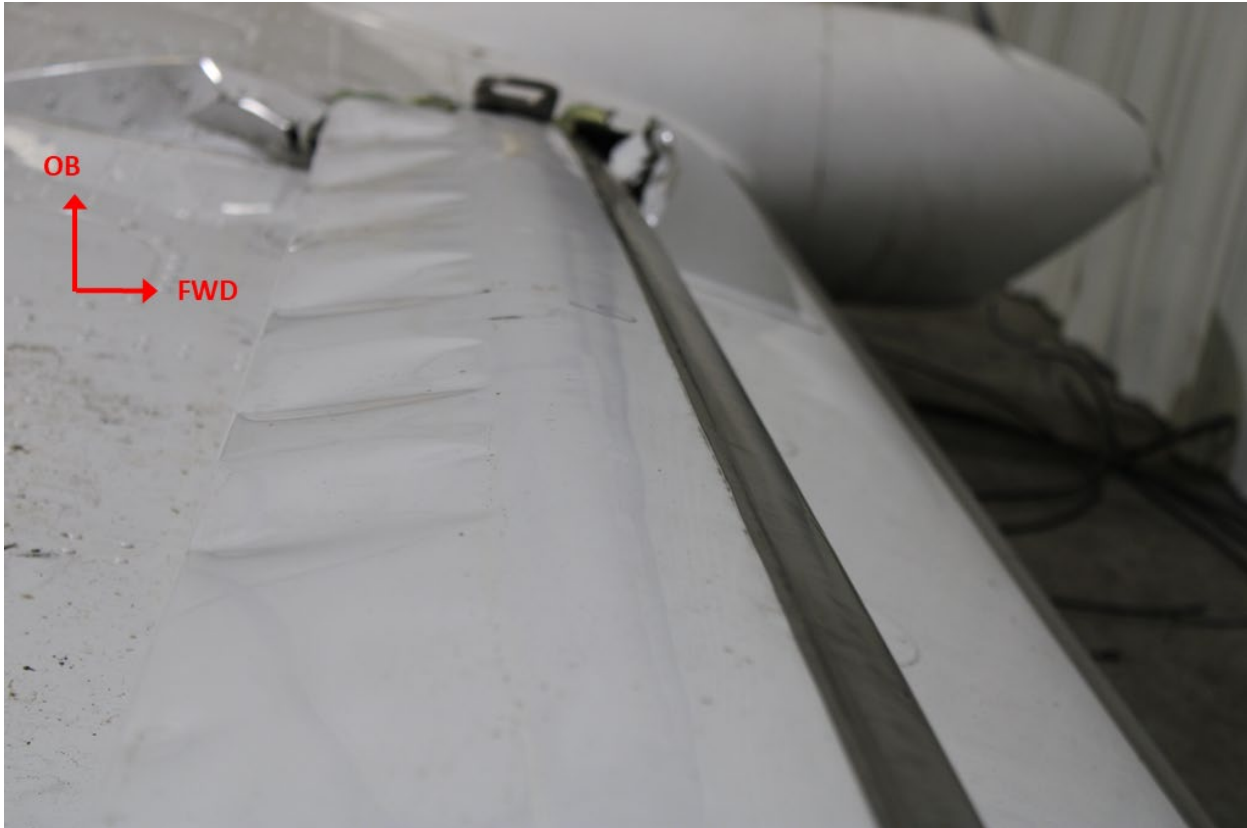
The right wing strut remained attached to the right wing at the upper attach point. The lower forward and aft attach fittings remained attached to the lower end of the right strut, but both were fractured. There was buckling of the right strut trailing edge noted along its length and the strut forward and rear spars were deformed aft (Figure 7). The upper strut attach bolt was intact and installed. There was deformation, damage, and an impact impression on the lower wing skin outboard of the strut attach point consistent with the strut rotating outboard about the attach point. The right wing was recovered laying on its lower surface with the strut oriented outboard.

Figure 7. Right wing strut lower surface, looking outboard (NTSB photo)

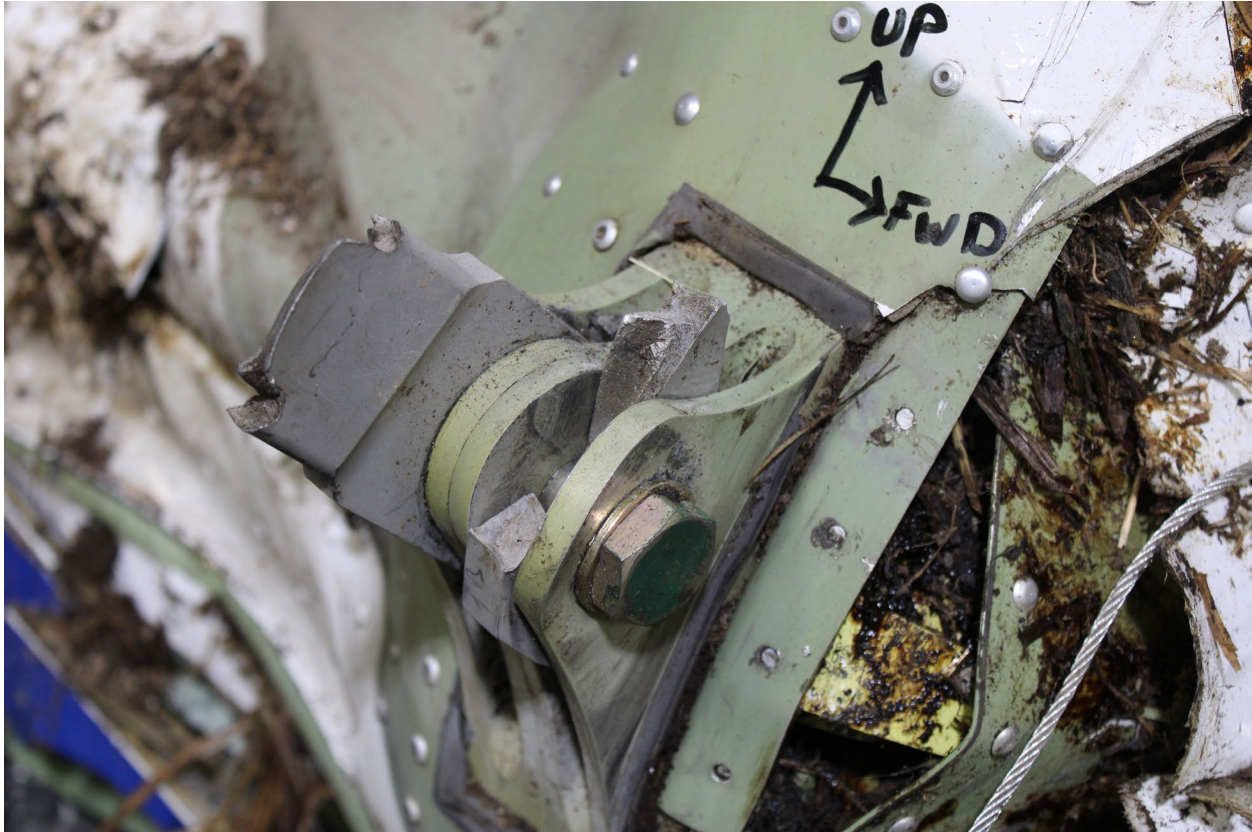
The lower 12 inches of the right strut was cut from the strut and the fractured forward fitting was removed before recovery. The lower aft strut fitting was fractured near the lower attach hole just above the lower edge of the strut. There was no obvious deformation of the lower aft strut fitting. The lower forward strut fitting was fractured partially through the attach bolt hole about 3 inches below the edge of the strut. The fractured end was deformed forward and twisted strut leading edge down. The strut fitting fracture surfaces had an angled, dull, grainy appearance consistent with overstress separation. The fractured ends of the lower forward and aft strut fittings were retained in the fuselage clevises (Figure 8). The retained forward piece was rotated upward relative to the aft piece. The lower strut attach bolt was intact and installed in the fuselage fittings. There was forward deformation noted to the forward fuselage clevis lug.

Figure 8. Fractured right strut lower fittings in fuselage clevis (NTSB photo)

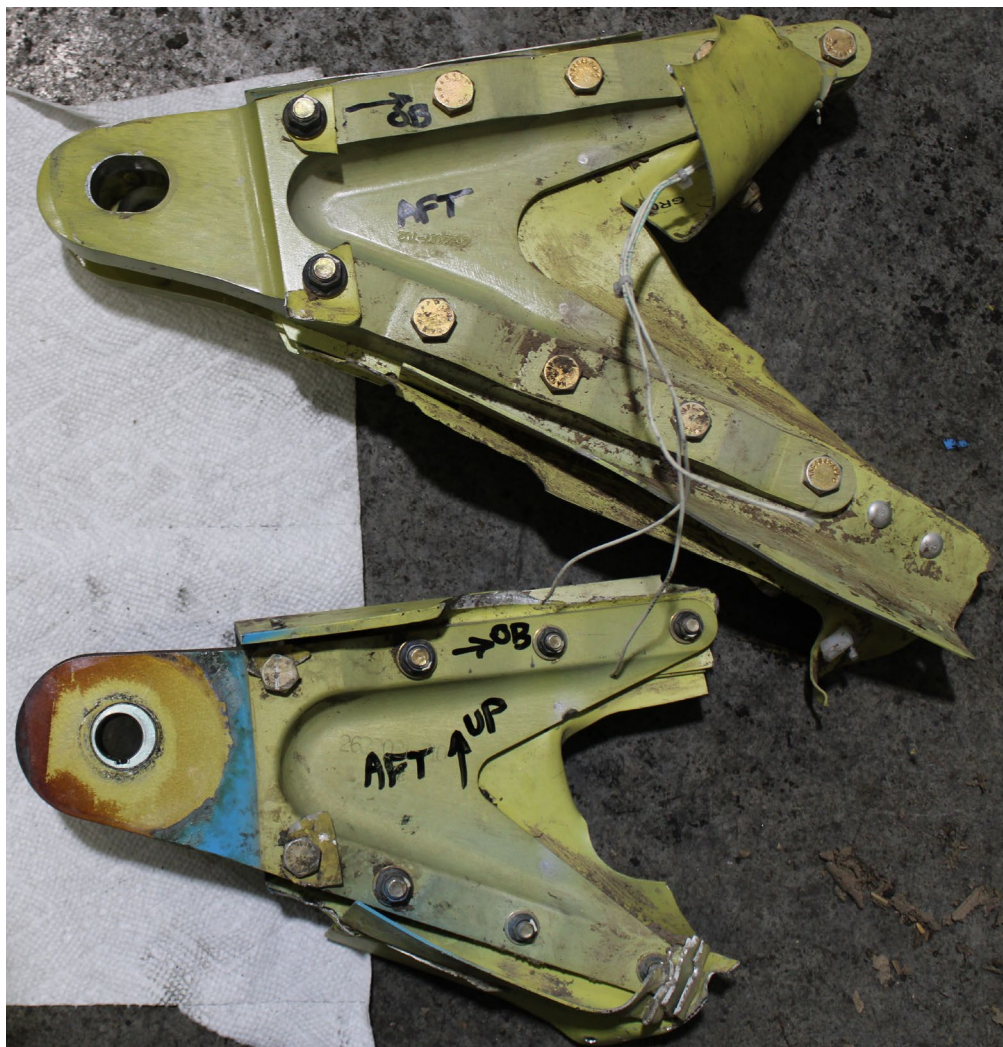
The right forward and aft wing attach points and the right lower strut attach point were disassembled and the fittings were separated. All 3 bolts had no obvious evidence of deformation. The right lower aft strut fitting fragment measured 0.500 inch thick and the hole measured 0.752 inch diameter vertically and 0.765 inch diameter horizontally. The right lower forward strut fitting measured 0.498 inch thick. The hole diameter could not be measured due to the fracture. The right wing forward spar attach fitting forward lug measured 0.498 inch thick and the hole measured 0.877 inch diameter vertically and 0.894 inch diameter horizontally. There was a ridge of deformed material along the outboard side of the hole. The right wing forward spar attach fitting aft lug measured 0.490 thick above the hole and 0.498 below the

hole and the hole measured 0.870 inch diameter vertically and 1.151 inch diameter horizontally. The hole was visibly elongated horizontally (Figure 9). The right wing aft spar attach fitting forward and aft lugs measured 0.440 inch thick. The keyed eccentric bushings remained installed in the lugs. The holes in the bushings measured 0.623 inch diameter horizontally and vertically.

Figure 9. Right wing forward and aft spar attach fittings, aft side, after disassembly (NTSB photo)
