National Transportation Safety Board

WPR23FA034

AIRCRAFT PERFORMANCE & SIMULATION STUDY

April 11, 2024

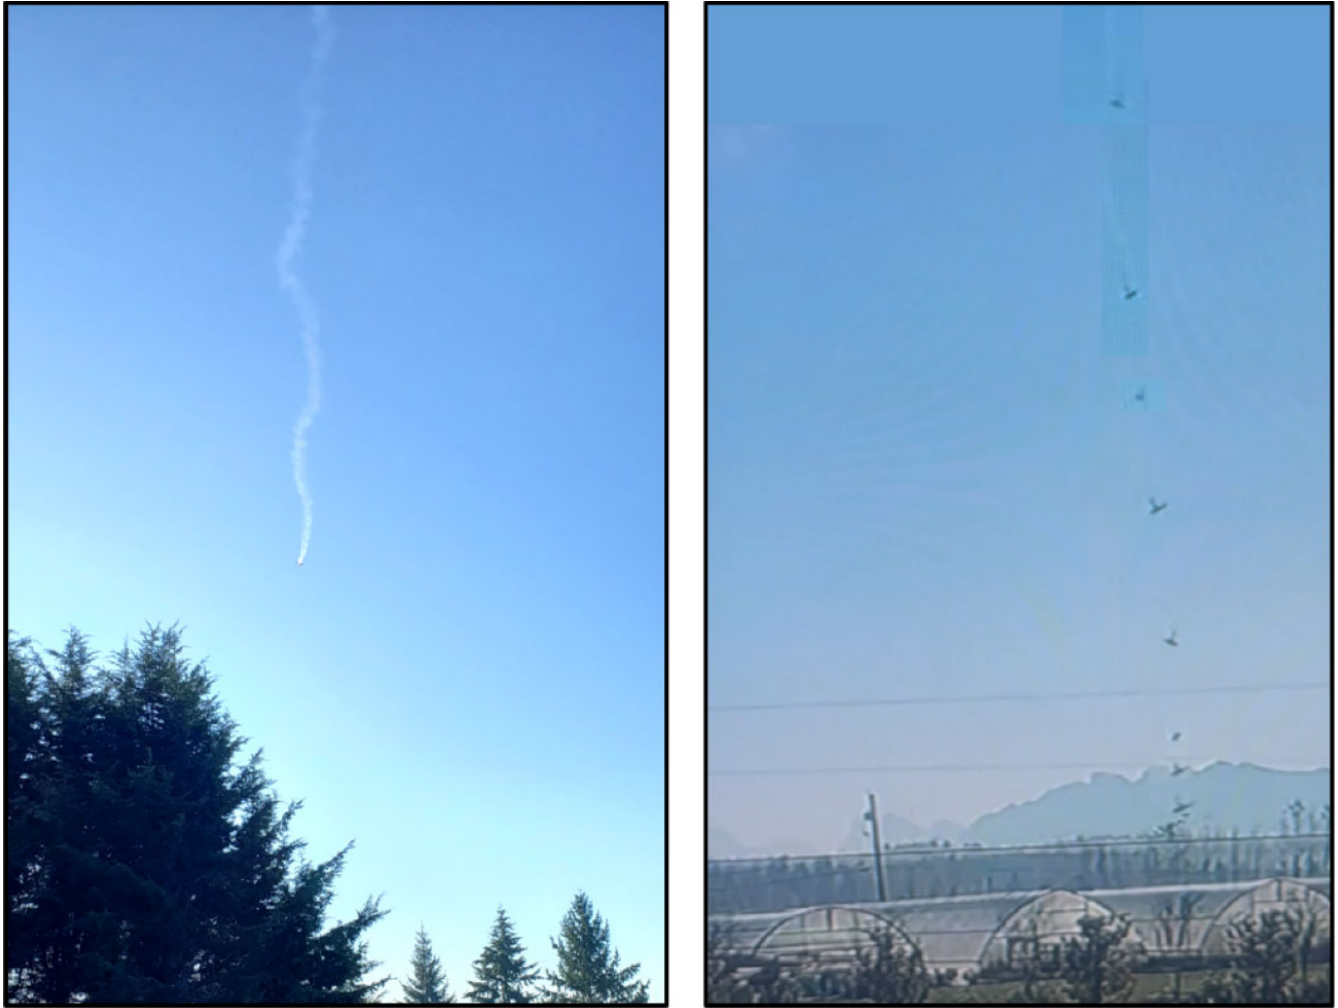
The FAST pressure altitude data in Figure 9c shows a change in slope (vertical speed) following the end of the ADS-B data at about 10:19:18, and a relatively constant rate of descent between that time and impact with the ground. This likely corresponds to the period after the in-flight structural failure of the airplane, and the spiraling descent depicted in Figure 1.

Figure 1. Photograph of N2069B spiraling to the ground provided by a witness (left), and composite of frames from a security camera video of the same (right). The images on the right show the left wing attached to the fuselage and the right wing missing. (Images taken from the NTSB preliminary report of the accident (Reference 2).)

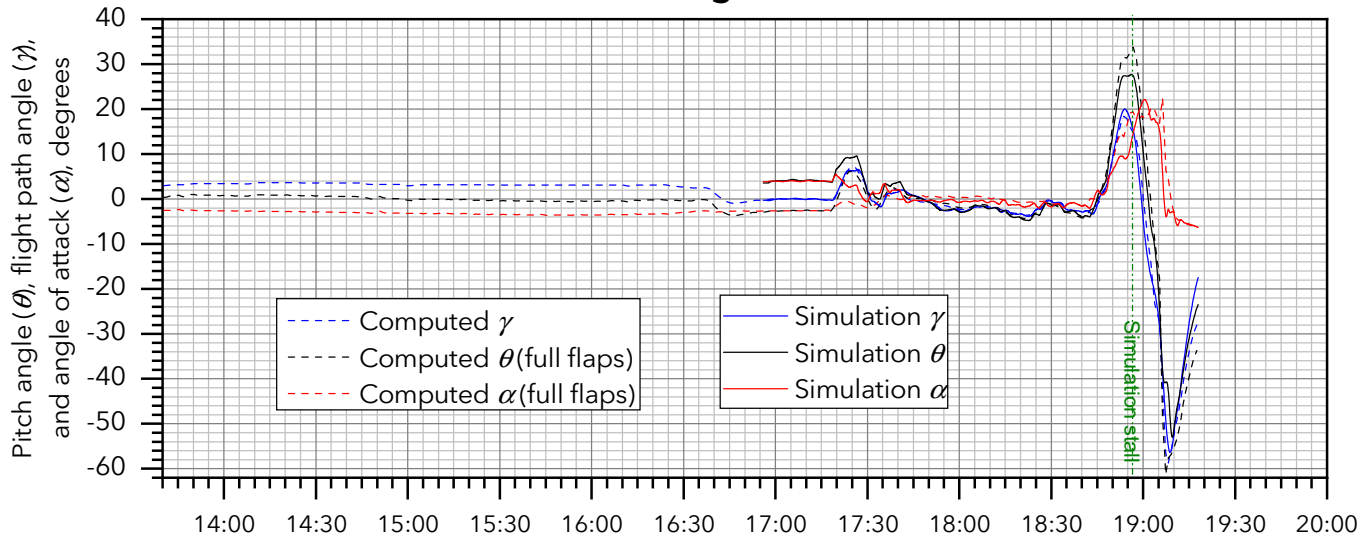
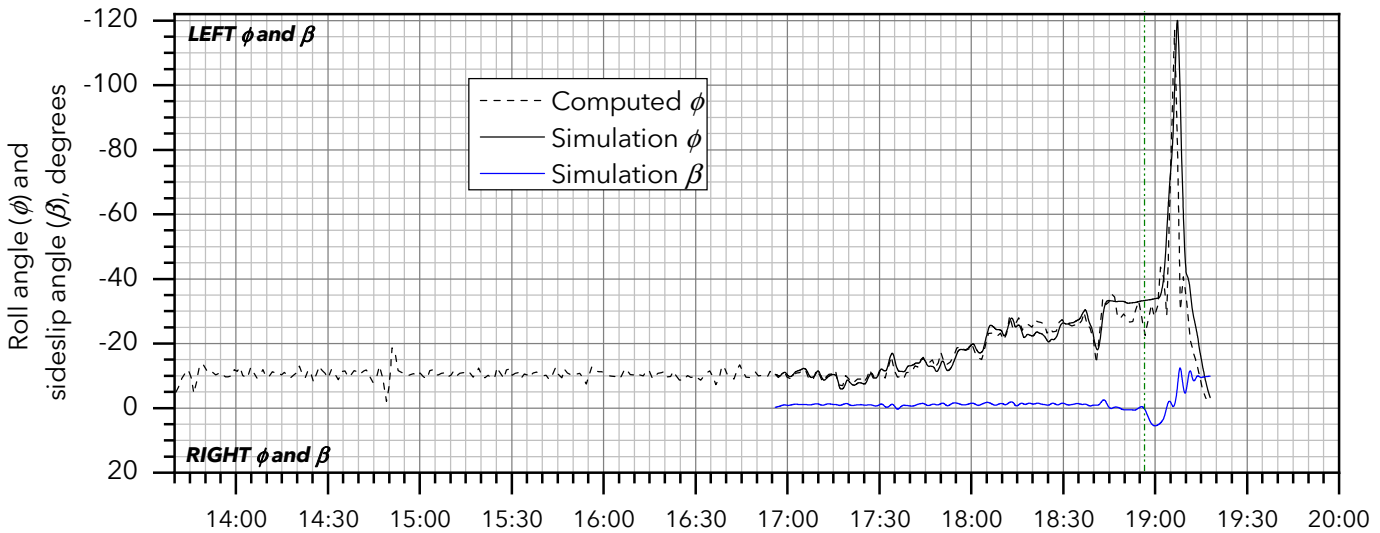
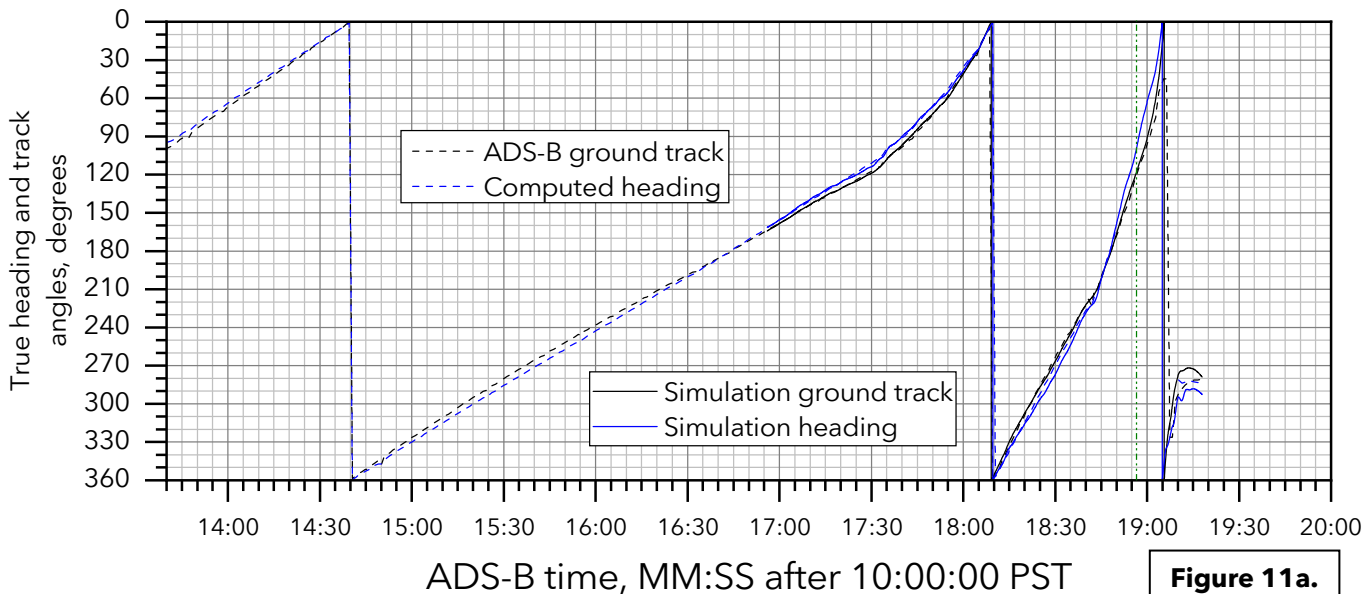
Figure 11a.

Figure 11 presents several longitudinal and lateral / directional flight angles for the last 5.5 minutes of flight. The top plot presents the pitch angle (θ) and flight path angle (γ), the middle plot presents roll angle (ϕ) and sideslip angle (β), and the bottom plot presents true heading (ψ) and ground track. As noted in the plots of altitude (Figure 9) and speed (Figure 10), the simulation pitch and flight path angles in the post-stall dive are not as steep as those computed from the ADS-B data. The computed pitch angle reaches -61° , whereas the simulation pitch angle only reaches -53° . This difference is likely the result of the limitations of the math pilot controller and the rapid and relatively extreme dynamics of the maneuver.

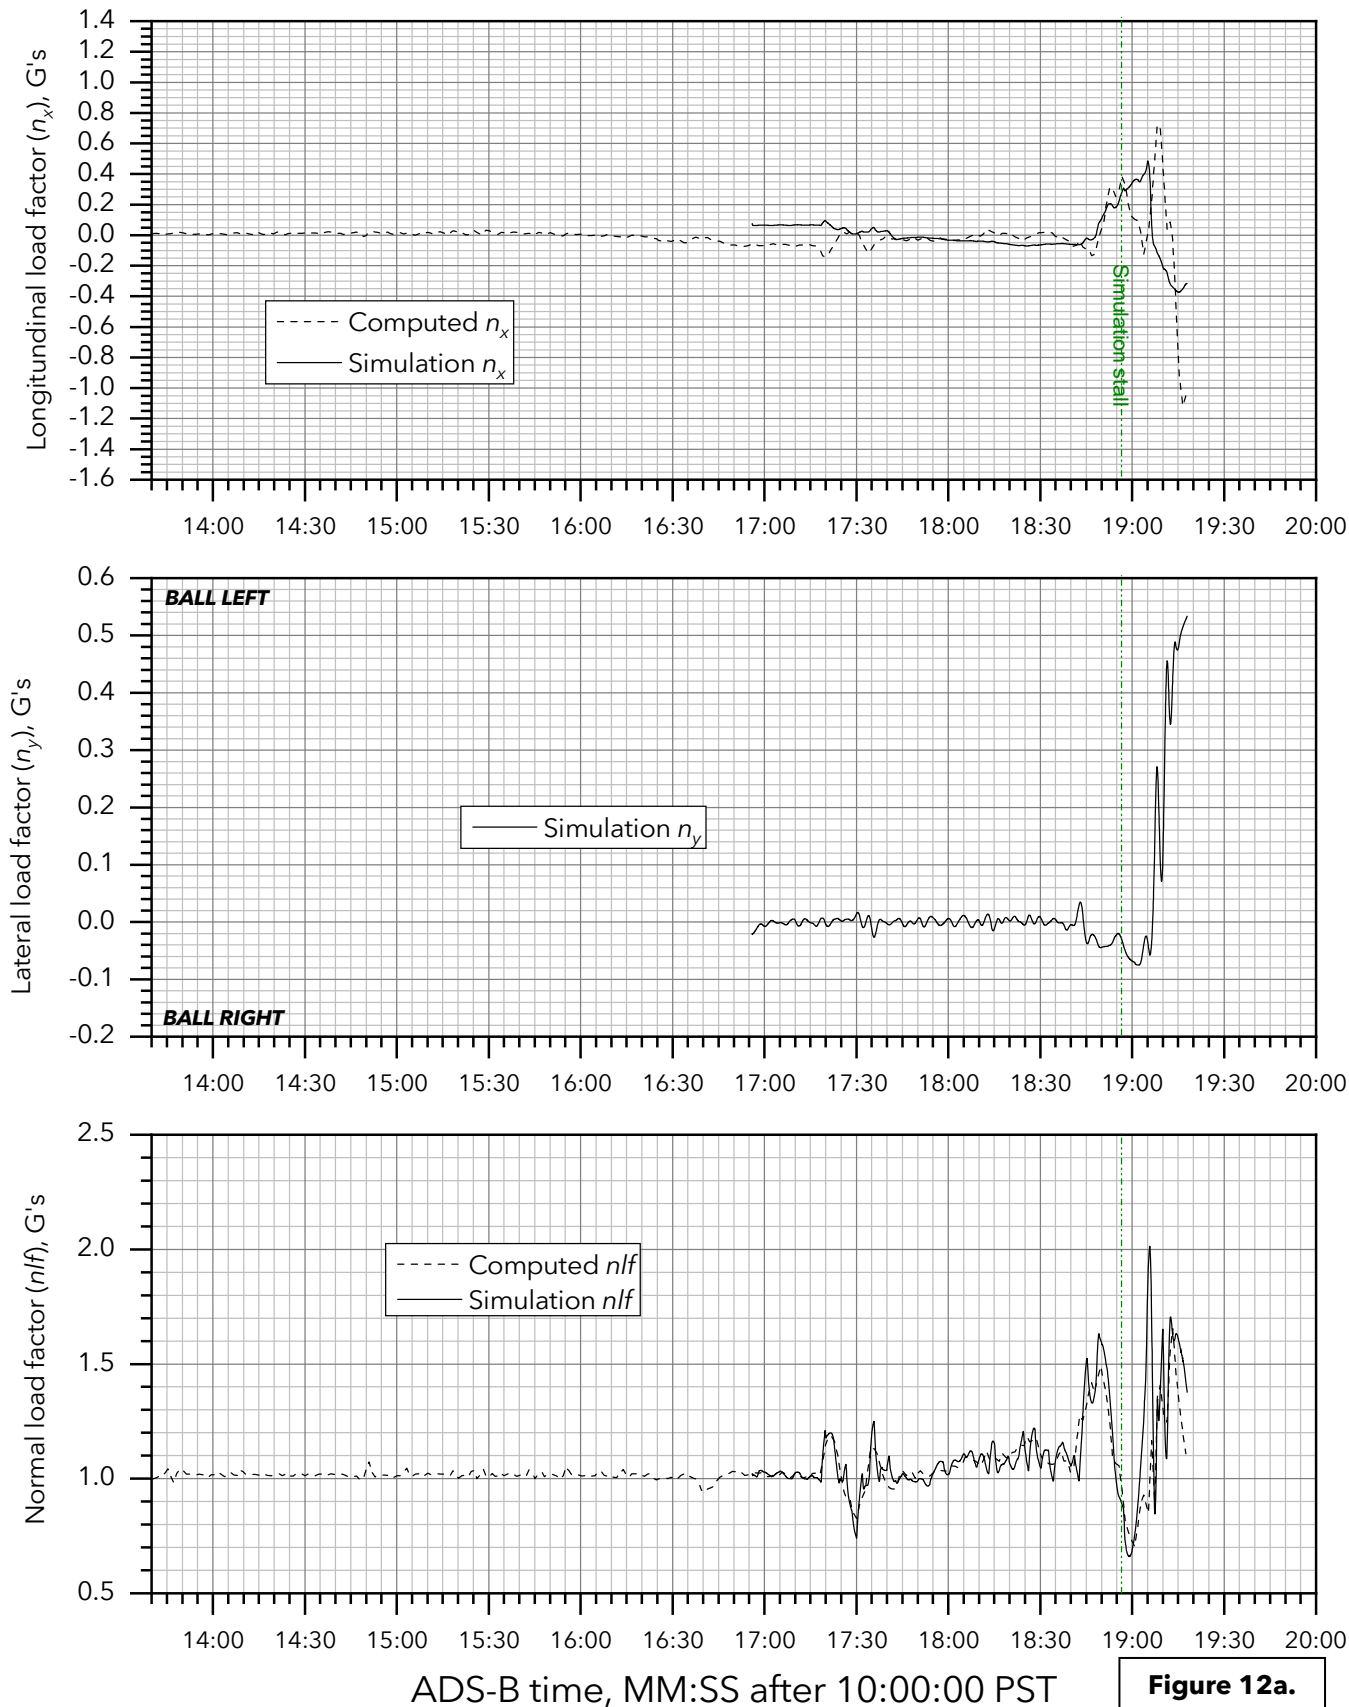
Figure 12a.

Figure 12 presents the body-axis load factors during the last 5.5 minutes of flight. The load factors are not remarkable, and neither the computed nor the simulation vertical load factors exceed 2 G's. This finding underscores the fact that when the airspeed limitations of the airplane are exceeded, structural damage can occur even if the load factor limitations are not exceeded.

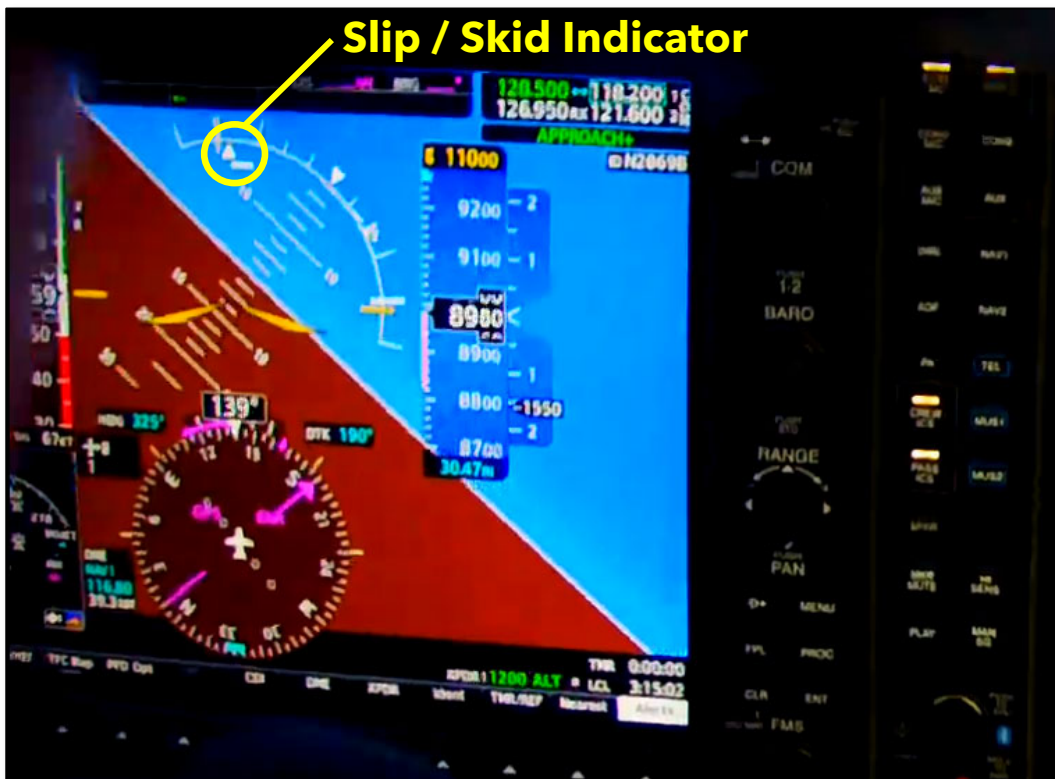
Figure 17a. Video frame from Flight 07 condition 5.6L, showing displacement of the Slip / Skid Indicator bar, and a roll angle greater than 30° just prior to the stall break.

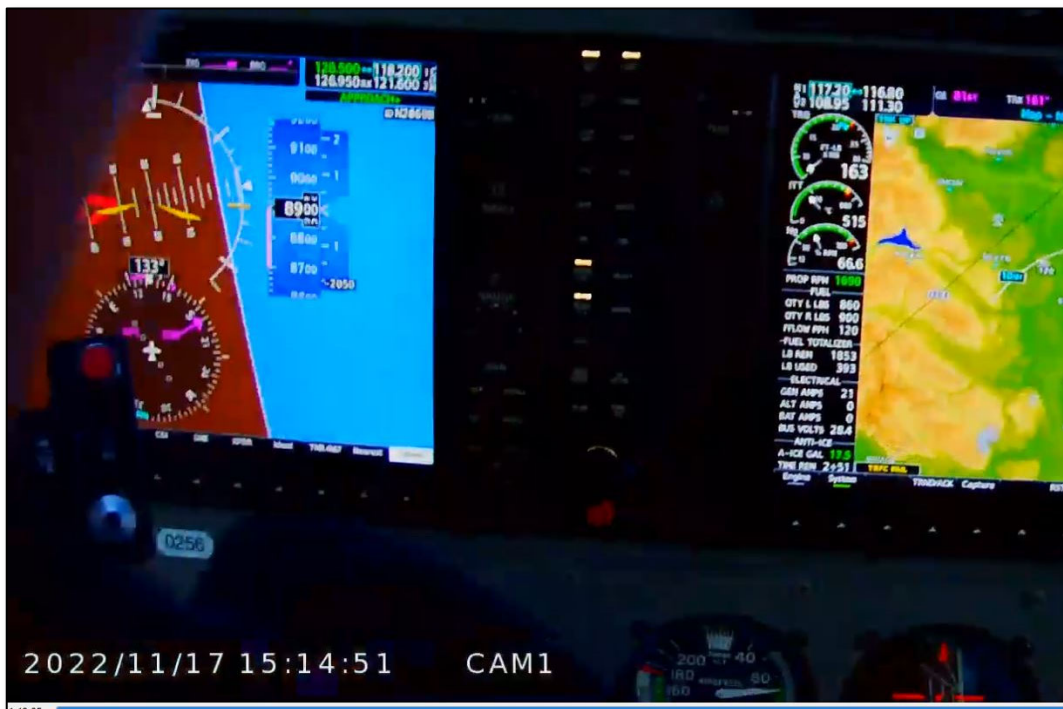
The video from Flight 07 records the crew discussing whether condition 5.6L was a “pass” or “fail.” Table 2 presents relevant portions of this conversation, which took place following a minute-long discussion about how to interpret the column position display presented to the pilot. The peak roll angle of -83° recorded in the flight test data occurred at 15:14:52.

An effective review of these items after Flight 07 might have identified the V_{MO} exceedance as an event requiring an inspection per the Maintenance Manual. Such a review might also have called attention to the excessive roll on condition 5.6L.

Figure 17b. Video frame from Flight 07 condition 5.6L, showing a roll angle past -60° following the stall break. The PFD was obscured by the pilot's body for a few seconds after the stall, but recorded data indicates that the roll angle reached -83°. Subsequent frames show the pitch angle at about -45°.

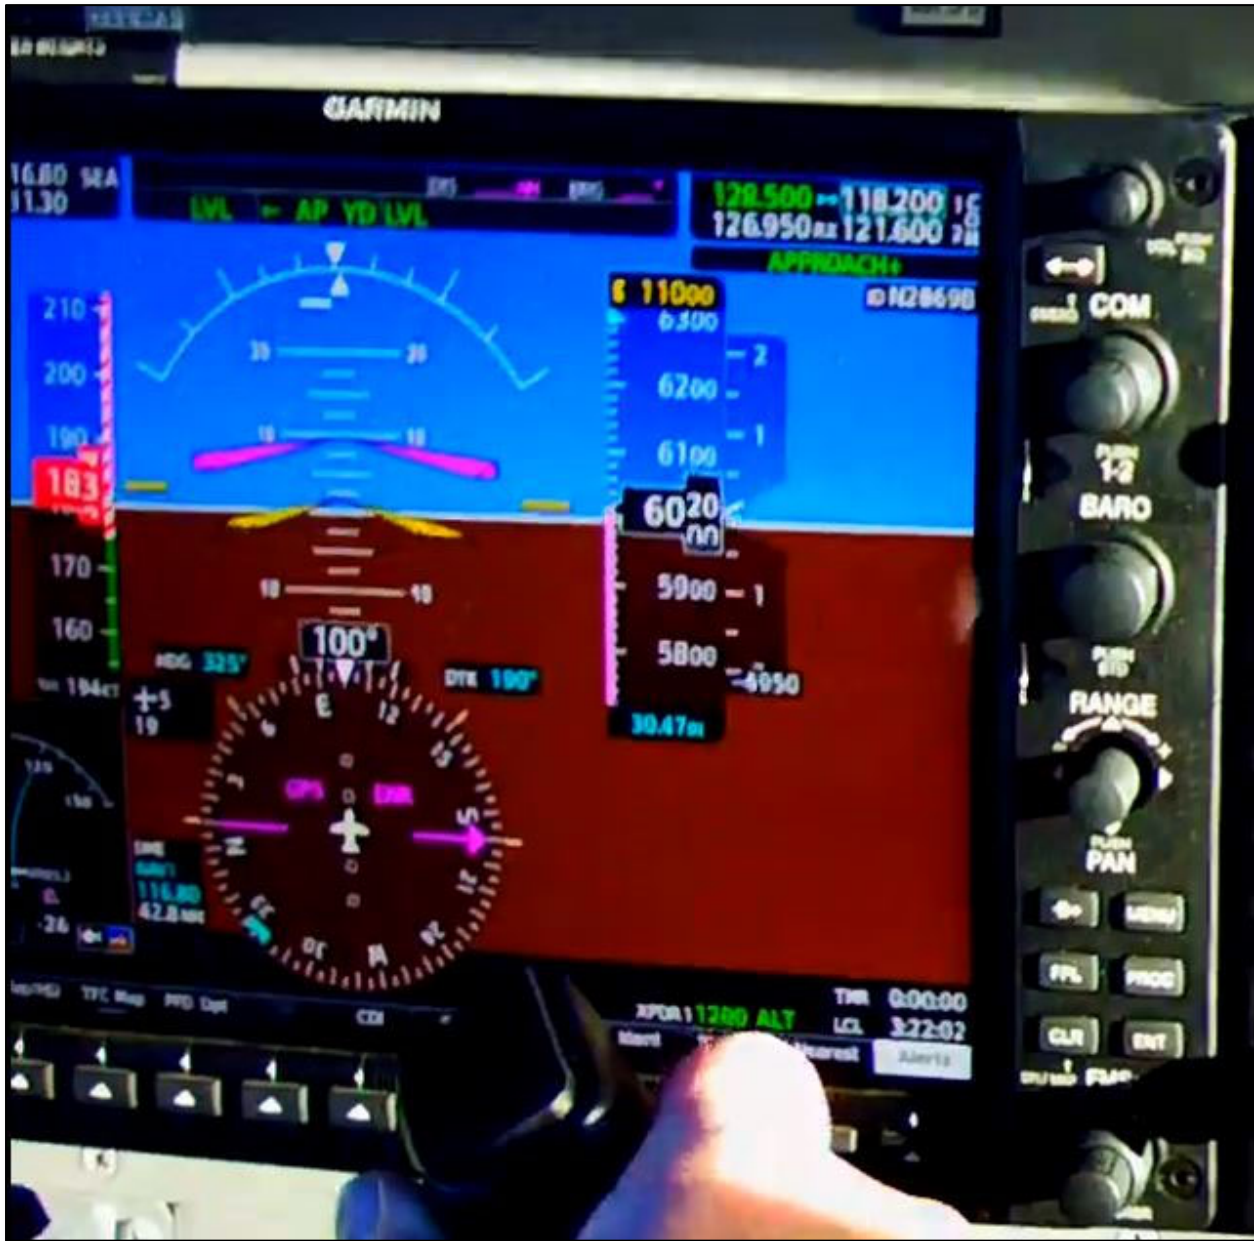
The video recording of Flight 07 on the day before the accident indicates that at the end of that day’s testing, following a pitch-over to “recover airspeed” (as stated by the pilot), the airplane exceeded V_{MO} (175 KIAS) for over 6 seconds and reached a peak airspeed of 183 KIAS (see Figure 20). This condition would have satisfied the requirements for the overspeed inspection described in the Maintenance Manual, but the investigation did not find any record of an overspeed inspection. According to the copilot on Flight 07¹⁷, the overspeed condition was not recorded in the airplane’s logbook.

The omission of a record of the overspeed condition and of the required inspection was inconsistent with the guidance in FAA Order 4040.26C. Appendix B of the Order, titled *FAA Flight Test Briefing Guide*, contains “a detailed list of most things that should be covered in a thorough pre- and post-flight briefing.” Among the items listed in the “Post-Flight” section of the Appendix are the following (emphasis added):

- The test crew failed to identify the exceedance of the roll angle limits during condition 5.6L, which would have rendered that condition a "failed" test.
- The airplane was apparently not inspected after exceeding V_{MO} shortly after the termination of testing on Flight 07, as required by the 208B maintenance manual.

Figure 20. Video frame from Flight 07 showing an airspeed of 183 KIAS, 8 knots above V_{MO} .

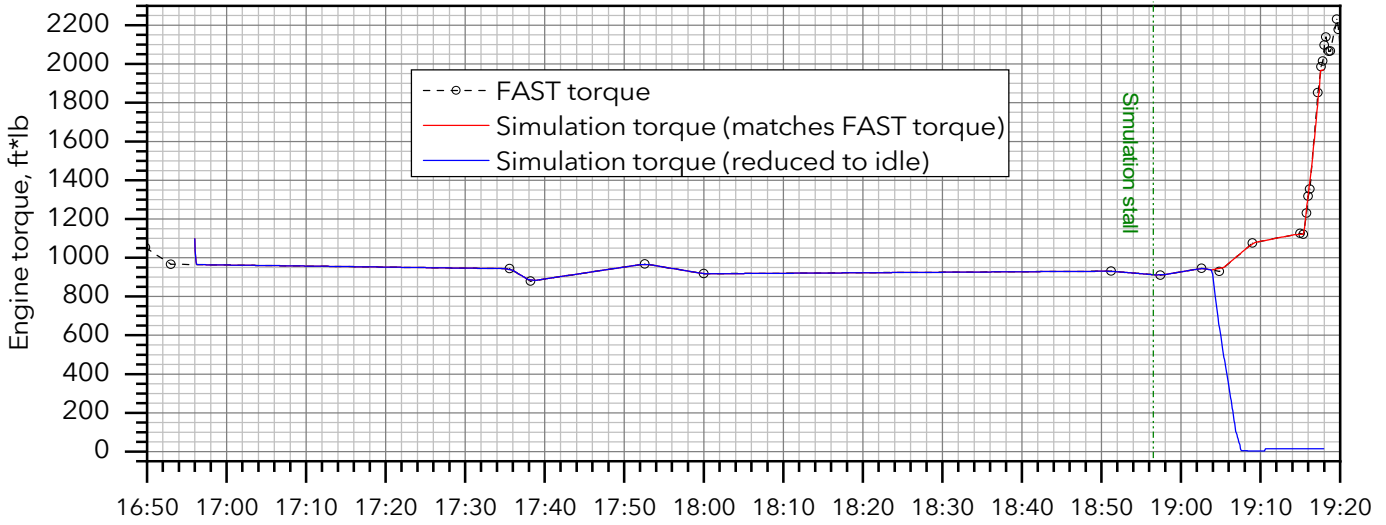
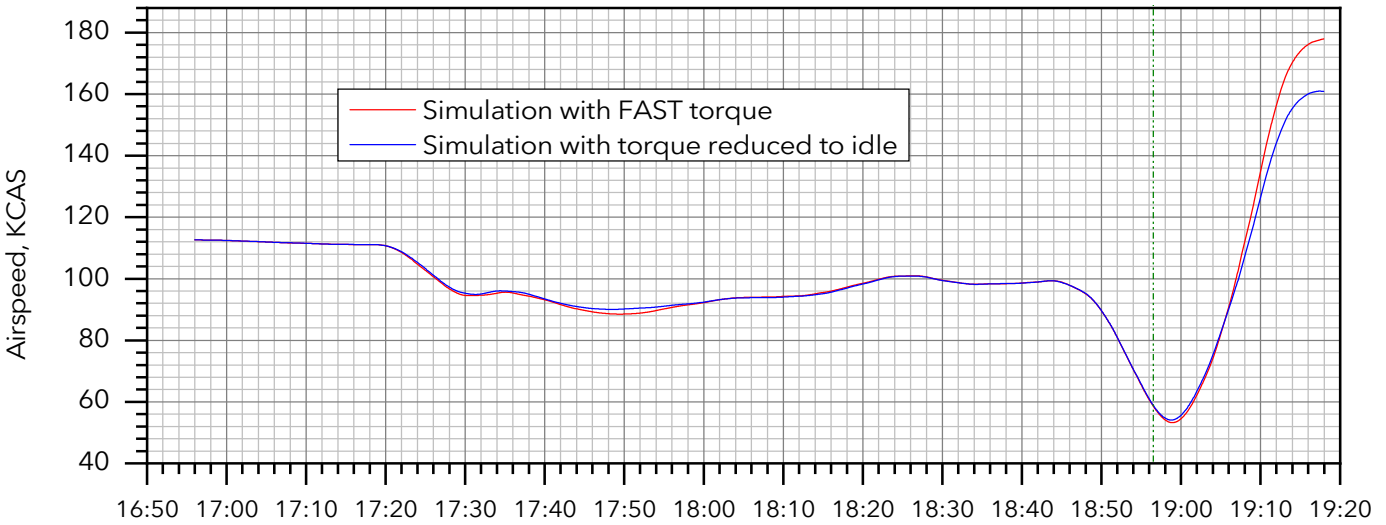
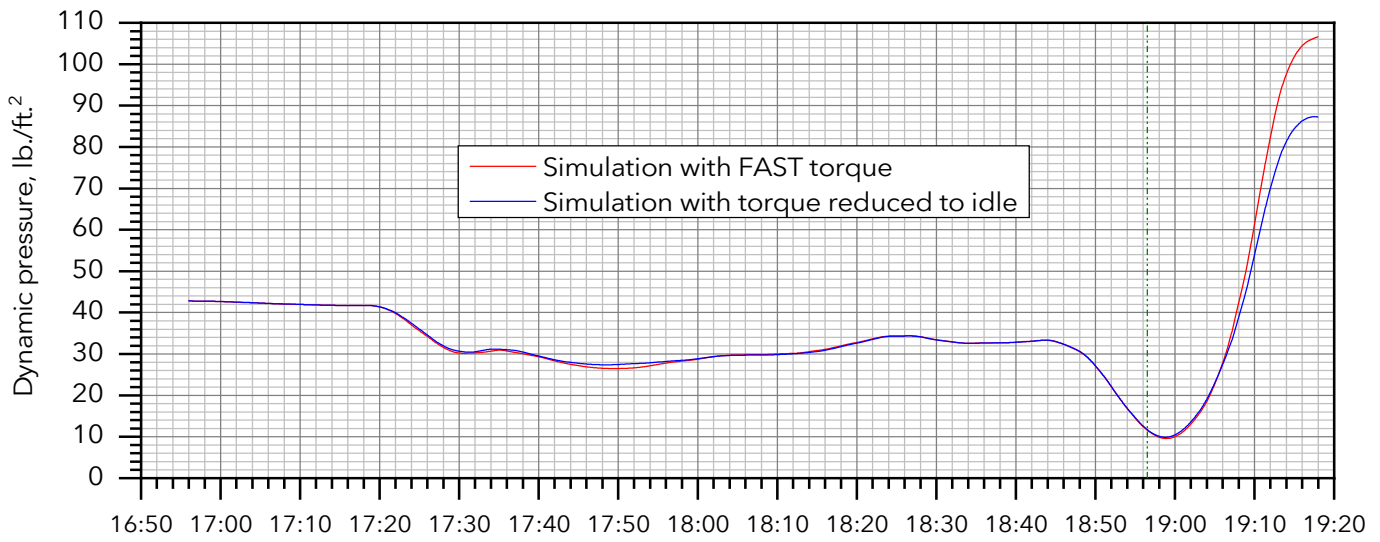
As noted above, following the condition 5.80L stall on the accident flight, the engine torque did not decrease, but increased. This likely contributed to the rapidity with which the airplane accelerated past V_{FE} and V_{MO} . To quantify the difference a reduction in torque would have made on N2069B’s post-stall airspeed behavior, the simulation of the stall maneuver was repeated, keeping the math pilot control logic the same as in the original simulation but forcing the engine power to idle over 4 seconds after the pitch angle decreases below -10° following the stall. The results of this second simulation are compared to the original simulation in Figure 22.
