National Transportation Safety Board

WPR23FA137

AIRFRAME AND ENGINE EXAMINATION

Location: Alcova, Wyoming
Date: March 21, 2023
Time: 16:01 mountain daylight time
Airplane: Cessna, 182S, N314FR

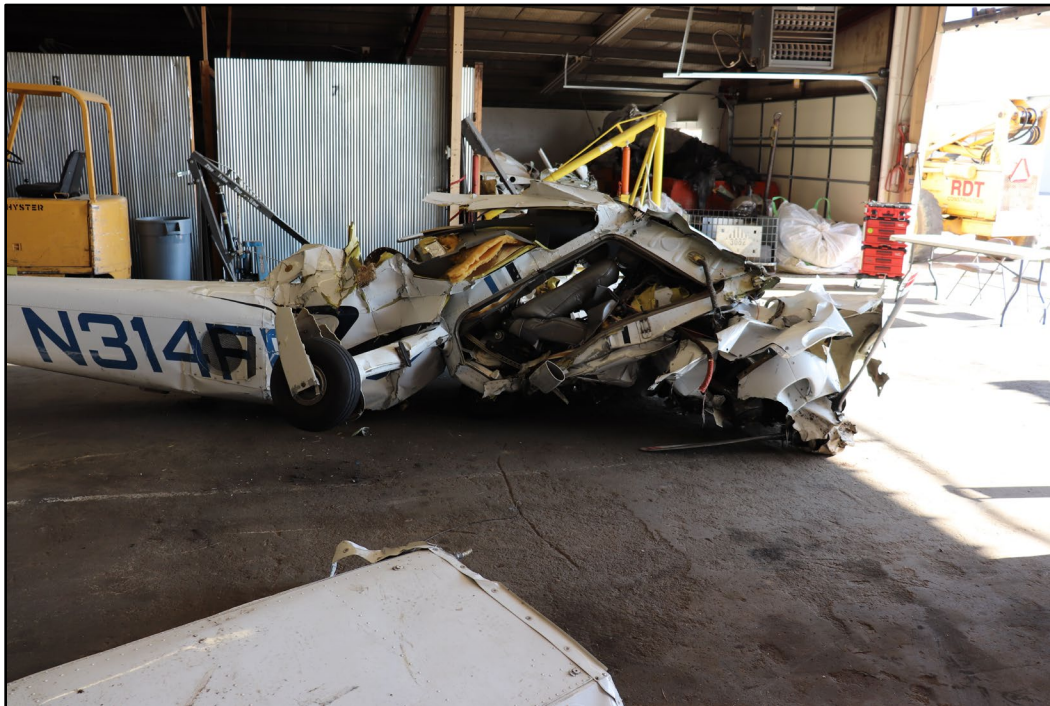
Examination of the recovered airframe revealed that the recovery organization had removed both wings, horizontal and vertical stabilizer, elevator and rudder for transport. The forward section of the cockpit was impact damaged and crushed aft. The instrument panel was impact damaged with multiple instruments displaced. Crushing and bending was observed throughout the fuselage.

Figure 1: View of accident airplane during examination.

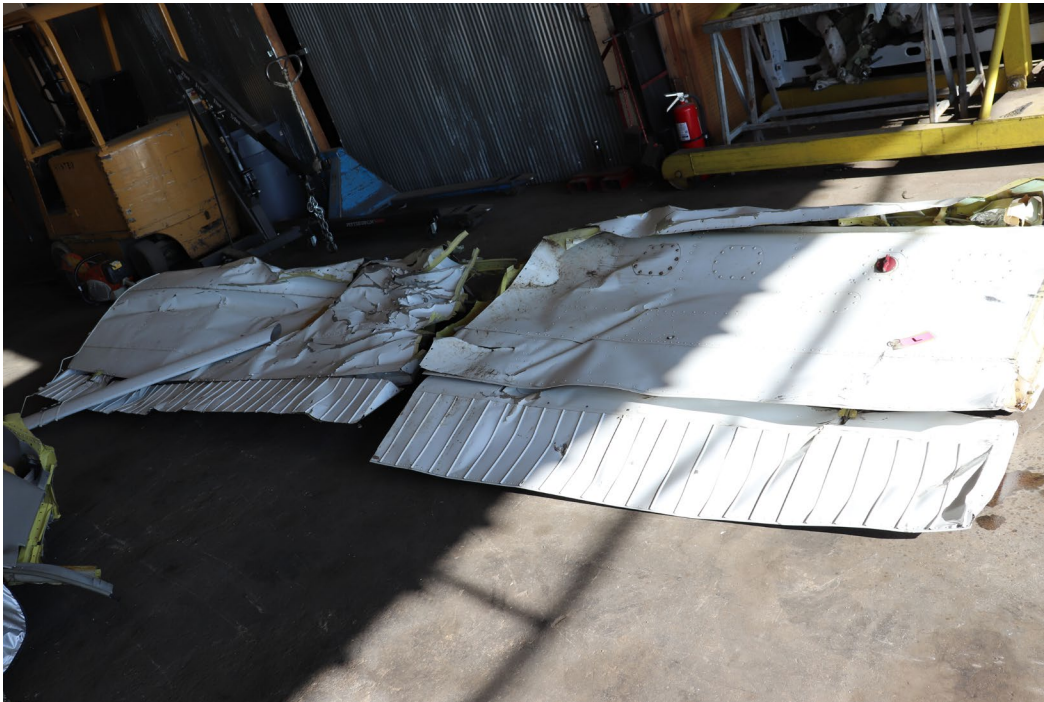
The left wing was separated from the fuselage near the wing root and fragmented about mid span. Crushing and bending was observed throughout the wing. The left wing tip was separated from the wing. The bottom side of the wing surface, near the wing root exhibited hydraulicing. The left flap and aileron remained attached via their mounts. The left aileron was moved by hand, the attached flight control cable was observed to move in the corresponding direction. Visual inspection of the left fuel cap revealed rust on the rubber seal and the fuel filler port.

Figure 2: View of left wing damage.

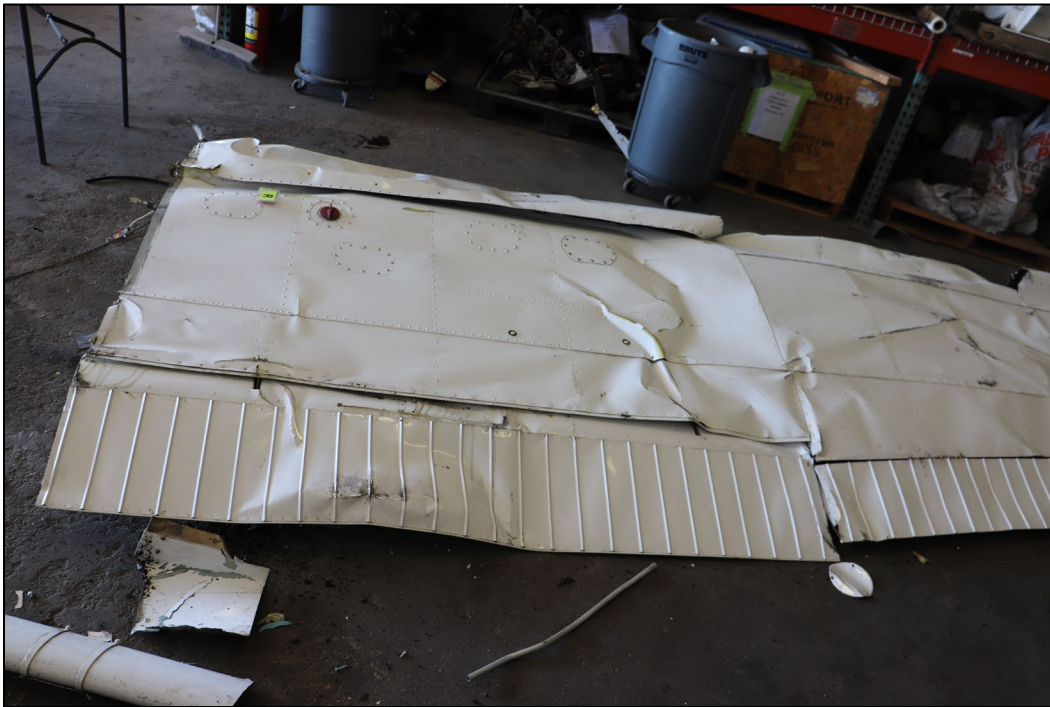
The right wing was separated from the fuselage near the wing root. Crushing and bending was observed throughout the wing consistent with impact damage. The right flap and aileron remained attached via their mounts. The right aileron was moved by hand, the attached flight control cable was observed to move in the corresponding direction. Visual inspection of the right fuel cap revealed that the rubber seal appeared normal and unremarkable. The fuel filler port was also normal and unremarkable.

Figure 3: View of right wing damage.

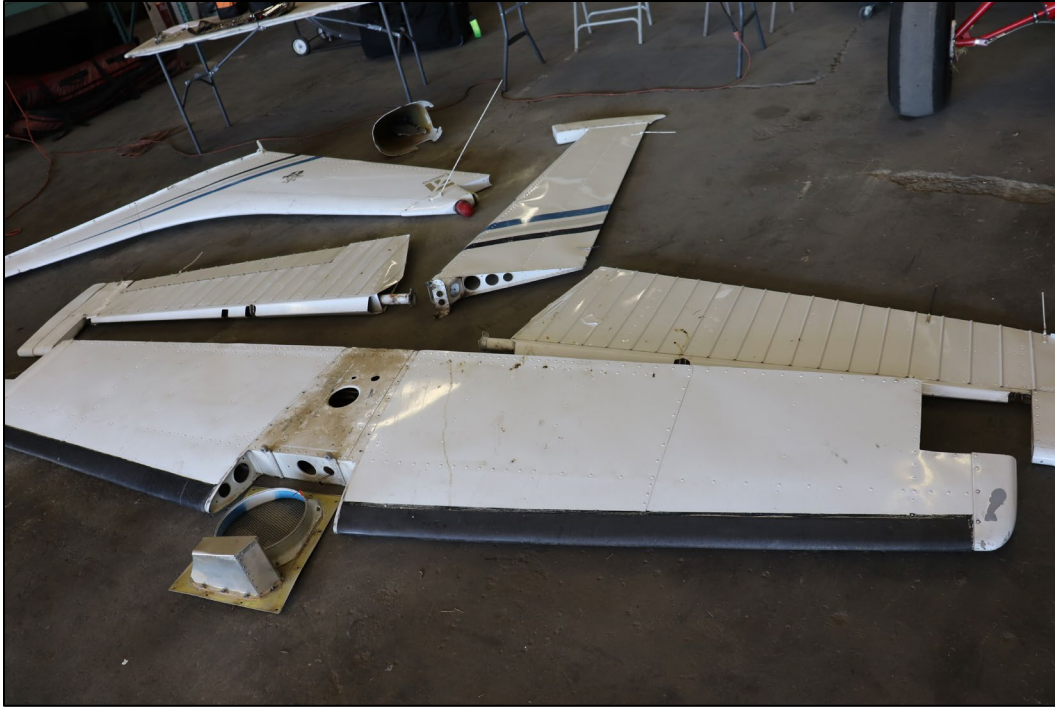
The horizontal stabilizer, vertical stabilizer, elevator, and rudder were removed by the recovery company for transport. No visible damage was observed to the horizontal stabilizer, vertical stabilizer, elevator, and rudder.

Figure 4: View of horizontal stabilizer, vertical stabilizer, elevator, and rudder.

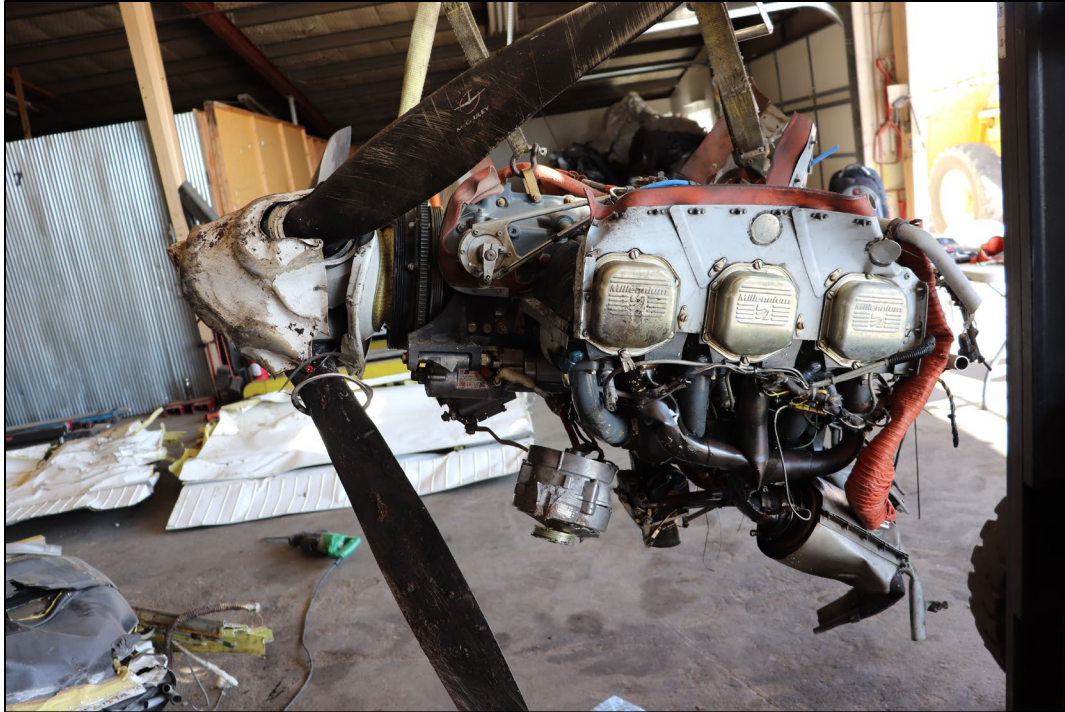
Examination of the recovered engine revealed that top two engine mounts had fracture separated. All six cylinders and various engine accessories remained attached. All fuel and oil lines that were removed were tight. No evidence of any mechanical damage was observed to the engine crankcase.

Figure 5: View of airplane engine during examination.

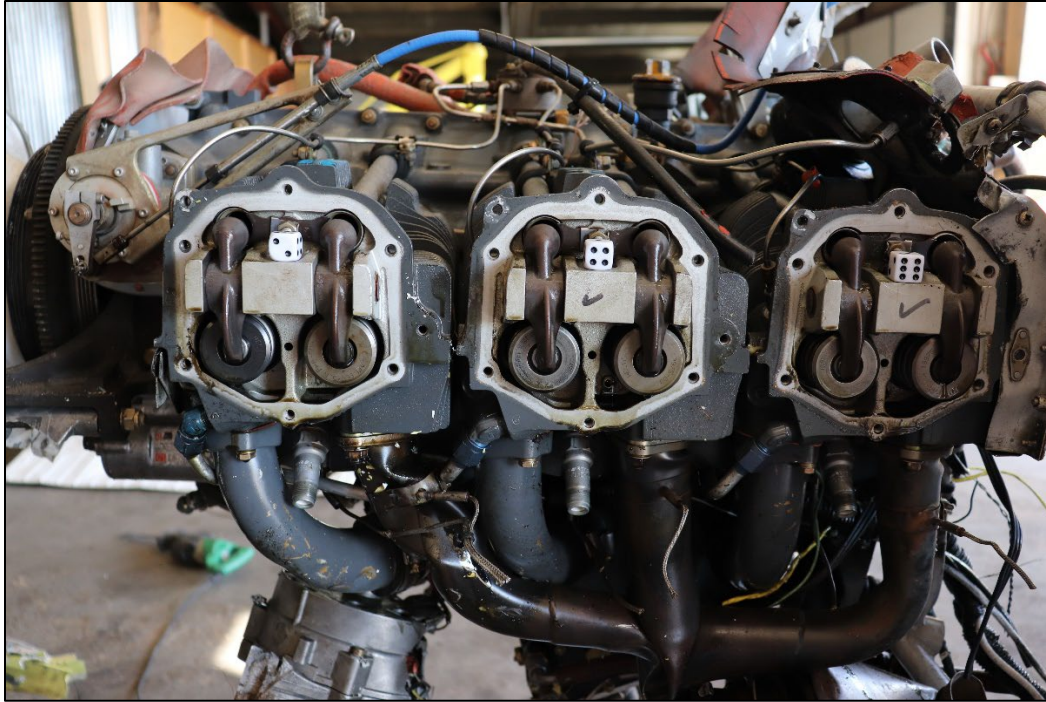
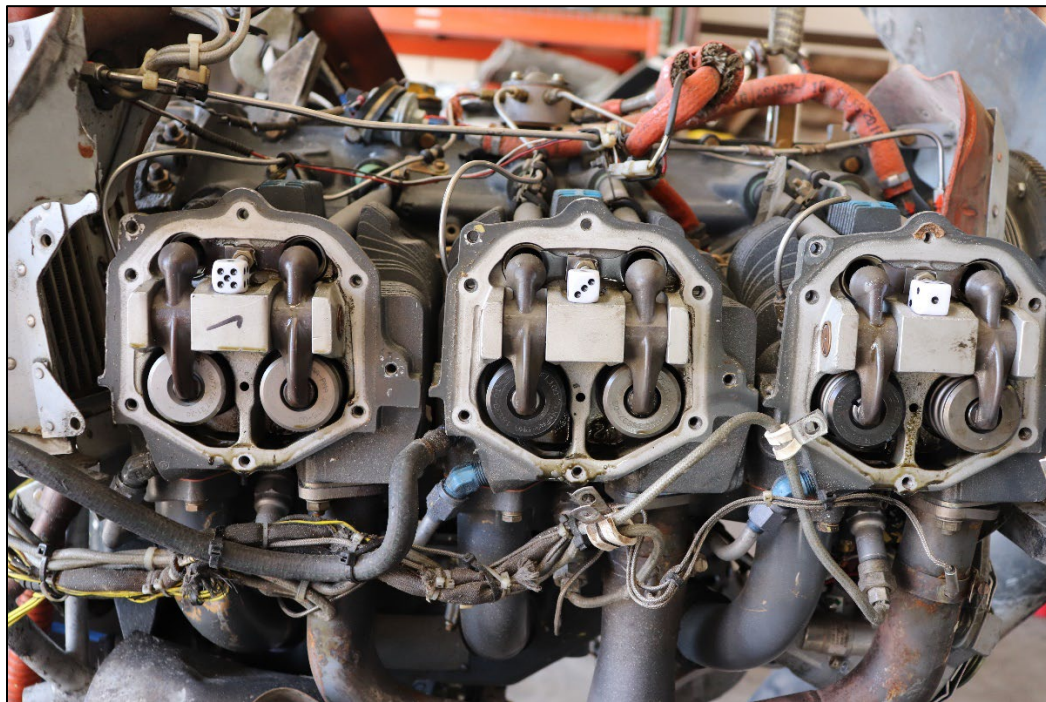
The rocker box covers were removed. The intake and exhaust rocker arms were intact and oil coated on all cylinders. All intake and exhaust valve springs were in place and visually appeared to be undamaged. The upper spark plugs were removed, and all six cylinders were examined internally using a lighted borescope. A normal amount of combustion deposits was observed within the combustion dome of each cylinder and piston face. All of the intake and exhaust valves were unremarkable. The crankshaft was rotated by hand using the propeller. Rotational continuity was established throughout the engine and valve train. Thumb compression and suction was obtained on all six cylinders.

Figure 6: View of left side of the engine with the rocker box covers removed.

Figure 7: View of right side of the engine with the rocker box covers removed.

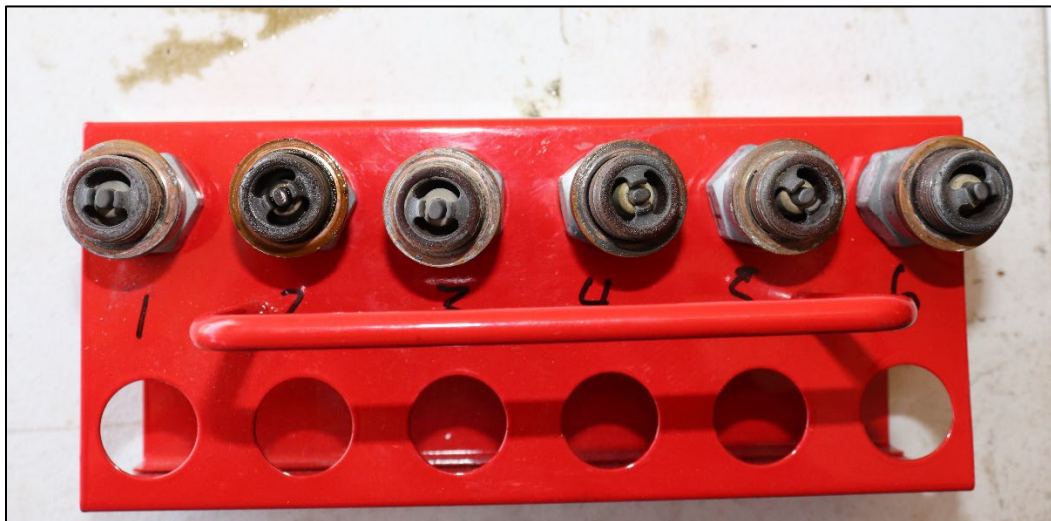
The top spark plugs were removed from the engine and they were the massive electrode type. All sparkplugs exhibited black and gray deposits within the electrode area with the exception of No 2 cylinder, which were oil soaked. All of spark plugs

exhibited signatures consistent with worn out-normal when compared to the Champion Check-A-Plug comparison chart.

Figure 8: View of the top spark plugs.
