# National Transportation Safety Board

WPR23LA023

## **ENGINE EXAMINATION**

Location: Marble Canyon, Arizona  
Date: 10/15/2022  
Time: 0830 MST  
1530 UTC  
Airplane: N6031Q, Mooney M20E

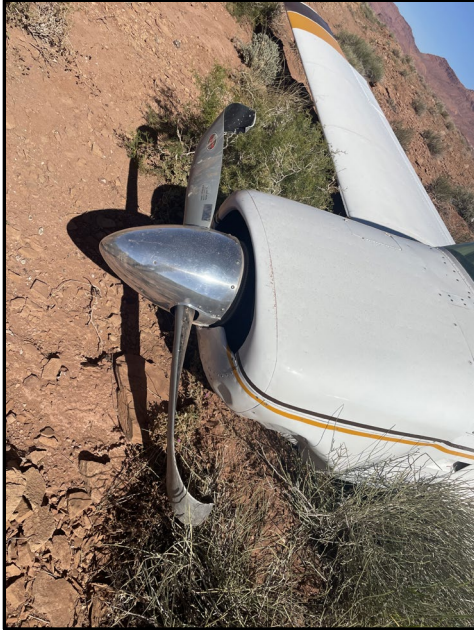
**Figure 1: Engine viewed at accident site.**

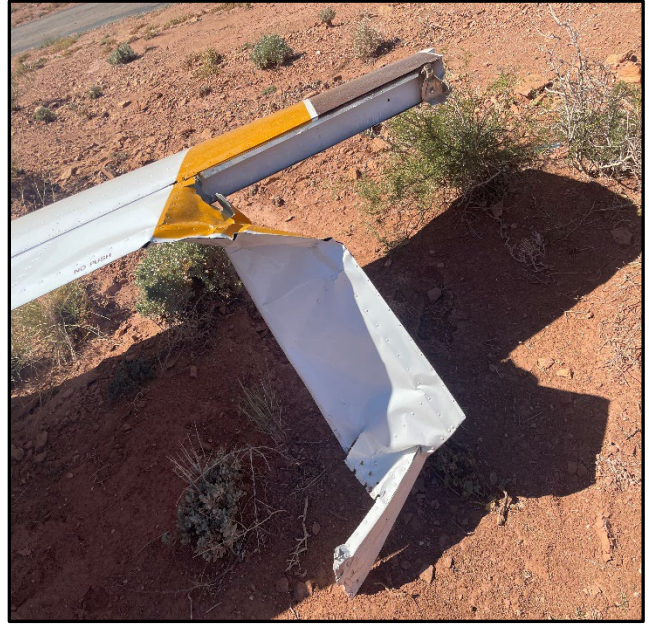
**Figure 2: Right wing viewed from the rear.**

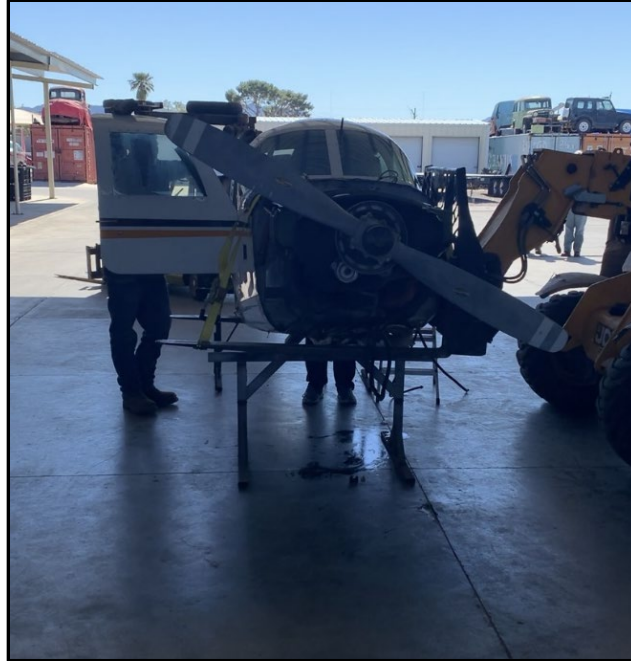
The Lycoming O-360-AA engine, serial number L-177051A, was secured to the airframe and no damage was noted to the engine mounts or engine mounting carriage. There was impact damage sustained to the bottom portion of the engine, particularly the left side.

**Figure 3-Front view of the wreckage.**
