National Transportation Safety Board

WPR23LA162

WRECKAGE EXAMINATION SUMMARY

Location: Grand Canyon, Arizona
Date: 4/19/2023
Time: 1400 Local
Airplane: Cessna R182

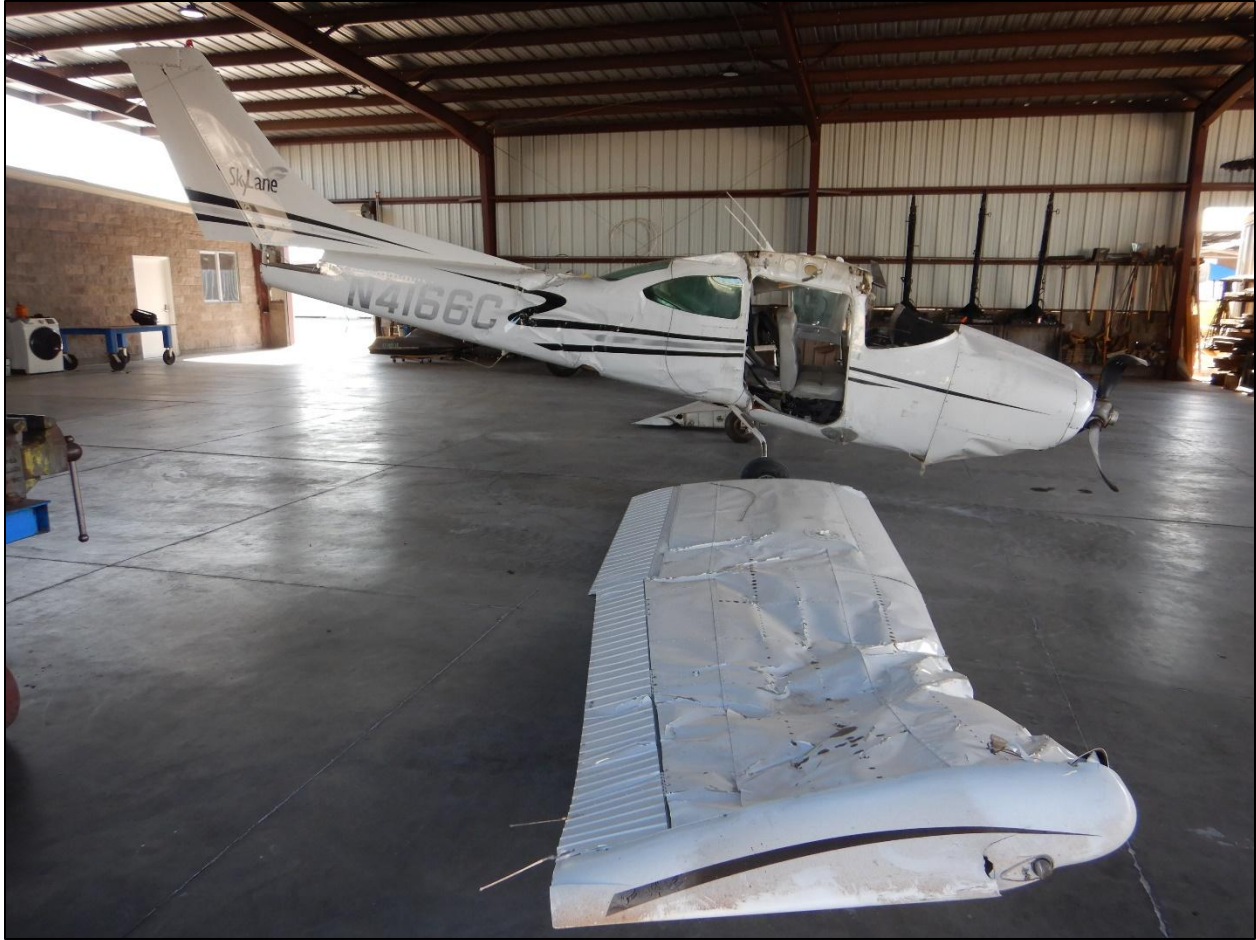
The forward fuselage had impact damage and was crushed upwards. The remaining fuselage was buckled throughout. The nose landing gear had impact damage and the wheel assembly separated. The right main landing gear brake caliper separated. The engine remained secured to three of the four engine mounts. The upper left engine mount bracket was fractured separated. The windscreen separated.

Figure 1-Follow-up examination, main wreckage.
