National Transportation Safety Board
Office of Aviation Safety
Washington, DC 20594

WPR24FA002

AIRFRAME AND ENGINE EXAMINATION REPORT

Location: Moab, Utah
Date: October 1, 2023
Time: 2022 mountain Daylight time
Airplane: N7153R

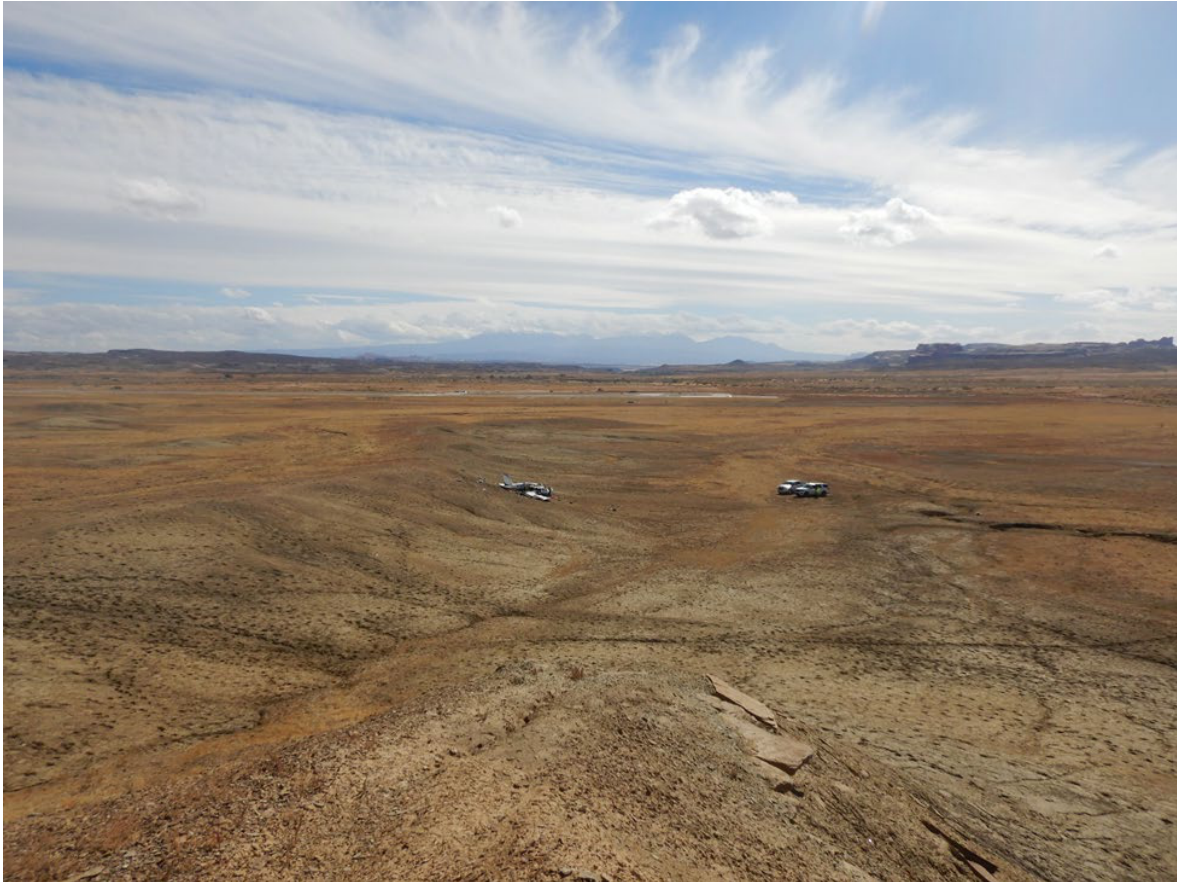
See Site Survey Report. See figure 1.

Figure 1. Photo looking east. The accident airplane is to the left. Two law enforcement vehicles are to the right.

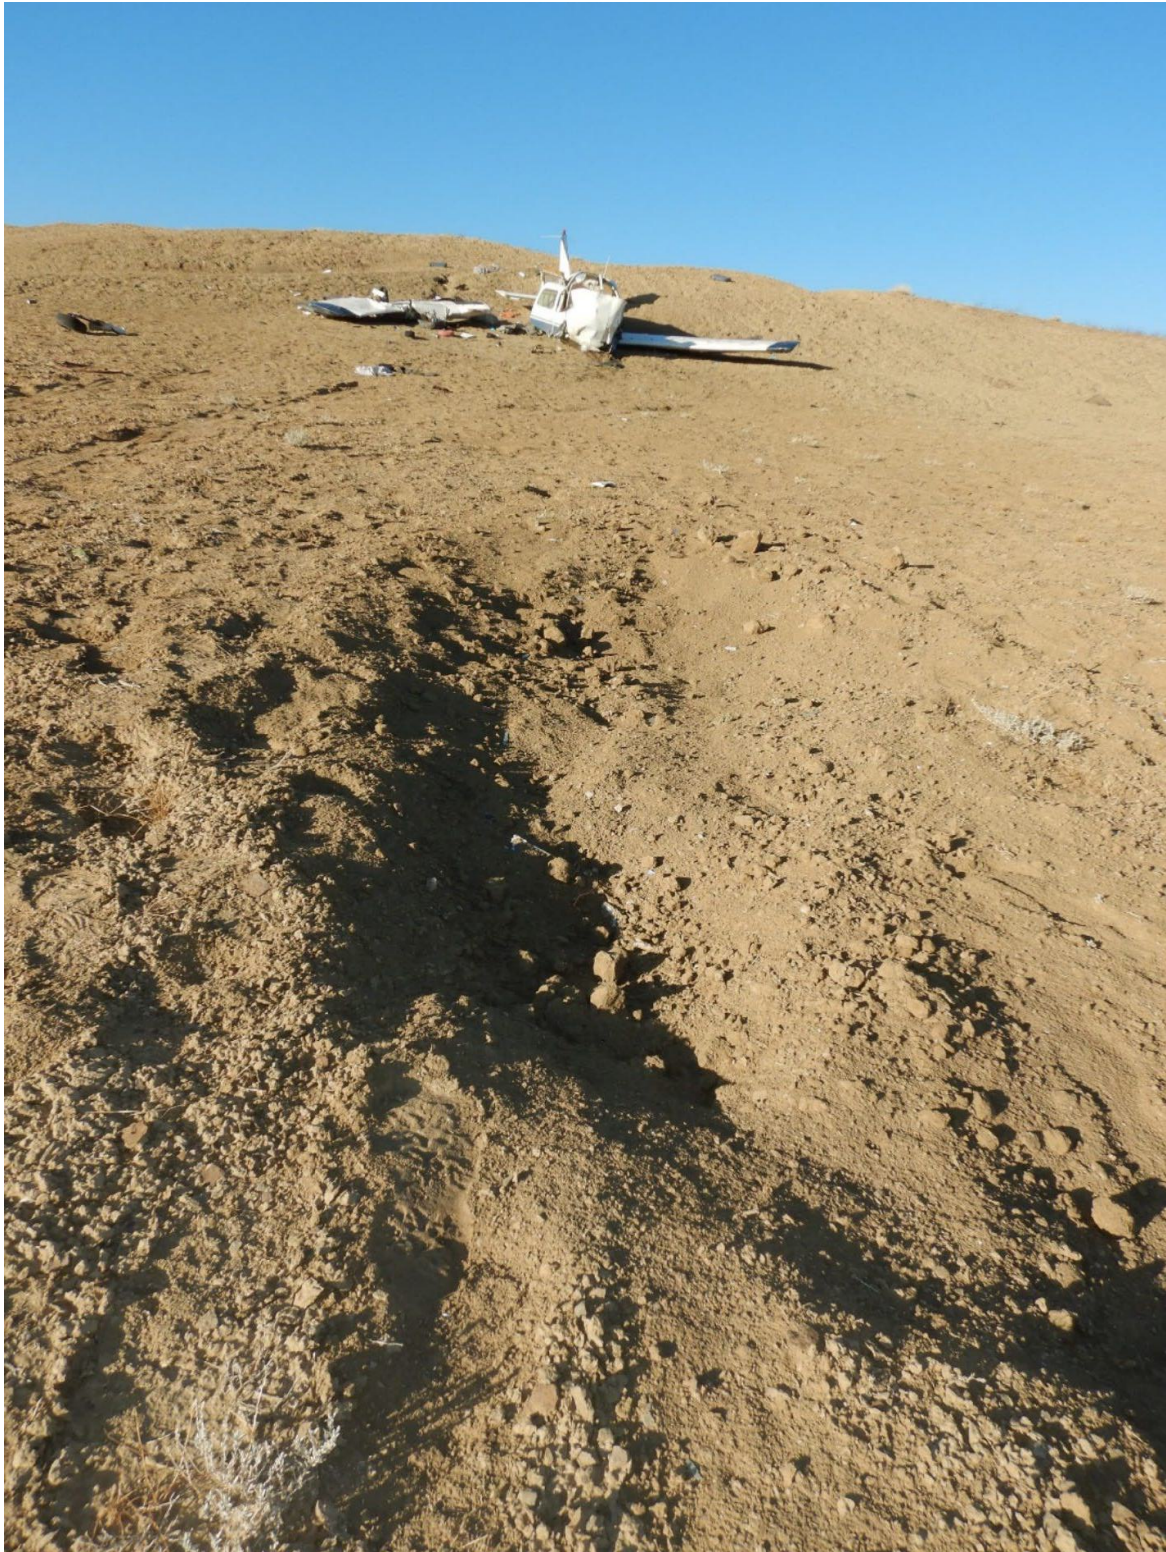
The fuselage remained intact but substantially damaged. The right-side cabin area was cut open by first responders. The right side exhibited accordion wrinkling aft of the right-wing trailing edge. The fuselage was bent about mid-section with compression on the right side and tension on the left side. The engine cowling area was bent downward with the engine about 75° to 85° down. The cabin floor was displaced upwards. See Figures 2, 3, 4, and 5.

Figure 2. Front view, looking uphill about 020° magnetic.

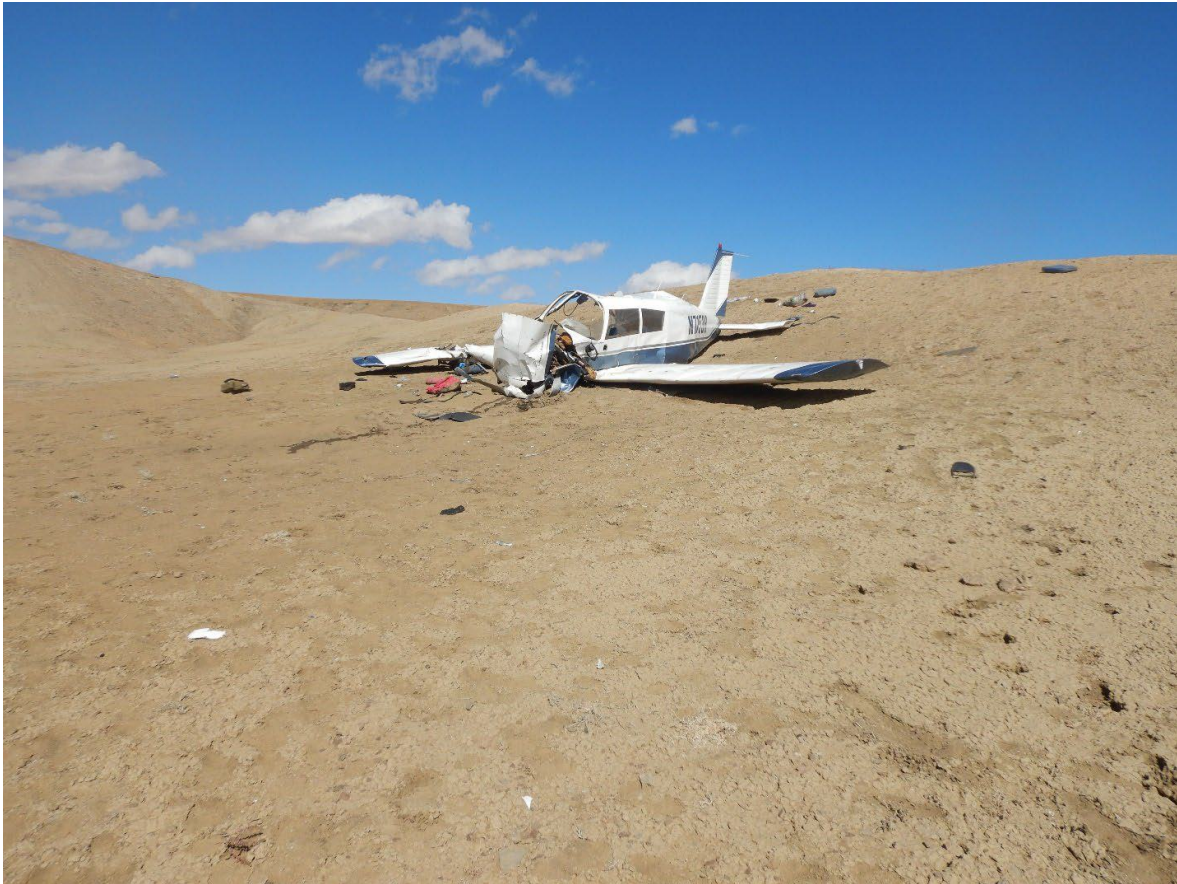
Figure 3. Left-front view.

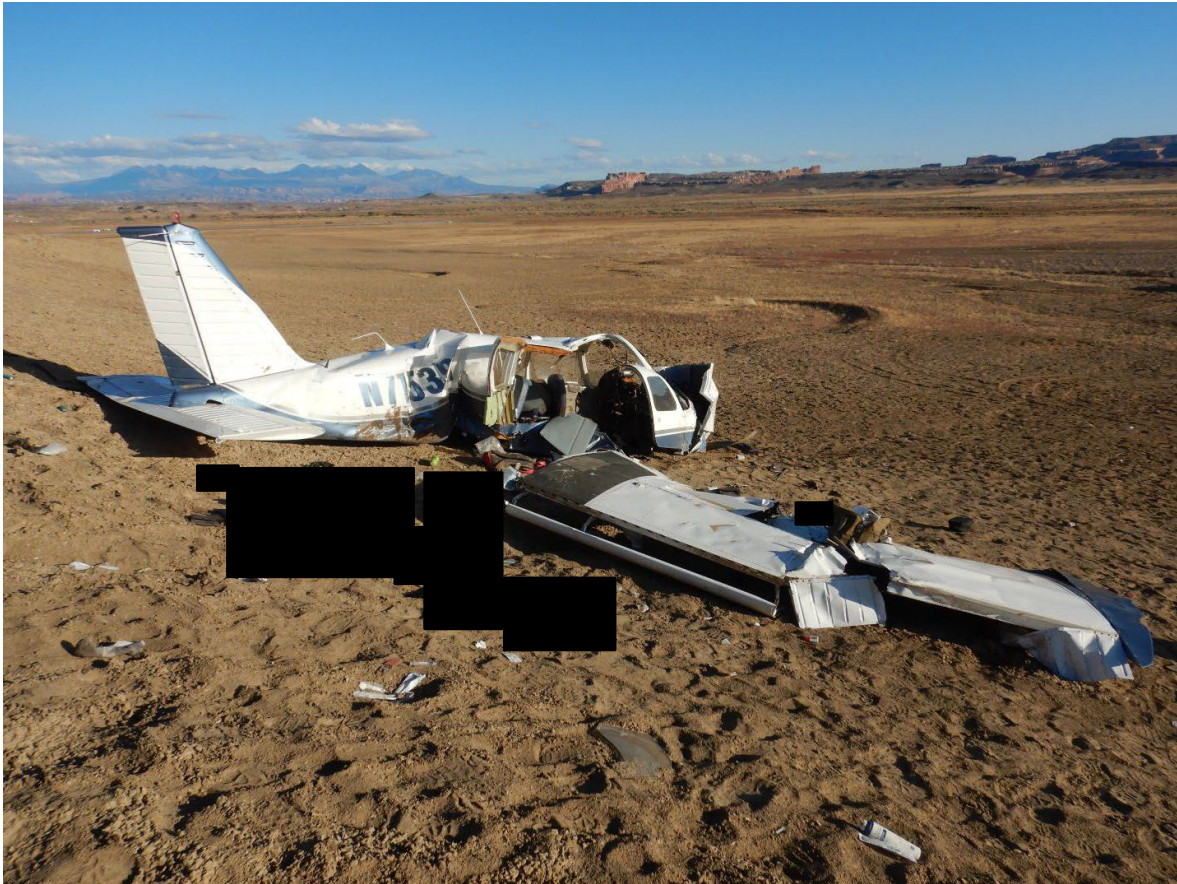
Figure 4. Right-rear view.

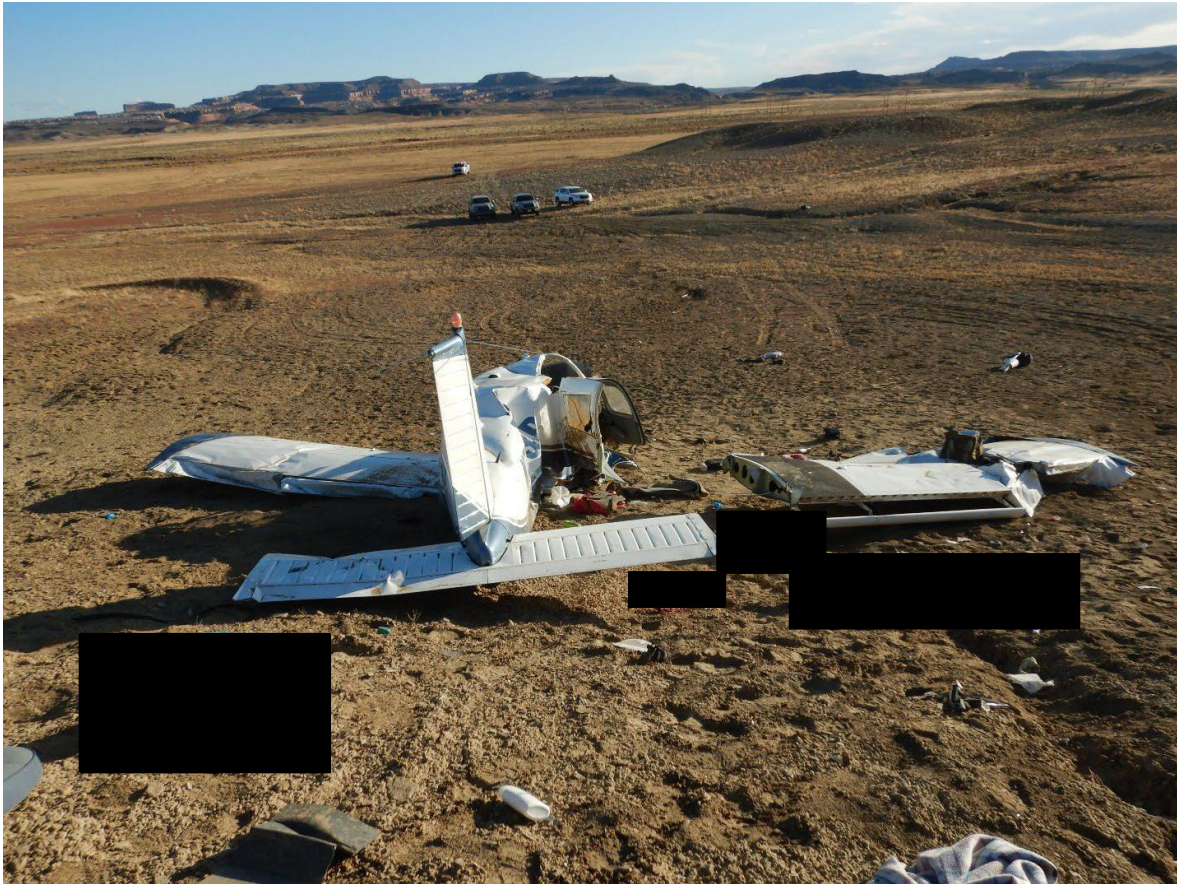
Figure 5. Rear view, looking about 200° magnetic.

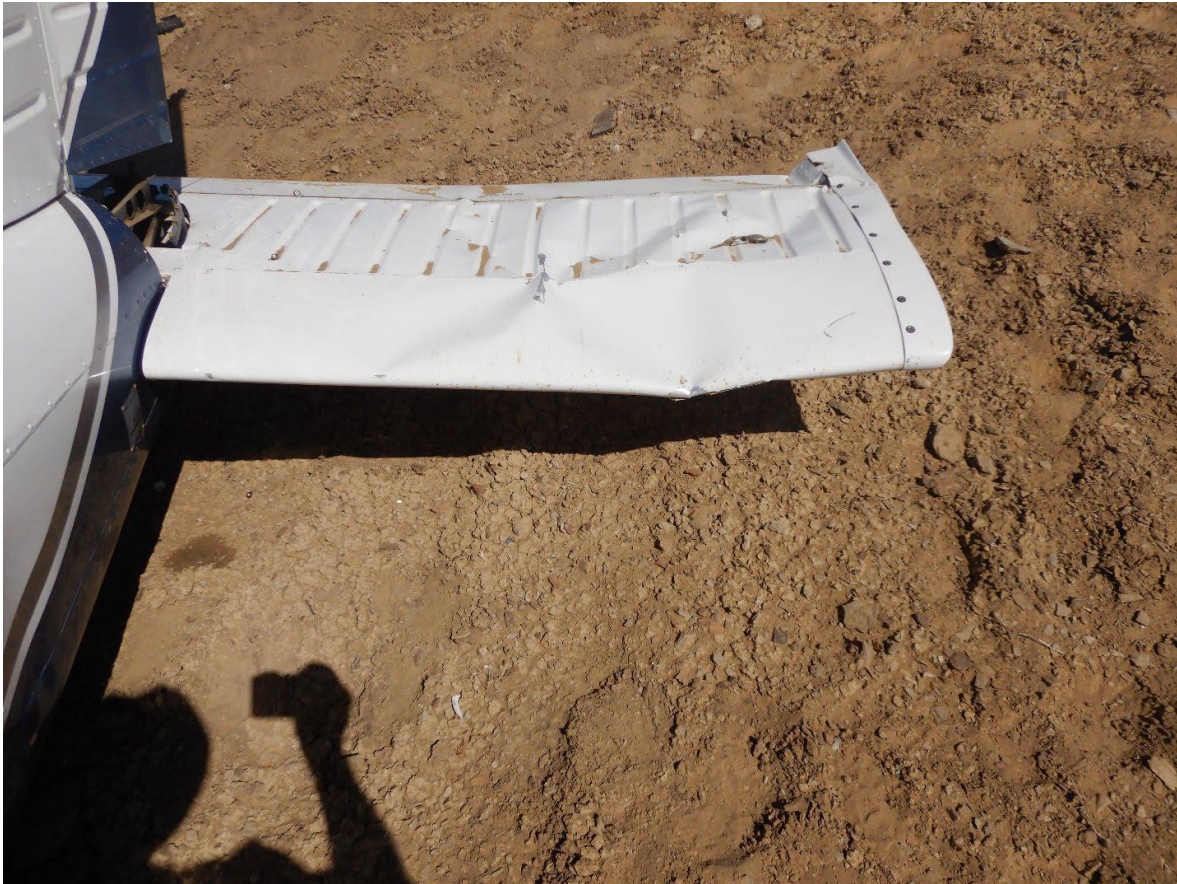
The empennage remained attached to the aft fuselage. The vertical stabilizer and rudder exhibited minor damage. The rudder articulated to the left and right limits but had no resistance. The stabilator remained attached to the aft fuselage. The left side of the stabilator exhibited substantial damage with dents and bends throughout the span. The right side of the stabilator exhibited minor damage. See figures 6, 7, and 8.

Figure 6. Left horizontal stabilizer and left elevator.

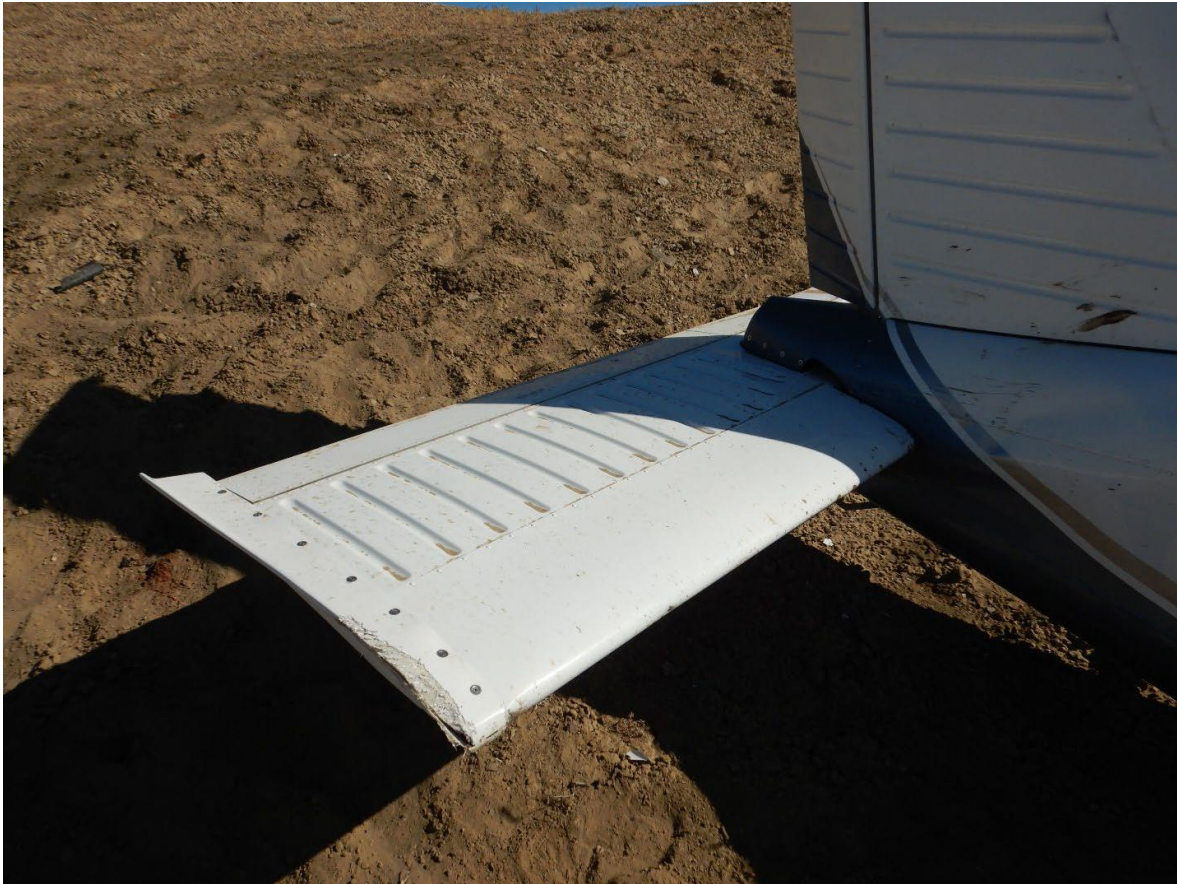
Figure 7, Right horizontal stabilizer and right elevator.

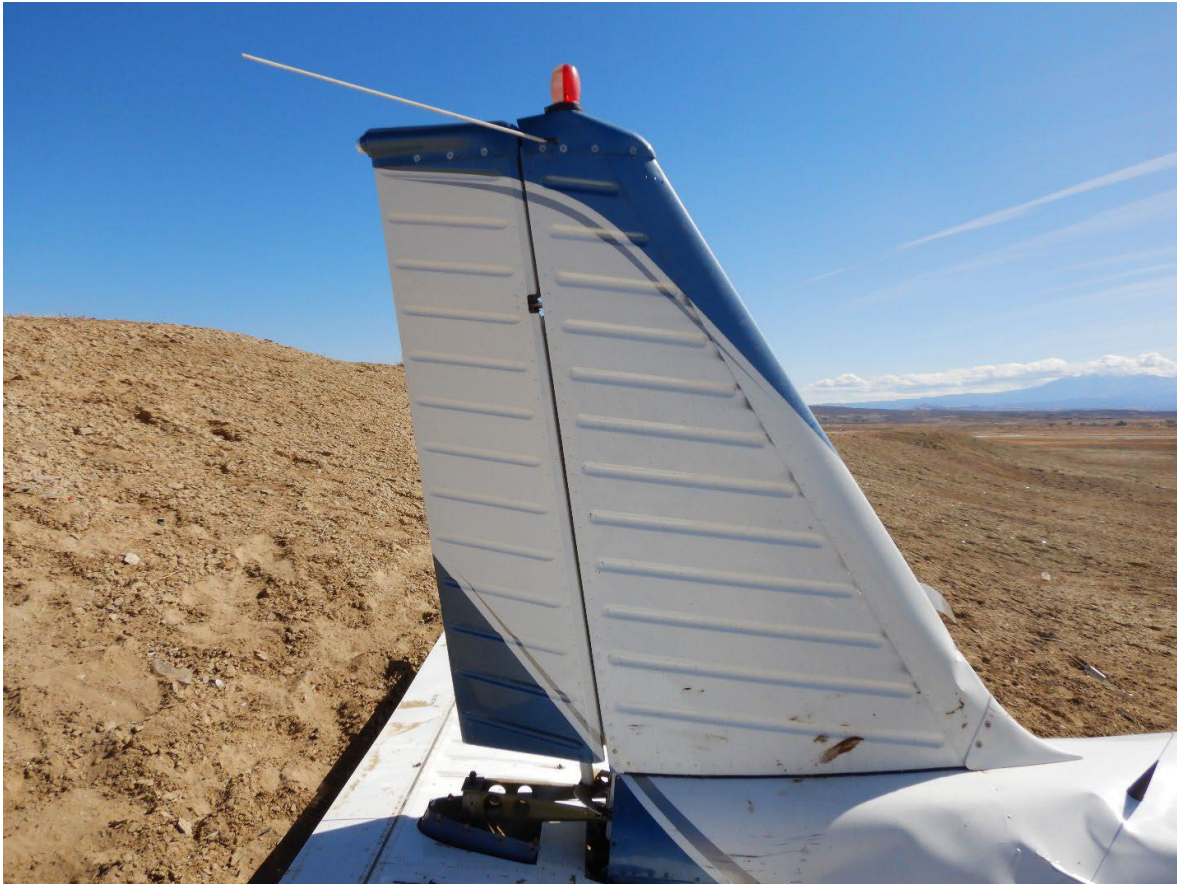
Figure 8. Vertical stabilizer and rudder.

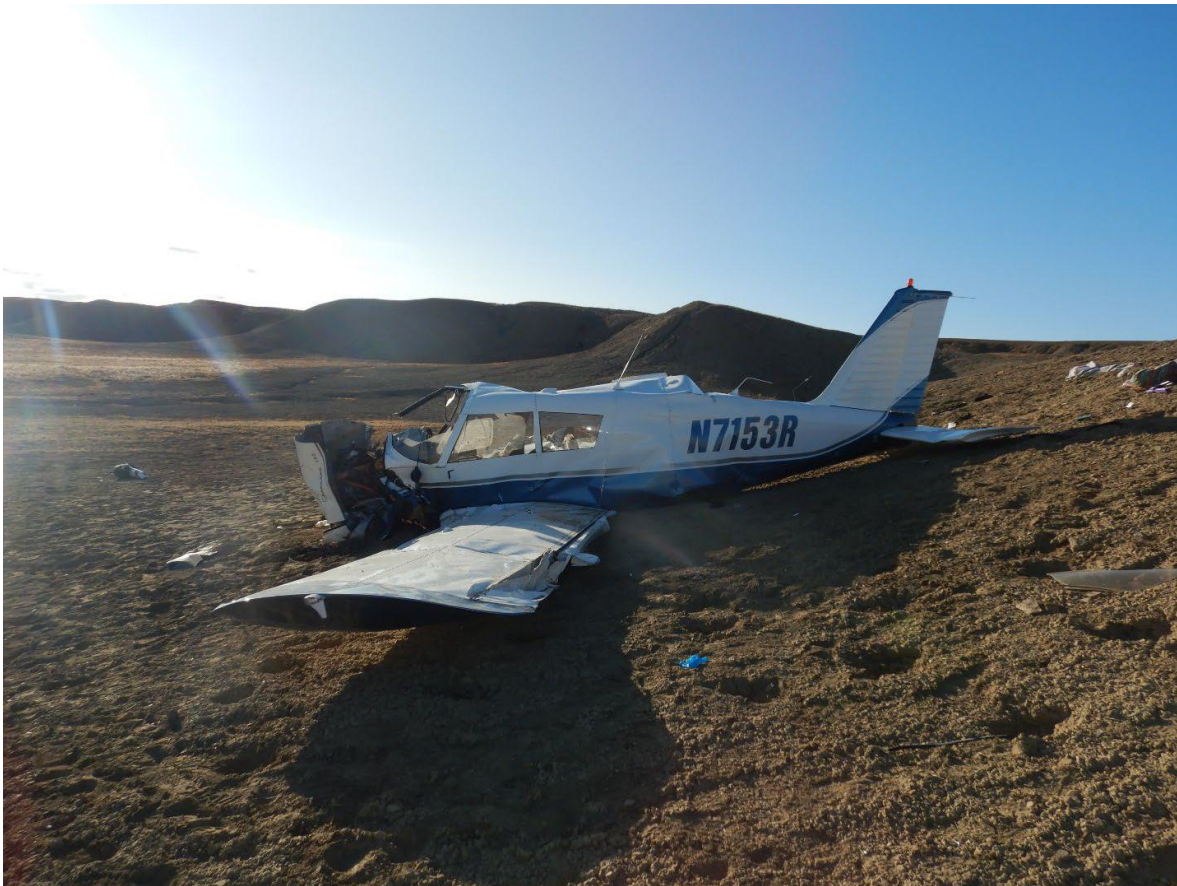
The left wing remained attached to the fuselage and exhibited substantial damage to the aileron and flaps. The right wing fractured and separated from the fuselage. One aileron control cable remained attached to the fuselage. The right wing exhibited a substantial fracture about mid-span that extended, chordwise from the leading edge to the trailing edge. The aileron and flap were substantially damaged. See figures 9 and 10.

Figure 9. Left wing, aileron, and flap.

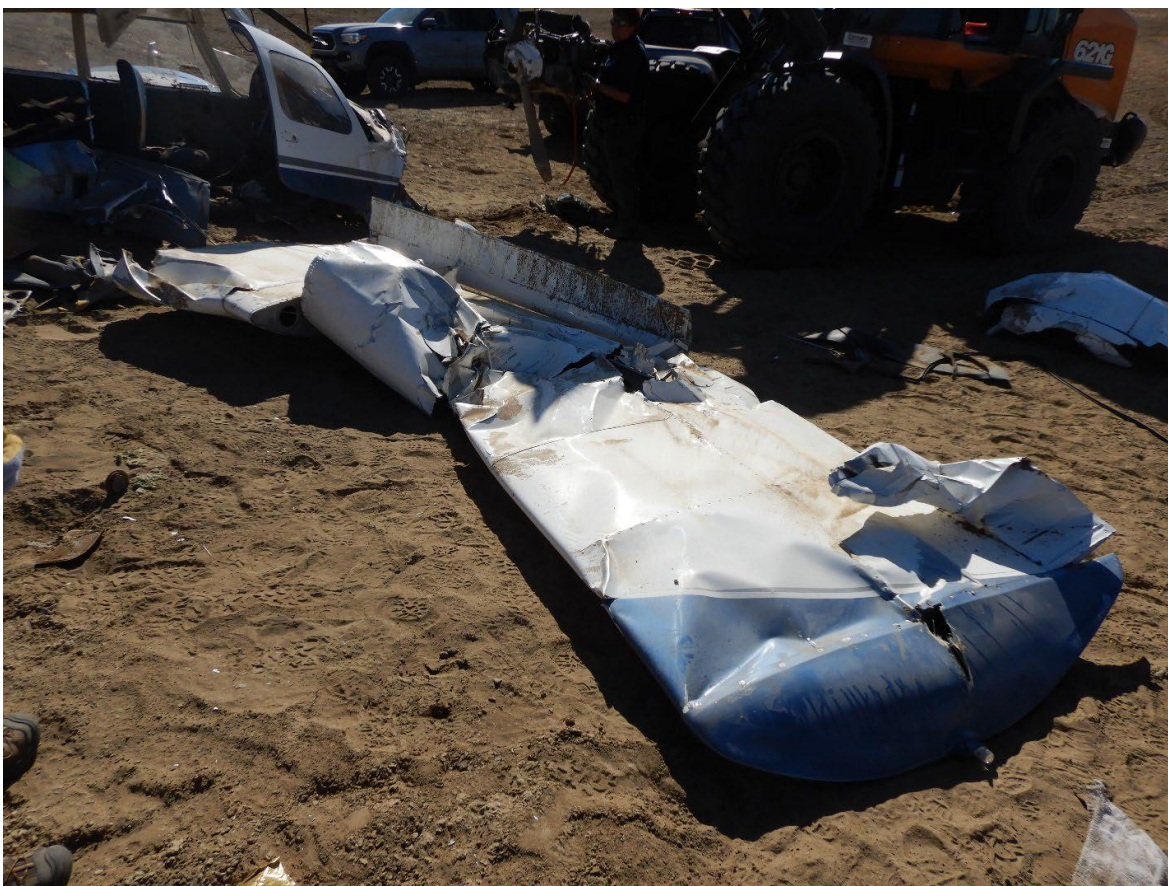
Figure 10. Right wing, aileron, and flap.

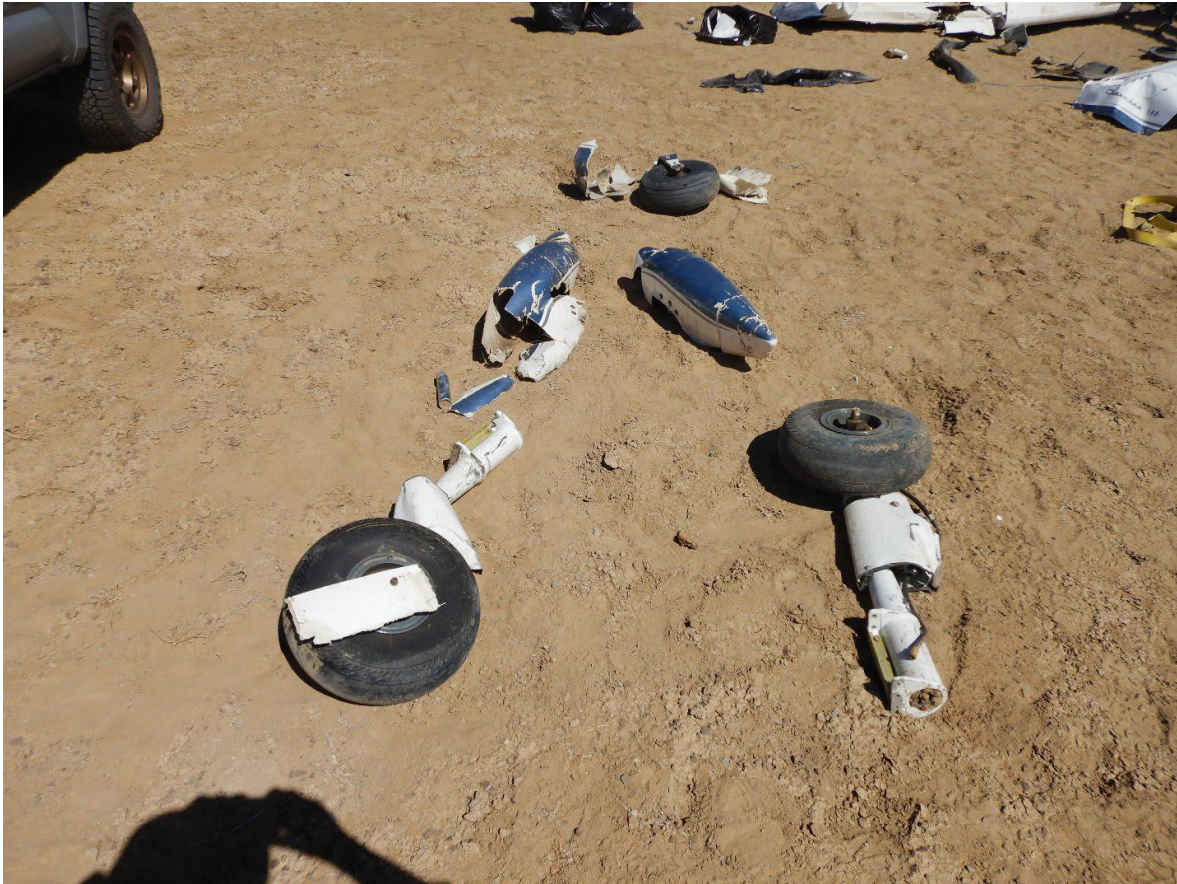
The nosewheel and both main landing gear assemblies fractured and separated from the underside of the fuselage. The nosewheel was found at the third impact point. The left main landing gear was found northeast of the FPPI but not near the main wreckage. The right main landing gear was found near the main wreckage. See figure 11.

Figure 11. Nosewheel, left and right main landing gear.

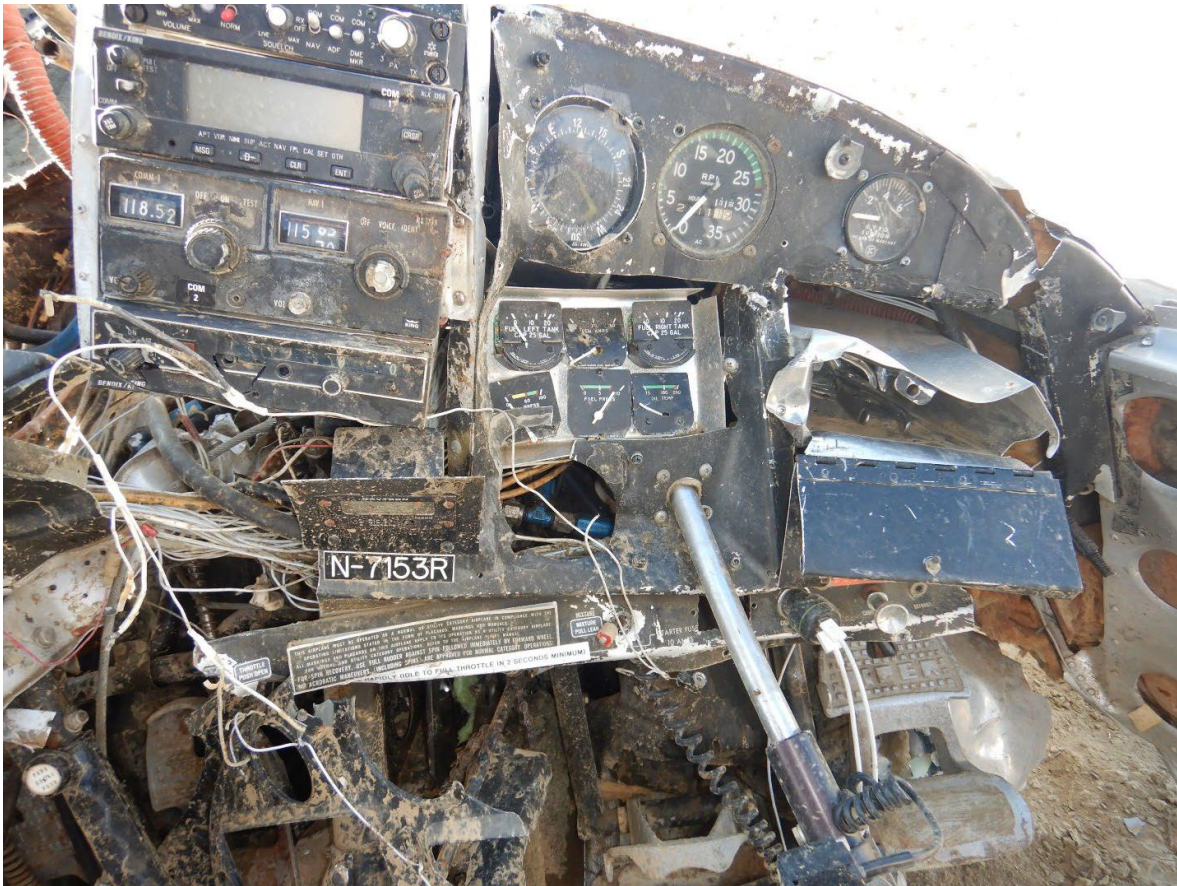
The cockpit was substantially damaged. The instrument panel fractured, and some instruments were separated from the instrument panel. The right front seat tracks were fractured and separated from the floor. The seat was found outside of the cabin. The left seat remained in the cockpit. The aft right seat was fractured and separated from the floor. The aft left seat pan, and cushion remained partially attached to the floor. See figures 12.

Figure 12. Right side of the instrument panel.

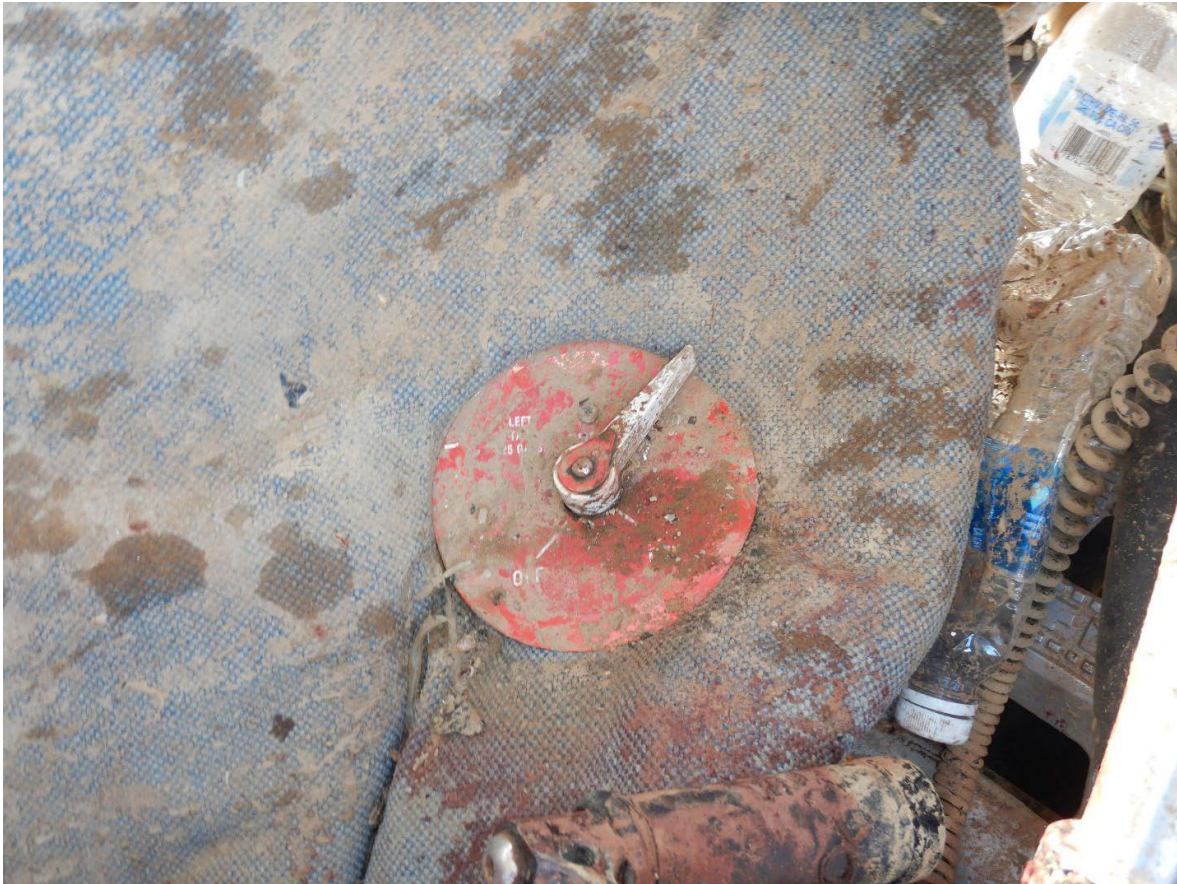
Figure 13. Fuel selector valve switch.

The right-wing fuel tank was breached, and all the fuel drained out of the tank. The left-wing tank remained secure and contained fuel above the tabs. The gascolator was breached and contained only a few drops of liquid. The fuel pump exhibited fractured fuel lines but exhibited suction when manipulated. The carburetor was fractured just above the bowl with the bowl separated from the carburetor. See figure 14.

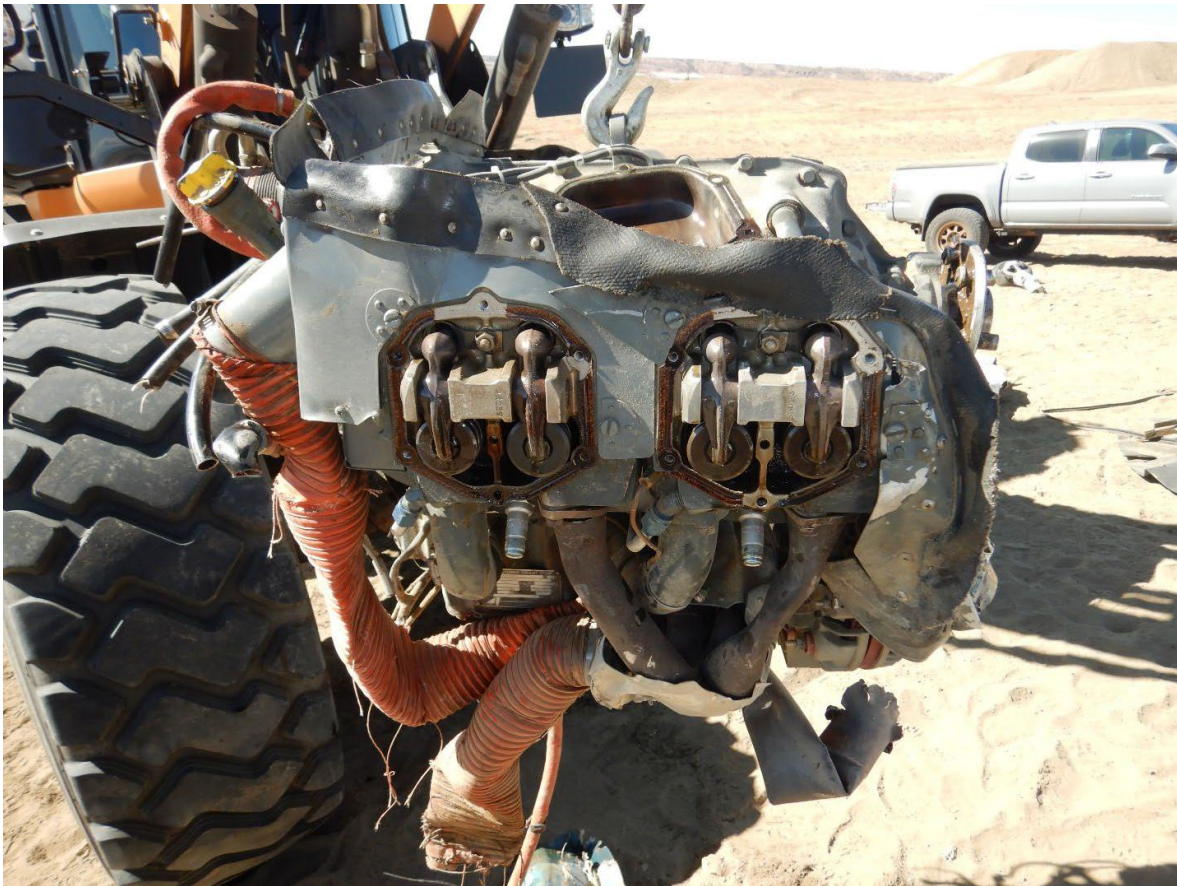
The engine, model O-320-E2A, serial number L-19316-27A, remained partially attached to the firewall by damaged engine mounts. The engine was oriented 90° down. The carburetor was fractured at the bowl with the bowl separated from the mount. See figure 15, 16, and 17.

Figure15. Engine right side.

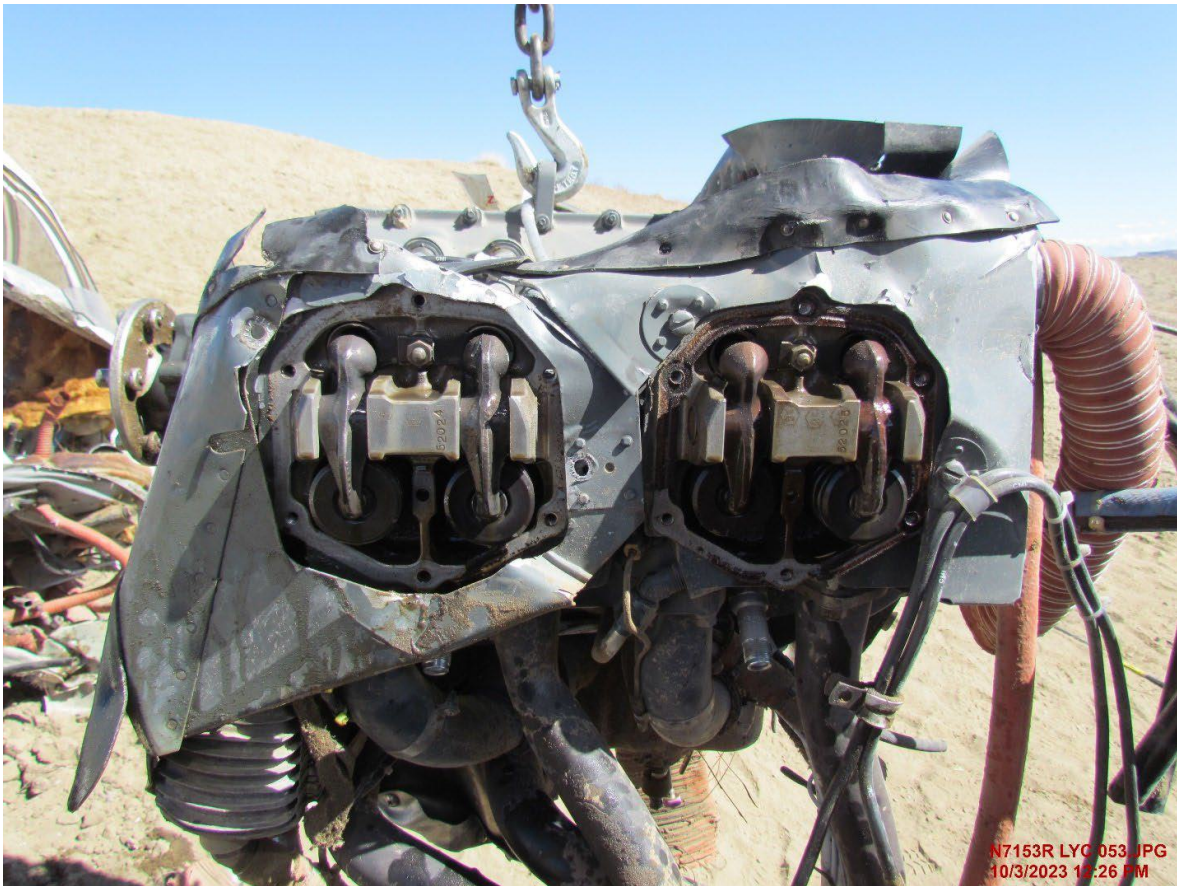
Figure16. Engine left side.

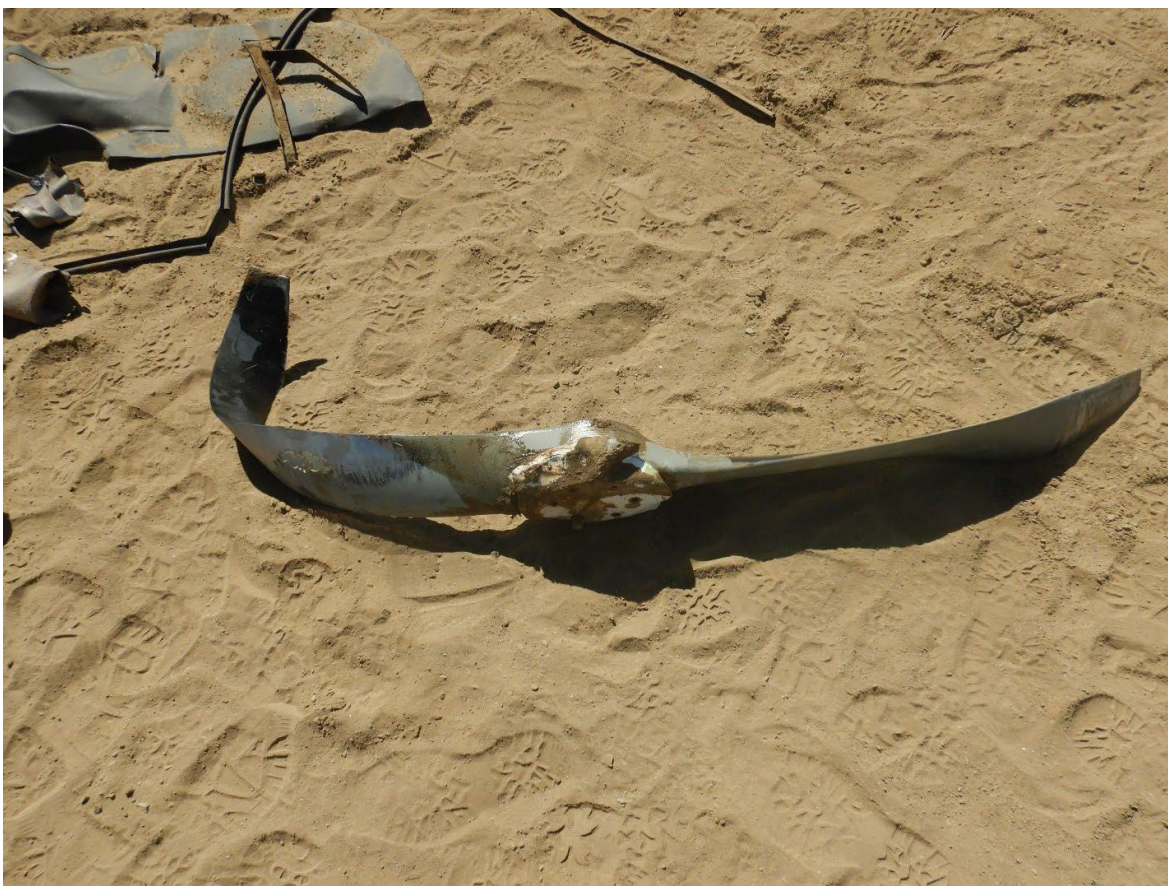
The propeller remained attached to the propeller flange; however, four of the six bolts fractured. One propeller blade exhibited an S-bend with chordwise striations near the tip. The other blade exhibited a curl with chord-wise striations. See figure 18.

Figure17. Propeller.
