# National Transportation Safety Board

WPR24FA004

## **ACCIDENT SITE EXAMINATION**

Location: Newberg, OR  
Date: October 3, 2023  
Time: 18:47 PDT  
Airplane: N8360K, Piper, PA-44-180

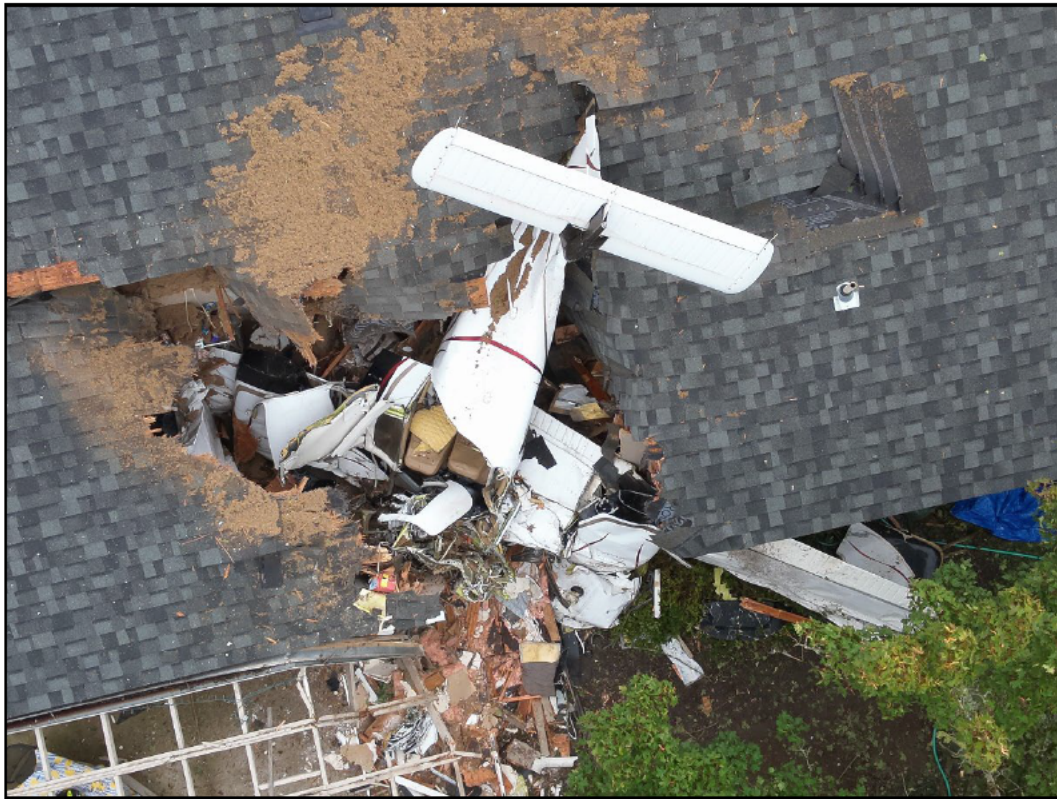
Examination of the accident site revealed that the airplane impacted a residence 10 miles northwest of the Aurora State Airport (KUAO), Aurora, Oregon, as seen in figure 1. The airplane came to rest in a near vertical attitude in a residential structure ( [REDACTED] Newburg, Oregon), on a heading of about 285° magnetic, at an elevation of 249 ft msl. No visible ground scars were observed surrounding the wreckage. All major structural components of the airplane were located within about 10 ft of the main wreckage.

**Figure 1: View of accident airplane from above. (courtesy of local law enforcement)**

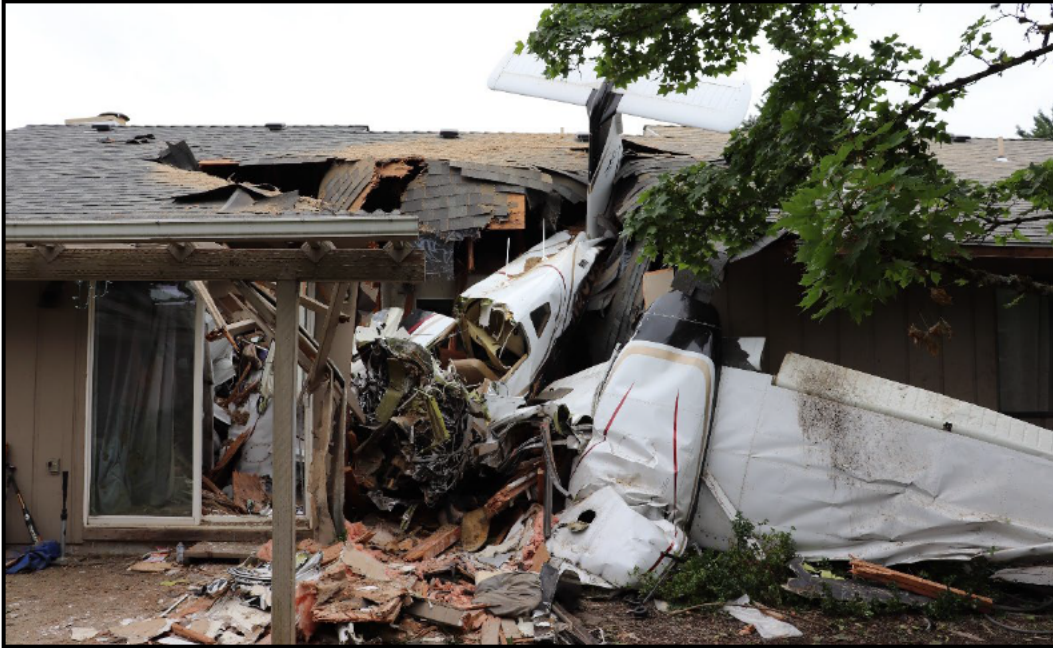
Examination of the airframe revealed that the forward section of the cockpit was heavily impact damaged and crushed aft. The instrument panel was impact damaged with multiple instruments displaced. The fuselage was mostly intact, crushing and bending were observed throughout. The landing gear lever was observed in the down position. The forward portion of the fuselage was impact damaged and displaced aft. The flap handle was observed in the 40° position.

The cockpit flight controls were separated and exhibited impact damage throughout. The rudder pedals were observed in the cockpit area with heavy impact damage. Flight control continuity was not established due to impact damage and location of the wreckage.

**Figure 2: Front view of accident airplane.**

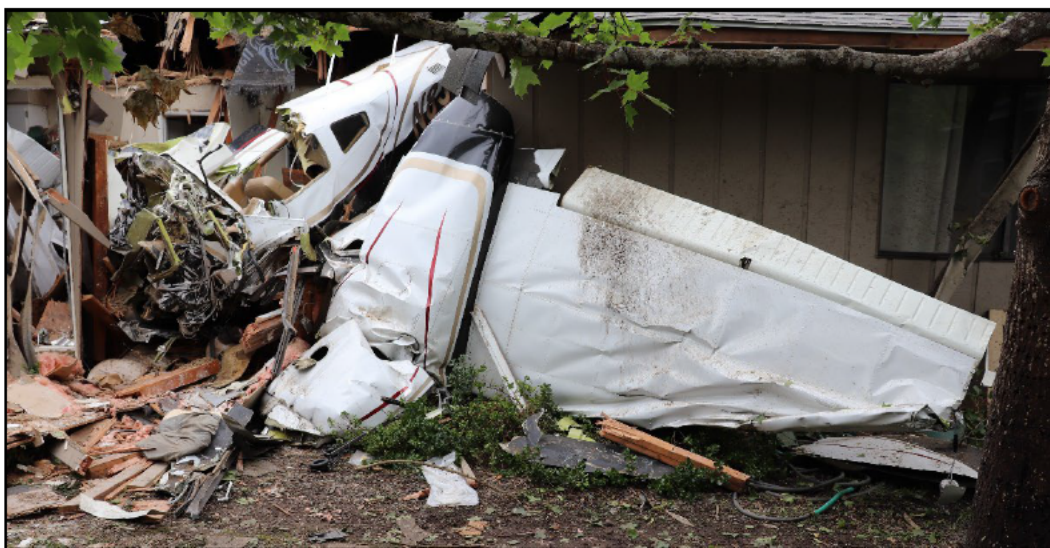
The left wing remained attached to the fuselage. The wing exhibited buckling, crushing and tearing of the skin from the wing root to about mid span. Crushing and bending were observed throughout the wingspan. The left flap and aileron remained attached via their respective mounts. The flap was observed partly extended. The left aileron had separated from the bellcrank at the aft control rod end. The aileron control cable was observed exiting the fuselage near the wing root. The left main landing gear remained attached via the wing mounts and was partly extended. The left main fuel tank fuel cap was observed in place and secure. The left wing bladder style fuel tank was torn.

**Figure 3: View of left wing.**

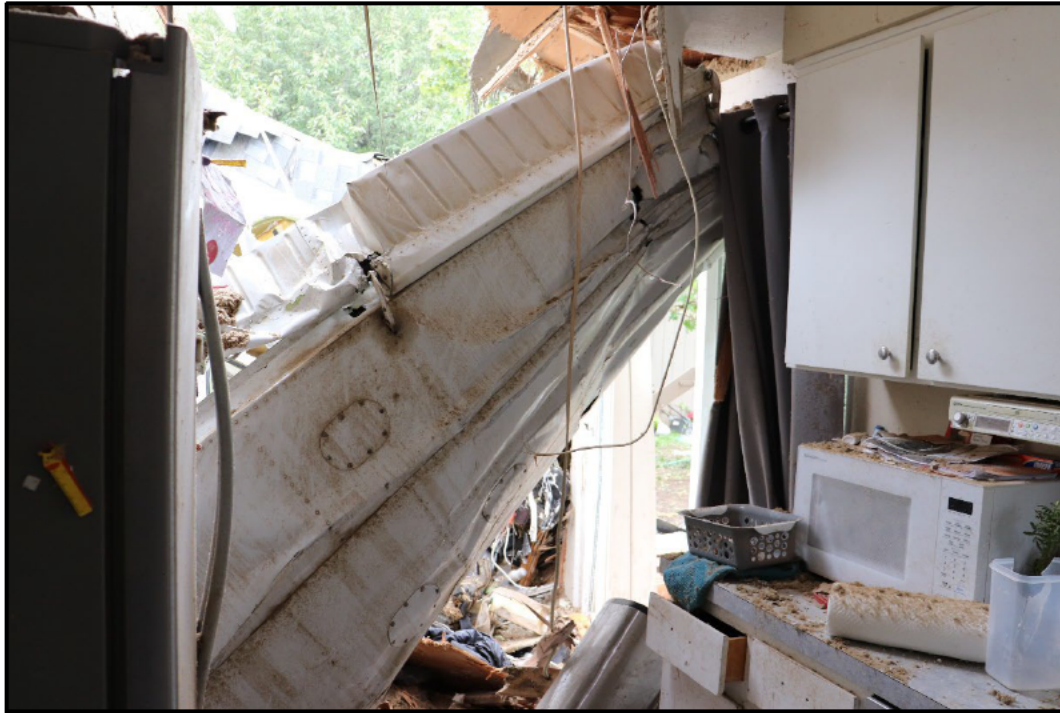
The right wing remained attached to the fuselage. The wing exhibited buckling, crushing and tearing of the skin. The wing separated outboard of the engine nacelle, was folded upward and remained tethered via various cables and wires. The flap remained attached to the wing via its attachment points. The aileron remained attached to the wing via the two outboard attachment points. The right aileron had separated from the bellcrank at the aft control rod end. An engine mount support structure was crushed aft, protruding into the filler neck of the right fuel tank. The fuel cap was not observed. The right wing bladder style fuel tank was torn.

**Figure 4: View of right wing.**
