# National Transportation Safety Board

WPR24FA004

## **AIRFRAME AND ENGINE EXAMINATION**

Location: Newberg, Oregon  
Date: October 3, 2023  
Time: 18:47 Pacific daylight time  
Airplane: Piper, PA-44-180, N8360K

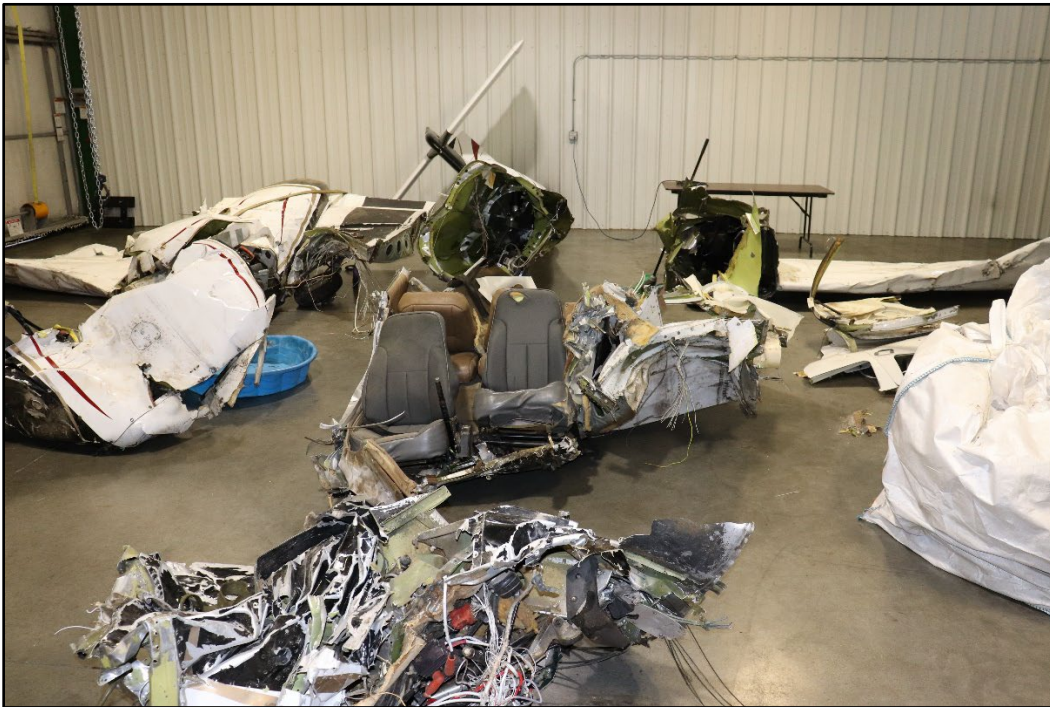
Examination of the airframe revealed that the forward section of the cockpit was heavily impact damaged and crushed aft. The instrument panel was impact damaged with multiple instruments displaced. The landing gear lever was in the down position. The forward portion of the fuselage was impact damaged and displaced aft. The flap handle was observed in the 40° position. The flap torque tube assembly was observed in a position that was consistent with 40°. The front nose gear was fracture separated. The aft fuselage was mostly intact, crushing and bending was observed throughout.

**Figure 1: View of airplane during exam**

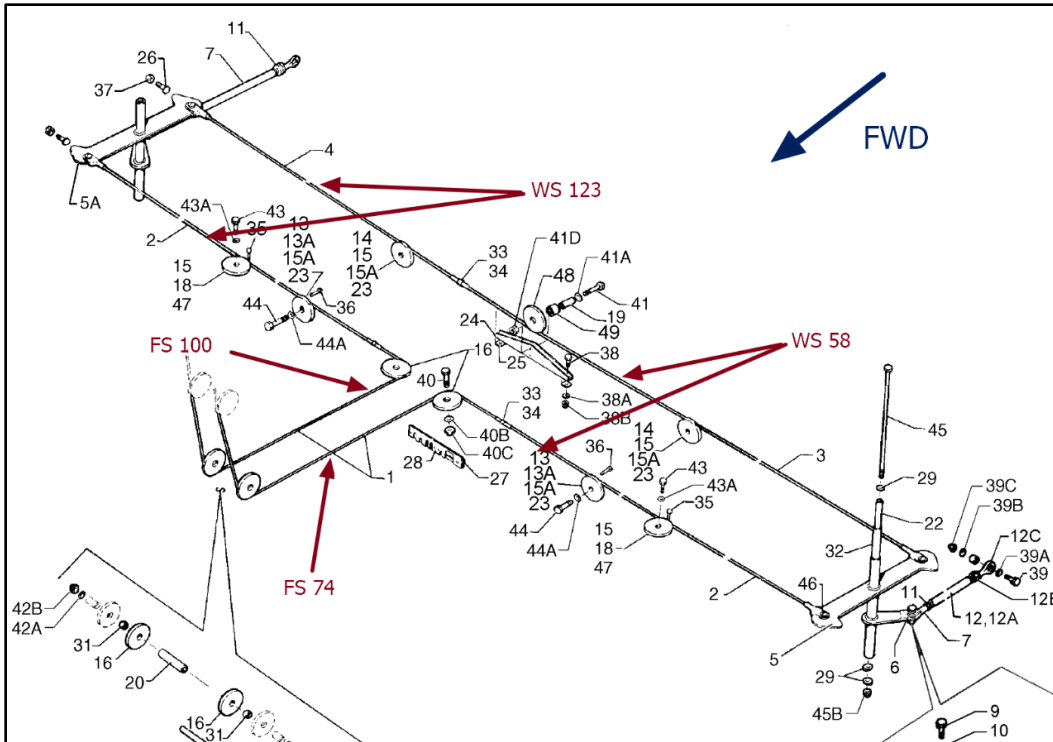
The cockpit flight controls were separated and exhibited impact damage throughout. The rudder pedals were observed in the cockpit area with heavy impact damage. Flight control continuity was established from the flight controls to the primary flight control surfaces. Multiple separations in the control cables were observed, consistent with impact damage or cut by recovery personnel.

**Figure 2: View of flight control cables (figure courtesy of Piper Aircraft)**

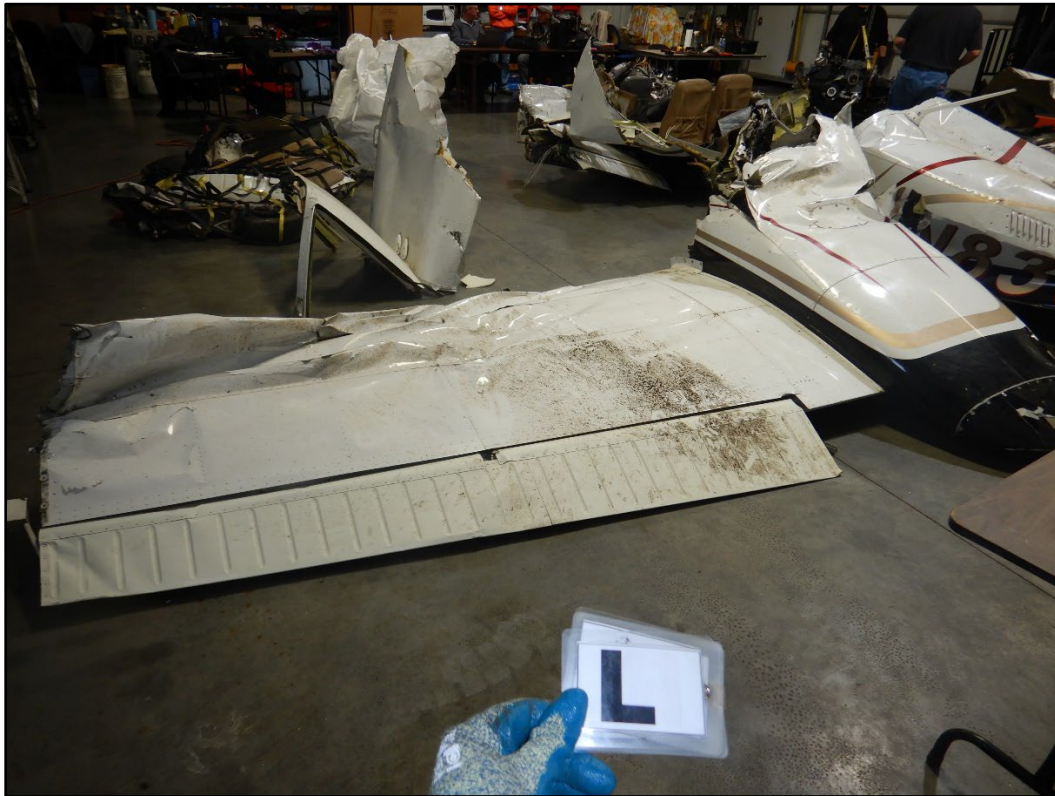
The left wing was separated from the fuselage at the wing root. The wing exhibited buckling, crushing and tearing of the skin from the wing root to about mid span. Crushing and bending was observed throughout the wingspan. The left flap and aileron remained attached via their respective mounts. The flap was observed in an intermediate position near 10°. The left main landing gear remained attached via the wing mounts, was partly extended and the landing gear actuator rod was observed extended from the actuator. The left aileron had separated from the bellcrank at the aft control rod end. The aileron control cable was traced to the wing adjacent to the

engine nacelle. The left main fuel tank fuel cap was observed in place and secure. The left wing bladder style fuel tank was torn.

**Figure 3: View of left wing during examination (courtesy of Piper Aircraft)**

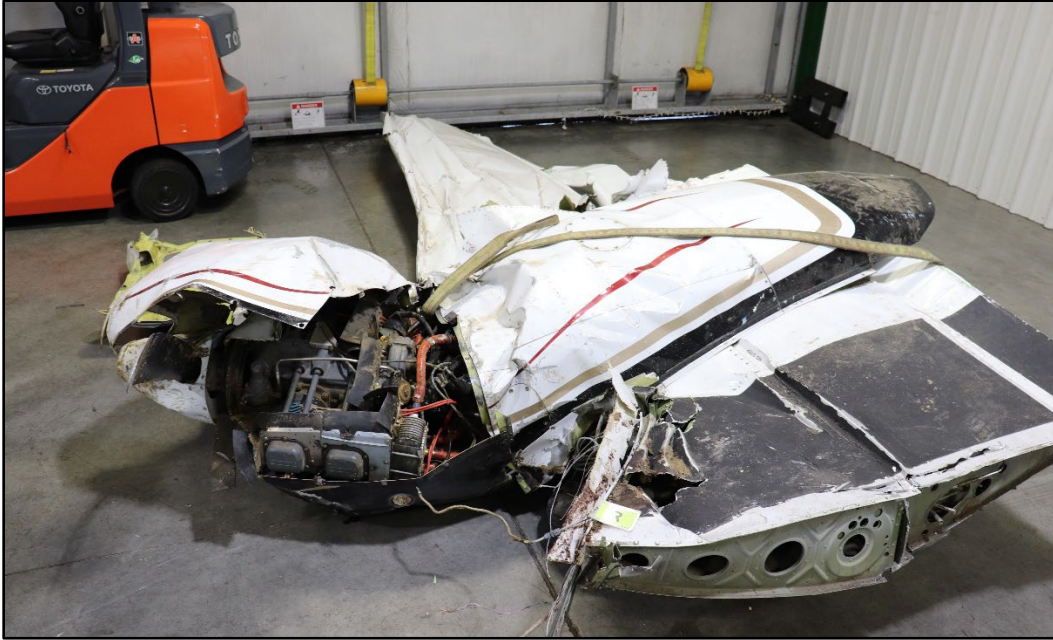
The right wing was separated near the wing root. The wing exhibited buckling, crushing, and tearing of the skin. The outboard wing separated near the engine nacelle. The flap remained attached to the wing via its attachment points. The aileron remained attached to the wing via the two outboard attachment points. The right aileron had separated from the bellcrank at the aft control rod end. The aileron control cable was traced to about wing station 123. An engine mount support structure was crushed aft, protruding into the filler neck of the right fuel tank. The fuel cap gasket was observed on the engine mount support structure. The right wing bladder style fuel tank was torn.

**Figure 4: View of right wing during examination**

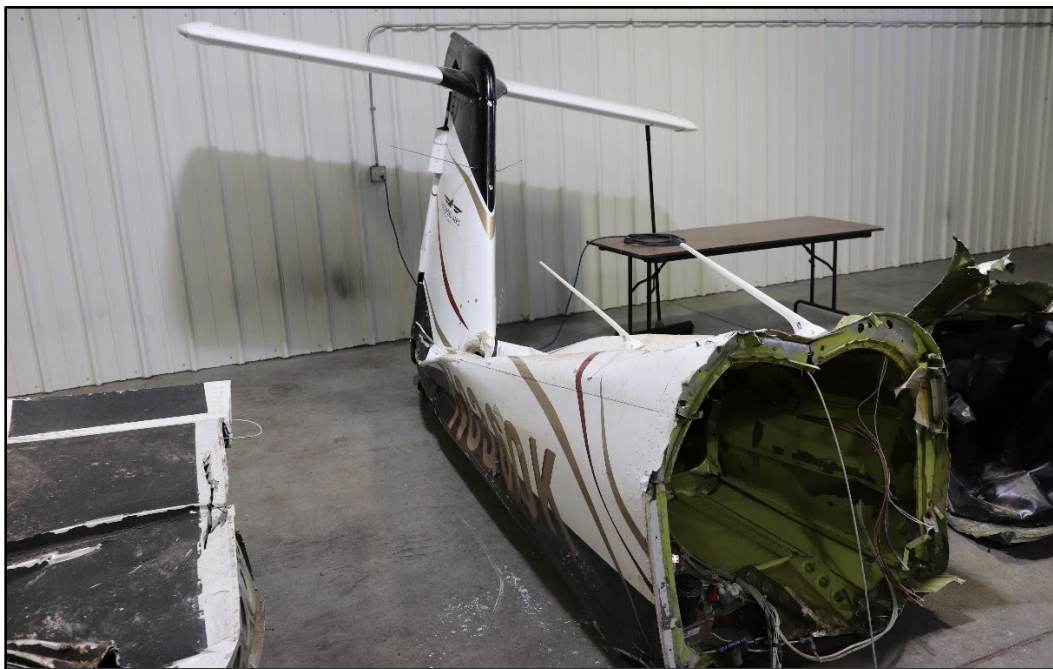
The vertical stabilizer, rudder, stabilator, and elevator trim tabs remained attached and secure to their respective mounts. Crushing and bending was observed throughout. The empennage, aft of the cargo compartment was separated by recovery personnel to facilitate wreckage recovery. The flight control cables to the rudder and stabilator remained attached to their respective attachment points. The flight control cables were traced through the aft fuselage to about fuselage station 156.

**Figure 5: View of empennage during examination**

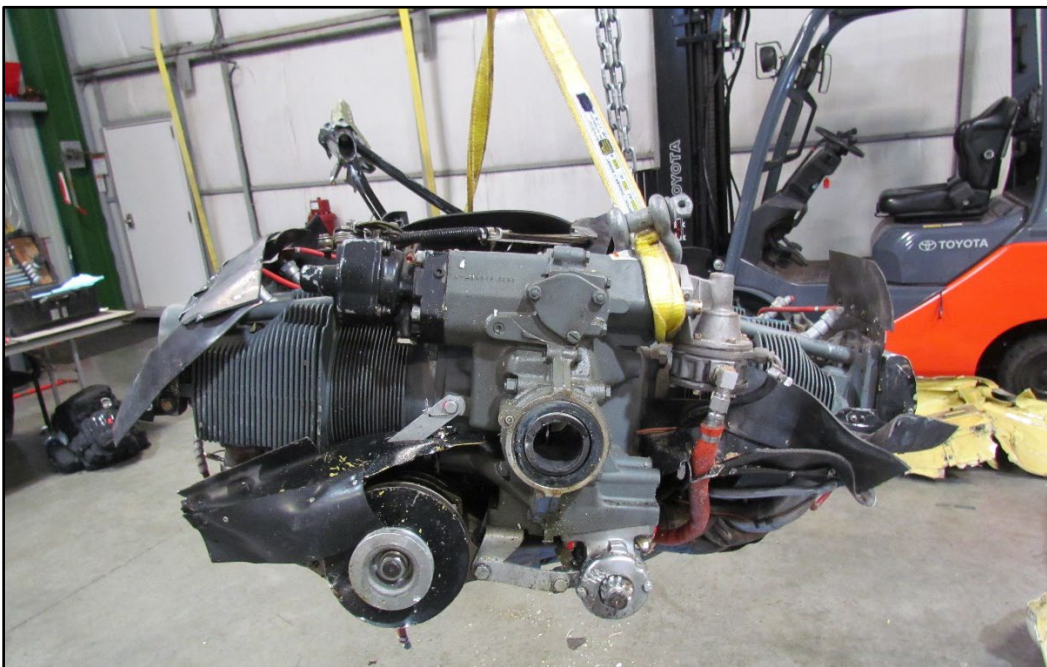
Examination of the recovered engine revealed impact damage to the four engine mounts. All four cylinders remained attached to the engine. All fuel and oil lines that were removed were tight. The crankshaft was fracture separated at the propeller flange. No evidence of any mechanical damage was observed to the engine crankcase.

**Figure 6: View of left engine during examination (courtesy of Lycoming Engine)**

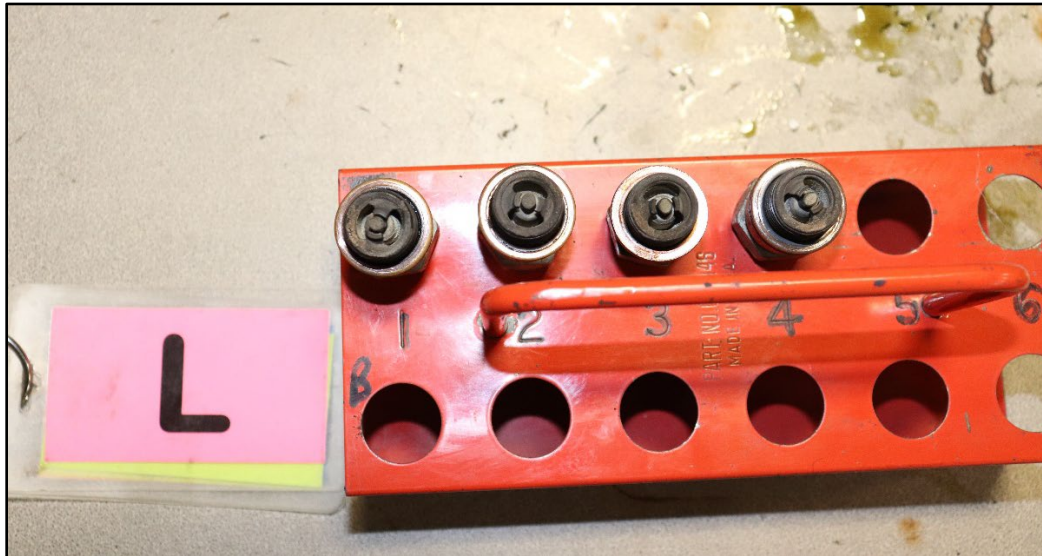
The spark plugs were removed from the engine and they were the massive electrode type. All sparkplugs exhibited gray deposits within the electrode area. All spark plugs exhibited signatures consistent with worn-normal when compared to the Champion Check-A-Plug comparison chart.

**Figure 7: View of left engine spark plugs**

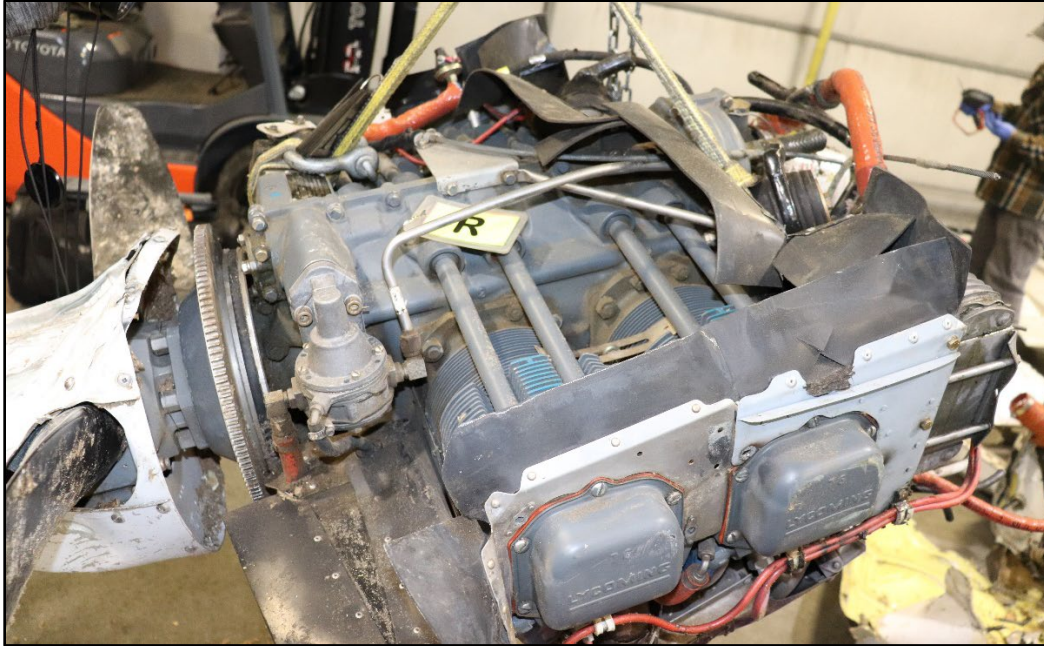
Examination of the recovered engine revealed impact damage to the four engine mounts. All four cylinders remained attached to the engine. All fuel and oil lines that were removed were tight. The propeller and propeller hub remained attached to the engine via the crankshaft. No evidence of any mechanical damage was observed to the engine crankcase.

**Figure 8: View of right engine during exam**

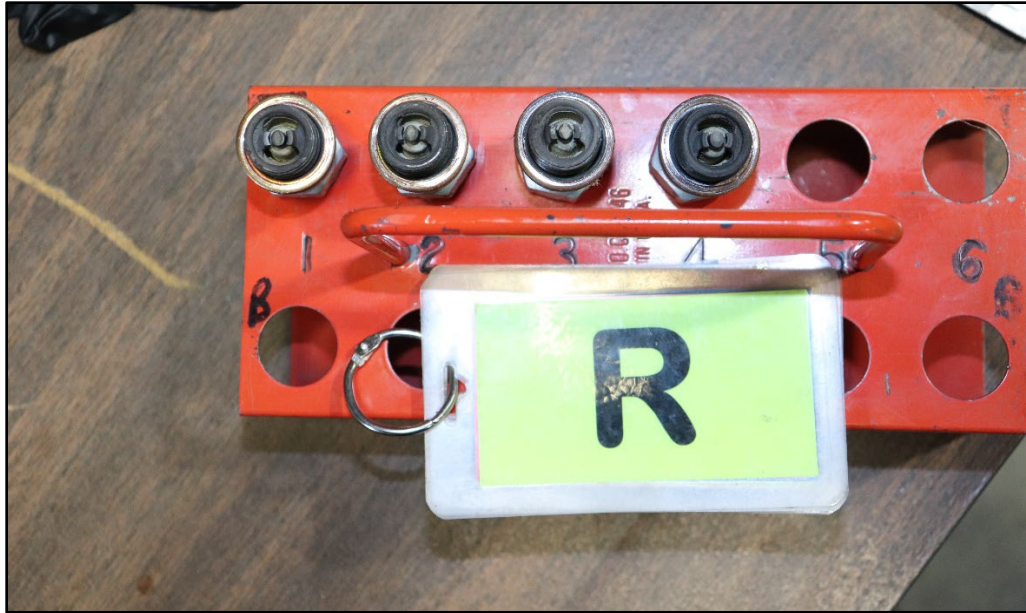
The spark plugs were removed from the engine and they were the massive electrode type. All sparkplugs exhibited gray deposits within the electrode area. All spark plugs exhibited signatures consistent with worn-normal when compared to the Champion Check-A-Plug comparison chart.

**Figure 9: View of right engine spark plugs**

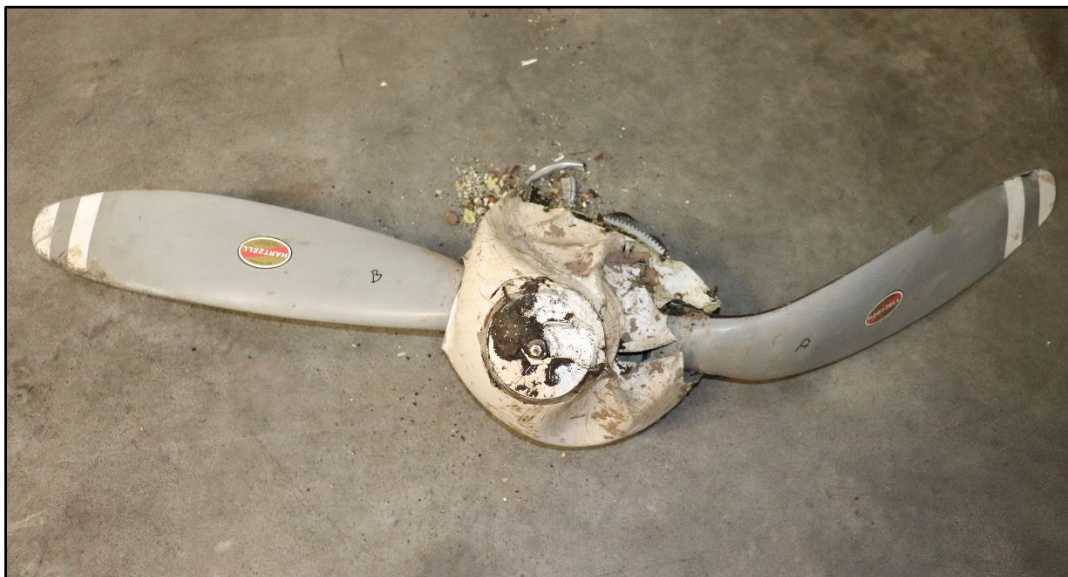
The left engine was equipped with a two blade Hartzell propeller. The propeller and propeller hub separated at the propeller flange. Propeller blade A exhibited aft bending at the hub, with unidirectional striations on the cambered side of the blade and polishing along the leading edge. Propeller blade B exhibited aft bending about mid span and chordwise striations along the cambered side.

**Figure 10: View of left engine propeller**

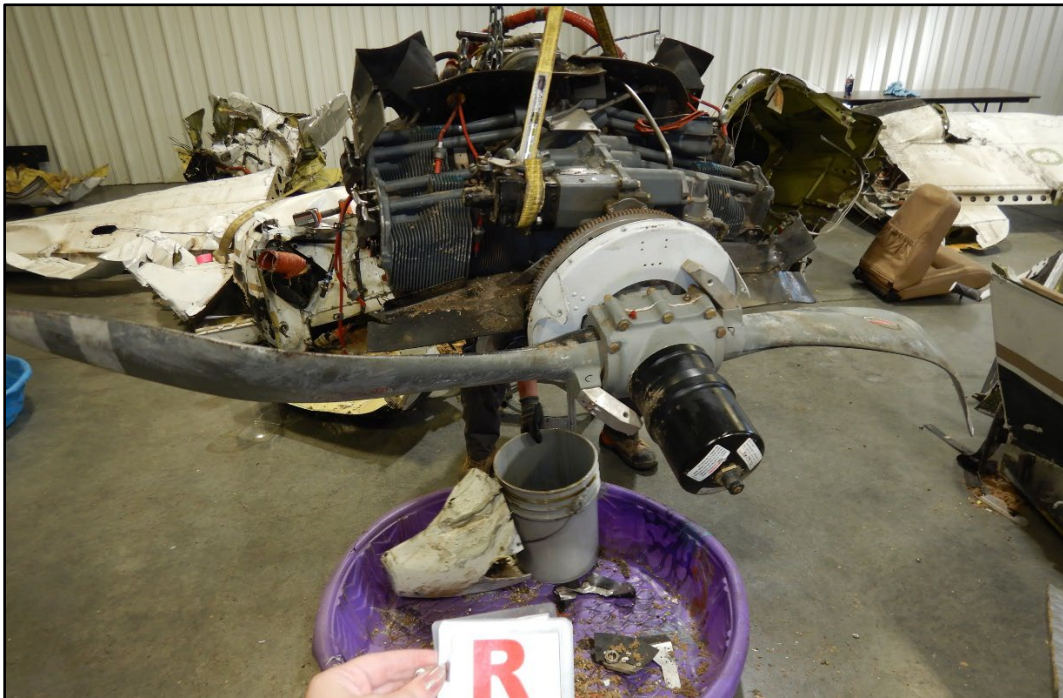
The airplane was equipped with a two blade Hartzell propeller. The propeller and propeller hub remained attached to the engine. Propeller blades C and D exhibited aft bending about mid span, with unidirectional striations on the cambered side of the blades.

**Figure 11: View of right engine propeller (courtesy Piper Aircraft)**
