**NATIONAL TRANSPORTATION SAFETY BOARD**

**UAS Aerial Imagery Field Notes**

**A. ACCIDENT                      WPR -TBD**

Location:                      Jean, NV  
Date:                              September 5, 2018  
Time:                              2145 Local Time (PDT)  
Event:                              N6064C Commander 114-TC accident

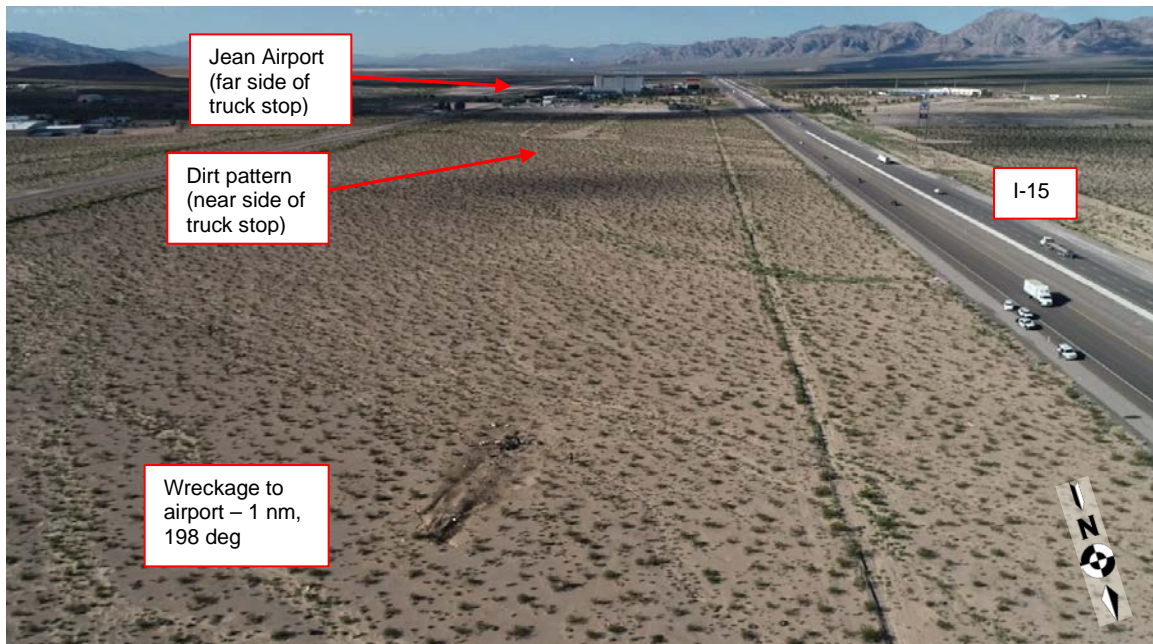
Figure 1 – Overview of wreckage area with Jean airport in background

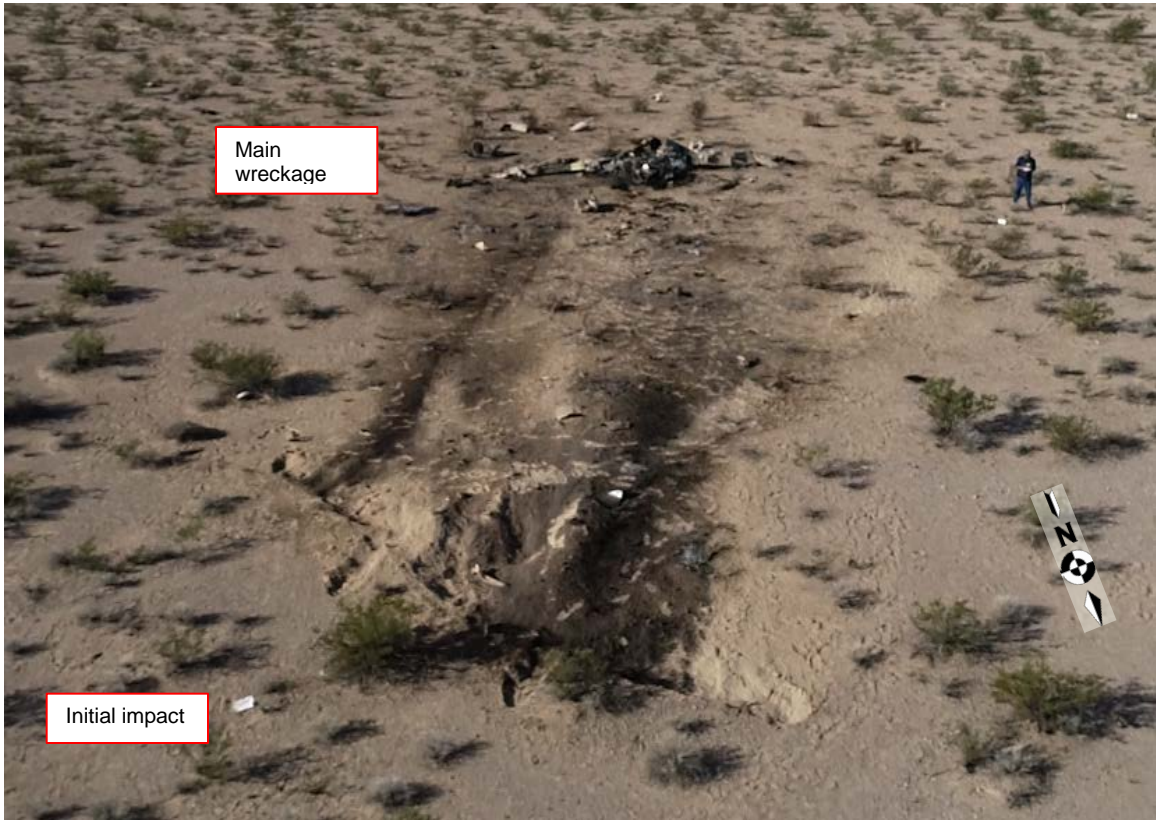
Figure 2 – Initial impact

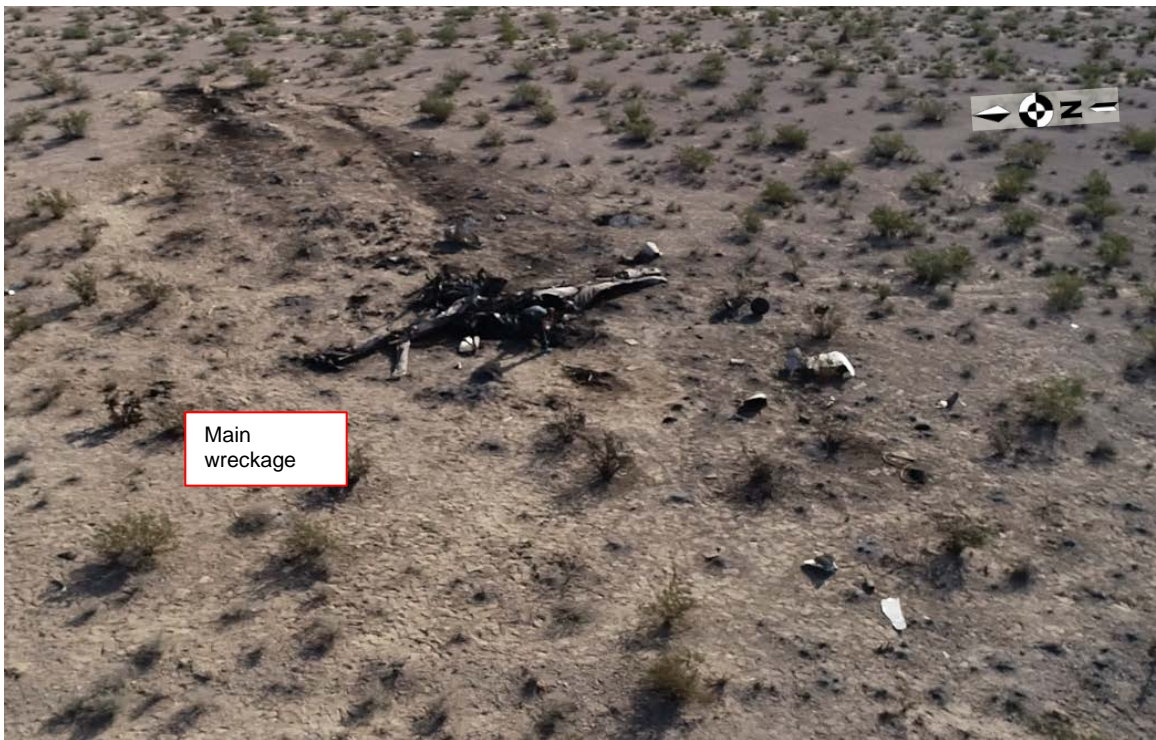
Figure 3 – Main wreckage looking back along impact path

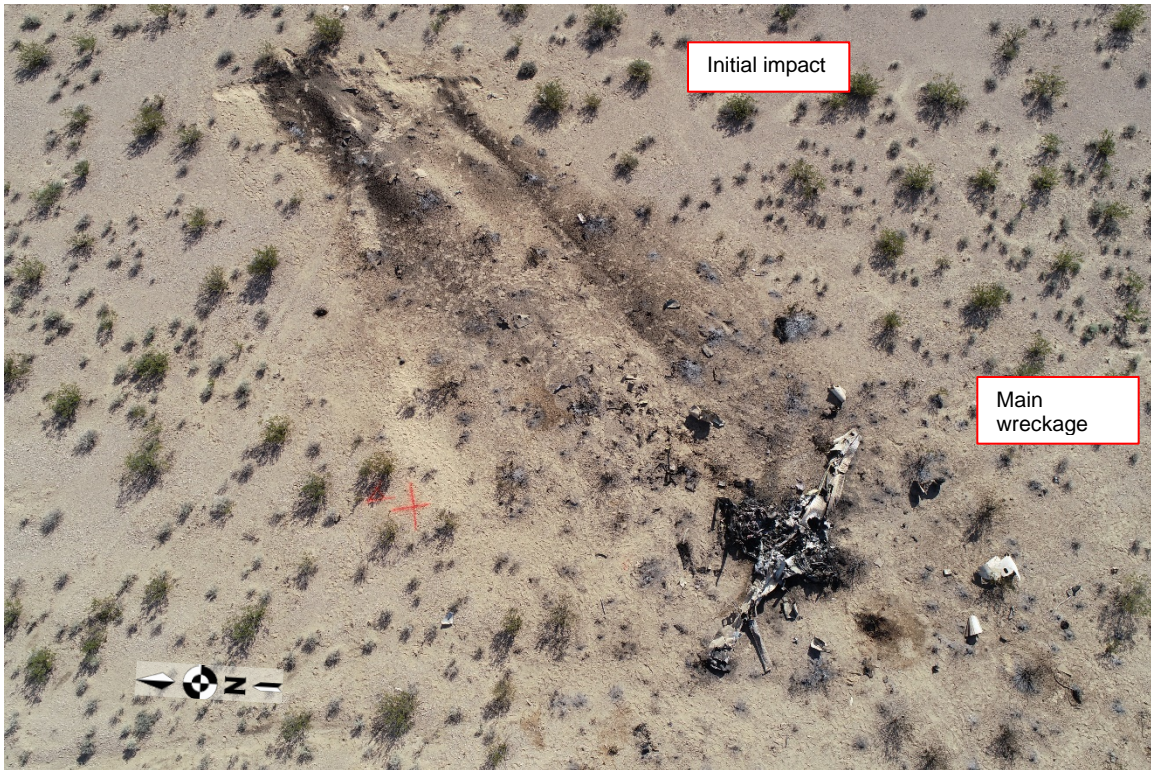
Figure 4 – Overhead of impact area and main wreckage

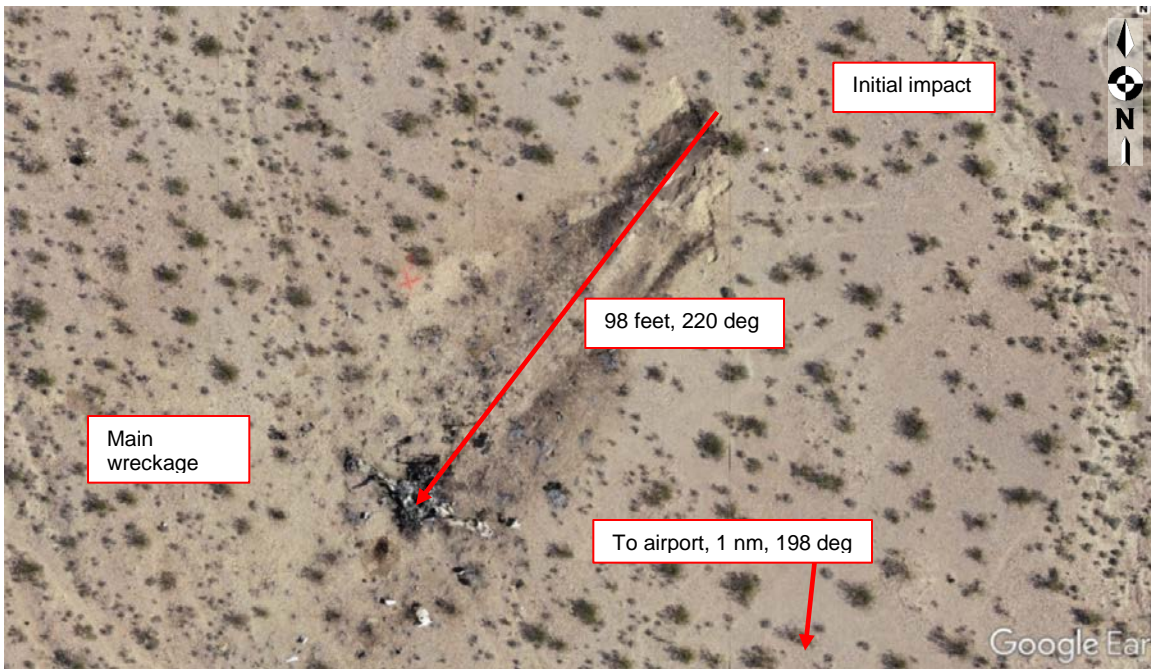
Figure 5 – Excerpt from Google Earth orthomosaic

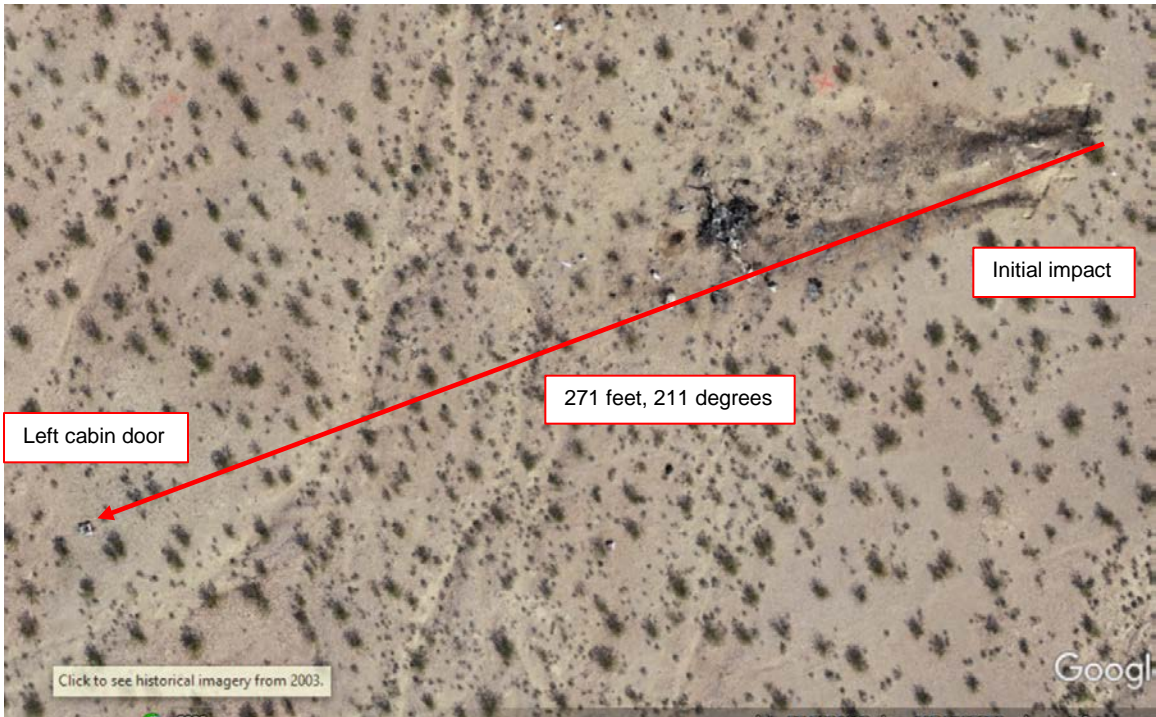
Figure 6 – Excerpt from Google Earth orthomosaic from initial impact to left cabin door.

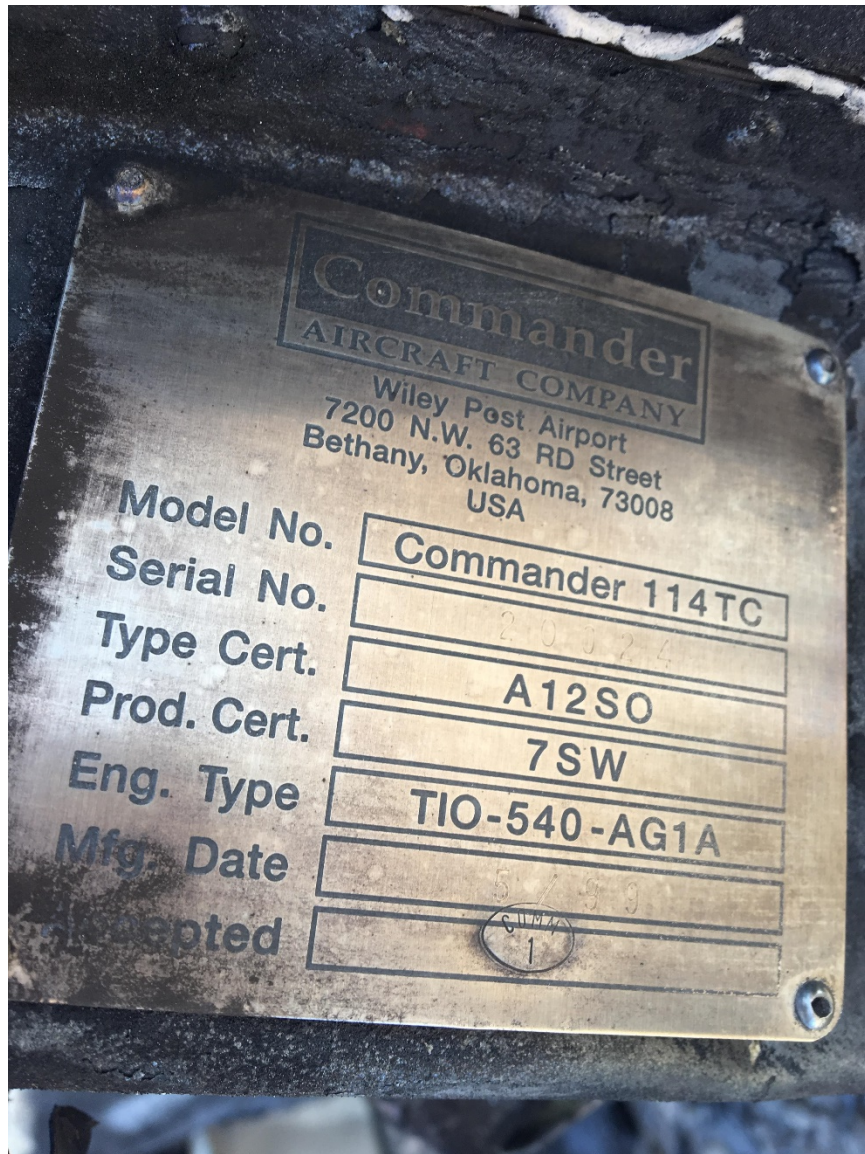
Figure 7 – Aircraft data plate (cleaned)
