**Washington State Ferries
Report of Formal Investigation
M/V Cathlamet Allision with Fauntleroy Dolphin and Subsequent Grounding
17 February 2023**

Investigating Authority: Washington State Ferries

Investigation and Report Preparation: Bill Michael, Operations Manager WSF Eagle Harbor Facility

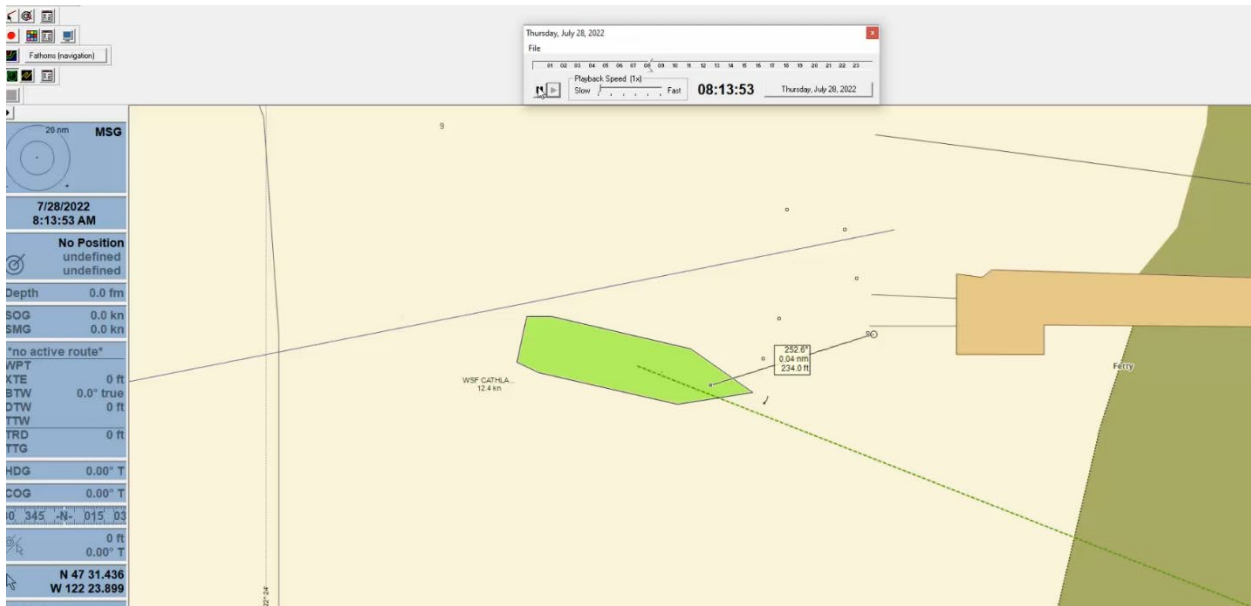
08:13:53 PDT bow handle moved from 8 to 10 astern.
