Factual Report – Attachment 6

METEOROLOGY

DCA19MA086

UAL 1788 MCO-IAH & UAL 1754 IAH-MSY 23FEB2019

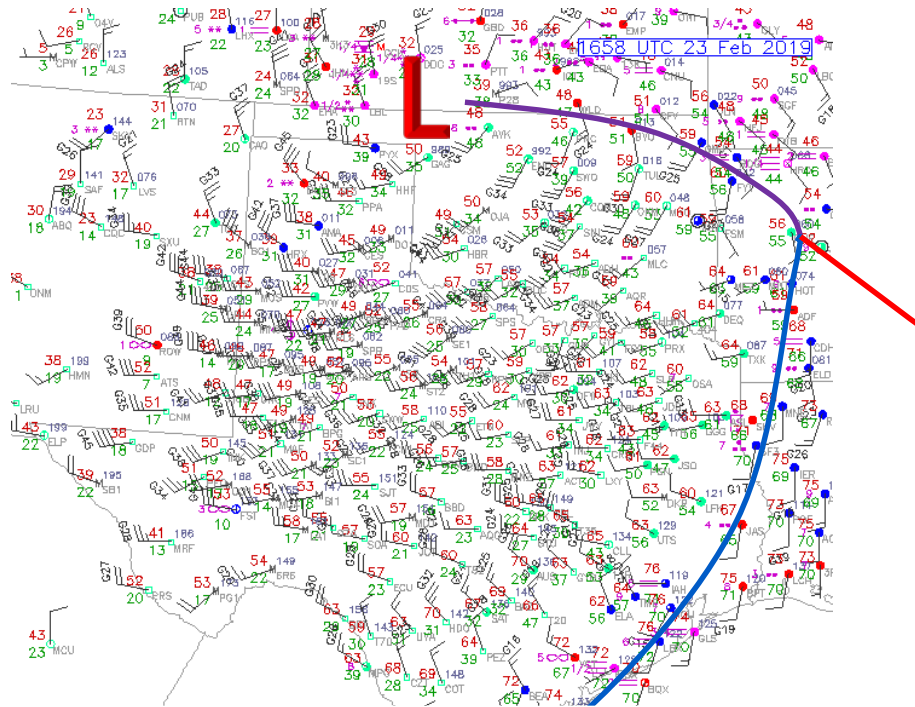
On the morning of February 23, 2019 a strong surface cold front is depicted moving eastward through southeastern Texas. This surface weather analysis is from 1700z or 1100CST. In the METARS below, KIAH reports a peak surface wind gust to 29kts at 1701z and KHOU peaks at 34kts about 40 minutes later. Both also report a brief rain shower.

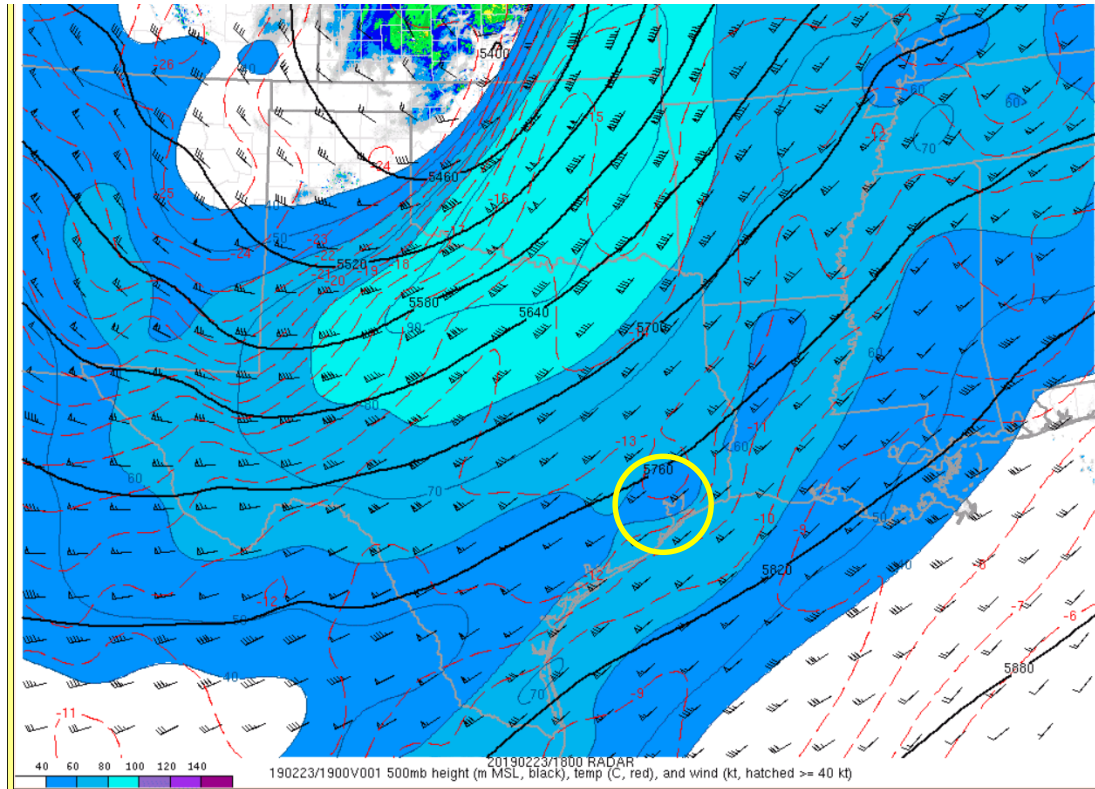
The front is developing eastward as a result of a strong mid level trough translating across the Southern Plains. An analysis of wind at 500mb or about 18,000ft AGL shows southwest winds of about 60kts above the accident location and in the terminal environment (circled in yellow).

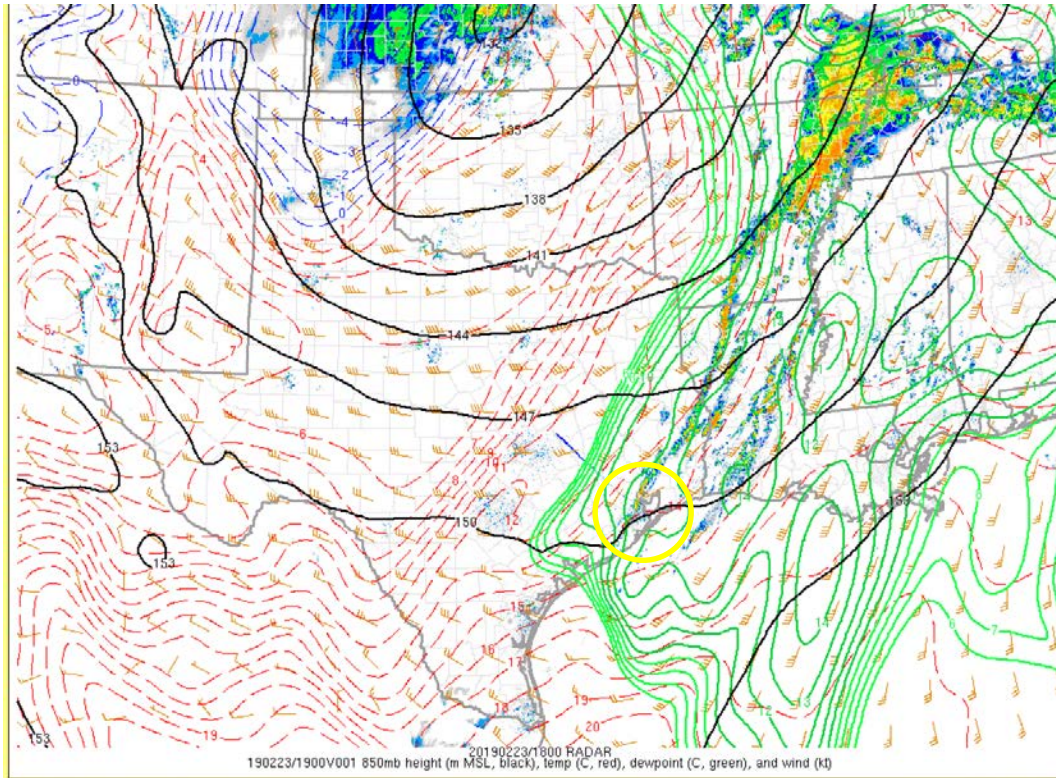
An analysis of wind at 850mb or about 5,000ft above ground shows southwest winds of 20-30kts above the accident location and in the terminal environment (approximated by the yellow circle). Dewpoint temperature, contoured in green, indicates sufficient available moisture to support thunderstorm development.

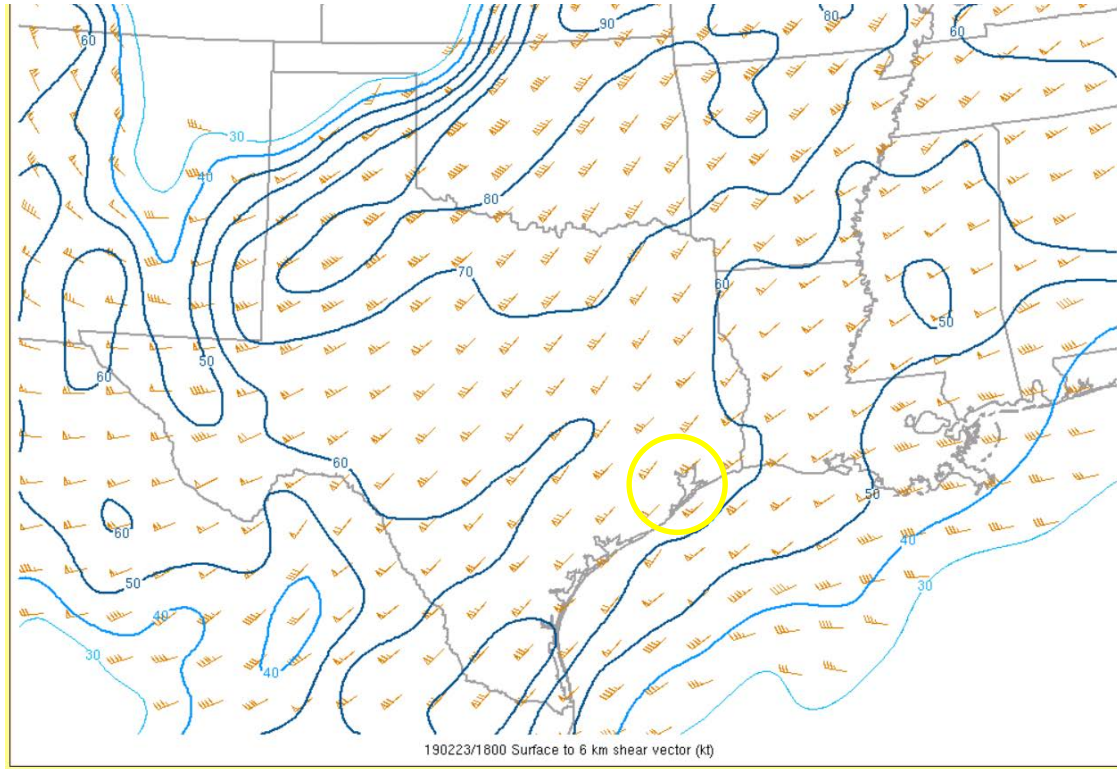
An analysis of wind shear from the surface to about 20,000ft above the accident location and the terminal environment (approximated by the yellow circle) indicates a shear vector of 65-70kts. Wind shear is a key ingredient in thunderstorm development and maintenance.

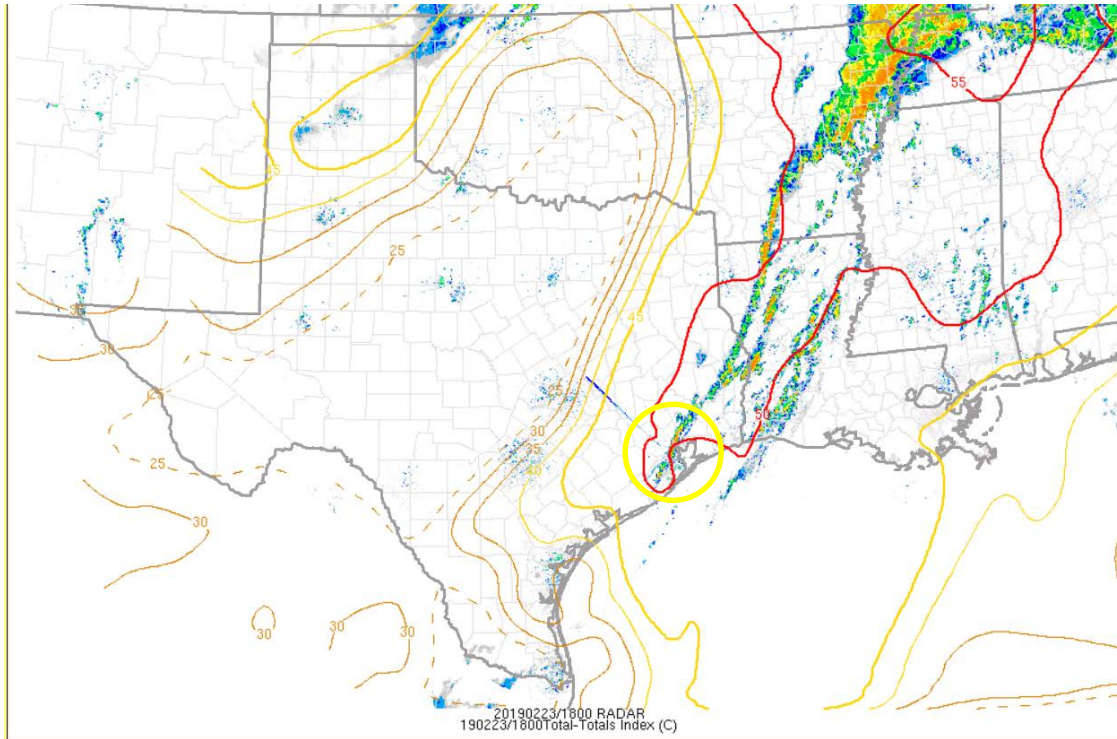
An analysis of the Total-Totals index above the accident location and within the terminal environment (approximated by the yellow circle) indicates a value of 50 or more which is sufficient for thunderstorm activity.

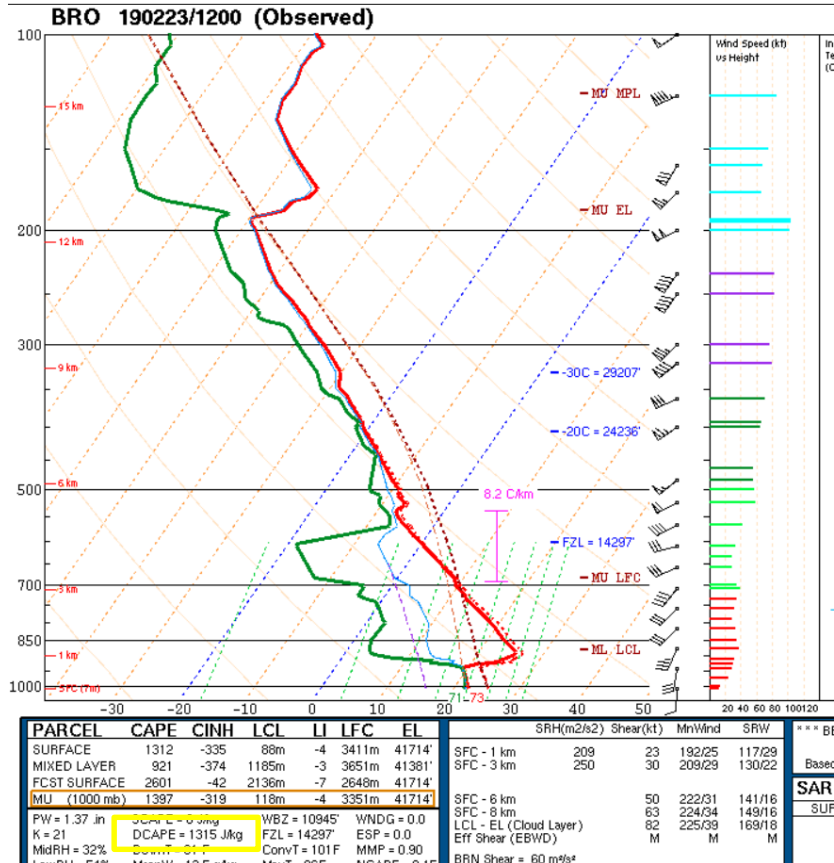
Of particular interest, this upstream weather balloon launched over Brownsville, TX the morning of the accident indicates a very dry lower atmosphere supportive of convective downbursts as evidenced by the calculated DCAPE of 1315 (highlighted in yellow) in the table below. DCAPE can be used to measure the potential strength of rain cooled downdrafts. Larger DCAPE values are associated with stronger downdrafts and values greater than 1000 are significant.

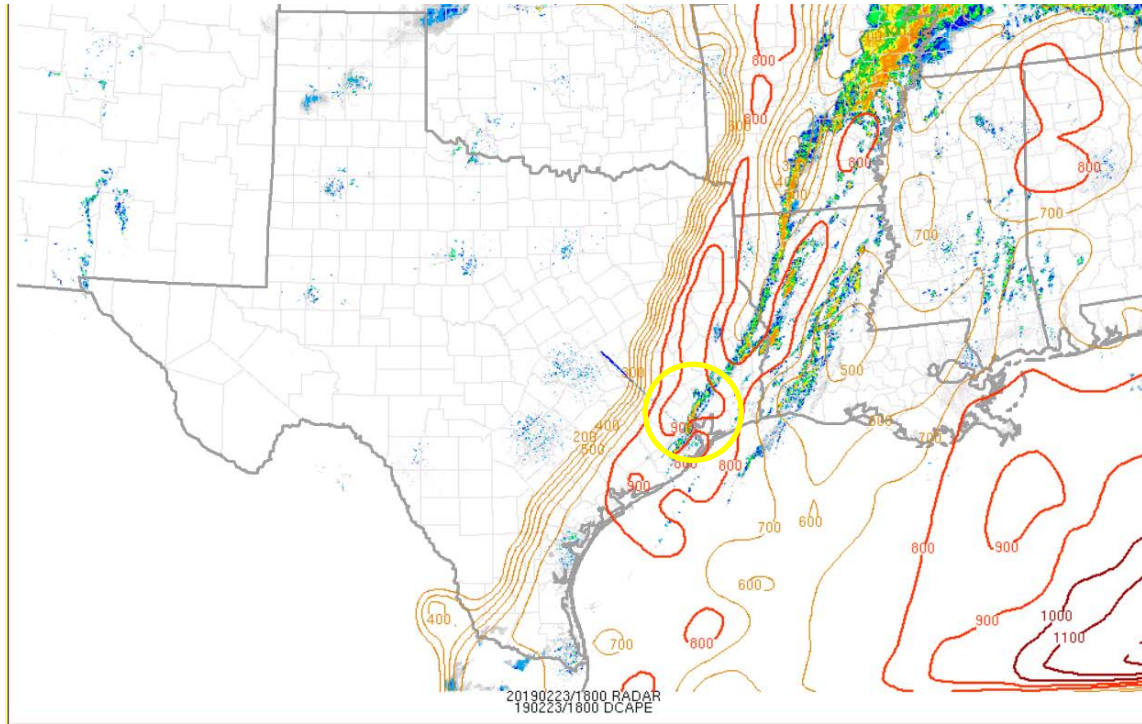
This analysis of DCAPE over the IAH terminal area and the accident location (circled in yellow) at 1800z indicate a DCAPE value near 900. Not as large a value as measured in the BRO sounding earlier in the morning however still capable of stronger downdraft winds.

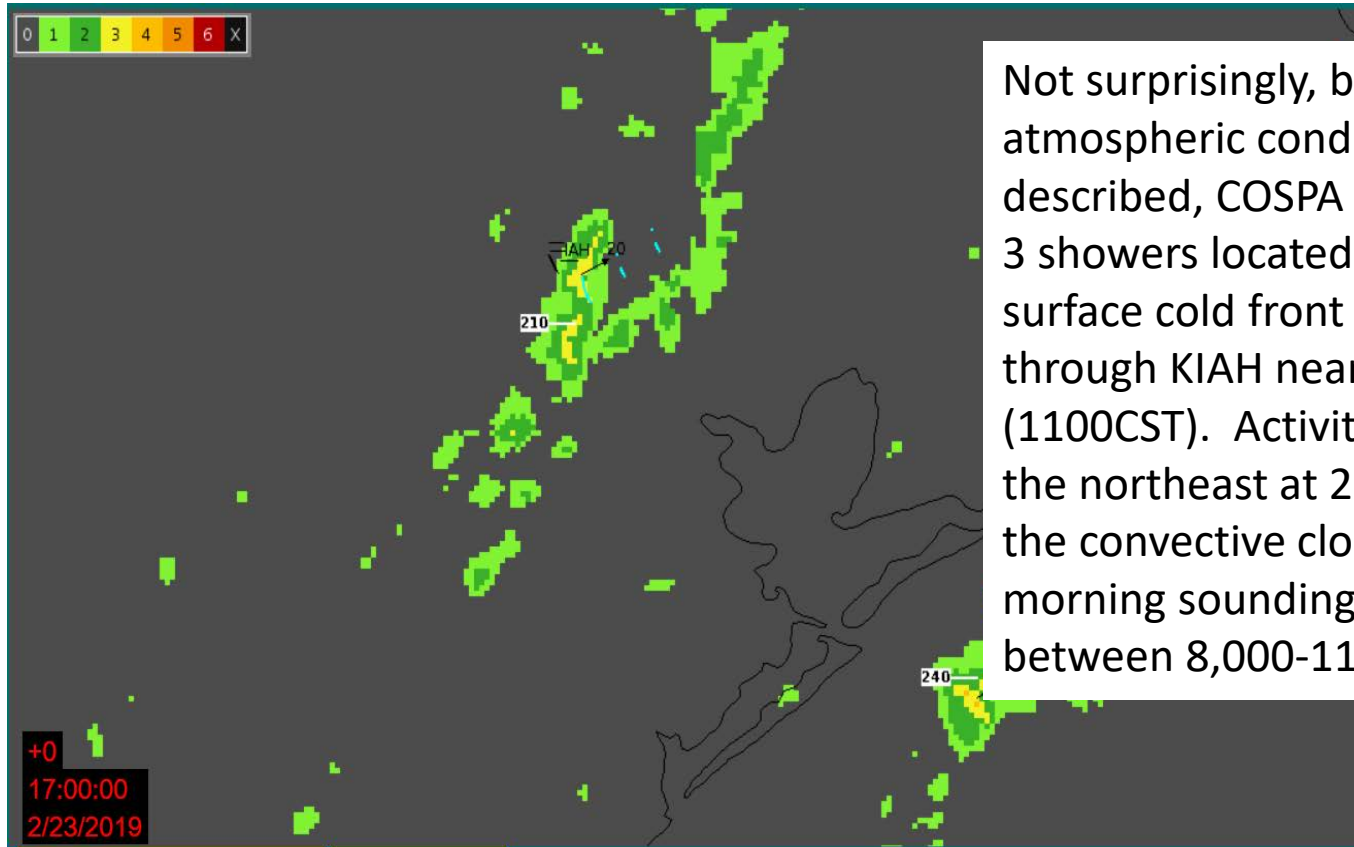
Not surprisingly, based on the atmospheric conditions just described, COSPA is depicting level 3 showers located along the surface cold front as it moves through KIAH near 1700z (1100CST). Activity is developing to the northeast at 20-30kts. Bases of the convective clouds from the morning sounding are estimated between 8,000-11,000 feet.

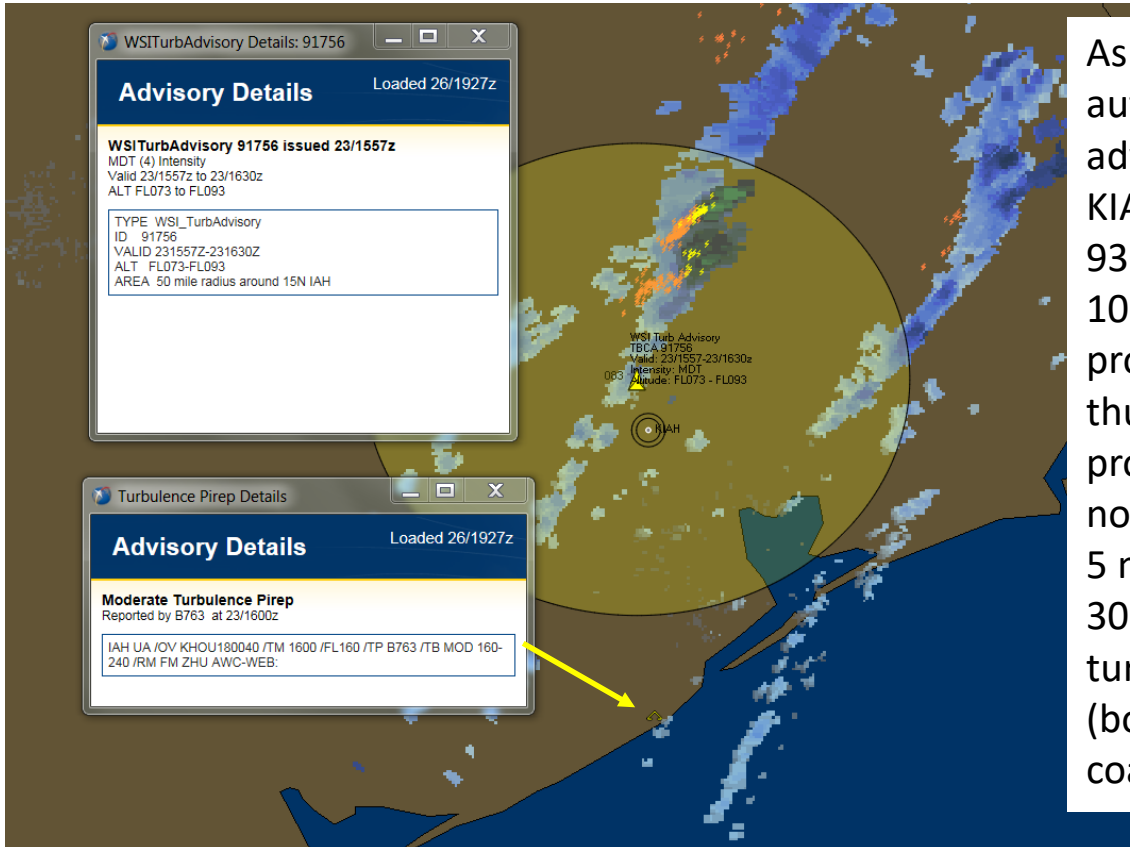
As early as 1600z (1000CST), an automated TWC moderate turbulence advisory (yellow ring) encompassing KIAH is triggered for flight levels 7300-9300ft as a result of a TAPS report about 10nm to the north of IAH. This is in close proximity to the showers and isolated thunderstorms shown in this echo tops product. Lightning is also evident to the north (yellow strikes are within the past 5 min. while orange are within the past 30 min.) There also is a moderate turbulence report from FL160-240 (bottom) from a B767 along the Texas coast

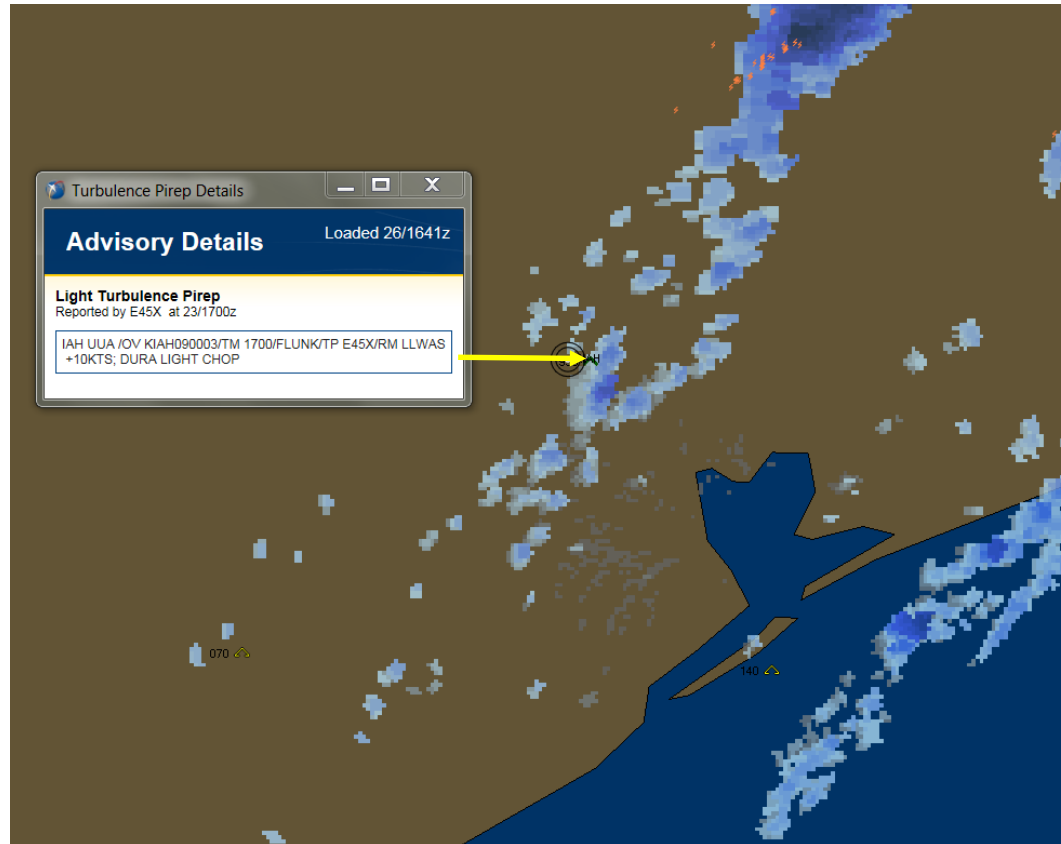
At 1700z (1100CST), an E45X reports light chop and low level wind shear of + 10 knots on approach into KIAH. Lightning is diminishing and moving further northeast of the terminal (yellow strikes are past 5 min. while orange are past 30 min.)

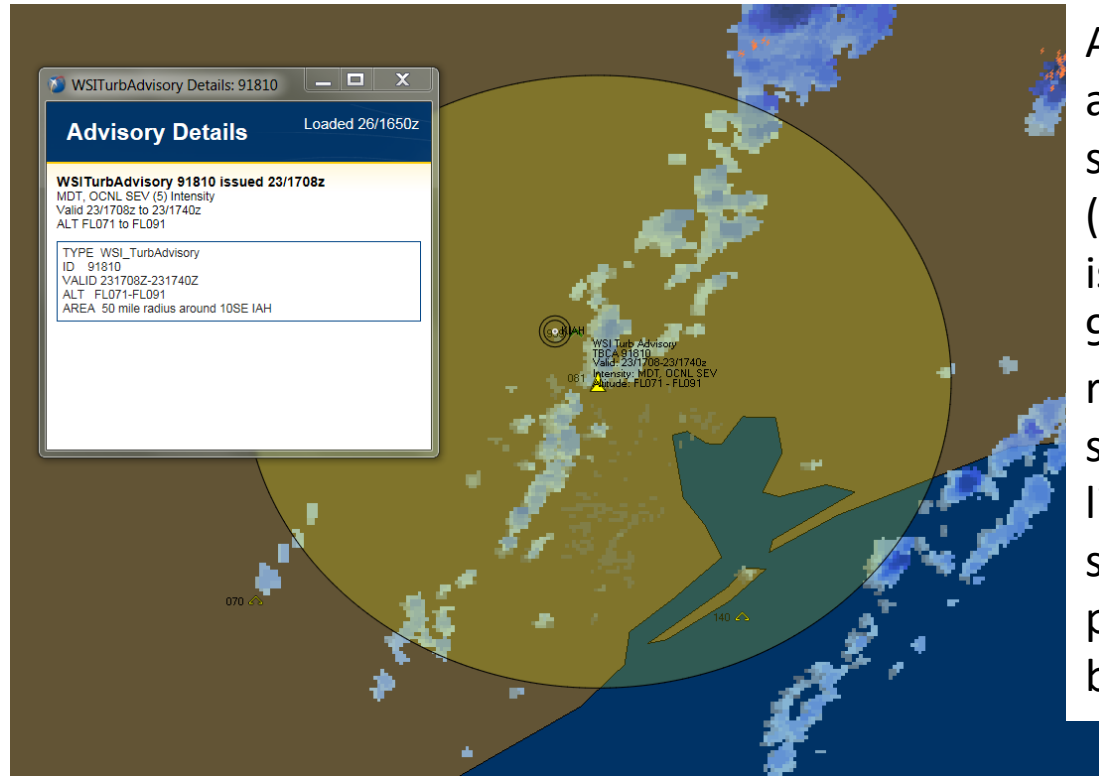
At 1708z (1108CST), a second automated TWC moderate to severe turbulence advisory (yellow ring) encompassing KIAH is triggered for flight levels 7100-9100ft as a result of a TAPS report about 13nm to the southeast of IAH. This is most likely a result of proximity to the showers shown in this echo tops product. No recent lightning has been observed.

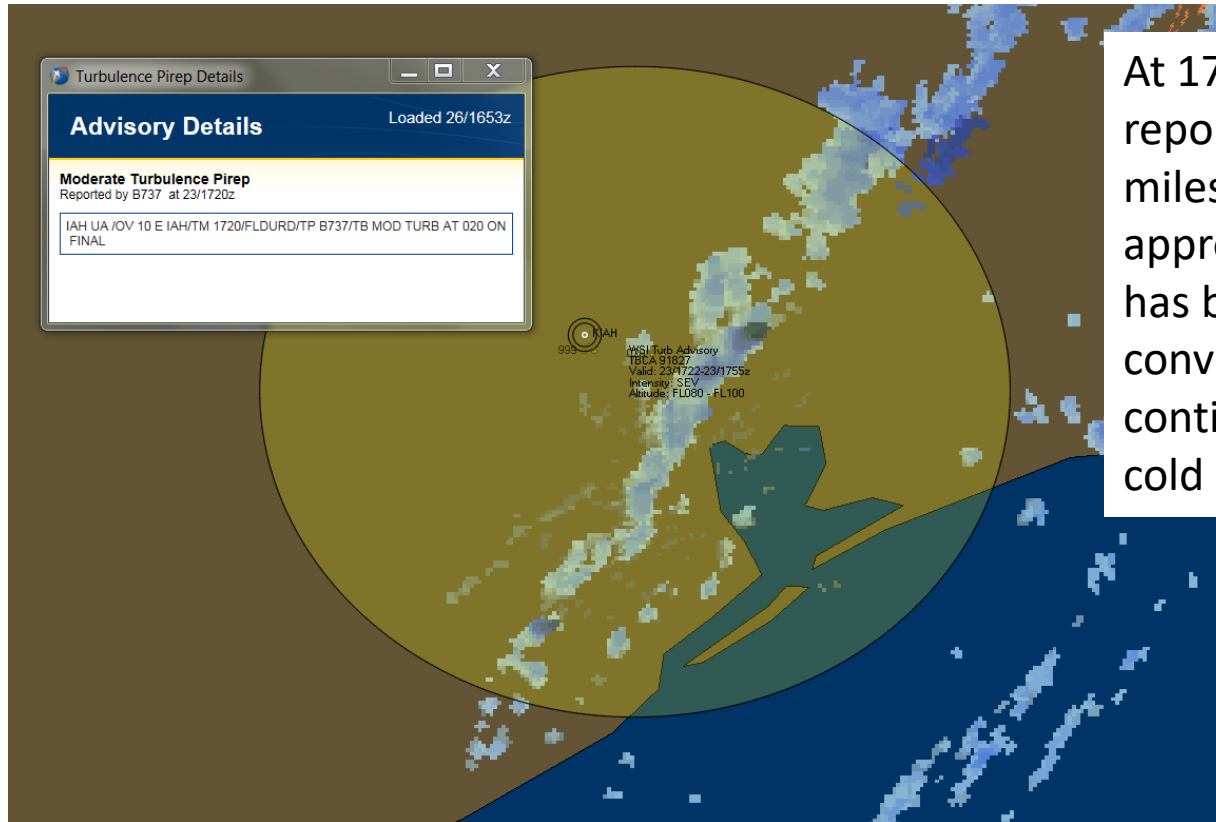
At 1720z (1120CST), a B737 reports moderate turbulence 10 miles east of KIAH at FL020 on approach. No recent lightning has been observed, however convective rain shower activity continues eastward along the cold front.

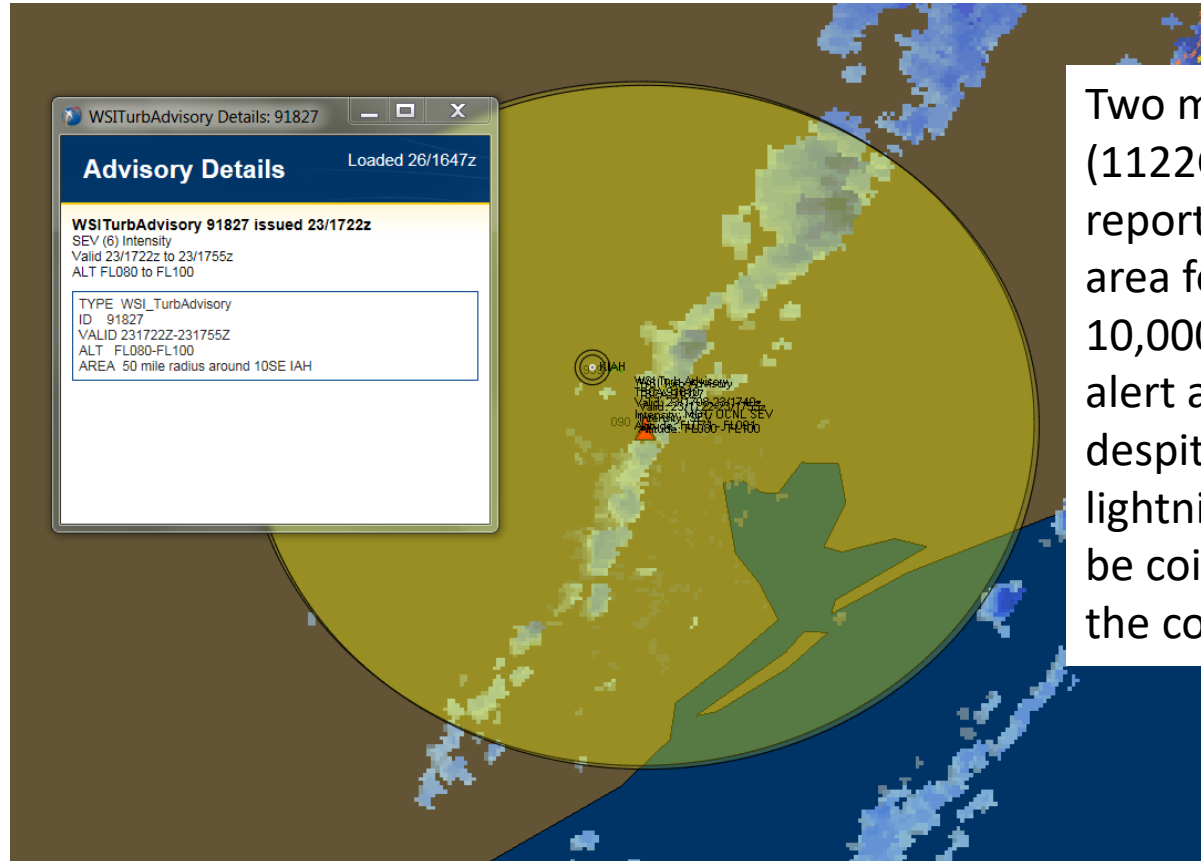
Two minutes later, at 1722z (1122CST), a third TWC TAPS report triggers a severe alert area for flight levels 8,000-10,000ft valid until 1755z. The alert area includes KIAH and despite the continued lack of lightning, the reports appear to be coincident with and beneath the convective cloud bases.

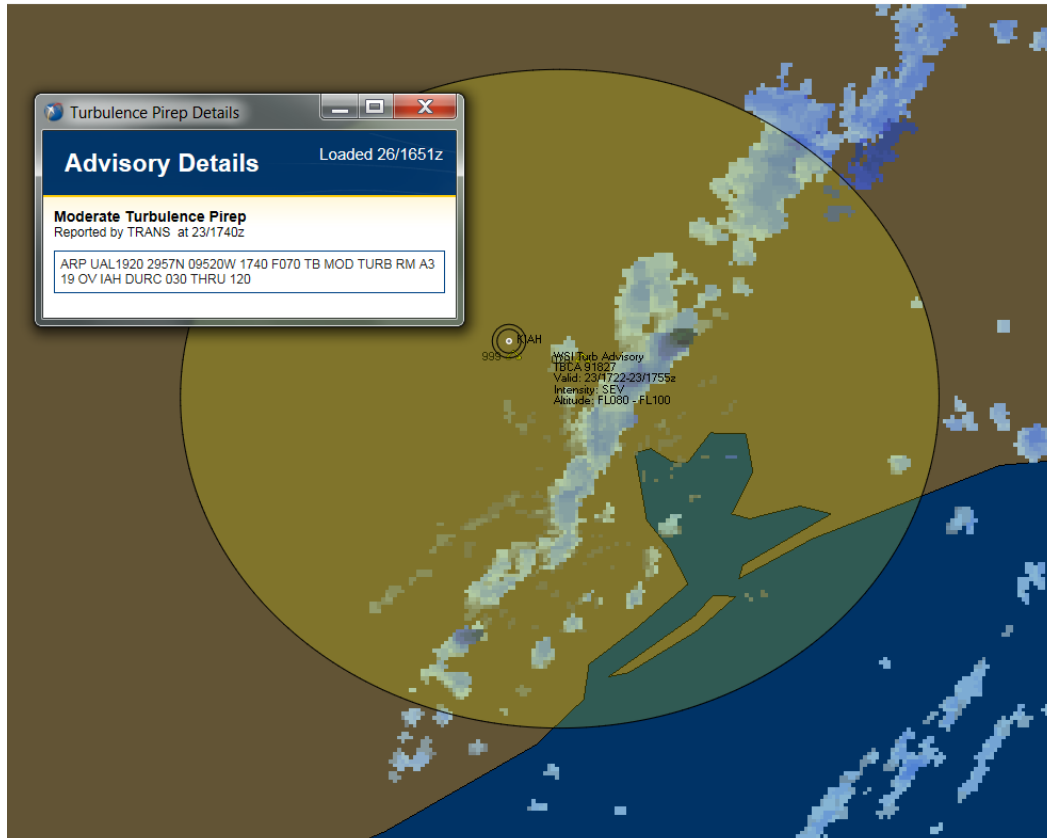
At 1740z (1140CST), UAL 1920 reports moderate turbulence from flight levels 3000-12,000 feet during climb out from KIAH.

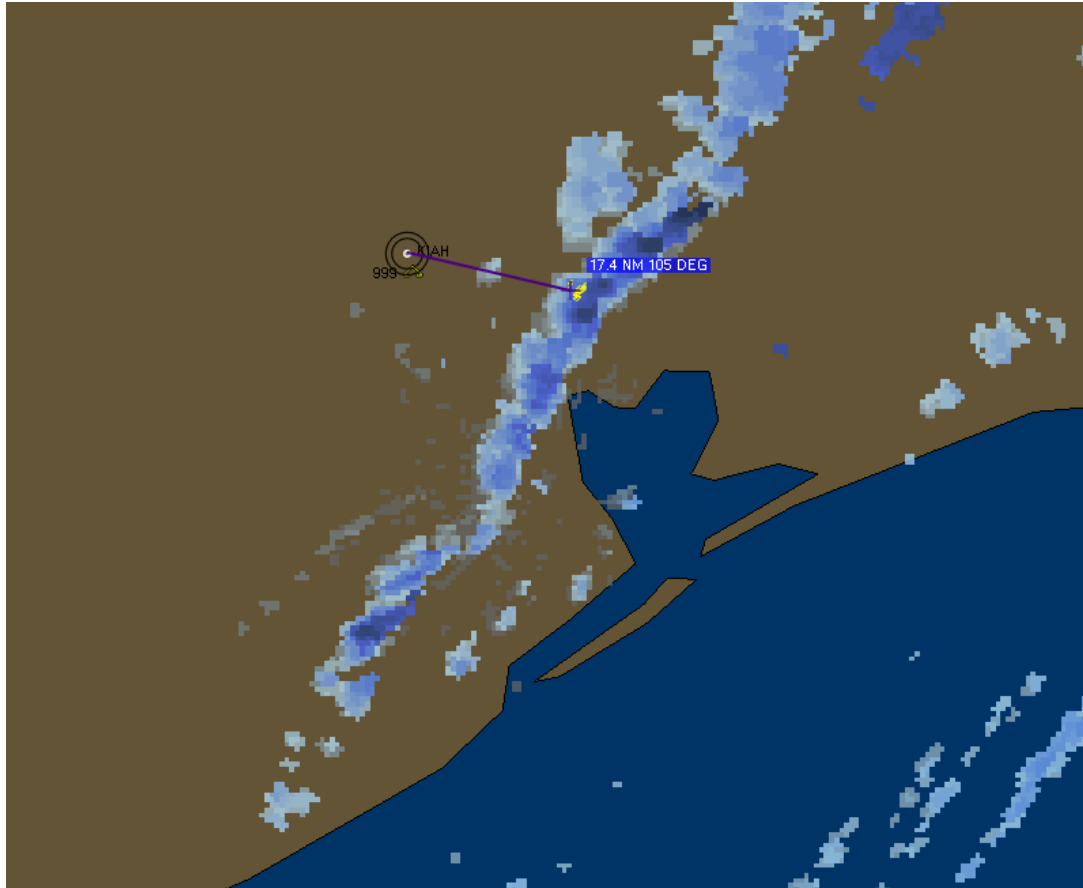
Between 1750-1755z isolated lightning strikes are once again being observed in the taller echo tops about 17nm to the east-southeast of KIAH. Overall, the tops have the appearance of strengthening and organizing into a short linear feature across southeast Texas.

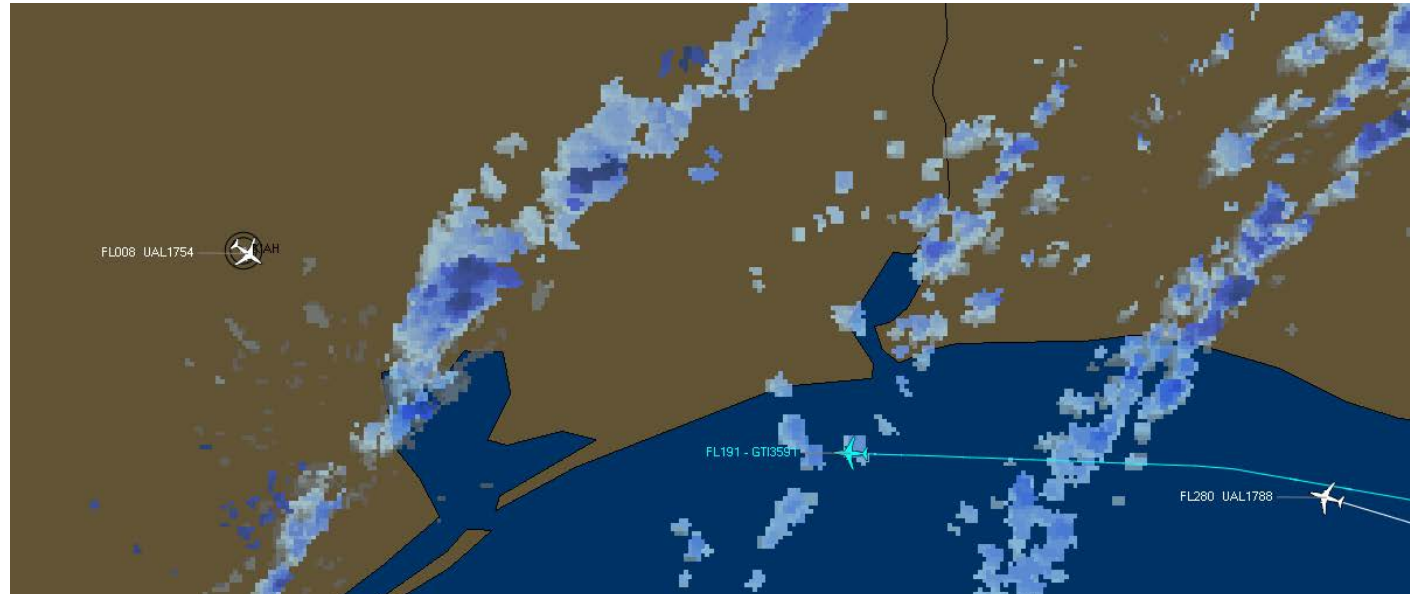
At about 1830z (1230CST) UAL 1754 departs KIAH (left). GTI3591 is descending through 19,000ft (middle) and UAL 1788 (right) is located behind at 28,000ft. Lightning is no longer being observed in the showers and no adverse pilot reports have recently been received.

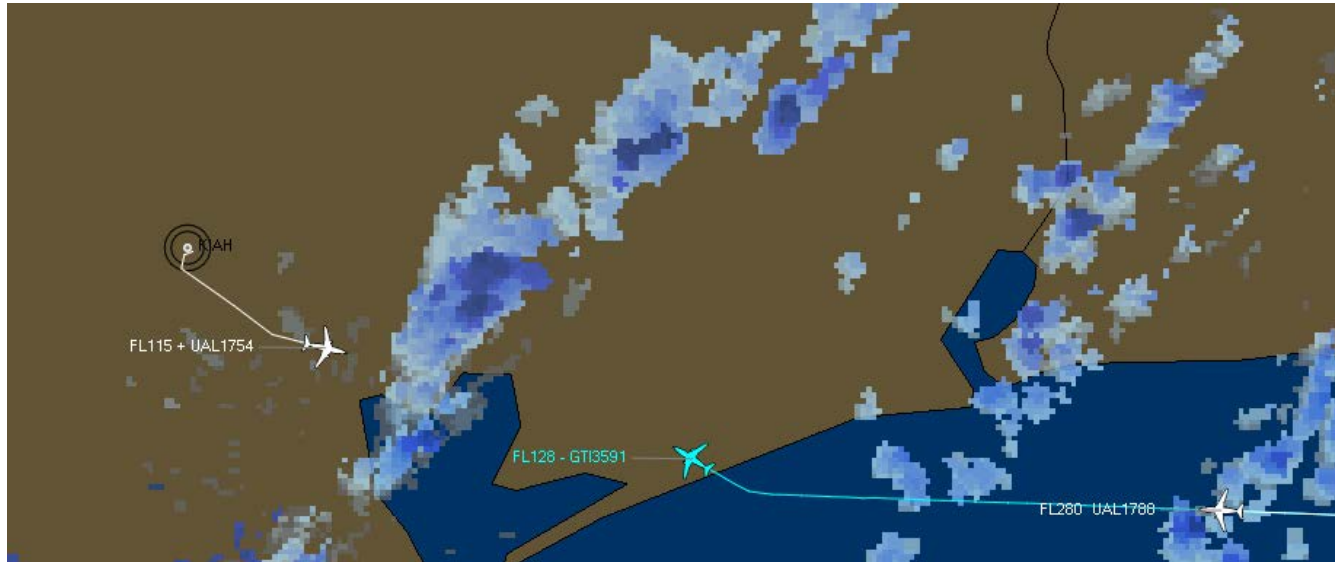
By 1835z (1235CST) UAL 1754 is climbing through 11,500ft and heading toward the weather (left). GTI3591 has moved onshore and continues to descend through 12,800ft (middle) and UAL 1788 (right) is located behind at maintains 28,000ft. Lightning is not being observed and no recent pilot reports have been received.

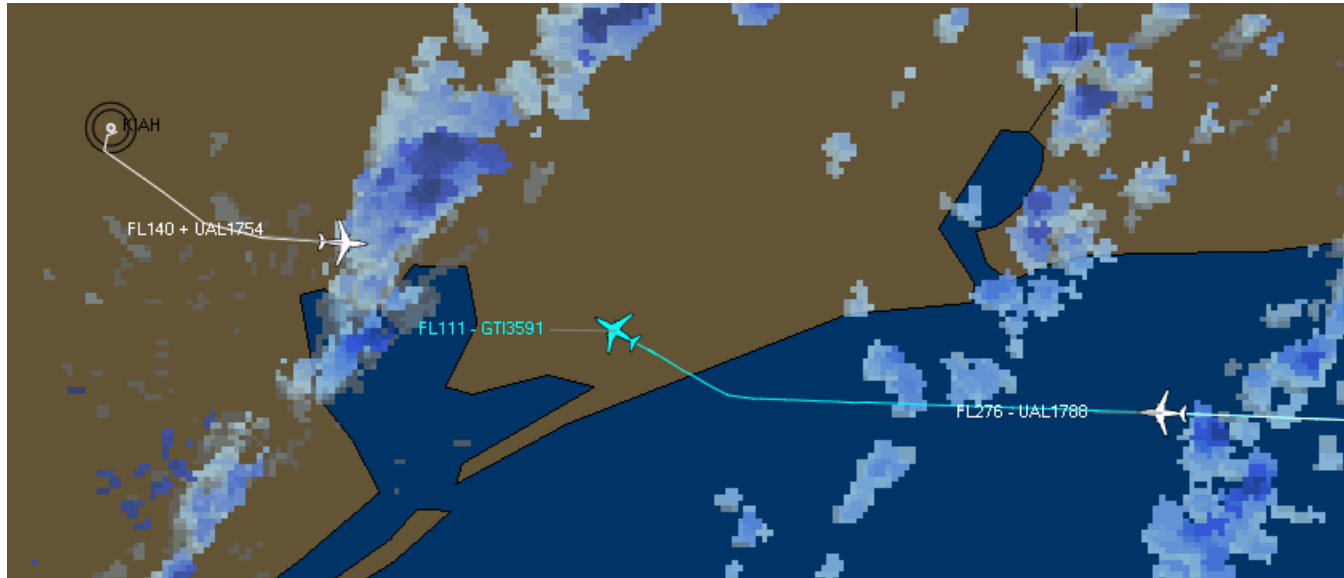
By 1836z (1236CST) UAL 1754 is climbing through 14,000ft and is in close proximity to the weather (left). GTI3591 continues to descend through 11,100ft (middle) and UAL 1788 (right) has descended to 27,600ft. Lightning is not being observed and no recent pilot reports have been received.

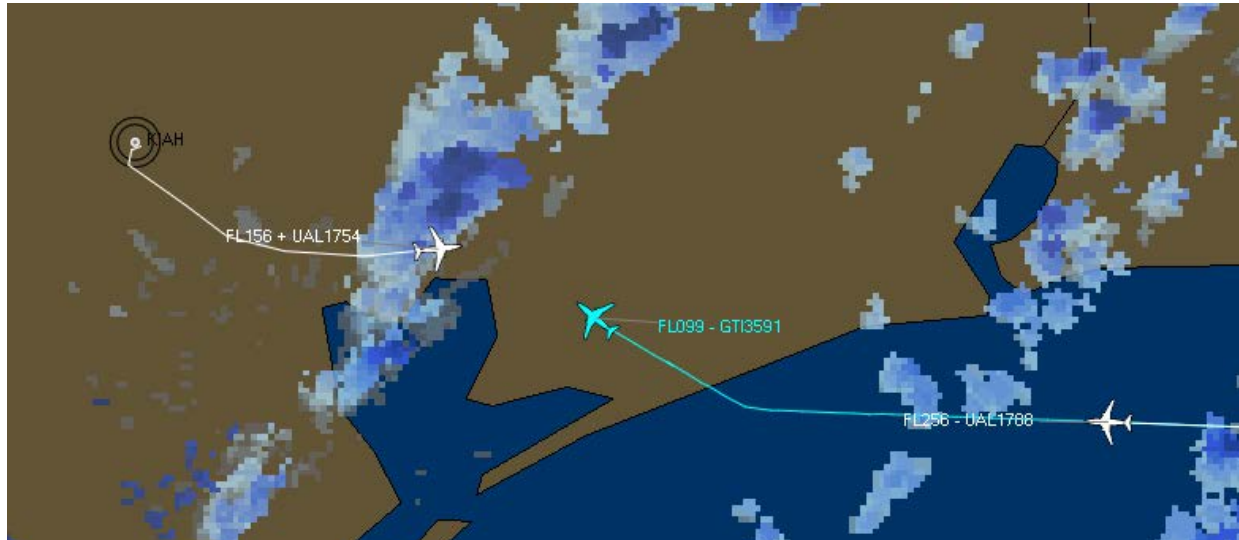
At 1837z (1237CST) UAL 1754 is climbing through 15,600ft and close to moving east of the weather (left). GTI3591 has now descended below 10,000ft (middle) and UAL 1788 (right) has descended to 25,600ft. Lightning is not being observed and no recent pilot reports have been received.

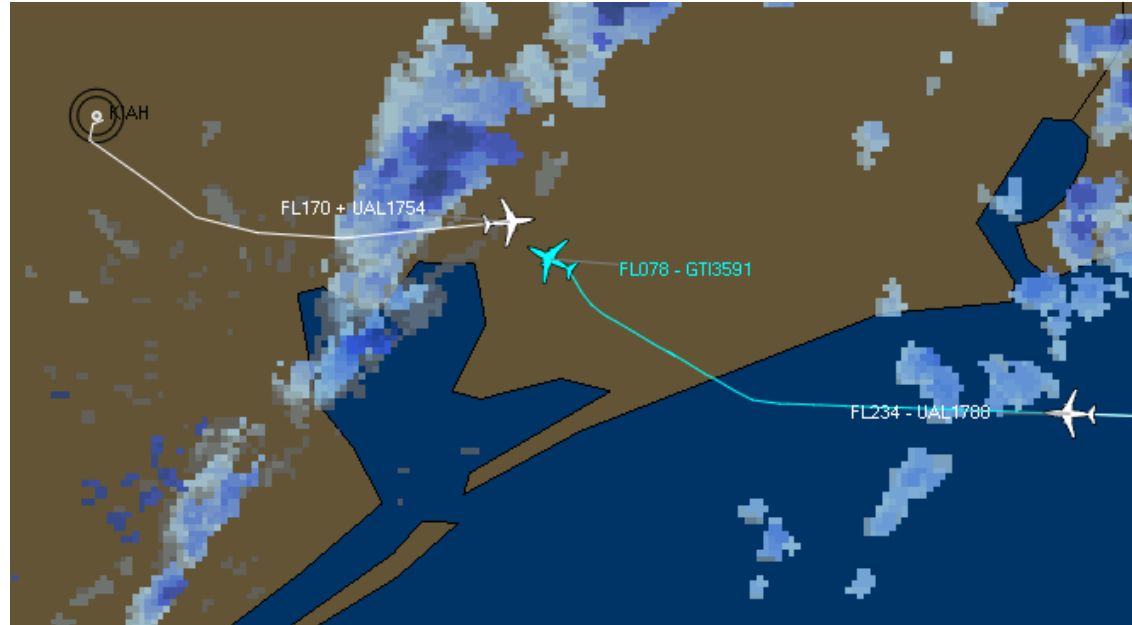
At 1838z (1238CST) UAL 1754 is climbing through 17,000ft and now clear of the weather (left). GTI3591 has now descended to 7,800ft (middle) and UAL 1788 (right) has descended to 23,400ft. Lightning is not being observed and no recent pilot reports have been received.

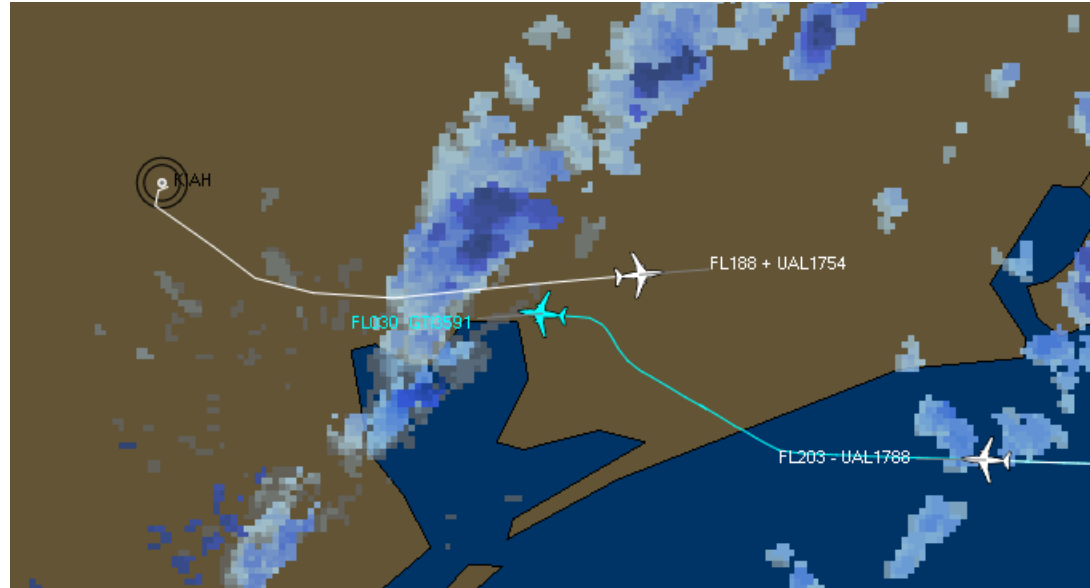
By 1839z (1239CST) UAL 1754 is climbing through 18,800ft and continues eastbound (top/middle). GTI3591 has now descended to 3000ft just ahead of the weather (left). UAL 1788 (right) continues it's descent to 20,300ft. Still no lightning is not being observed and no further pilot reports have been received.
