## **Weather Study – Attachment 2**

PADU weather observer interview summary and office log notes from the day of the accident.

# **METEOROLOGY**

DCA20MA002

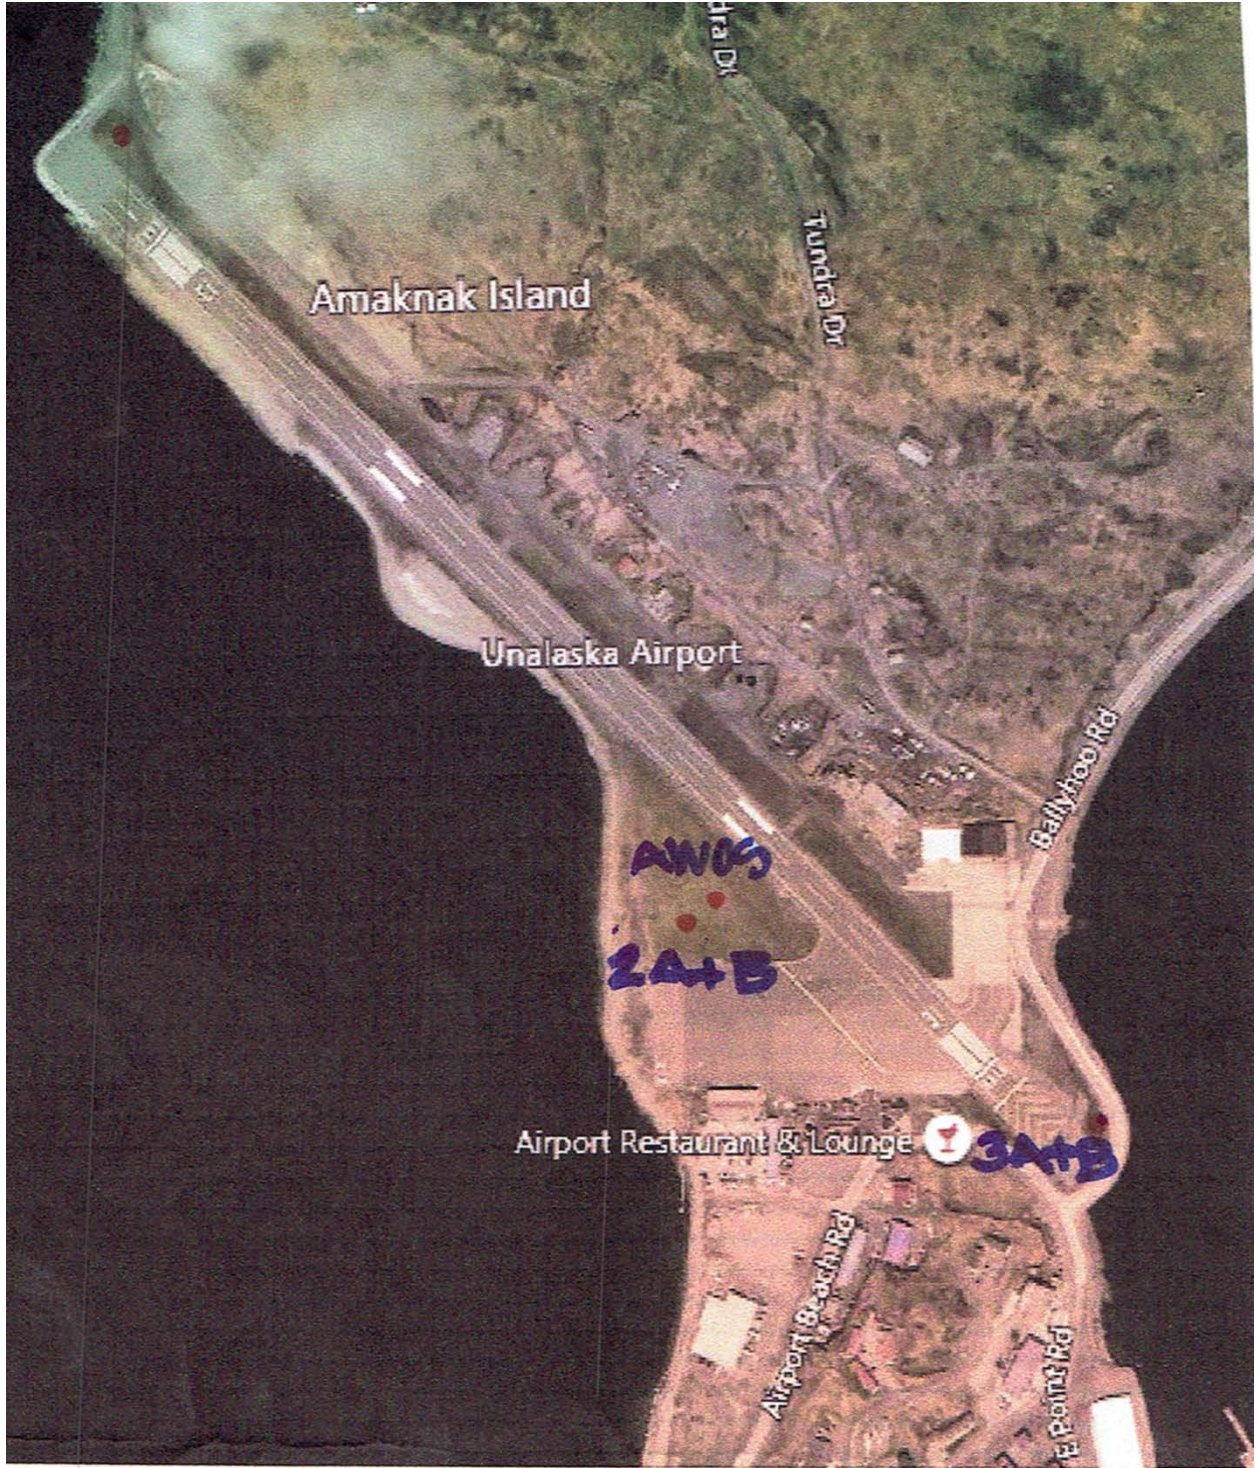
FIGURE 1

*[Ms. Hester provided an image (Figure 1) which depicts the approximate locations of the AWOS and 420 instruments. The label of "2A+B" denotes the location of the 420 anemometer whose*

There are three windsocks at PADU, one near the approach end of Runway 13 (the unlabeled red dot in Figure 1), one near the AWOS and one near the approach end of Runway 31 by the 420 anemometer [labelled “3A+B” in Figure 1].

When aircraft are on approach to Runway 13, she will provide wind information from the “midfield” anemometer [labelled as “2A+B” in Figure 1]. When aircraft are “coming in the backdoor” to Runway 31, she will provide them with wind information from the both 420 anemometers. The wind directions from the 420 instruments are displayed as referenced to magnetic north and this is how she delivers the wind direction to incoming aircraft on final approach. She does not identify this wind as “magnetic.”

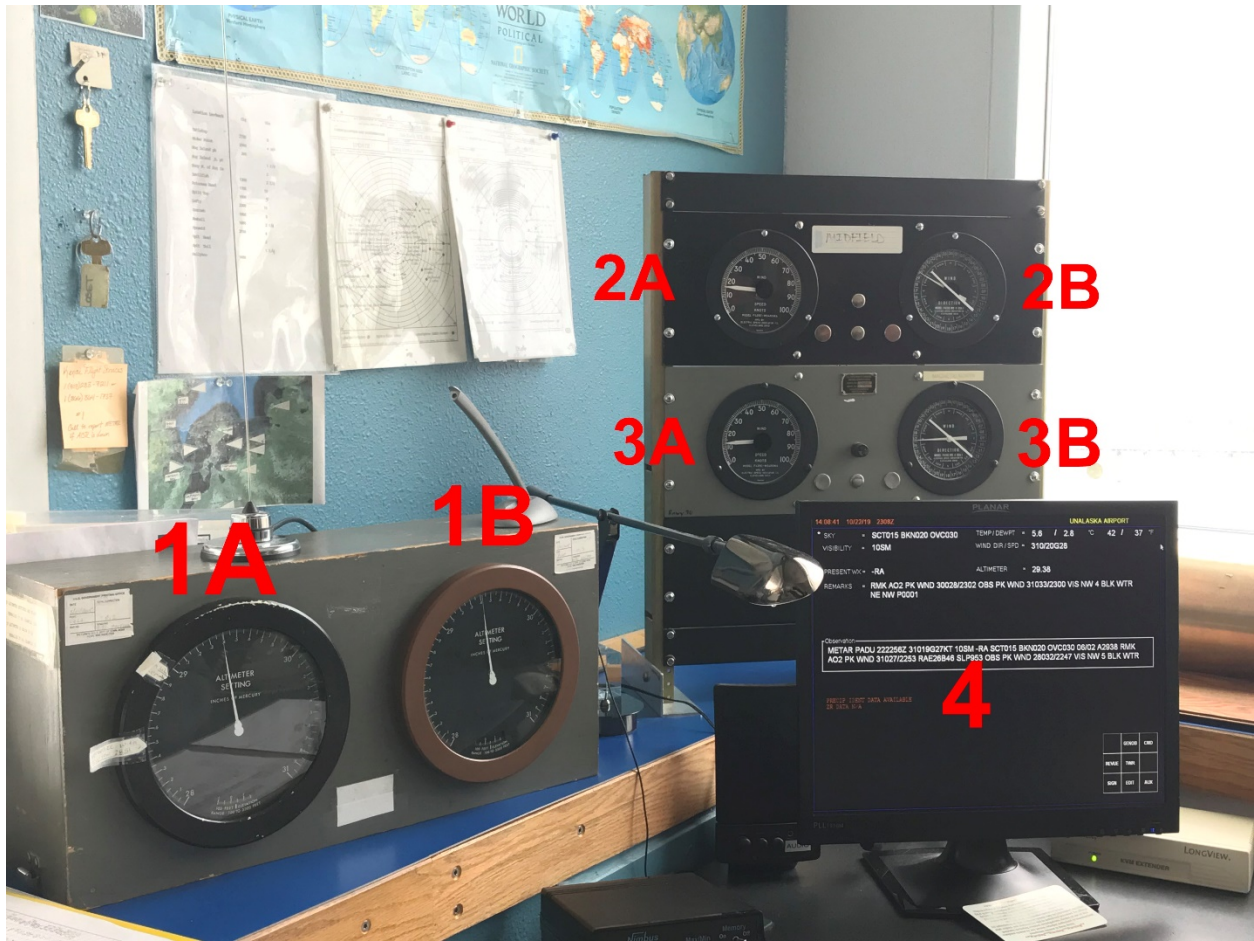
FIGURE 2

*display is shown in Figure 2 as “2A” and “2B.” The label of “3A+B” denotes the location of the 420 anemometer whose display is shown in Figure 2 as “3A” and “3B.” Figure 2 is a photograph of live displays of weather information in the weather observer’s office at PADU. “1A” and “1B” in Figure 2 are the displays of the two backup altimeter setting instruments, and “4” is the AWOS display]*
