## **NATIONAL TRANSPORTATION SAFETY BOARD**

### **Weather Study**

# **METEOROLOGY**

DCA20MA002

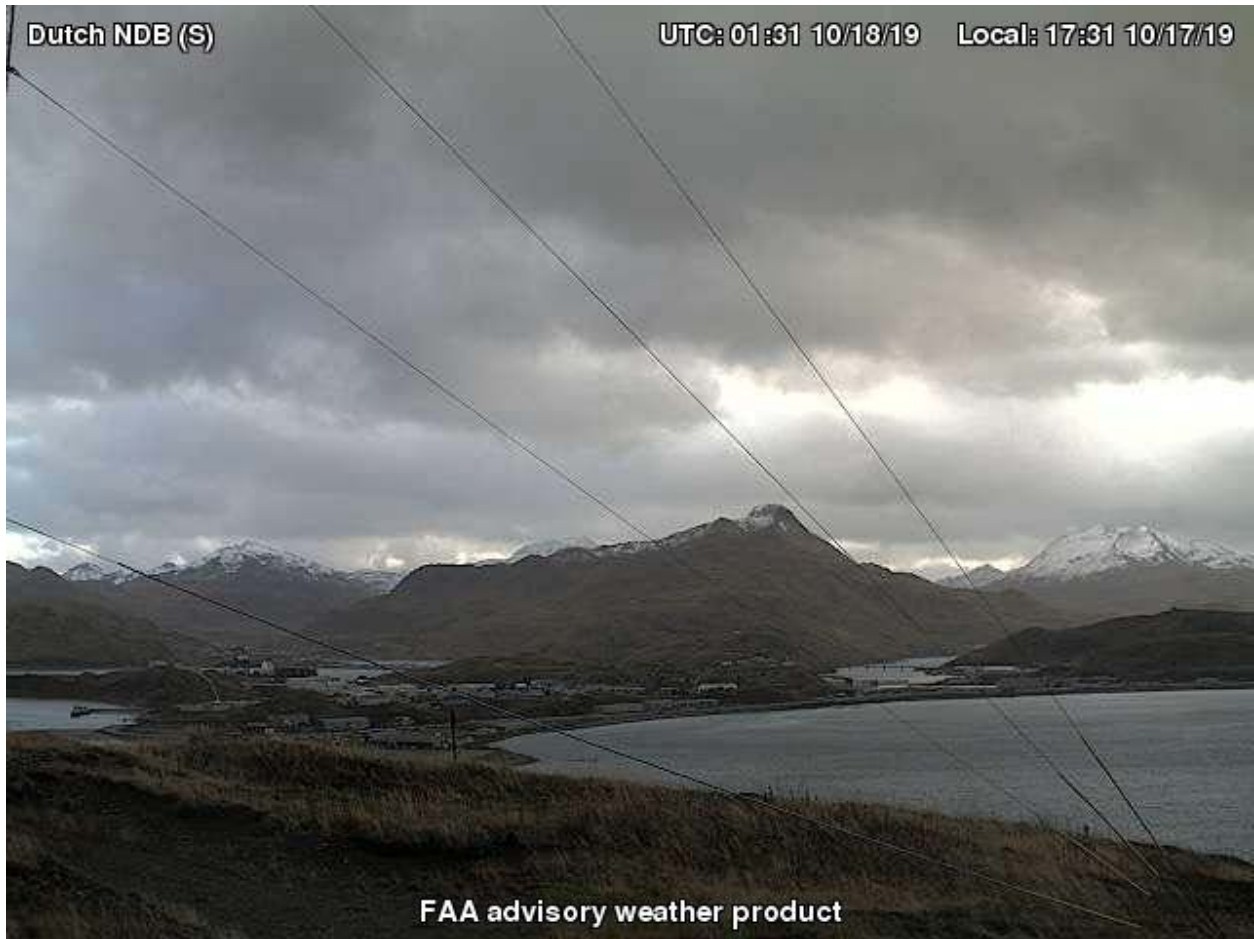
**Figure 3** – South-facing Dutch NDB weather camera image at 1731 AKDT.

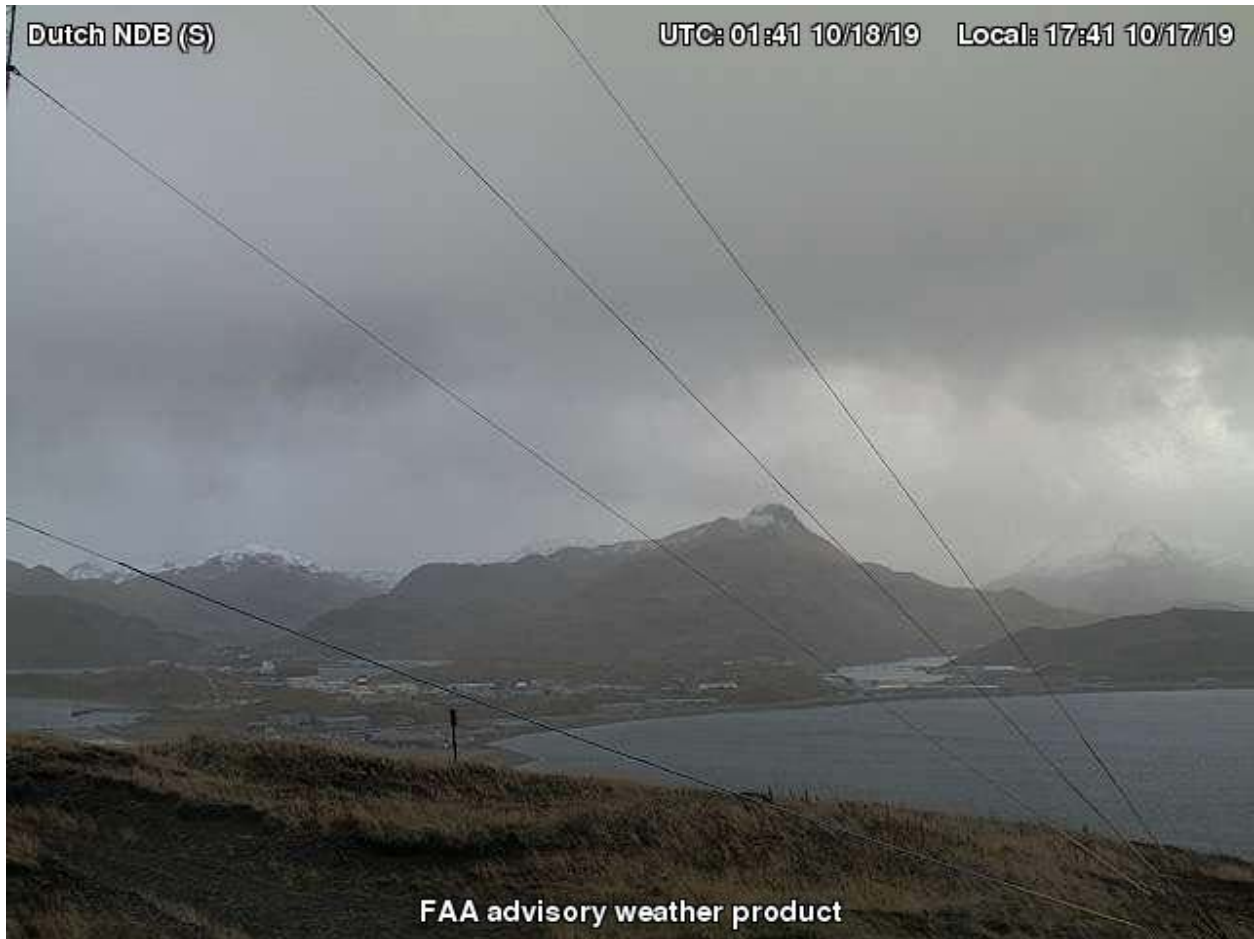
**Figure 4** – South-facing Dutch NDB weather camera image at 1741 AKDT.

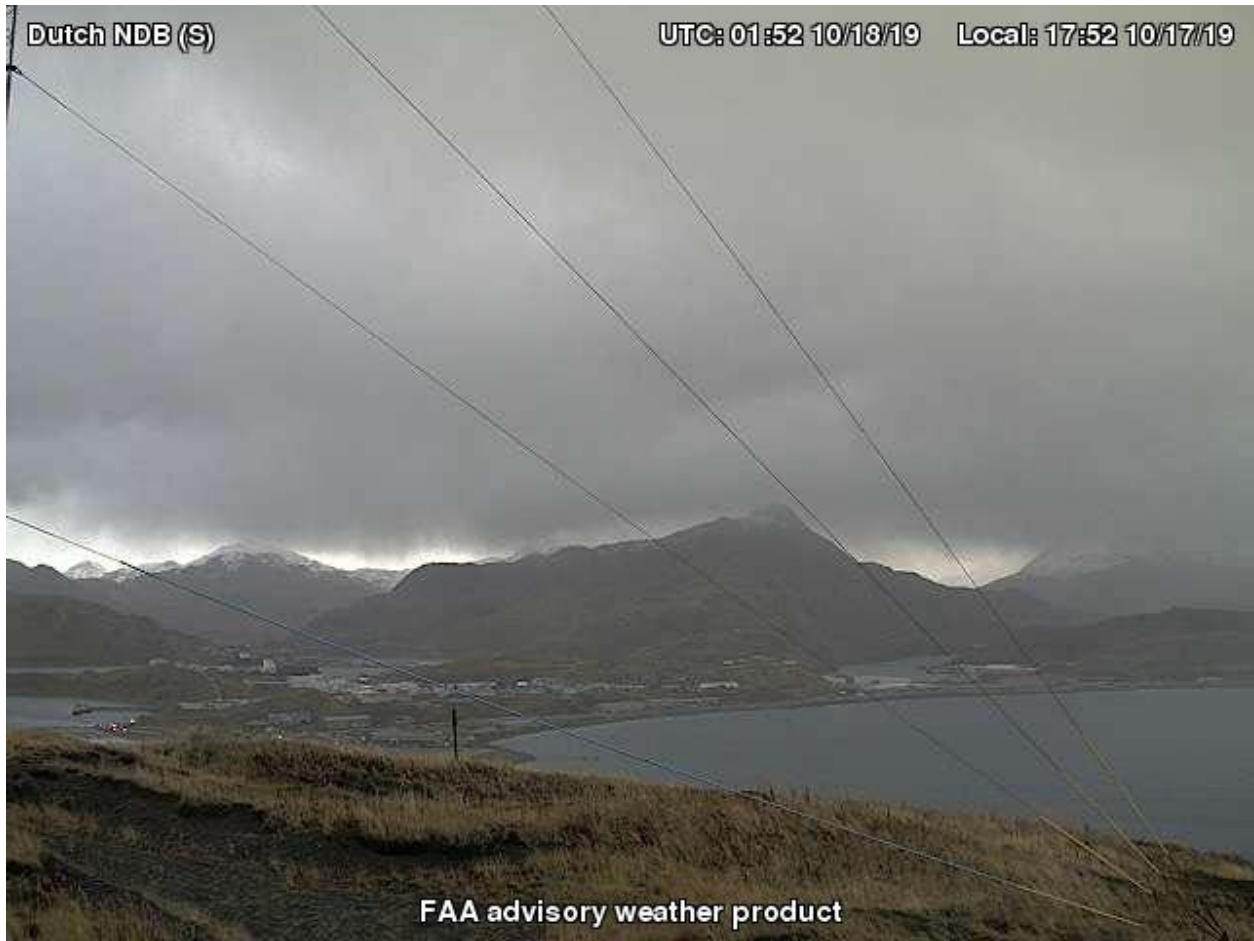
**Figure 5** – South-facing Dutch NDB weather camera image at 1752 AKDT.

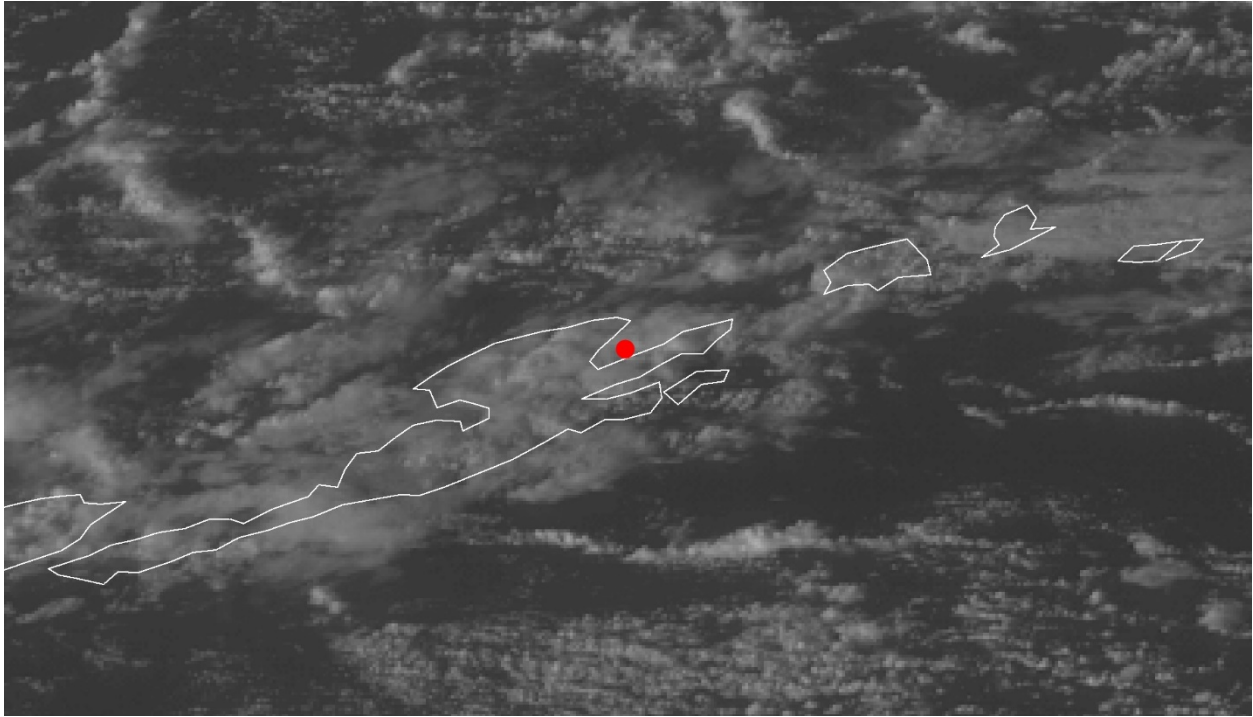
Geostationary Operational Environmental Satellite (GOES)-17 visible (0.64 $\mu$ m) data were obtained from an archive at the Space Science Engineering Center at the University of Wisconsin-Madison. An image from 1740 AKDT is presented in figure 6. The satellite imagery identified cloudy conditions across the accident region.

**Figure 6** – GOES-17 visible imagery from 1740 AKDT. Accident location denoted by red dot. This image has not been corrected for any parallax error.
