# National Transportation Safety Board

RRD23FR017

## **INVESTIGATION FACTUAL REPORT**

Group Chair's Factual Report

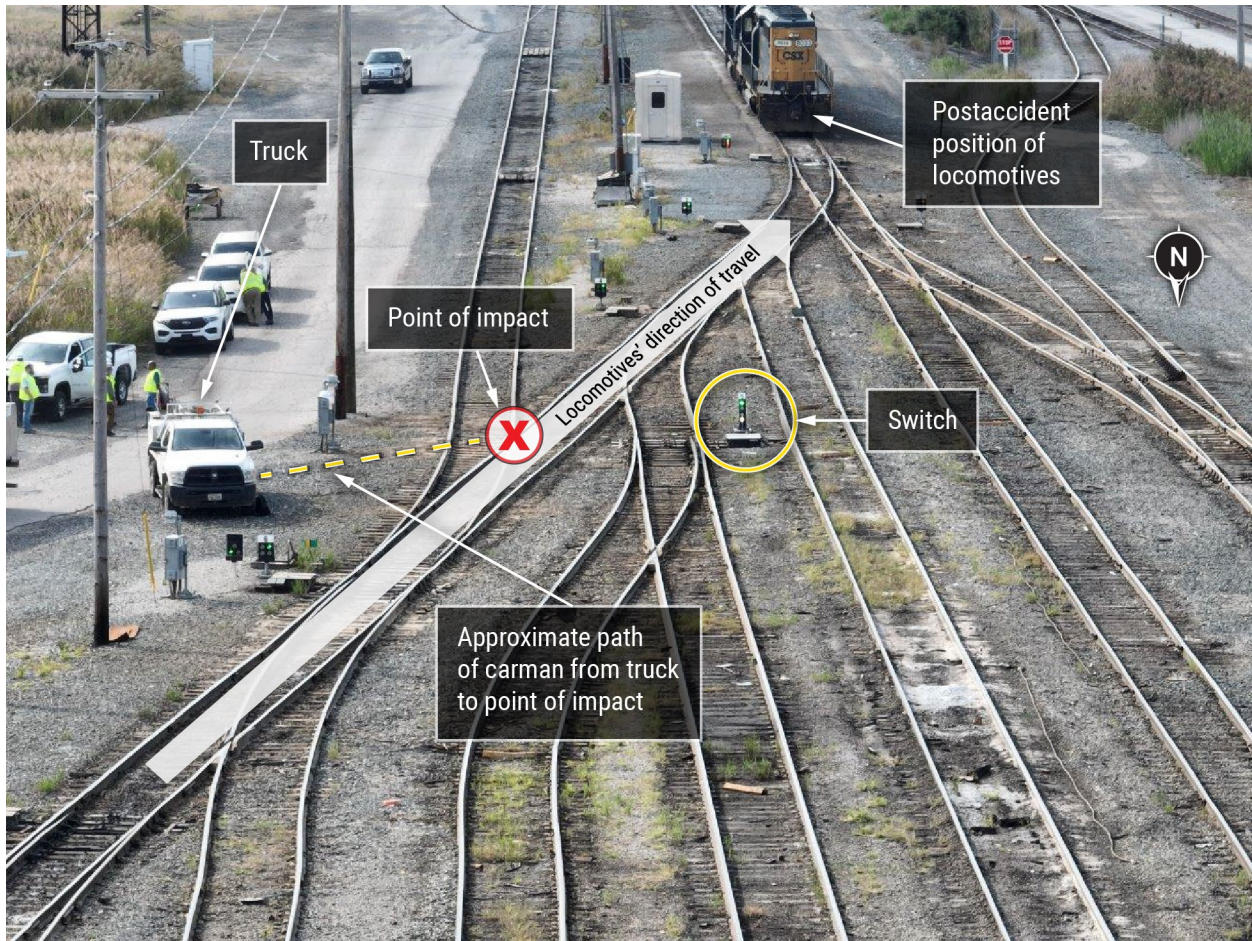
Figure 1- View of the accident location (Drone footage provided by CSX)

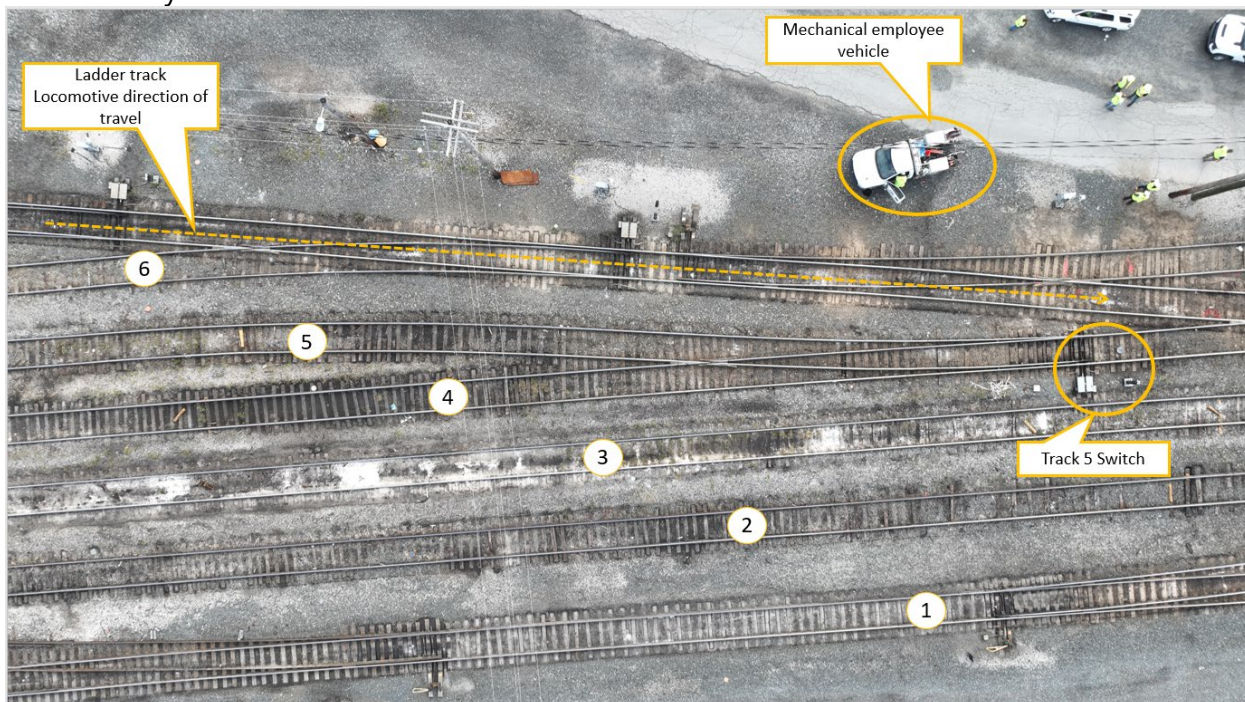
Figure 2 - Overhead view with track labels (Drone image provided by CSX)

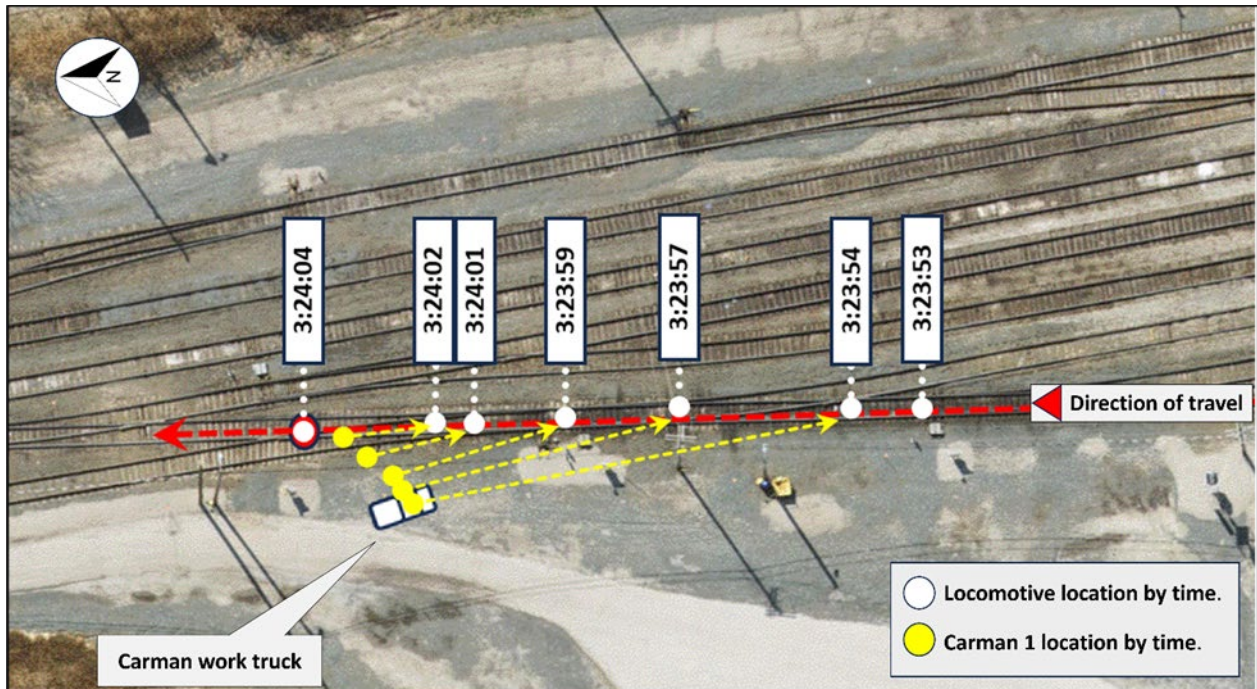
At 3:24:02, carman 1 is seen walking across within the gauge of the "ladder" track looking straight ahead and did not look at the locomotives approaching from the right.

At 3:24:04 the security camera records CSXT 2032 striking carman 1 in the vicinity of the "ladder" track and the "new track lead". Carman 2 is seen walking timetable west and around the front of the work truck. He then proceeds across the ladder track in the vicinity of track 6 after the locomotives pass his location.

Figure 3 - Time detail of the fatal accident.
