**FACTUAL REPORT OF INVESTIGATION ATTACHMENT**

**Burbank Inspection Photographs**

**West Hollywood, CA**

**HWY18FH014**

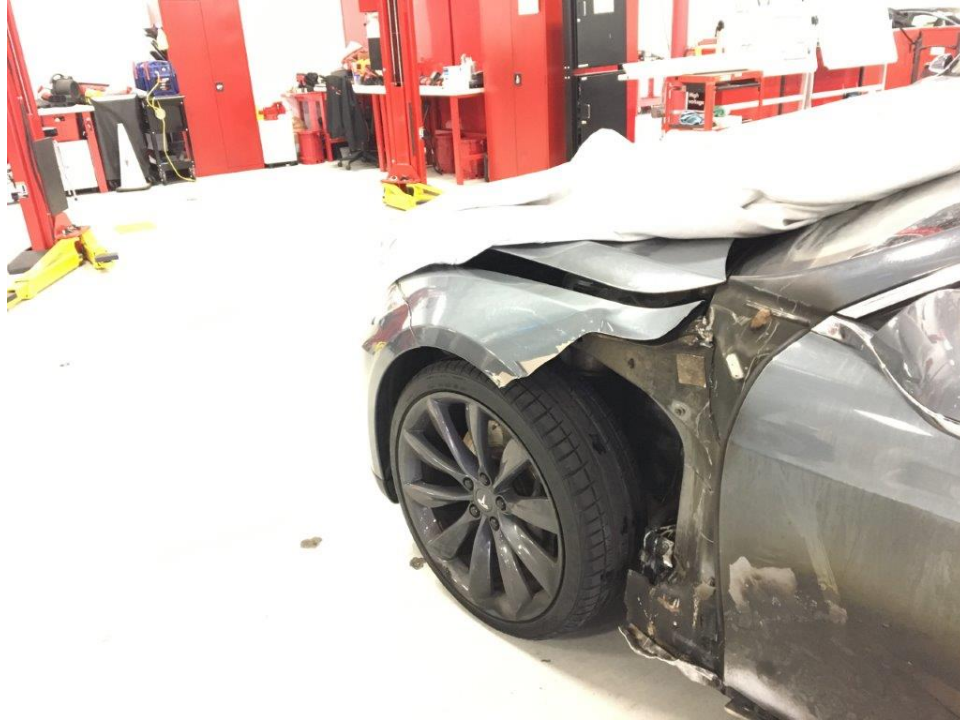
**Burbank Inspection Photo 5: view showing detail of the cut away left front fender panel and exposed area of the wheel well**

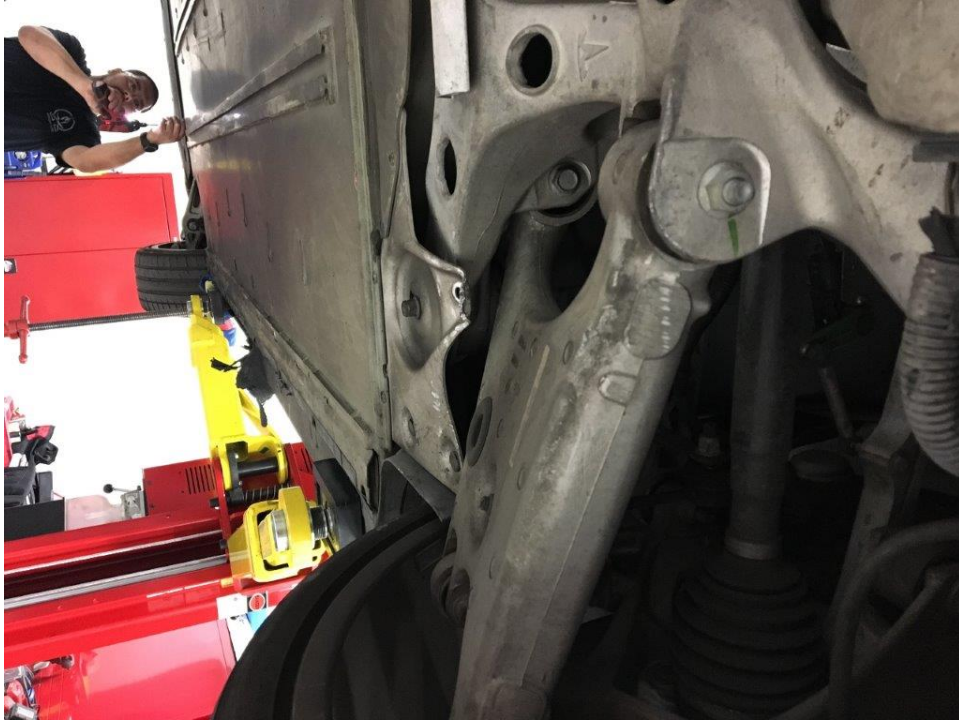
**Burbank Inspection Photo 13: damage to left front underside**

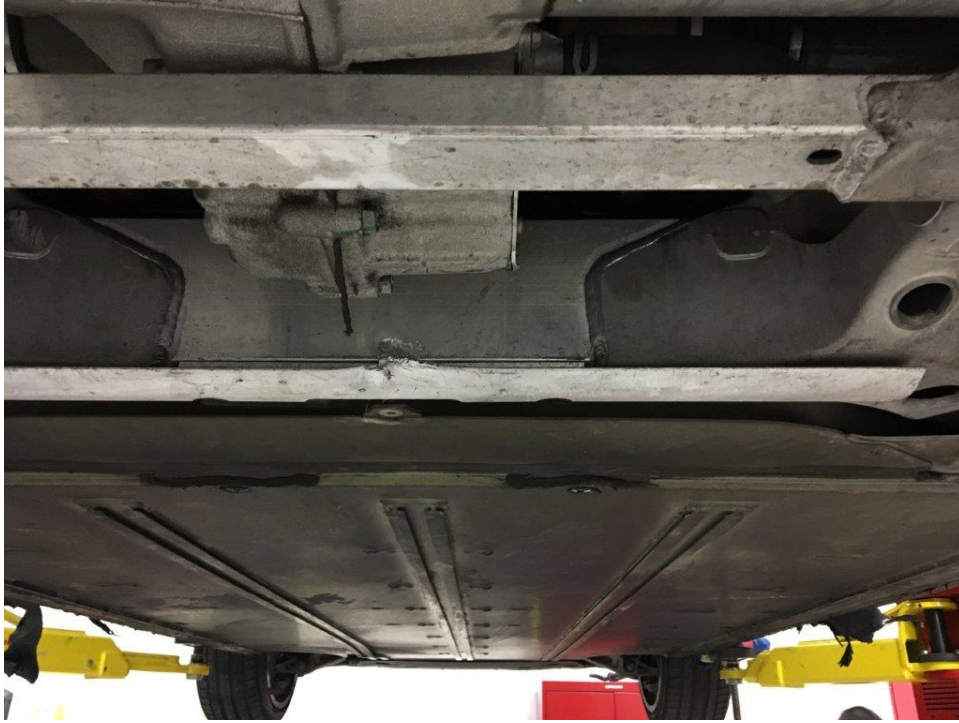
**Burbank Inspection Photo 17: damage to rear motor and deflector overall**

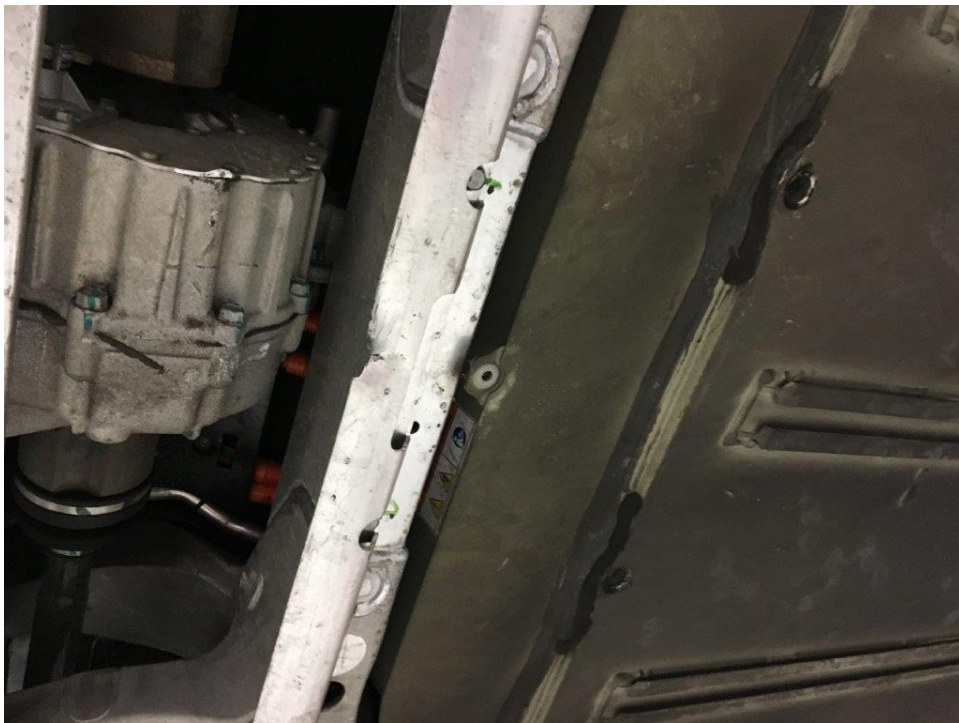
**Burbank Inspection Photo 18: damage to rear motor and deflector**

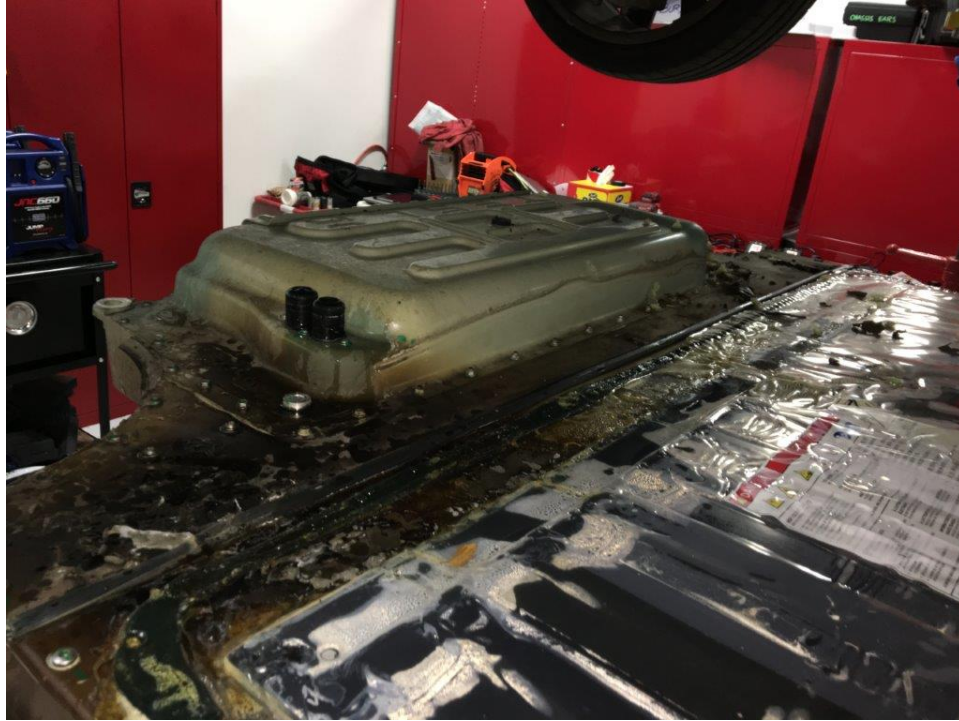
**Burbank Inspection Photo 25: left front pack as dropped from vehicle**

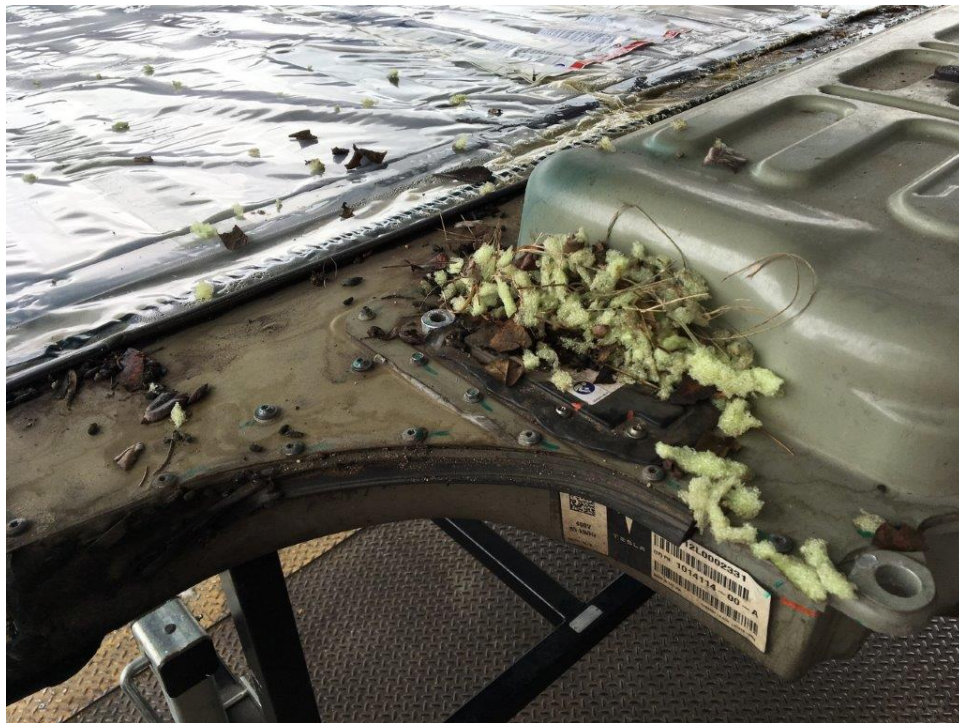
**Burbank Inspection Photo 26: top left front battery pack as removed, showing rodent nest**

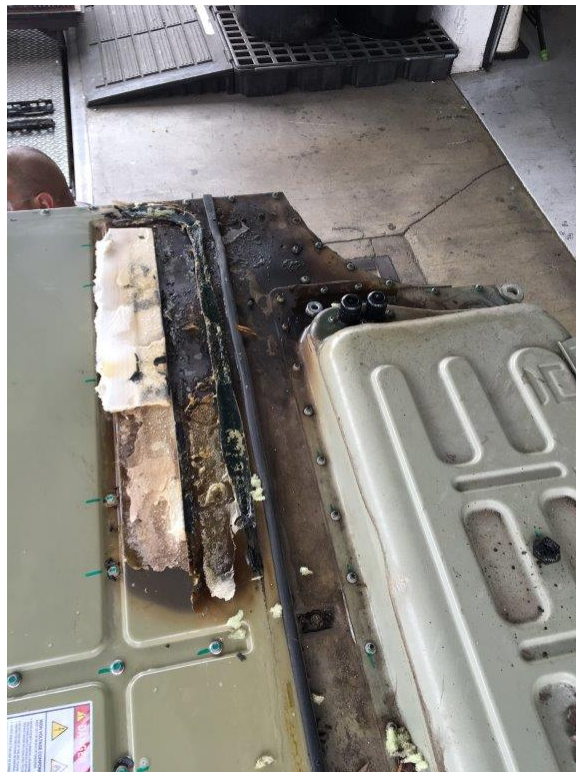
**Burbank Inspection Photo 34: left front battery pack, showing thermal damage**

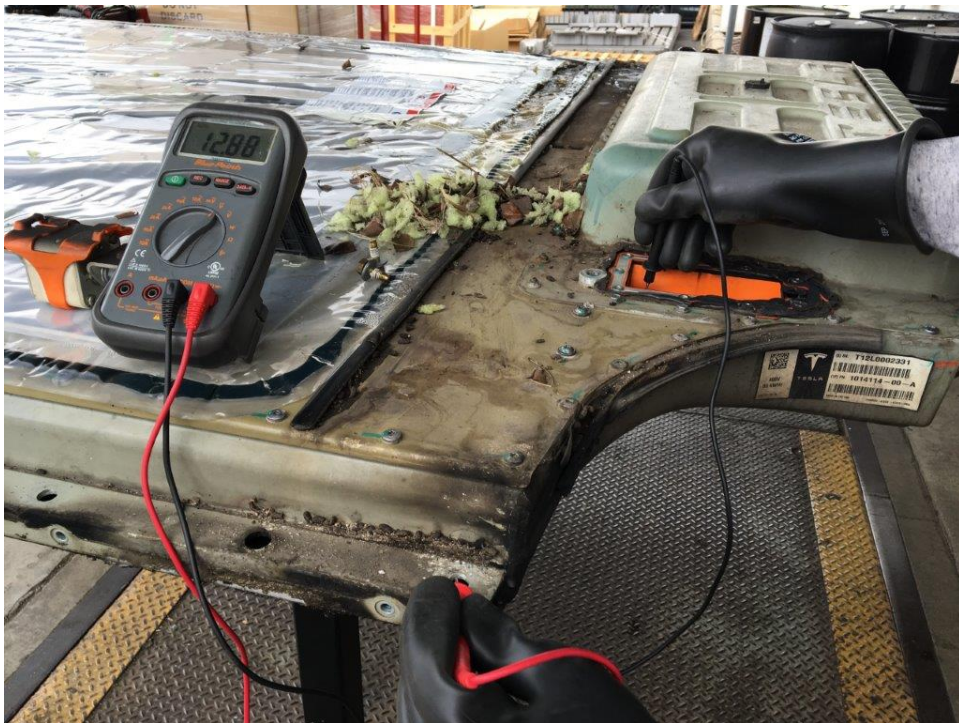
**Burbank Inspection Photo 36: view showing voltage test to aft terminal of battery case**

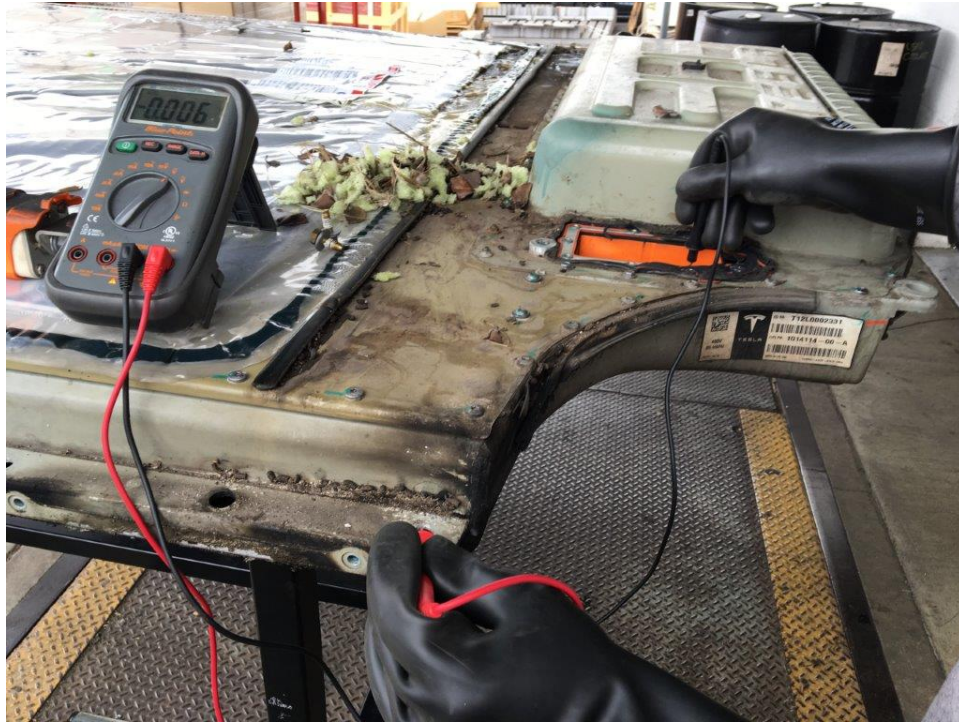
**Burbank Inspection Photo 37: view showing voltage test to forward terminal of battery case**
