## **National Transportation Safety Board**

## **Investigator-in-Charge's Accident Summary**

NTSB Accident #PLD23LR002 Natural Gas-Fueled Explosion and Fire March 24, 2023, West Reading, Pennsylvania

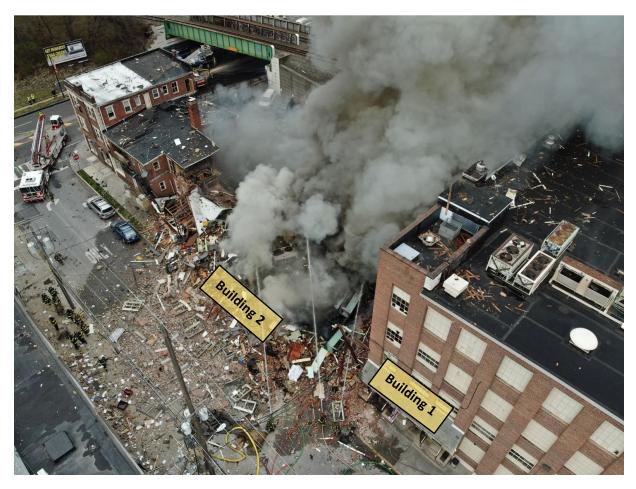
Figure 1. Post-accident aerial photo of accident site with Buildings 1 and 2 identified. Photograph taken on March 24, 2023. (Courtesy of the Western Berks Fire Department) [508 text: Photo displays aerial view of accident site following the explosion, including buildings 1 and 2.]
