# National Transportation Safety Board

HWY23MH004

## **TECHNICAL RECONSTRUCTION**

Group Chair's Factual Report

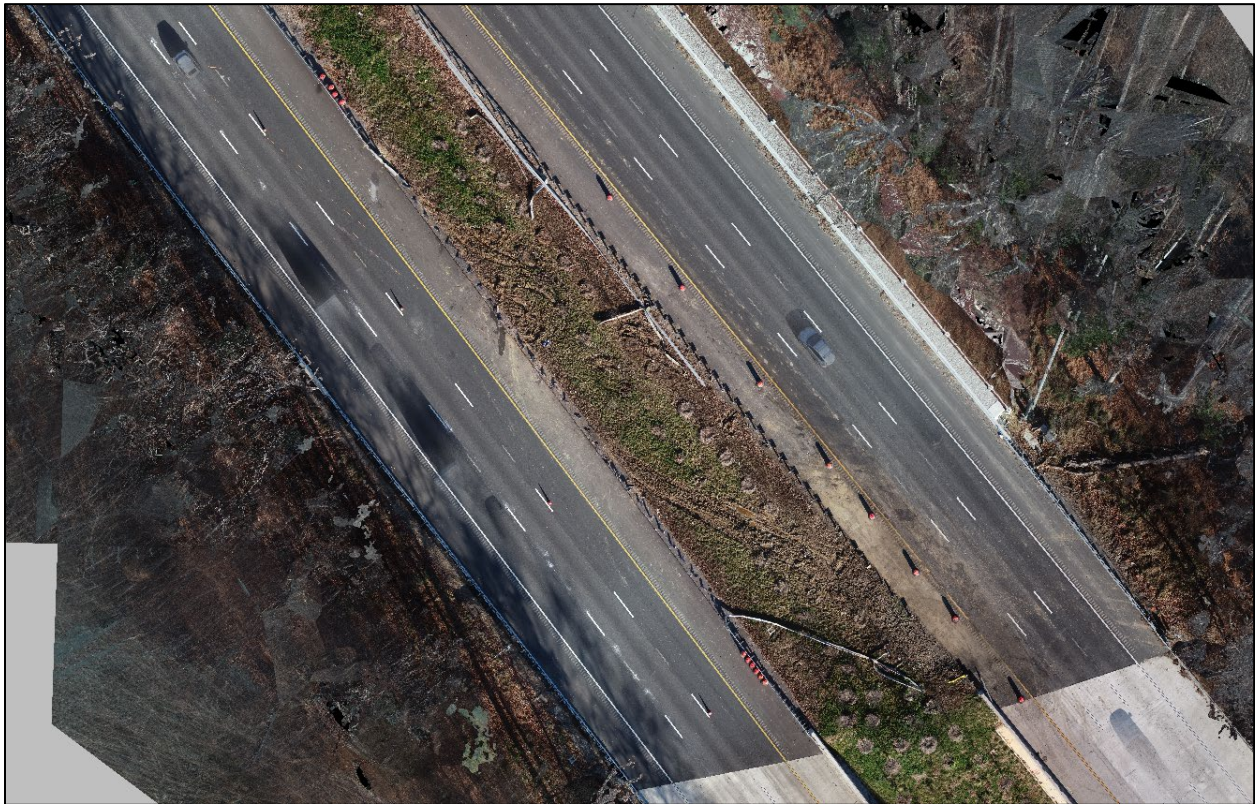
When examined by NTSB investigators, the roadway pavement surface in the collision area exhibited light scrapes and scratches superimposed with intermittent darker scuff marks consistent with tire friction marks. These surface marks were discernible beginning in the center travel lane and angled eastward toward the left shoulder. Painted reference marks applied by VSP investigators highlighted the path of the surface marks. The surface marks continued across the travel lanes and left shoulder where they terminated and transitioned to surface furrows in the median.

**Figure 3:** Screen capture depicting a portion of the photogrammetry project orthomosaic image capturing road surface and median evidence as well as the displaced eastbound shoulder guardrail.

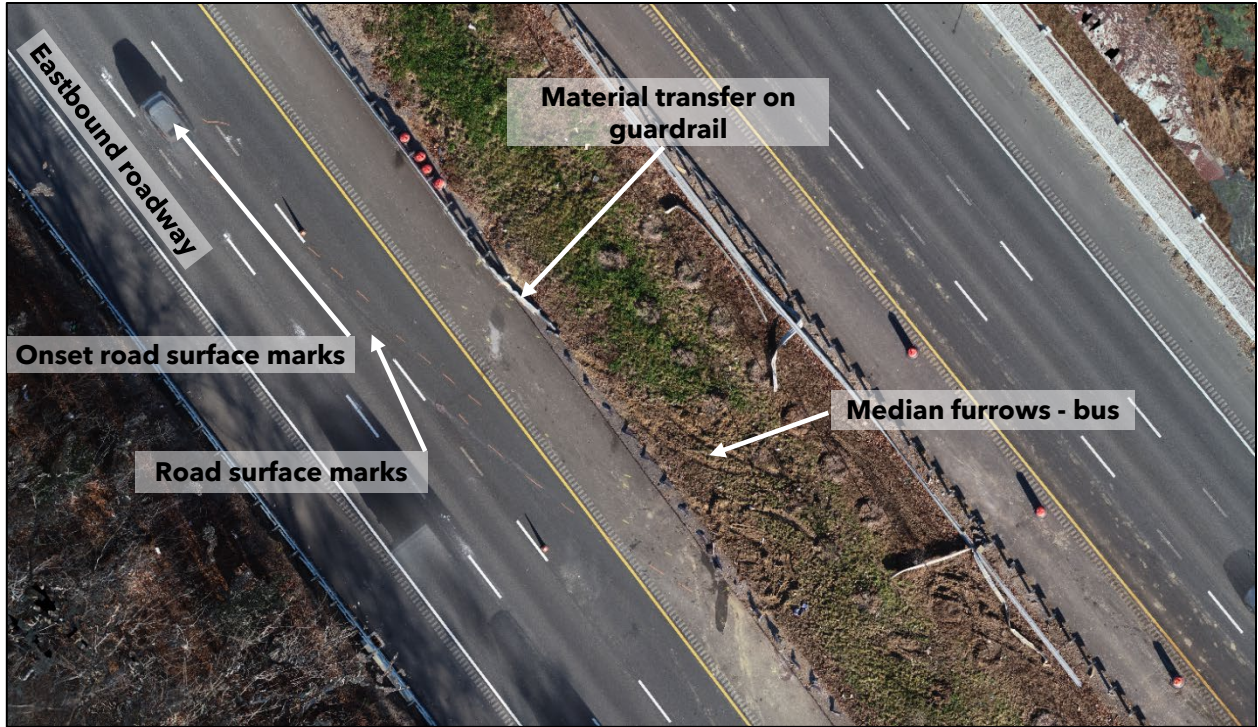
The approximate area of initial impact between the two vehicles was identified as having been in the right travel lane about 381 feet west of the Lakeshore Drive/Colonial National Historic Parkway overpass based on an analysis of the forward-facing video acquired from the Freightliner (see NTSB *Video Study* for methodology). Consequently, the initial area of impact was identified as being about 70 feet further west of the discernible roadway marks.

The pavement marks diverged along two paths as they crossed into the left travel lane. The trajectory of one path, consistent with that of the Eldorado bus, ended at an area of guardrail deformation consistent with an impact. Within this deformation was evidence of black colored material transfer. About 14 feet east of this impact area the guardrail was displaced (separated), and soil furrows appeared in the median beginning at the pavement edge. Following the trajectory of these surface marks, the guardrail impact occurred about 144 feet from the area of initial impact. The visible road surface marks indicate an angular heading of 30-35° relative to the guardrail.

The second path of roadway surface marks continued further eastward until they crossed onto the left shoulder and transitioned to surface furrows in the median about 268 feet from the initial area of impact. The heading of the marks relative to the guardrail was about 18-21°. These marks and the subsequent furrows through the median were consistent with the path of travel for the Freightliner combination.

**Figure 4:** Screen capture depicting a cropped portion of the photogrammetry project orthomosaic image highlighting initial road surface and median evidence at the crash location.

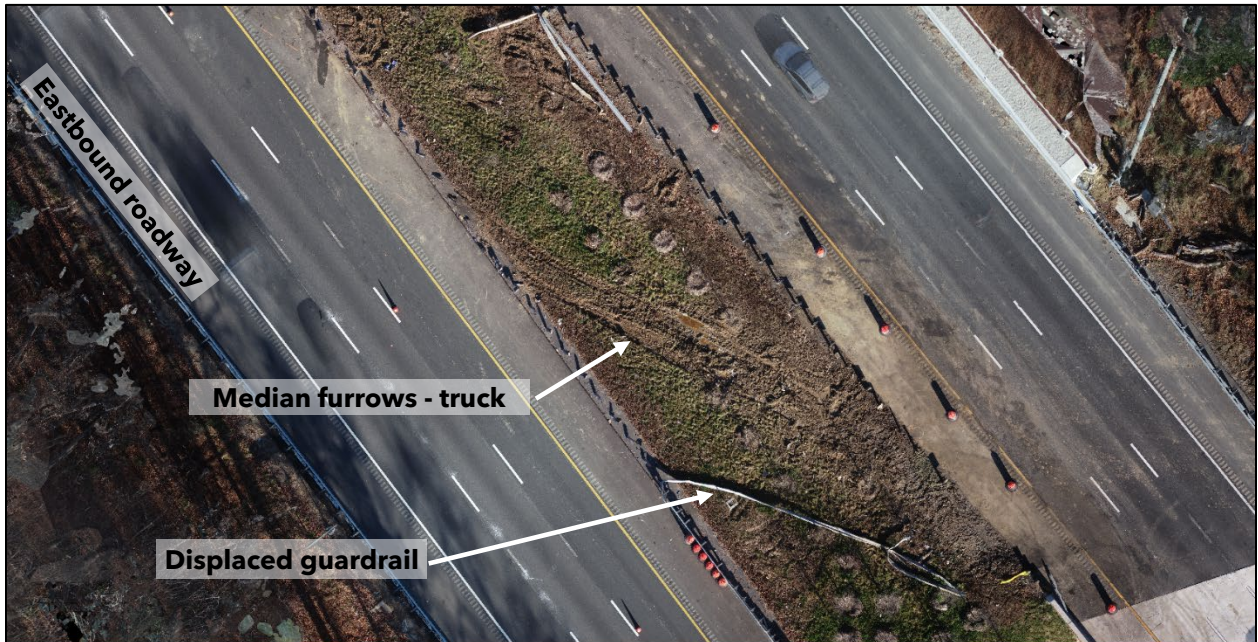
Approximately 190 feet of the median guardrail was fully displaced from the vertical support posts beginning about 51 feet west of its anchorage point with the concrete overpass rail. Scene photographs provided by VSP investigators depict a continuous segment of guardrail draped across the forward cab and engine compartment of the Freightliner truck tractor and trailing back across the median. The guardrail remained connected at the eastern end. Several vertical support posts were bent toward the median in a manner consistent with having been overrun by the Freightliner combination.

The median surface exhibited soil furrows consistent with both vehicles having departed the pavement and entered the median after the guardrail had been displaced. The western most area of furrows were consistent with the Eldorado bus having rotated as it entered the median and were consistent with VSP scene photographs. The Freightliner combination continued along an angled trajectory (averaging about 27° relative to the roadway) across the median over a distance of about 140 feet before coming to rest against the backside of the westbound roadway median guardrail (just west of the westbound roadway bridge rail).

**Figure 5:** Screen capture depicting a cropped portion of the photogrammetry project orthomosaic image highlighting median evidence and displaced guardrail further east at the crash location.

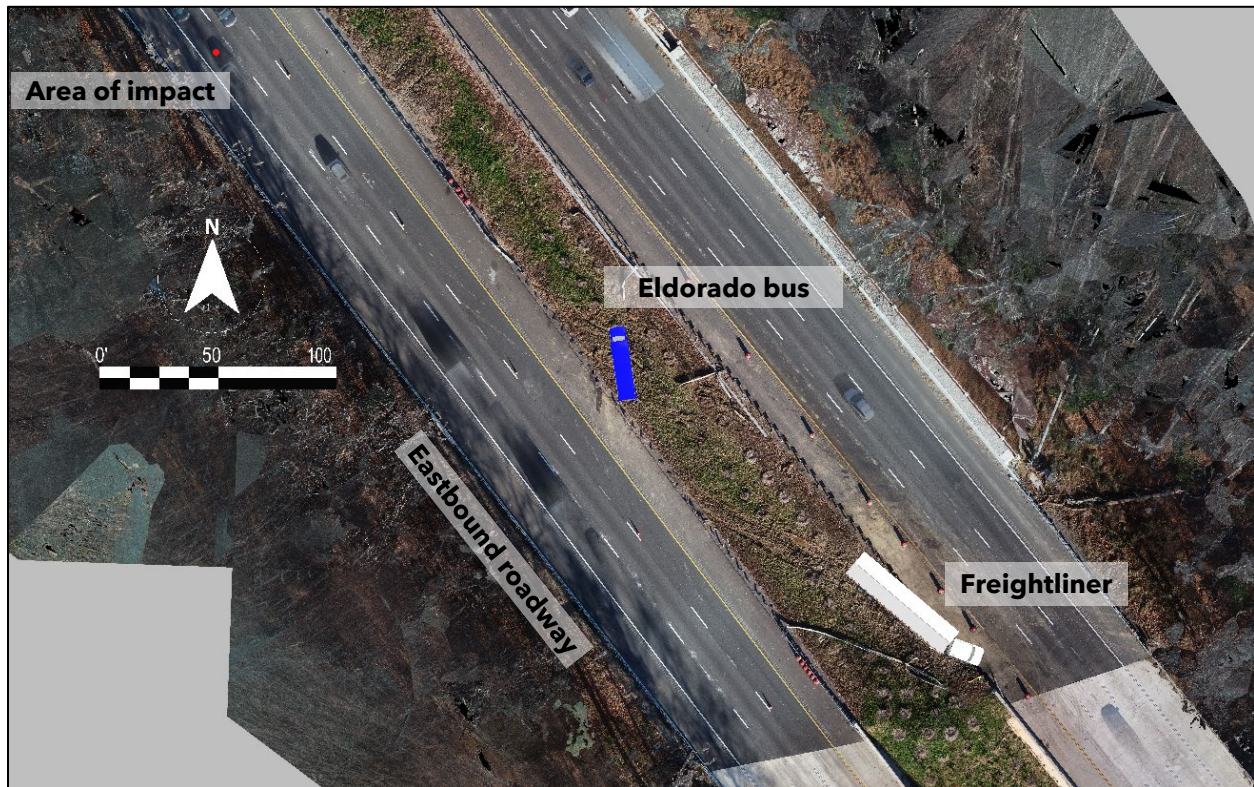
As identified through median surface furrow evidence and VSP scene photographs, both vehicles came to final rest in the median. As measured to its approximate CG, the Eldorado bus came to rest about 217 feet southeastward from the initial area of impact and about 72 feet from the guardrail contact evidence. At final rest, the bus exhibited a heading of about 150° relative to its original heading on the roadway.

As measured to the front of the truck tractor, the Freightliner combination came to rest about 413 feet southeast of the initial area of impact. The vehicle had departed the roadway pavement and entered the median about 129 feet before coming to a stop. At final rest, the combination vehicle was essentially parallel to the highway with the truck tractor angled such that the left front wheel occupied the westbound roadway left shoulder. The trailer remained off the pavement but had rolled partially toward the left (driver's) side. The front of the truck was entangled with both shoulder guardrails from the east- and westbound roadways. Although partially displaced from several vertical support posts, the westbound roadway shoulder guardrail remained anchored and exhibited evidence of having restrained the truck from additional forward travel. **Figure 6** is a screen capture of the orthomosaic map depicting the positions of rest for both vehicles.

**Figure 6:** Screen capture depicting a cropped portion of the photogrammetry project orthomosaic image highlighting the vehicle positions of rest.

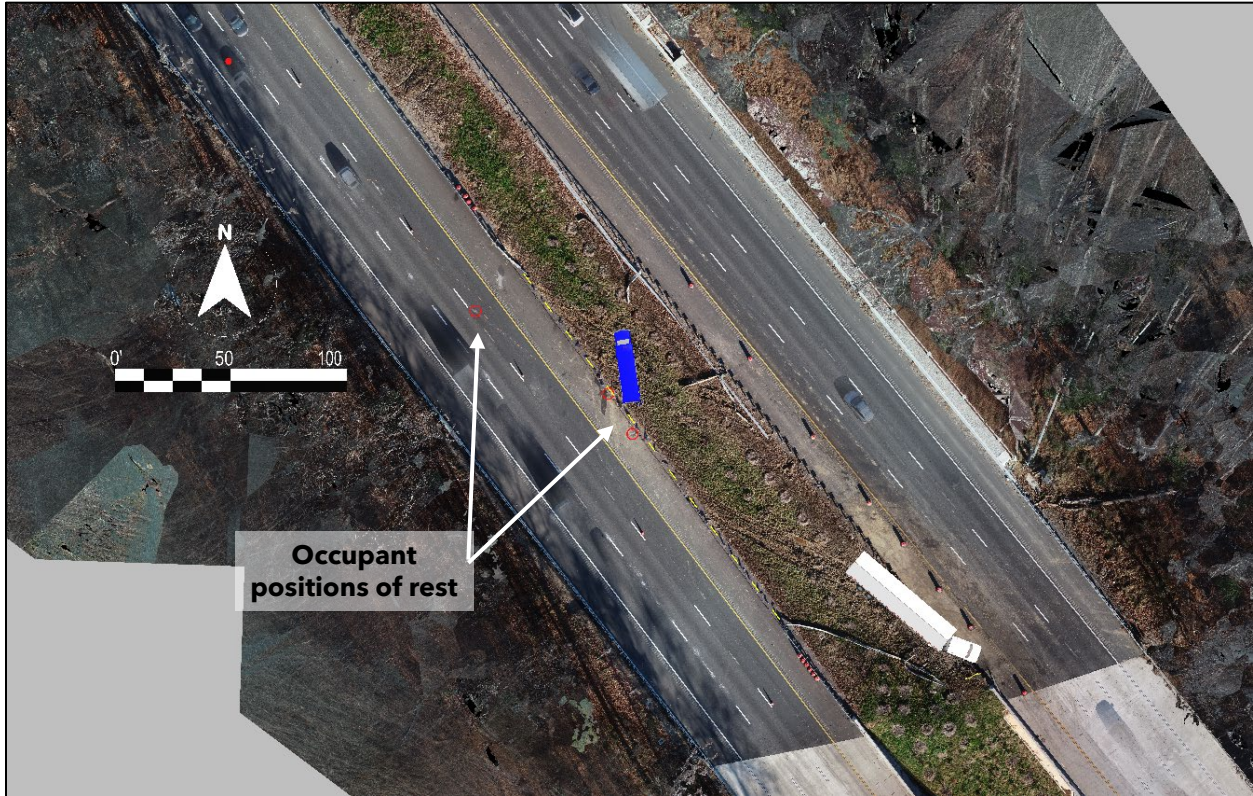
During the collision event, the three fatally injured occupants of the Eldorado bus were ejected and came to rest on the surface of the eastbound roadway. Those locations were identified by roadway evidence and are depicted by red circles in **Figure 7**.

**Figure 7:** Screen capture depicting a cropped portion of the photogrammetry project ortho image highlighting the vehicle and ejected occupant positions of rest.

Evidence for the western-most occupant was located in the left travel lane about 25 feet from the pavement edge and eight feet southward from the guardrail impact evidence. The second and third occupants were located on the left shoulder near the pavement edge about 71 and 91 feet southeastward from the guardrail impact evidence.

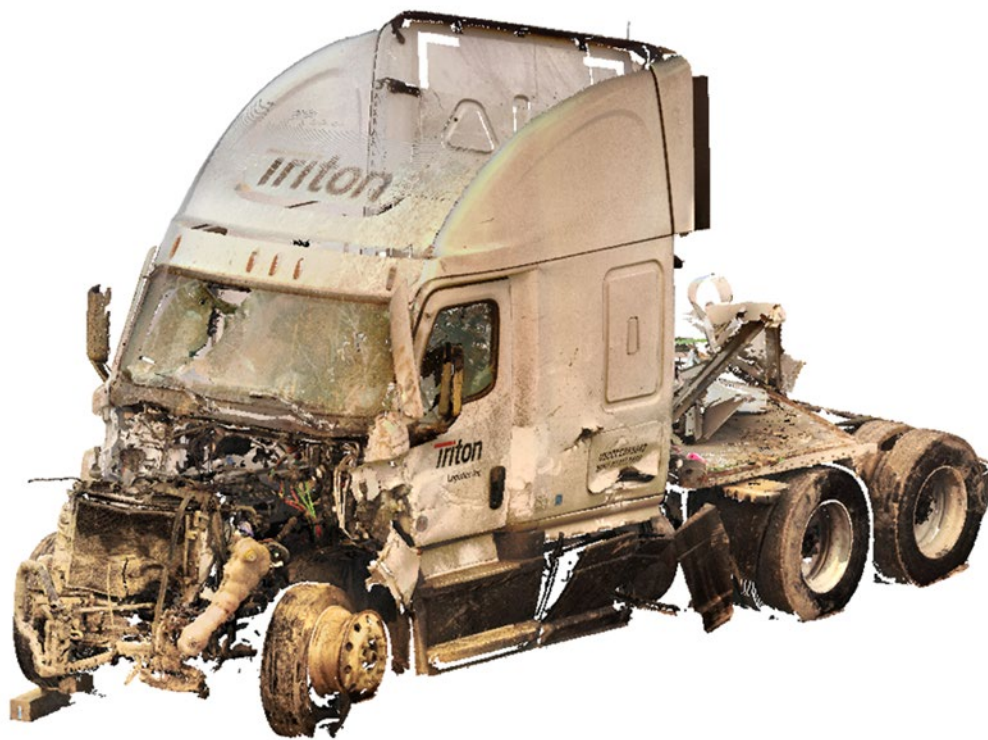
The truck tractor exhibited evidence of contact damage along both sides of the cab consistent with fixed object impacts and at the front consistent with a vehicular impact. Frontal impact damage exhibited more substantial component displacement at the left (driver's) side, consistent with an offset impact. Post-collision scene

photographs depicted considerable interaction between the vehicle and left shoulder guardrails for both the east- and westbound roadways. Black colored material transfer was also discernible along the driver's side A-pillar.

**Figure 8:** Screen capture depicting an oblique view of the Freightliner truck tractor 3D point cloud.

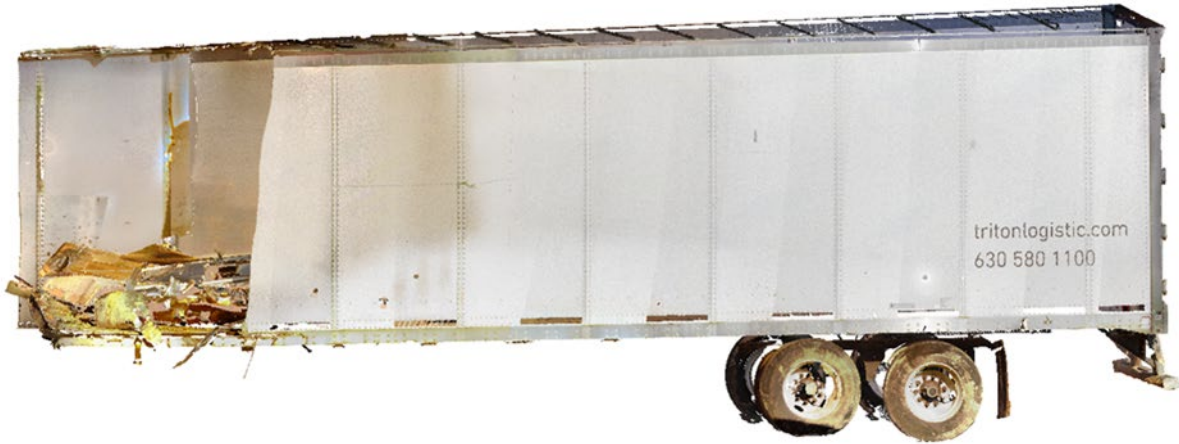
As observed at the storage facility, the van body semitrailer had separated at the trailing end of the king pin plate. The king pin plate and portions of the trailer lower sidewall frame remained coupled to the truck tractor. While the original length of the semitrailer was 53 feet, post-recovery the trailer measured no more than 36 feet in length. In addition, deposits of material consistent with biological material were observed on the left side of the semitrailer at the aft corner sidewall vertical support.

**Figure 9:** Screen capture depicting a left side view of the Great Dane semitrailer 3D point cloud.

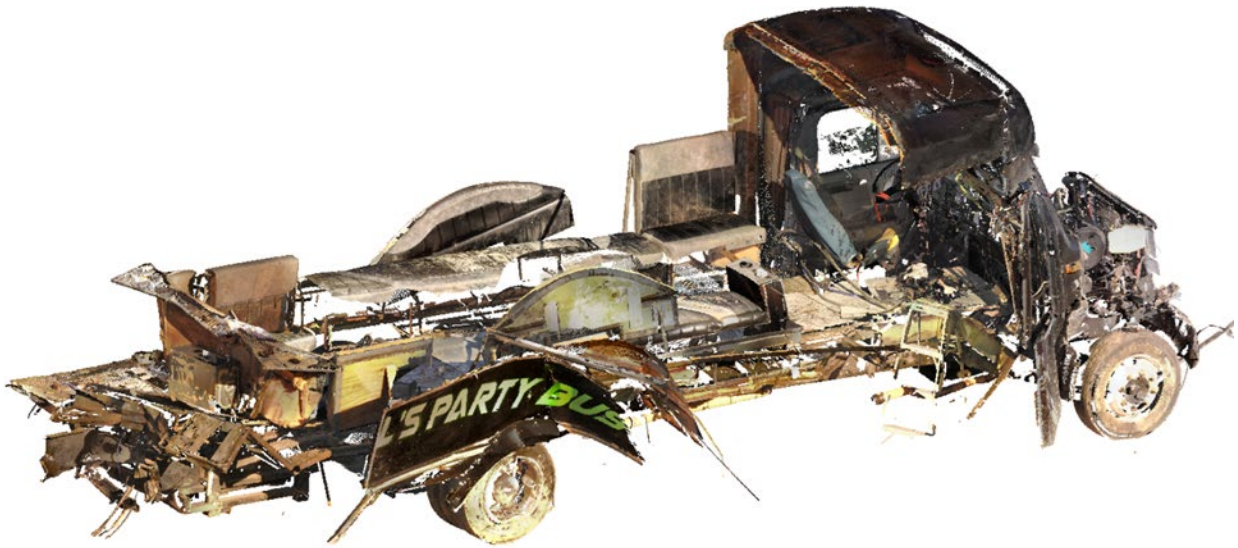
Prior to examination and 3D scanning, the bus chassis, an International 3400, had been cleared of most loose debris and the interior seating repositioned by NTSB investigators for inspection. The bus body (sidewalls and roof), identified as having been manufactured by Eldorado (formerly Eldorado National Co.), had separated completely from the chassis, and was essentially destroyed. The bus exhibited areas of contact damage at the front, consistent with a fixed object impact and at the rear consistent with a vehicular impact. Impact damage at the rear exhibited more substantial component displacement at the right (passenger's) side, consistent with an offset impact. A portion of the bus body rear vertical wall that included the rear identification lamps and right-side rear clearance lamp near the roof line exhibited evidence of vertical scrapes and paint scuffing.

**Figure 10:** Screen capture depicting an oblique view of the Eldorado bus 3D point cloud

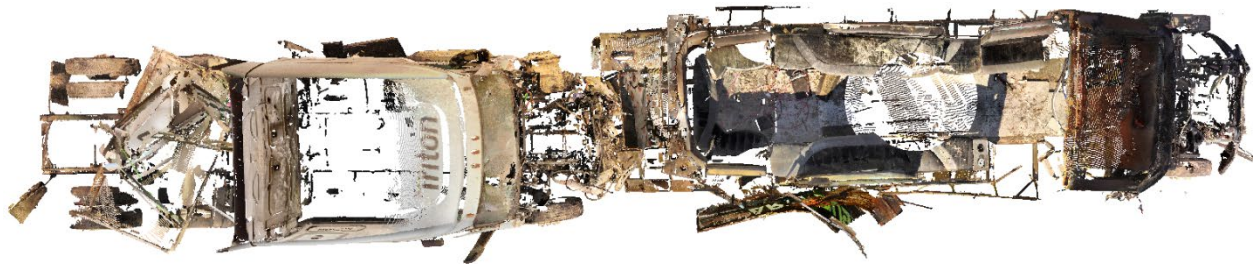
Alignment of the Freightliner and Eldorado bus point clouds corroborated an offset impact orientation as depicted in **Figure 11**.

**Figure 11:** Screen capture of the alignment of areas of contact for the Freightliner and Eldorado bus.

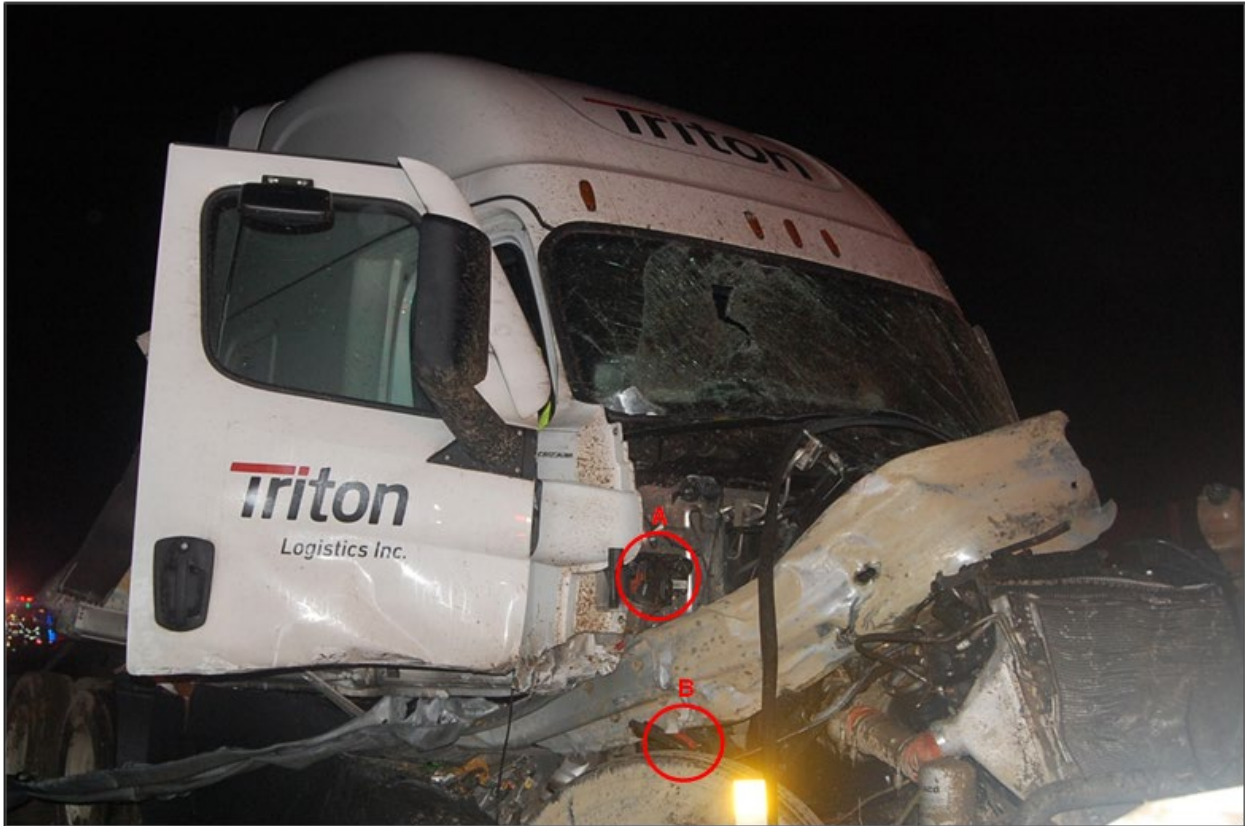
During examination of the truck, NTSB investigators observed a separation of the main battery cable that fed the Battery Cable Access (BCA) box (a power

distribution/fuse box) located on the passenger side firewall. The cable exhibited additional areas of damage - cuts and abrasions - to the sleeving and insulation. Although the cable was completely severed upon examination, the tow operator recalled observing electrical arcing in this area as recovery operations were commencing. Police scene photographs depict the guardrail that was carried by the Freightliner as having wrapped across the front of the tractor, displacing the hood, and overlaying the engine. Toward the passenger side of the tractor the guardrail made contact with the lower portion of the firewall and passed between the cab and upper surface of the fuel tank. The main battery cable and BCA are located in this area of the firewall and appear to have been compromised by the guard rail, likely leading to a power interruption that was interpreted by the engine ECM as a change in "ignition on" status thus triggering the LSR<sup>5</sup>. **Figure 12** depicts the Freightliner at its position of final rest with the guard rail wrapped across the engine.

<sup>5</sup> The firewall in the area of the damaged battery cable also exhibited deformation consistent with the edges of the guard rail.

**Figure 12:** Photograph provided by VSP investigators depicting the Freightliner truck tractor at its position of rest at the crash scene depicting the W-beam guard rail uprooted from the eastbound roadway draped across the engine compartment. Circle "A" indicates the position of the Battery Cable Access (BCA) box while circle "B" highlights a portion of the battery cable that ascends the firewall to the BCA.

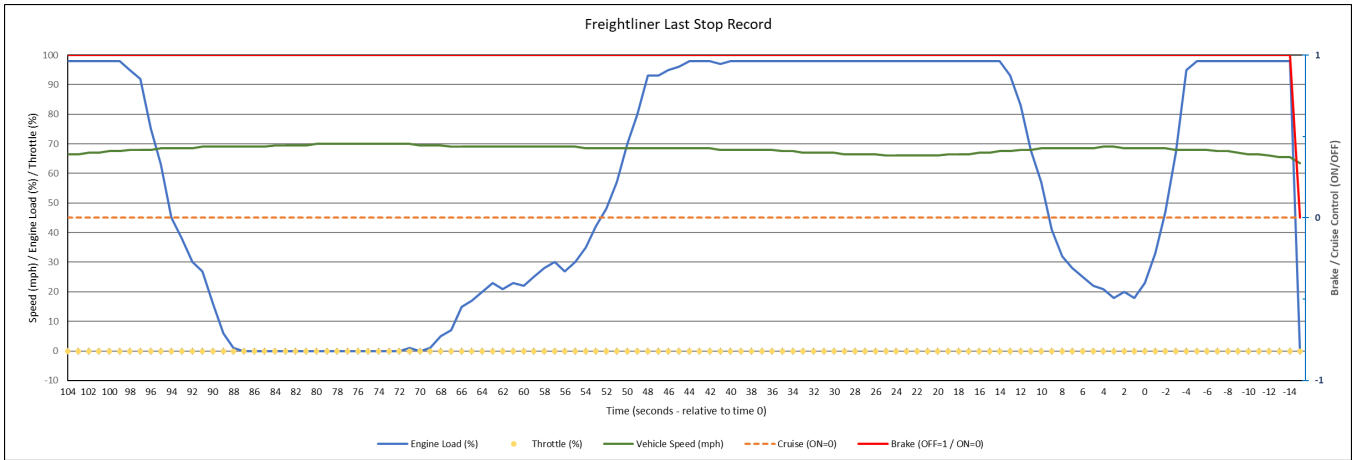
Data reported with the last stop event included vehicle speed (mph), engine speed (revolutions per minute-RPM), brake (signal lamp switch activation), clutch (pedal switch activation), percent engine load, percent throttle, cruise control ("on"/"off") and fault code (present "yes"/"no"), reported at one second intervals. Generally, what the recorded data indicated during the 120 seconds (2 minutes) was that the Freightliner was traveling at a relative constant speed, averaging about 68 miles per hour (ranging between 65 and 70 mph) with the cruise control active. Engine load, engine RPM and speed fluctuation appeared consistent with vertical changes in grade (e.g., engine load and RPM decrease while descending a grade as speed increases). Further corroborating cruise control activation was a constant zero percent throttle pedal application. Braking is not indicated until the final data sample, which when aligned with data acquired from the Samsara camera system appears at about or immediately following impact with the Eldorado bus. No DTCs were reported in the LSR.

**Figure 13** graphically depicts the DDEC Report data table - note that brake status was assigned an arbitrary value on the secondary vertical axis to be depicted as "on" or "off" ("off"=1, "on"=0); the cruise control status is similarly depicted on the secondary axis where "on" equals 0. An image of the data table is presented in an appendix to this report.

**Figure 13:** Graphical depiction of Freightliner *Last Stop Record* data.

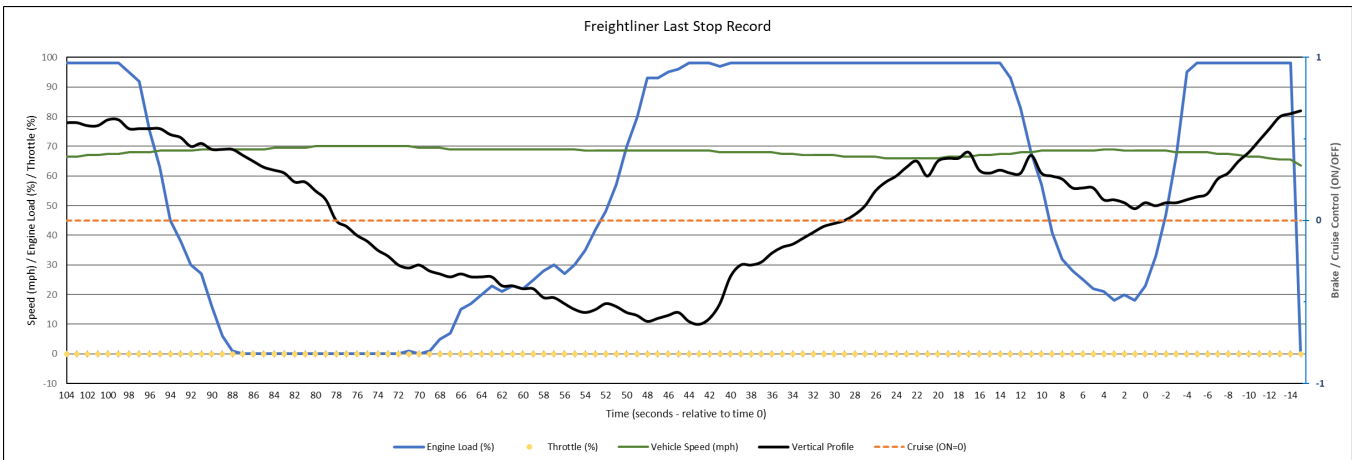
**Figure 14** depicts a similar graphical depiction of certain DDEC LSR data overlaid atop the highway vertical profile (solid black line) as depicted in plans provided by VDOT.

**Figure 14:** Graphical depiction of certain Freightliner *Last Stop Record* data overlaid atop the highway vertical profile (solid black line).
