National Transportation Safety Board

HWY23MH004

VEHICLE FACTORS GROUP

Group Chair's Factual Report

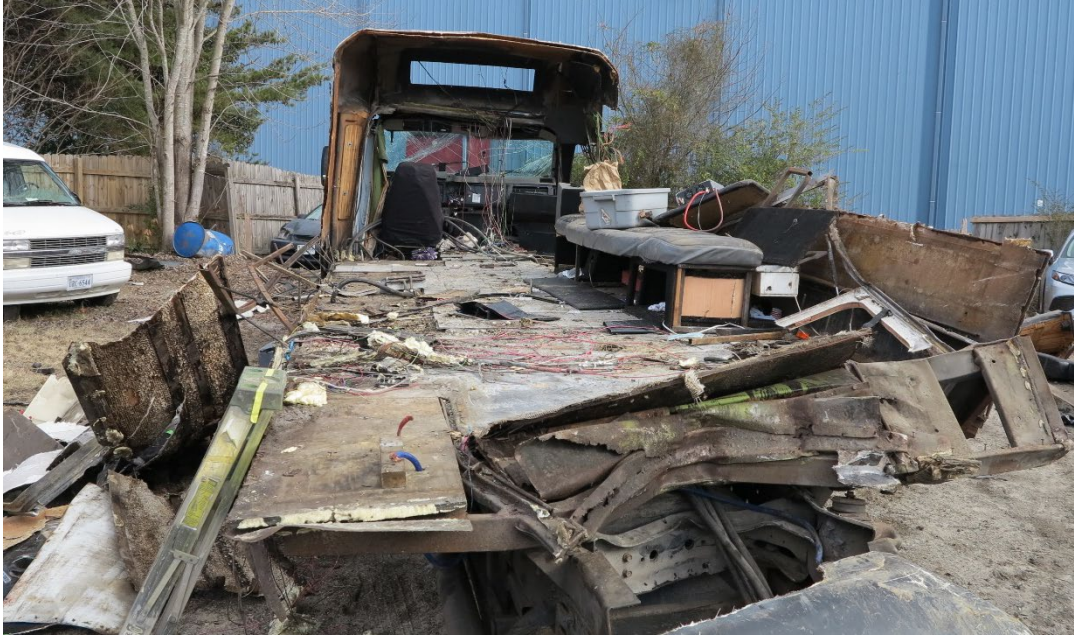
The frame rails, at the rear of the bus, were bent to the right. The rear of the right-side frame rail was crushed in a forward direction folding the end of the frame rail. The rearmost frame crossmember was displaced forward and broken.

The bus body, which started from the rear of the driver's seat, was no longer mounted to the vehicle chassis. The remnants of the bus body and vehicle contents were either strapped to the back of the chassis or found in the crash debris pile - **See Figure 1.**

Figure 1: Looking at the rear of the bus.

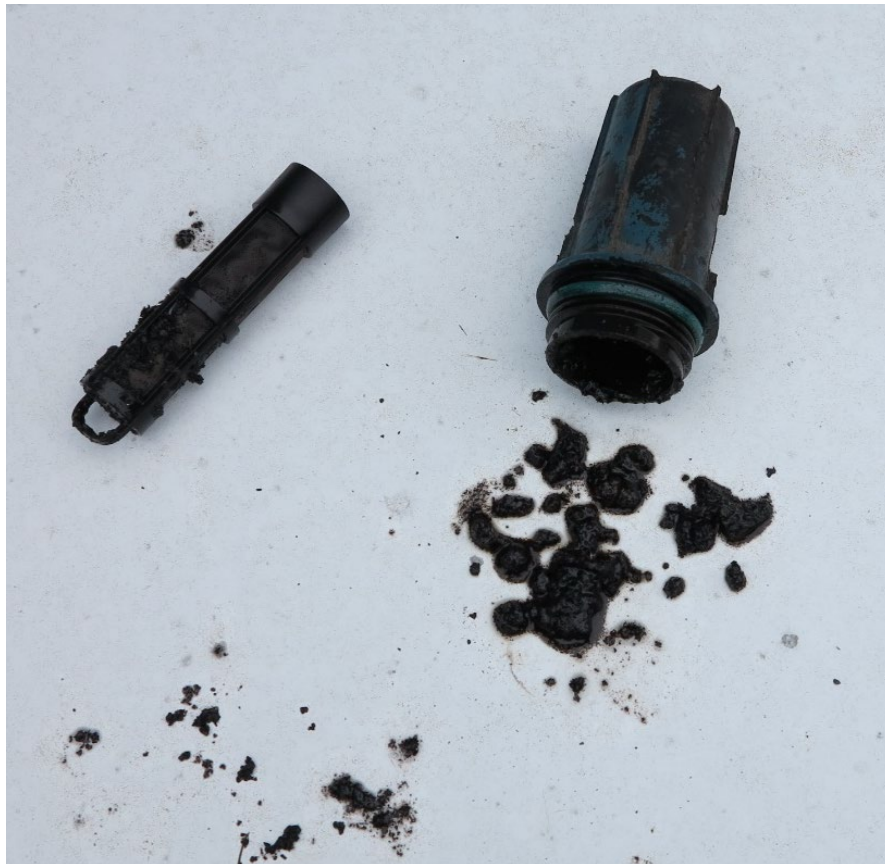
The engine was equipped with a paper element fuel filter assembly and a wire screen mesh pre-screen element assembly. The pre-screen element, between the fuel tank and the fuel pump was designed to filter out larger debris down to 25 microns coming from the fuel tank. The fuel filter assembly filtered the fuel coming directly from the pre-screen element and was mounted inside the fuel bowl and filtered the fuel for debris down to 14 microns before the fuel traveled to the fuel pump. The fuel filter assembly and fuel bowl were examined. The fuel filter, fuel bowl, and remaining fuel appeared clean and free of debris. The pre-screen element was examined, and it was found to be about 50% clogged with debris - **See Figure 2.**

Figure 2: Pre-Screen Element and Debris

A clogged fuel filter reduces the amount of fuel delivered to the fuel pump and can cause several issues such as difficulty starting, engine misfires, stalling, and reduced power. As a result, the engine may stall or shut off completely while driving, and it can be difficult for the engine to generate the power needed to operate properly, resulting in slower speeds and loss of towing and hill climbing power.

- Clean pre-strainer (pre-screen) filter every 10,000 miles, 350 hours, 1,000 gallons of fuel or 6 months; whichever occurs first.
- Change the fuel filter and pre-strainer (pre-screen) elements every 20,000 miles, 700 hours, 2,000 gallons of fuel or 12 months; whichever occurs first.⁶

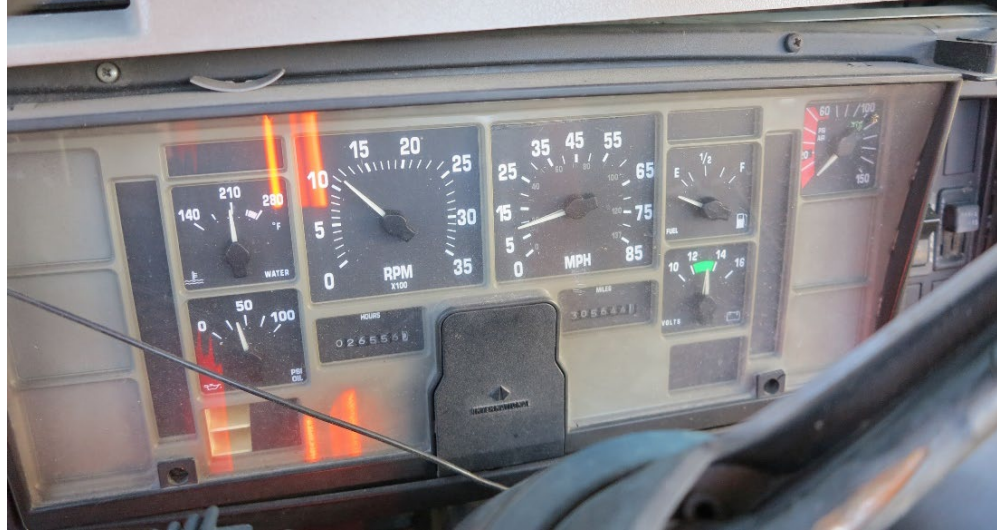
- Cruise control switch was in the on position.
- The windshield wiper switch was on the intermittent - 4th dash setting.
- The headlamp switch was in the on position and the panel lights were set to maximum illumination.
- The instrument cluster was intact with the following readings frozen on the analog gauges -**See Figure 3**
 - Tachometer: 1,200 rpms
 - Speedometer: 10 mph
 - Air Pressure: approximately 5 psi
 - Battery Voltage: between 12 and 14 volts
 - Vehicle Hours: 26, 556 hrs.
 - Oil Pressure: approximately 45 psi
 - Water Temperature: 210-degrees

Figure 3: Instrument Cluster of the Bus

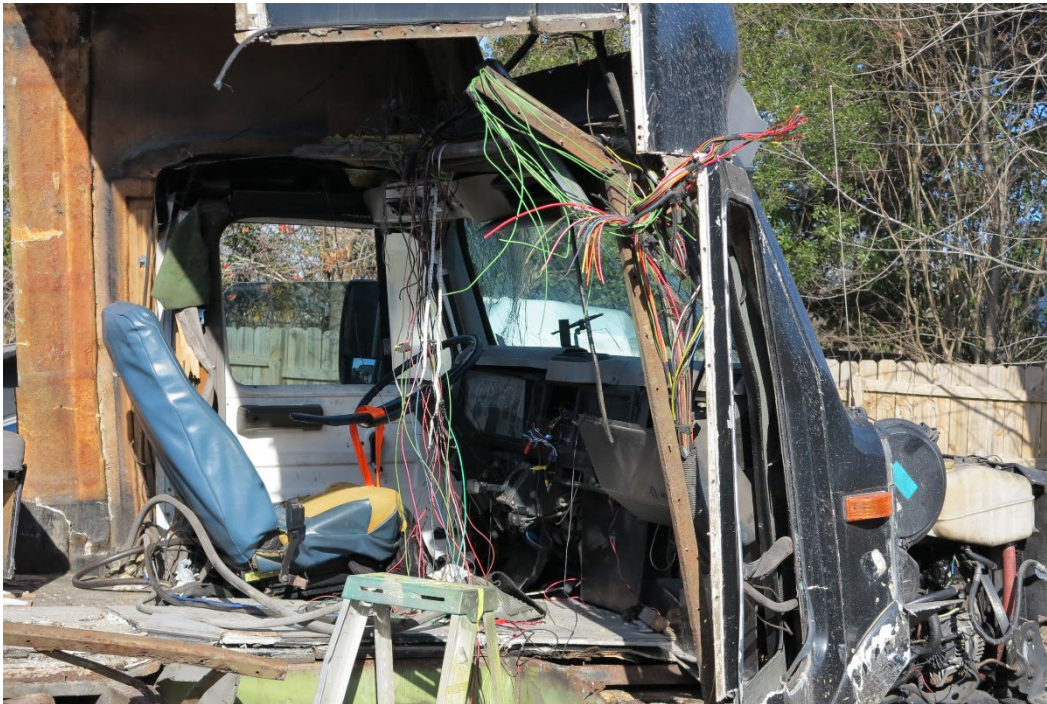
The positive and ground electrical cables had been disconnected from the batteries, which were located beneath the driver's door. The electrical system was compromised due to the crash. All the wiring from the rear of the driver's compartment was severed. A video of the crash event confirmed that all the rear-facing lights were functional at the time of impact - **See Figure 4.**

Figure 4: This is where the wiring for the rear of the bus was either severed or cut.

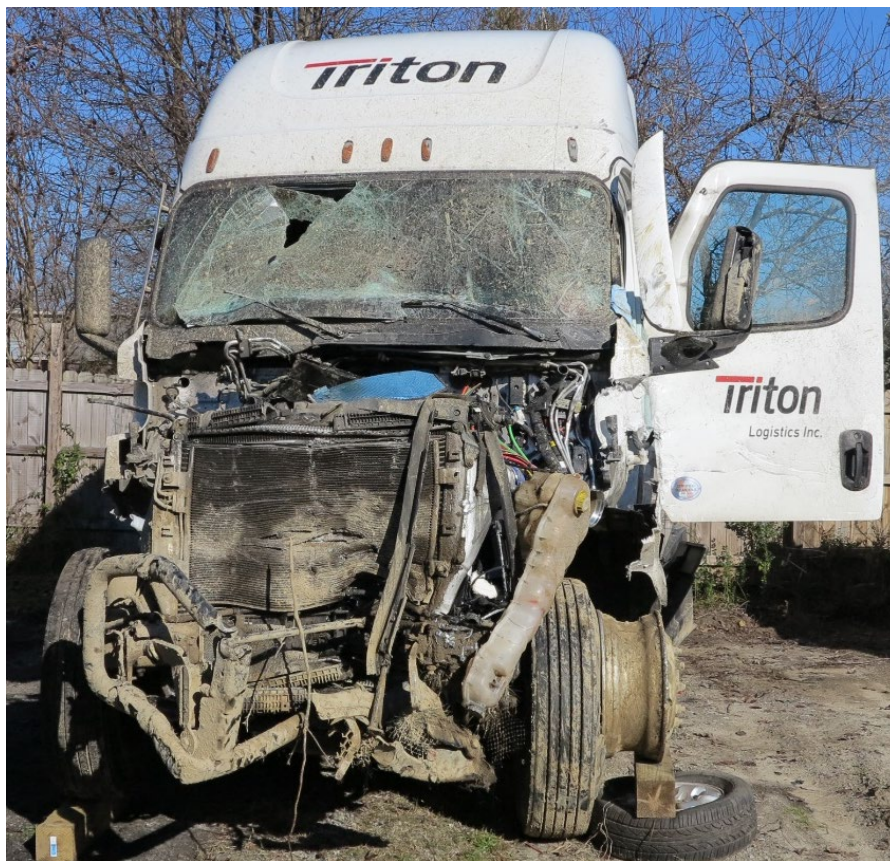
The hood and front bumper were missing. The bumper guard was bent and creased in multiple locations. The right-side bumper guard mounting bracket was displaced toward the left, and the left-side mounting bracket was displaced to the left and was in contact with the power steering gearbox. The full width of the windscreen was shattered. There was a large hole through the right side of the windscreen. Three of the five vehicle identification lights above the windscreen were broken. On the upper left side of the cab and on the left wind deflector there were black transfer marks. The left-side rear-view mirror was broken, and the driver's door had scratches and gouges forward of the door handle - **See Figure 5**. The exterior skin on the left side of the sleeper berth had been torn open, and there was a gouge that went from the bottom of the side storage compartment up into the storage compartment door bending the bottom of the door upward. The left fairing that attaches to the rear of the sleeper berth was missing. The right-side air suspension and shock absorber for the cab were broken away from their respective upper mounts.

Figure 5: The front of the truck-tractor

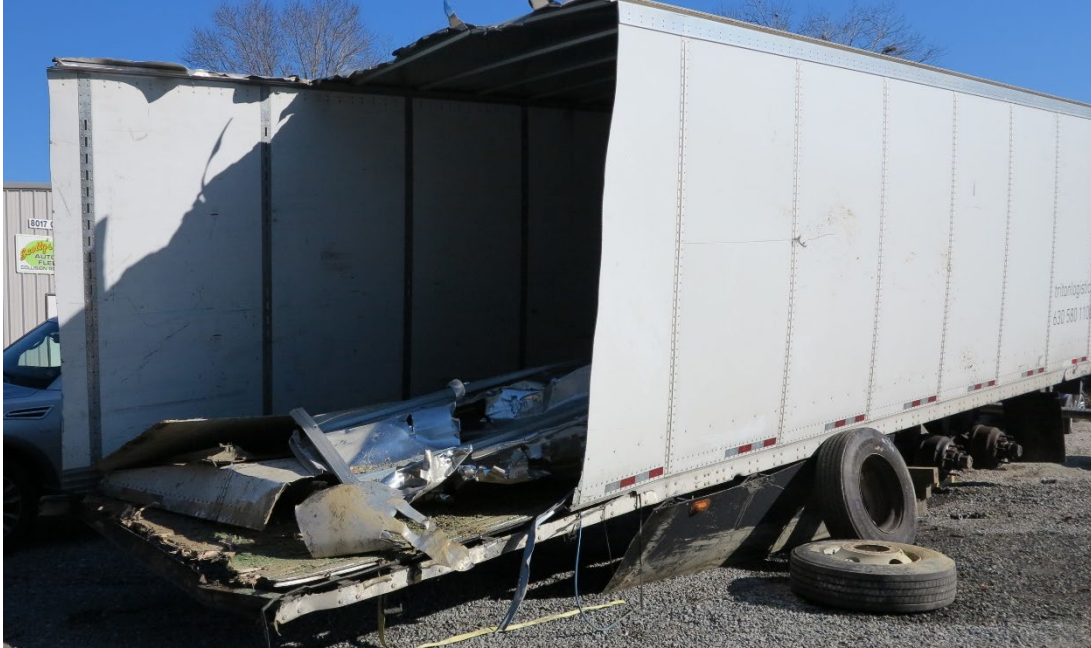
The front portion of the semitrailer was missing along with the king pin, upper fifth wheel plate, and the landing gear. The larger pieces of the semitrailer were located inside the remaining portion of the semitrailer - **See Figure 6.**

Figure 6: The left-front of the semitrailer
