National Transportation Safety Board

HWY23MH004

SURVIVAL FACTORS

Group Chair's Factual Report

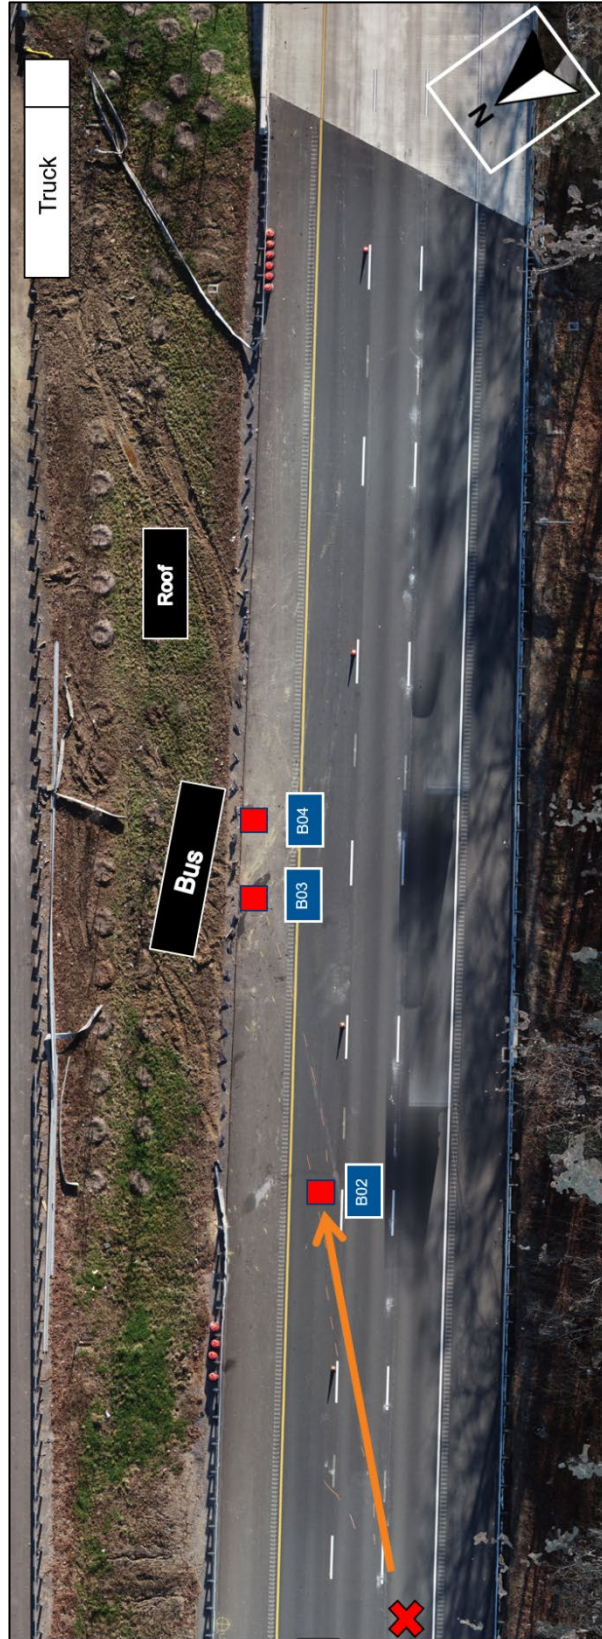
Figure 1: Collision Scene Overview

In Figure 1, the approximate impact location is marked with a red "x", the rest positions of the descendants are marked in red squares, and the final rest locations of the bus, the bus roof, and the Freightliner (herein referred to as truck-tractor) and semitrailer are marked and labeled in black and white, respectively.

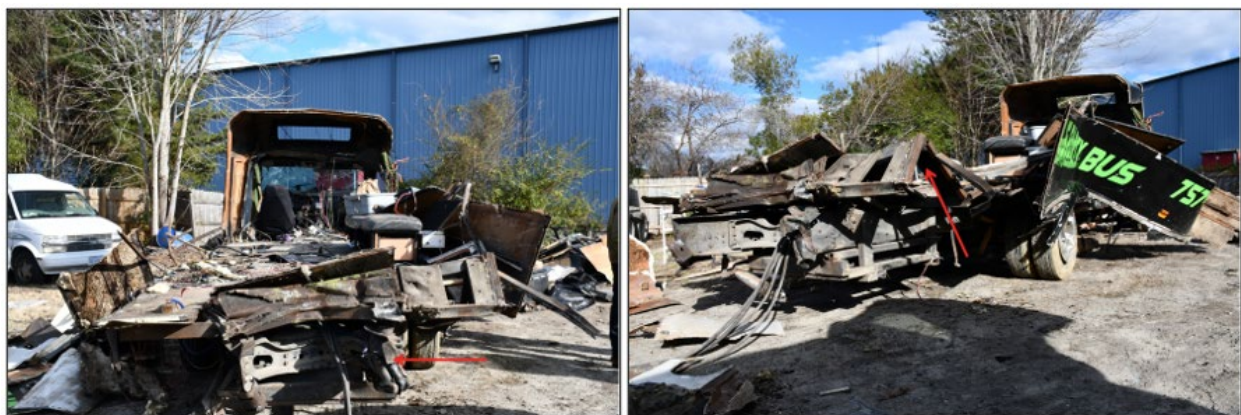
Figure 4: Bus - Damaged Right C-Channel & Buckled Floorboard

The post-collision condition of the bus can be observed in Figure 4. The roof and sidewalls of the bus separated from and became detached from the vehicle. The sidewall was a double-skin constructed sidewall. The exterior skin was made of galvanized steel that was less than 0.2 inches thick. The interior skin of the sidewall consisted of mainly fiberglass, and in some cases, interior paneling as well. The interior and exterior skins were separated by insulation. The exterior skin was attached to the interior skin as well as the waist rail and seating rail by rivets.

was observed on the rear of the bus, most notably, on the right frame C-channel, both upper and lower flange (Figure 4). The chassis frame was displaced to the right.

The rear-right floorboard area was contacted by the truck-tractor's front and buckled forward and upward, which compromised the rear of the bus body and the rearmost-right pillar. During the collision sequence, the rear structure and the roof of the bus separated from the rest of the vehicle, compromising the occupant compartment. After separation, a portion of the rear and the roof remained joined together, and came to a final rest, upside down in the grassy median of the crash scene, separated from the rest of the bus, as observed in Figure 5. In Figure 5, the red arrows denote the roof and the yellow arrows denote the rear structure that separated from the remainder of the bus.

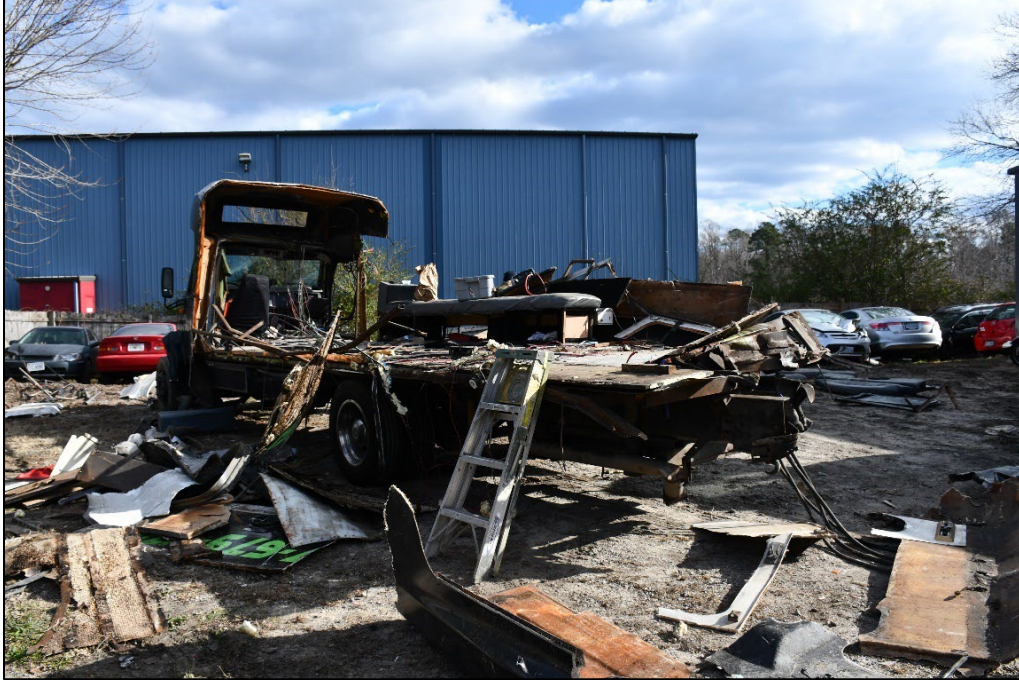
Figure 6: Bus - Damaged Observed from Rear-Left

The bus's roof separated from the rear of the bus (Figure 6). The structural integrity of the occupant compartment was compromised, the interior and exterior skins comprising the sidewall failed at many locations. Most of the sidewall components separated from the bus's various rails. The bus's stairwell, entrance door, and surrounding frame to the entrance door separated from the bus's cab, body, and compromised the vehicle's structural integrity. With the rear, roof, sidewalls, and other components separated from the bus, no portion of the occupant compartment structure or substructure remained to contain passengers in the compartment. All passengers were ejected from the bus.

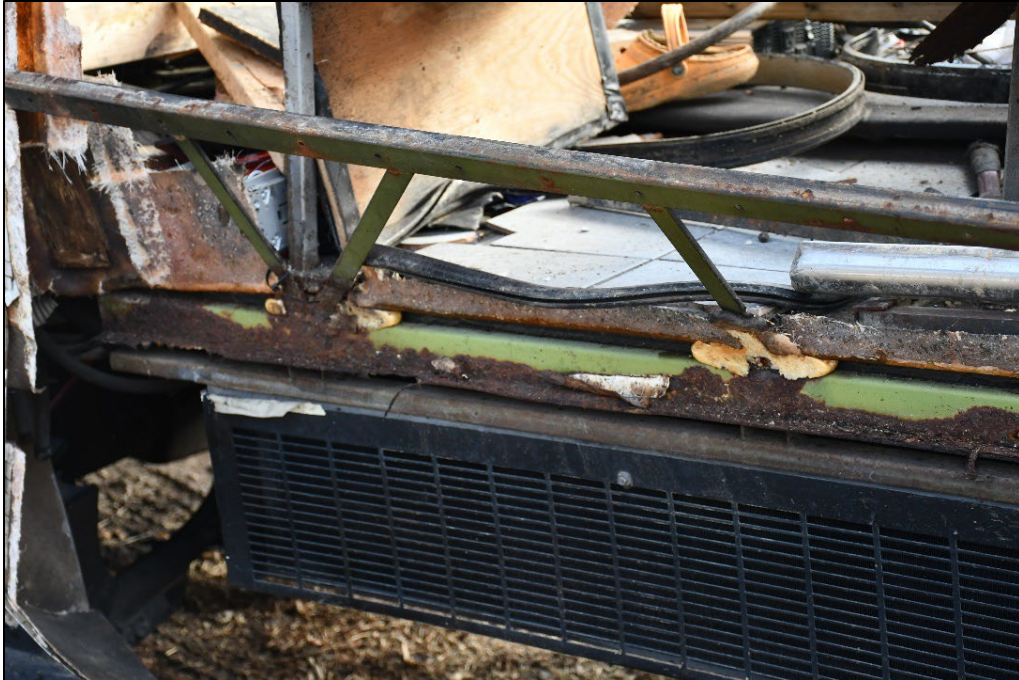
Figure 7: Bus - Corroded Components

There was notable corrosion to various metal portions of the bus's frames, rails, and undercarriage. There was also rotting wood discovered throughout the vehicle's floor and roof. Small portions of the bus's frames and rails were observed with a green coating (Figure 7). The green coating was what remained of the anti-corrosion primer applied during the construction of the bus body.⁴ In addition to the anti-corrosion primer to the substructure of the bus, the undercarriage of the bus was treated with a separate anti-corrosion barrier treatment. While the anti-corrosion primer does not require yearly maintenance and reapplication, the anti-corrosion barrier treatment to the undercarriage does require maintenance and reapplication every six to 12 months.⁴ There was no information obtained during the investigation as to the reapplication of the anti-corrosion treatment or if it was maintained according to manufacturer specifications.

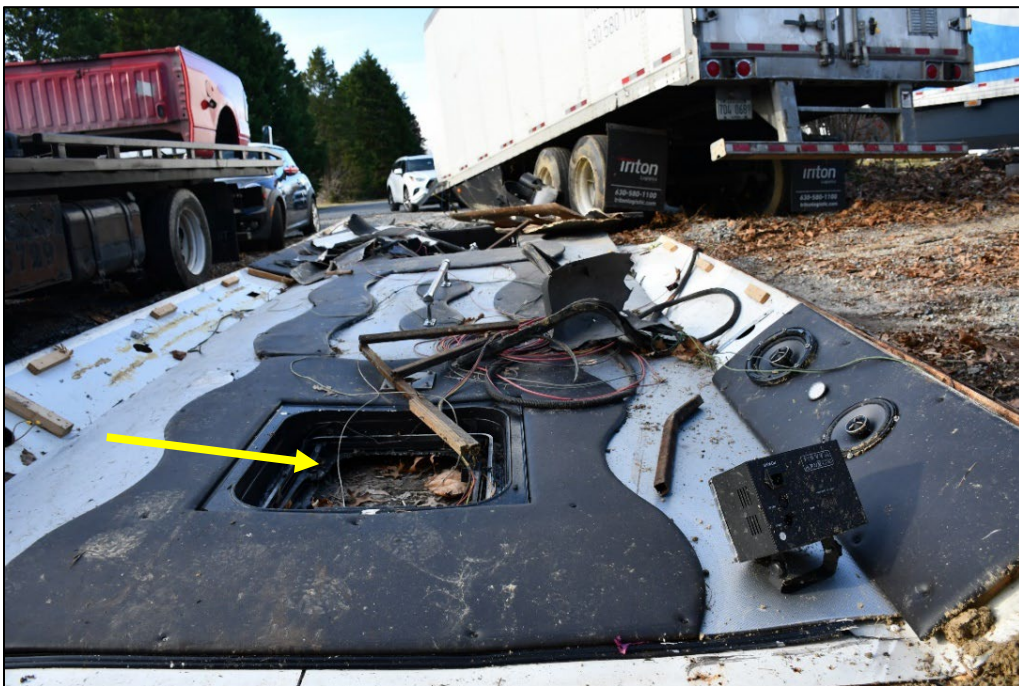
Figure 8: Bus - Roof with Emergency Exit Hatch

The bus was equipped with an emergency exit roof hatch (Figure 8). Due to the weight and the current condition of the roof, the emergency exit roof hatch was unable to be tested for proper functionality. Due to crash damage, not all side windows were recovered for evaluation, and the number of emergency egress windows is unknown. The right-side of the bus contained at least four passenger compartment side windows. The left-side of the bus had at least four passenger compartment side windows, in addition to the driver's side-window. Two of the recovered passenger compartment side windows were designed for emergency egress.

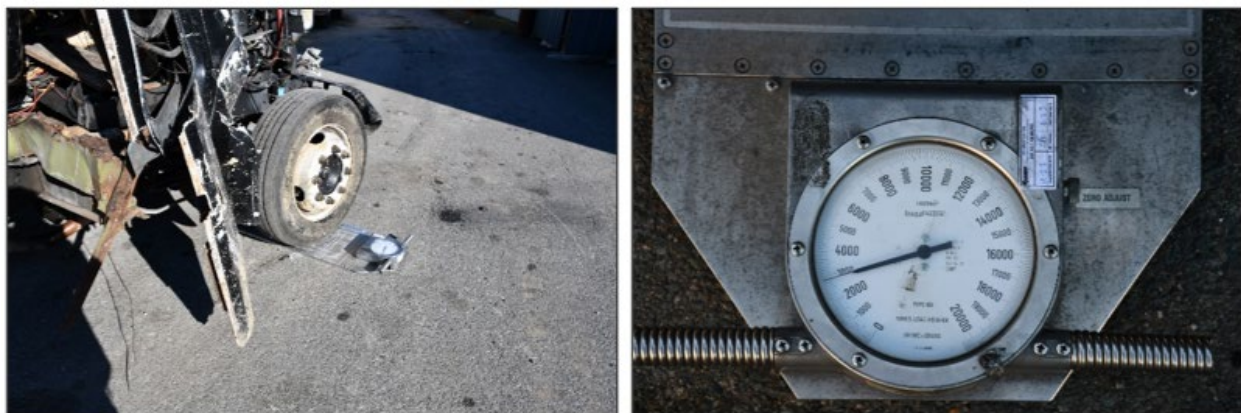
Figure 9: Bus - Scale Weight Measurements

overloaded and if its weight was a contributing factor for its reduced speed, NTSB investigators coordinated with law enforcement to have portable calibrated vehicle scales delivered to the tow yard. Prior to weighing the bus, all debris from the bus that was present at the tow yard was placed back onto the bus. A scale was placed under each of the bus's tires on each side of the vehicle (Figure 9). A total of four scales were used to weigh the bus. A weight was first recorded for the bus, debris, and components, except for the bus's roof. The roof was added onto the vehicle last, in efforts to determine the total weight of the vehicle, in addition to the total weight of the roof alone. The total weight of the roof was approximately 1,250 pounds. However, several speaker components were missing from the roof at the time it was weighed. The total weight of the bus was approximately 16,300 pounds; this does not account for the weight of the bus's occupants.

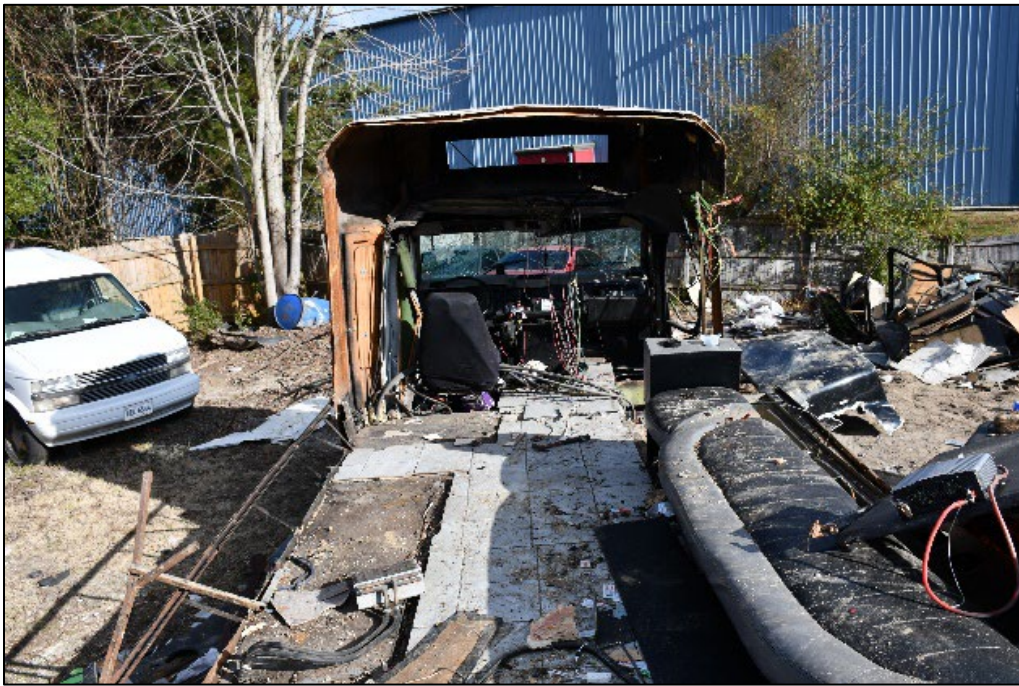
Figure 10: Bus - Post-Collision Interior View from Rear of Bus

During the removal of the bus from the scene, the bus's debris was loaded onto the bus by towing personnel. During the inspection of the bus, the debris was removed from the vehicle and sorted. Only the passenger-side bench seat remained affixed to the bus's floorboard (Figure 10). In addition to the roof and sidewalls separating from the vehicle, a stairwell, two mounted interior dancing poles, and multiple interior walls became detached from the vehicle as well. The bus's floor was lined with two layers of homestyle tile flooring. Various LED lights and connectors were in the passenger compartment area behind where the seats and benches previously resided.

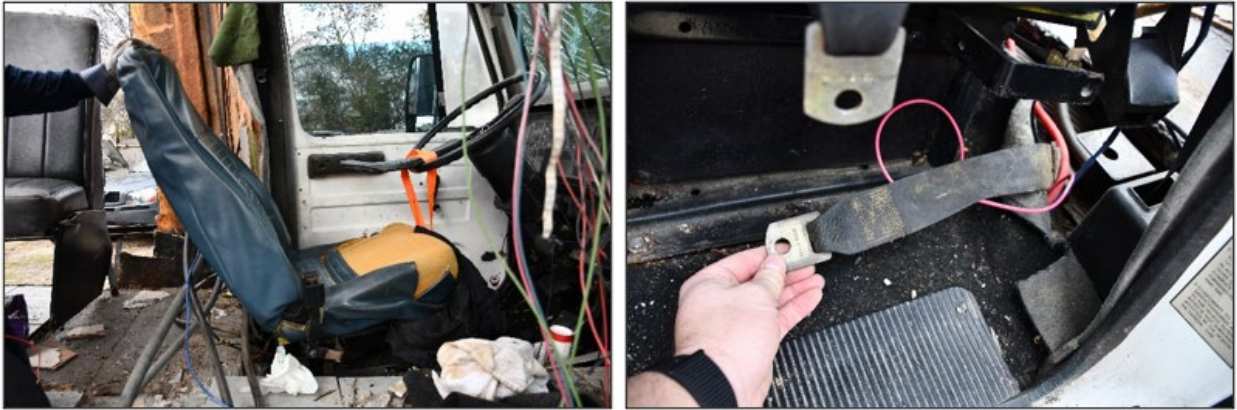
Figure 11: Bus - Driver's Seat and Seatbelt

The International chassis of the bus was not equipped with a supplemental inflatable restraint system and no airbag deployment or pyrotechnic pretensioner deployment was observed. The driver's seating area was equipped with a three-point retractable lap and shoulder seatbelt. The upper-right portion of the driver's seat mount was not connected to the vehicle and the driver's seat was loose upon touch. There were no identifying tags or information available on the vehicle or from the bus owner regarding make/model of driver's seat. The seat-pan measured to be 23-degrees from the horizon and the seat back angle with respect to the seat-pan was measured to be 117-degrees.

The driver's seatbelt was inspected. The driver's seatbelt was not functional prior to the subject collision. The seatbelt was found in a retracted position but was not locked. While examining the seatbelt, the seatbelt mechanism possessed the ability to extend and retract. The inertia wheel was tested and found to be functioning. The seatbelt buckle did not function as designed; as the seatbelt release was missing from the buckle prior to the collision (Figure 12). The lower portion of the driver's seatbelt webbing was connected to a bracket. The bracket was disconnected from a subsequent bracket that was attached to the manufacturer's lower anchor point (Figure 11). The two brackets should have been connected by a hex bolt; however, the hex bolt was missing. The brackets were free from fractures, witness marks, or other collision related damage. The bus driver stated in a written statement provided to VSP that he was not wearing his seatbelt while operating the bus.

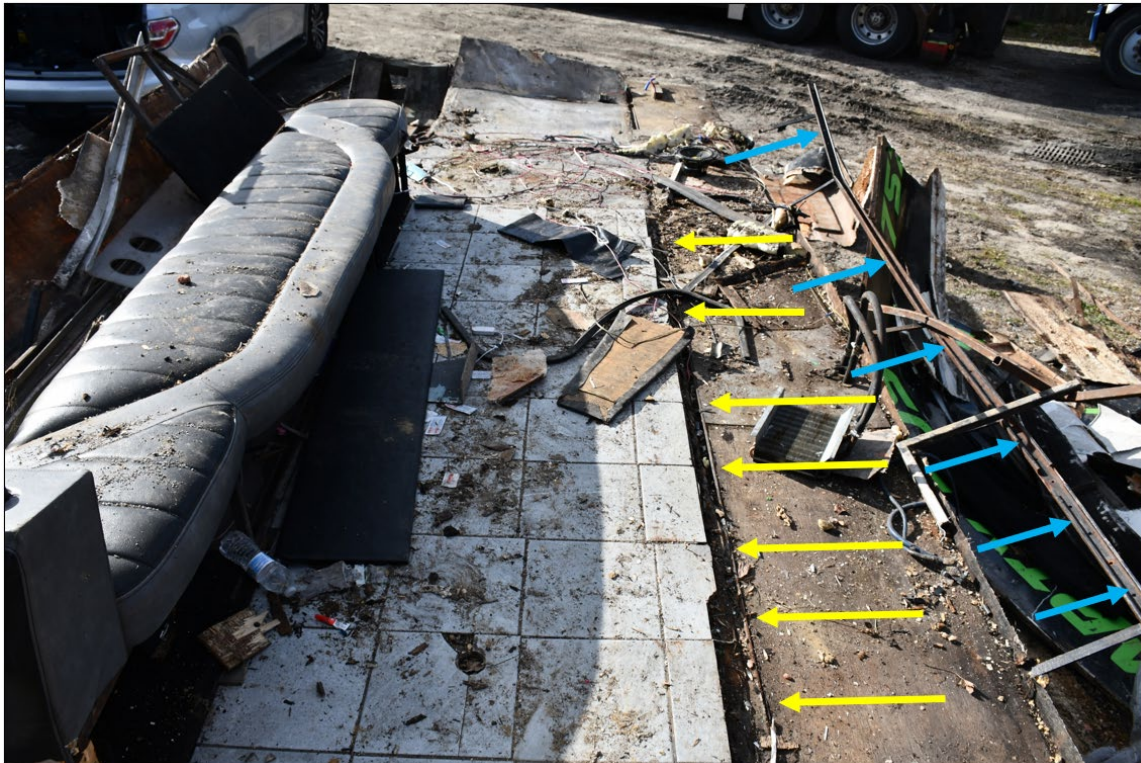
Figure 13: Bus - Floor Seat Track and Seat Rail

The seating configuration observed in the bus was modified from the original vehicle design. While the build documents were purged by Eldorado National Company due to exceeding retention policies, the two floor seat tracks observed in the floorboard of the bus and the two seating rails are consistent with forward facing seating, and not consistent with a perimeter seating configuration.

In Figure 13, the driver’s side floor seat track can be observed and is accented with yellow arrows. The blue arrows in Figure 13 show the driver’s side seat rail that contained an inboard C-channel. The floor seat track and the seat rail were two connection points that were originally used to properly install and anchor a passenger seat into the bus using a seat slider connection device when the bus was originally constructed. The perimeter seating arrangement that was later installed into the bus did not utilize either floor seat track, or either seat rail during the installation of the modified seating arrangement.

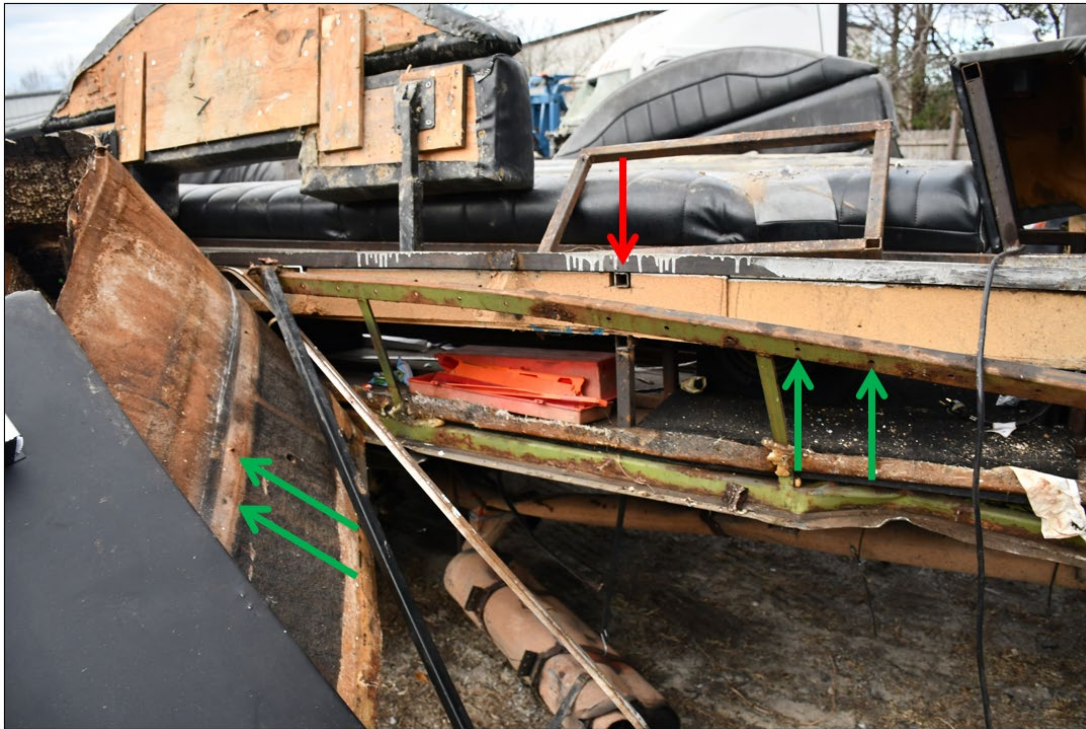
Figure 14: Bus - Seat Rail and Exterior Skin

The bench seats that are visible in Figure 14 are the only seat frame and seat pan that did not separate from the bus during the collision sequence. The outboard side of the seat rail contained slotted holes that allowed the exterior skin of the vehicle to be attached and secured (Figure 14 - green arrows). All perimeter seat pans were affixed to a custom metal frame comprised of 1-inch by 1-inch steel. The red arrow in Figure 14 accents an approximate six-inch metal extension that was welded to the custom seat frame below the bench seat pans. In Figure 15, a closer view of the metal-extension can be observed. The metal extension was welded to the custom seat frame and the other end of the metal extension appears to have once been welded to the inboard C-channel of the seat rail as a connection or anchor point.

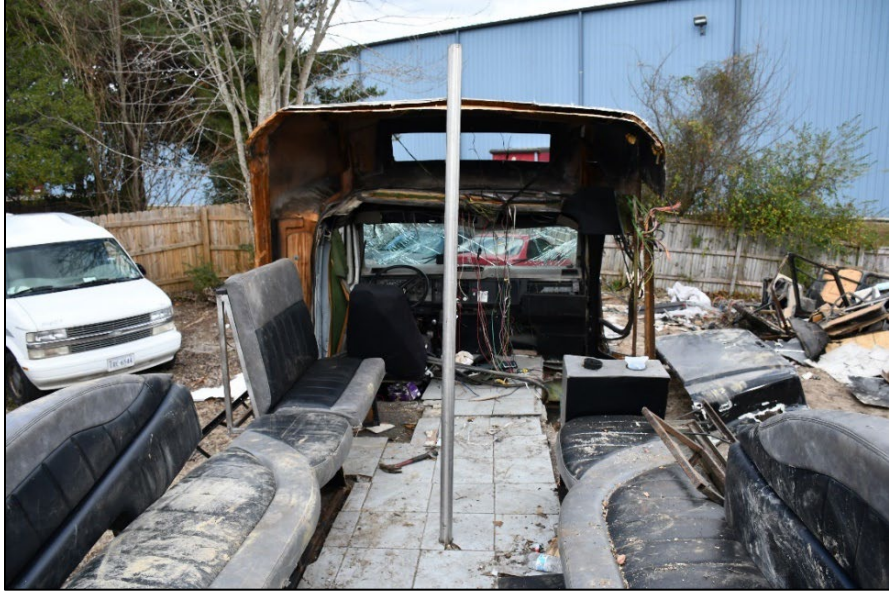
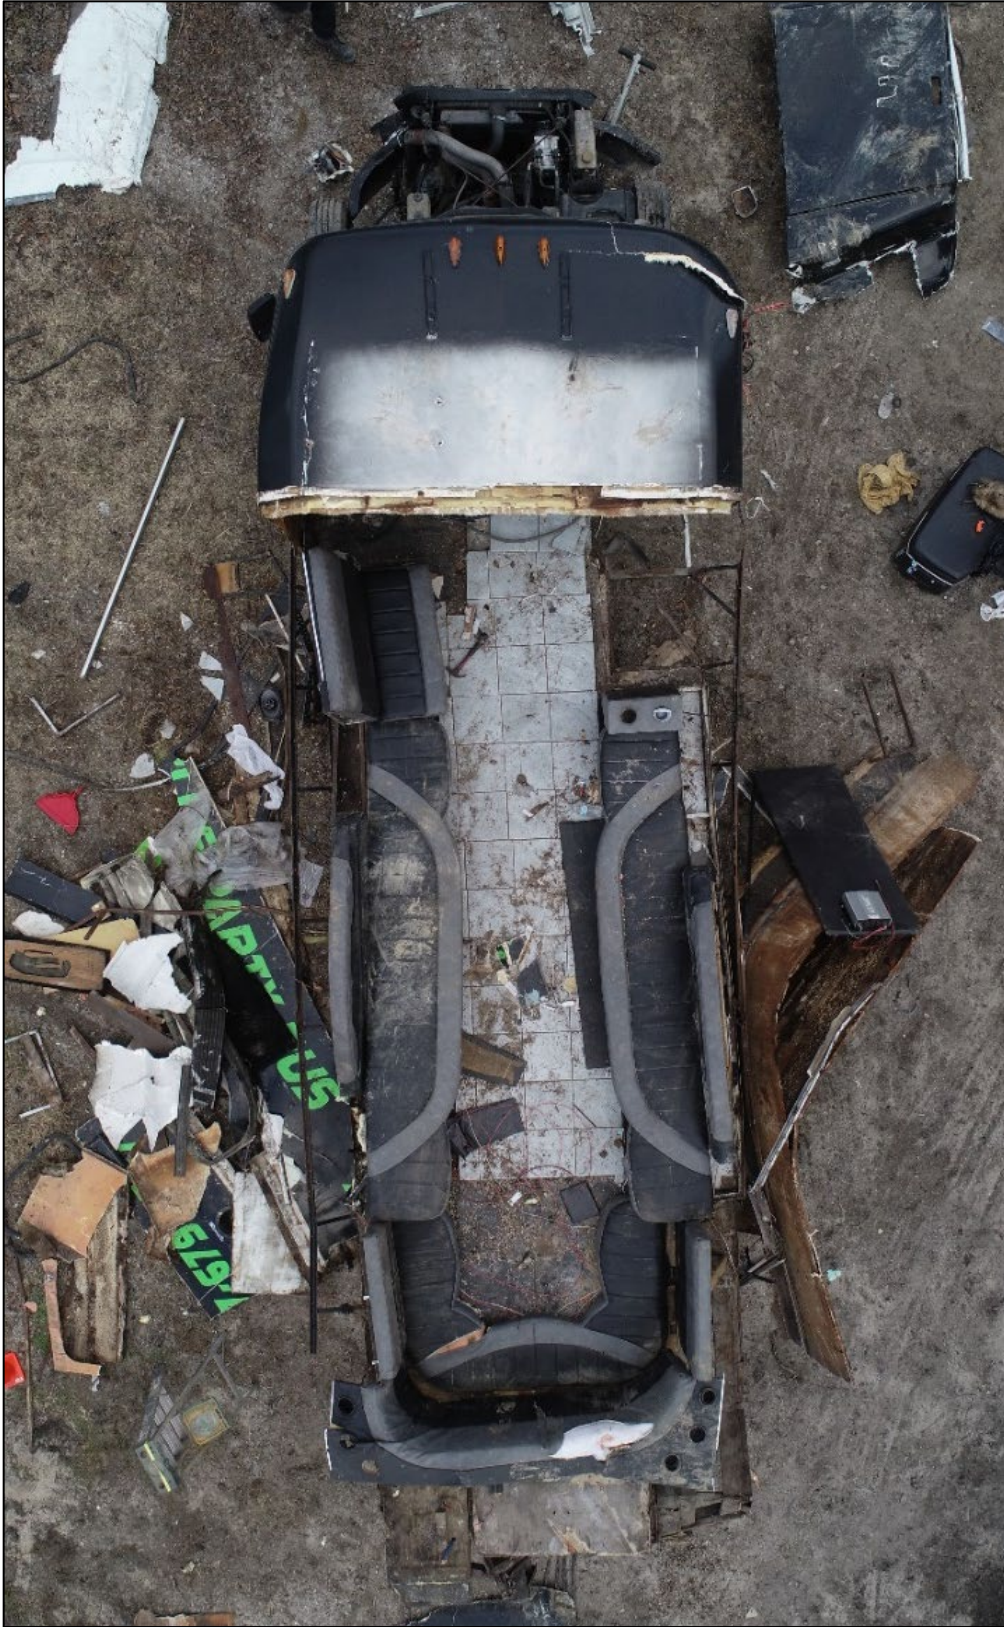
Figure 16: Bus - Reconstructed Interior and Seating Configuration

The passenger seat pans and seat backs, in addition to various metal frames, were located amongst the debris and collected to aid in the reconstruction of the pre-crash passenger seating configuration of the vehicle. The seat pans and frames were assembled outside of the vehicle. After confirming that the seating configuration was accurate using pre-crash video that showed the interior of the bus, the seating components were installed into the interior of the damaged bus. The reconstructed pre-crash seating configuration can be seen below in Figure 16 and Figure 18.

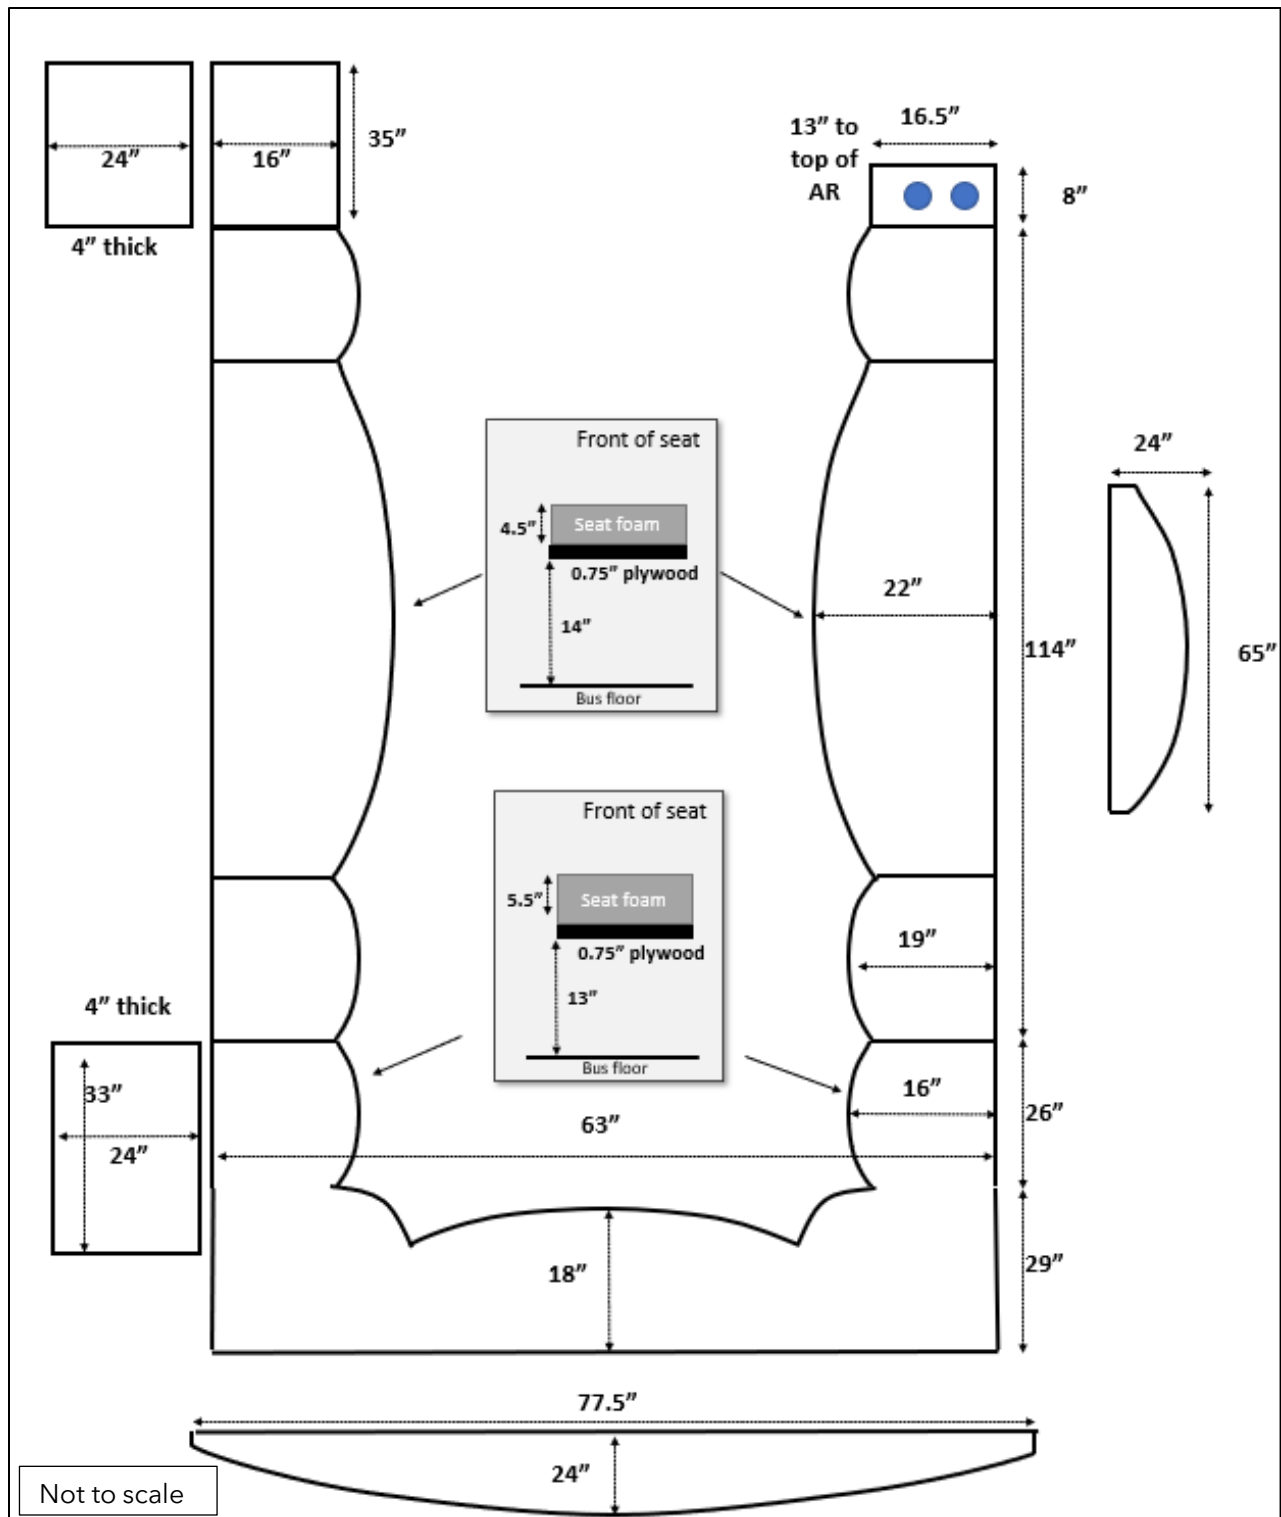
Figure 17: Bus - Seating Arrangement and Measurements

The passenger compartment consisted of custom seats pans, benches, and seatbacks that were mounted on top of a metal frame approximately 13 - 14 inches above the bus's floor. The seats and benches were comprised of leather-like material which encapsulated approximately 4.5 - 5.5 inches of foam and 0.75 inches of plywood. The approximate seating configuration and measurements obtained during the inspection of the bus can be observed in Figure 17.

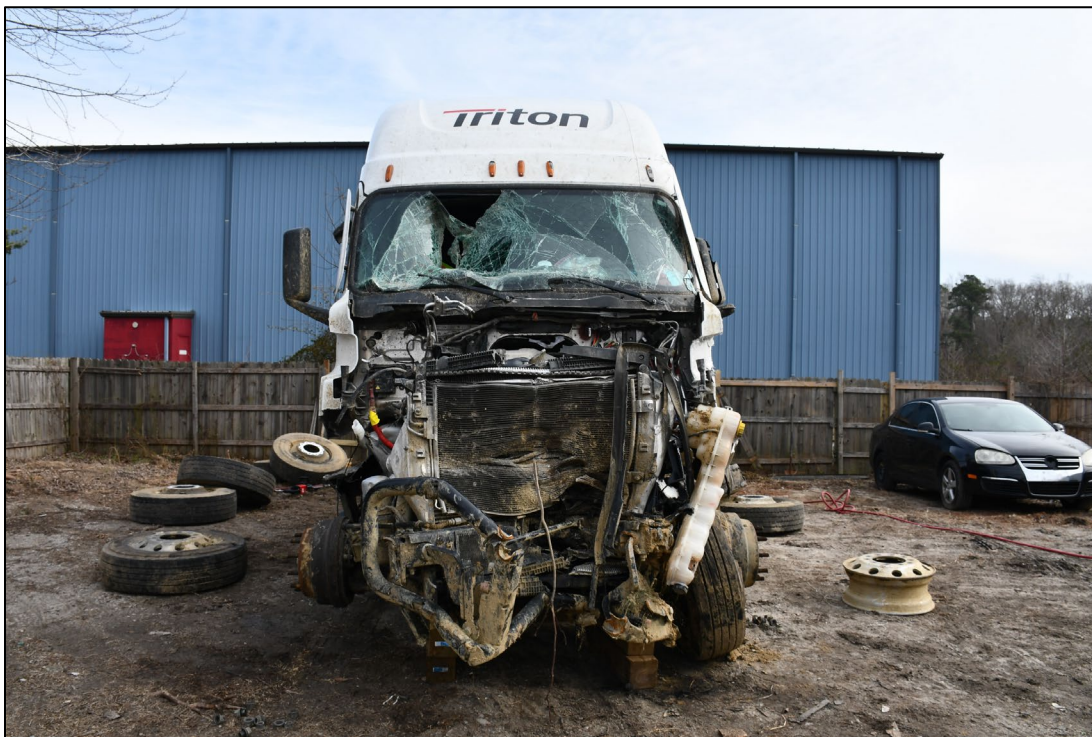
Figure 21: Truck-Tractor - Front Damage and Contact Points

The truck-tractor had significant damage to the front of the vehicle. The hood and both headlight assemblies were damaged during the collision sequence and separated from the vehicle (Figure 21). The truck-tractor was equipped with a moose-guard¹¹ on the front of the vehicle, which was crushed inward during impact. There was black transfer above the left A-pillar of the truck-tractor which was consistent with contact from the rear of the bus. Multiple marker and identification lights were cracked and or damaged. The marker and identification lights were located above the windshield area and spanned the width of the truck-tractor.

The entire width of the windshield was cracked and damaged, and the lower-right portion was torn. The integrity loss of the windshield at the tear allowed small pieces of debris from the bus to enter the truck-tractor.

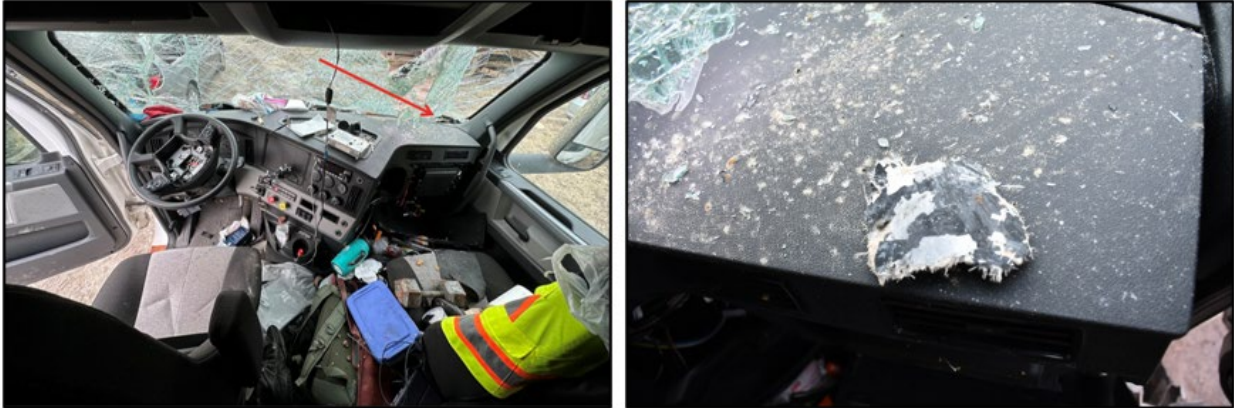
Figure 22: Truck-Tractor - Interior Overview and Fiberglass Bus Debris

The interior of the truck-tractor was in disarray from personal effects which reportedly belonged to the driver. The overall occupant compartment remained intact and with minimal intrusion, except for the windshield was intruded by the rear of the bus during impact (Figure 22). Black fiberglass penetrated the lower-right portion of the truck-tractor's windshield. The fiberglass material found inside of the truck-tractor was consistent with the materials that encompassed the rear of the bus.

The steering wheel cover belonging to the truck-tractor separated from the steering wheel of the vehicle. The truck was not equipped with a supplemental inflatable restraint system or pyrotechnic pretensioners. The sleeper berth area of the cab contained a bed and a small living space. This area was also in disarray during the truck-tractor's inspection as there were garbage and person effects scattered throughout the entire cab.

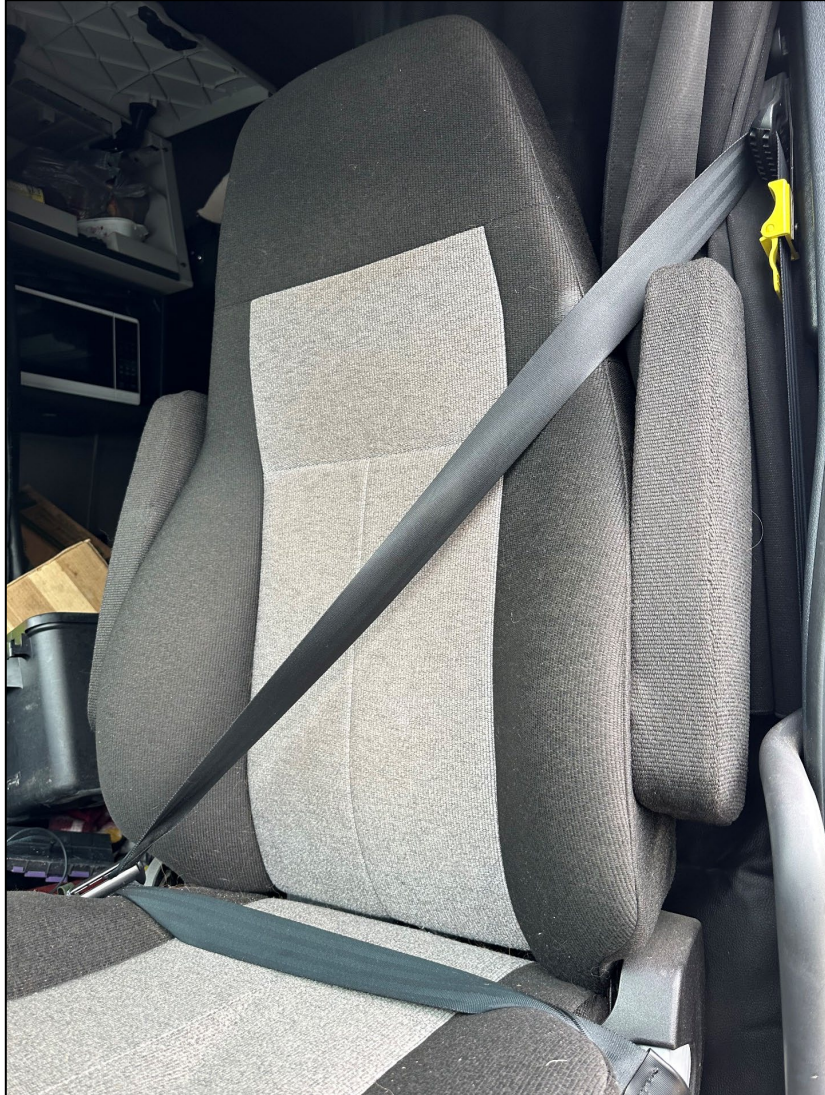
Figure 23: Truck-Tractor - Driver's Seat and Seatbelt Position

The cab of the truck-tractor was equipped with a three-point lap and shoulder seatbelt for both the driver and passenger seat positions. The driver's seatbelt was found in the buckled position during the post-collision inspection (Figure 23). The seatbelt was extended while buckled; however, it possessed the ability to retract and extend, as it was not locked. There was no indication that the seatbelt was in use by the driver during the collision sequence.

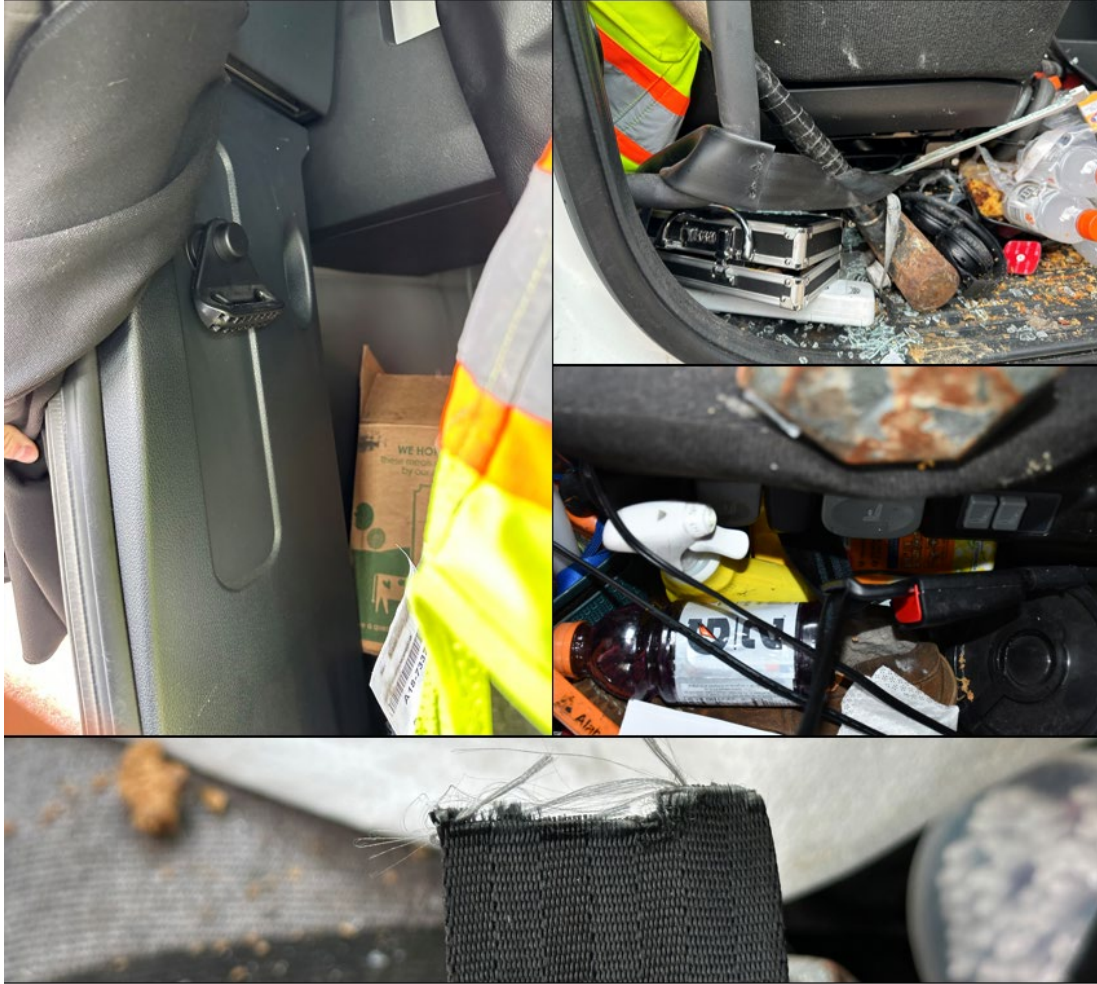
Figure 24: Truck-Tractor - Passenger Seatbelt Condition

The passenger's three-point lap and shoulder seatbelt were inspected. Upon closer examination of the passenger D-ring, there was no seatbelt webbing present (Figure 24). The webbing was located underneath the right-side of the passenger seat. The webbing continued underneath the seat and exited the left-side of the passenger seat. The seatbelt was latched, and the upper webbing was found torn and separated from the remaining portion of the seatbelt. The seatbelt was used to secure equipment belonging to the driver, that was located in the passenger seat during impact and severed when the truck-tractor experienced substantial forward speed loss during the collision sequence.
