RE: N894GT Pilot statement

Date: January 31, 2018
Subject: Information Provided by Inspector David D. Hays (FAA)
NTSB Case Number: ERA18IA078

On January 31, 2018, Inspector Hays, traveled to Air Evac's Jackson Tennessee helicopter operations base in support of the incident investigation of N894GT, where the helicopter had suffered a hard landing on top of the Regional One Medical Center in Memphis, Tennessee on January 28, 2018.

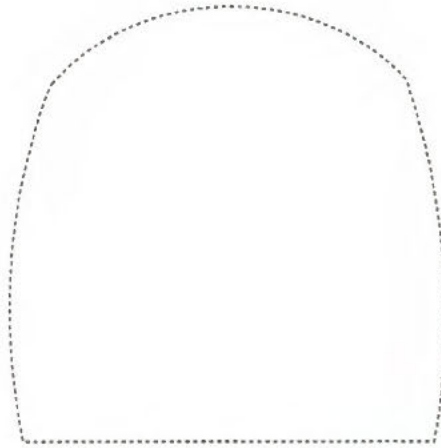
Fig. 1

Event Information
<p>Detailed Description of Event: During this flight I was seated in seat 3 (fig. 1) with lap and shoulder belts fastened and tightened, wearing a company approved and inspected helmet. Just prior to landing at Regional One Hospital's rooftop helipad a sterile cockpit was assumed by everyone onboard N894GT. After approach the aircraft was brought to a low hover, I looked out the left window and stated verbal confirmation the left side of the aircraft was clear and then the tail of the aircraft was turned left and the aircraft was landed on the center of the "H" of the helipad. At this time I saw the pilot begin his post-landing checklist procedures and I turned my head to the right to obtain the time from the clock located on the medical panel of the back wall between seats 3 and 4 (fig. 1). After obtaining the time I began to write the time down on the medical record when I felt movement and saw in my periphery the landscape outside the aircraft shift. I immediately looked up and saw that the aircraft was no longer on the helipad. I saw that the aircraft had rose about 5 ft off of the helipad and was moving in the direction of the elevator shaft and another brick wall of adjacent building (fig. 2); or in the aircraft's 1-2 o'clock direction. I also saw in my periphery the pilot was reaching with his right hand to touch the timer located on the flight control panel. I noticed all of this in the span of approx 1-2 seconds. I then saw the pilot move his arm from where he was reaching for the timer and the aircraft quickly returned to the deck of the helipad making for the second and what would be final landing. At this point I heard the pilot state that the collective lock is engaged but that he will not be taking his hand off of the collective until the rotor blades had completely stopped spinning and then I heard him restart the post-landing checklist aloud. During the shutdown sequence I assessed the situation and quickly confirmed that nobody onboard had been injured and proceeded to provide verbal reassurance of the situation to the patient. When the aircraft was shutdown and the blades had stopped spinning I opened the left door and stepped out of the aircraft. As soon as I stepped out I noticed the distance from the initial landing spot and the final landing spot was 20-25 ft. I then proceeded around to the right side of the aircraft to unload the patient.</p>
