Eric M. Gutierrez
Air Safety Investigator
Western Pacific Region

Date: September 9, 2022
Subject: DCA22MA193, Memorandum for Record
Contact: Calvin Bard, Witness

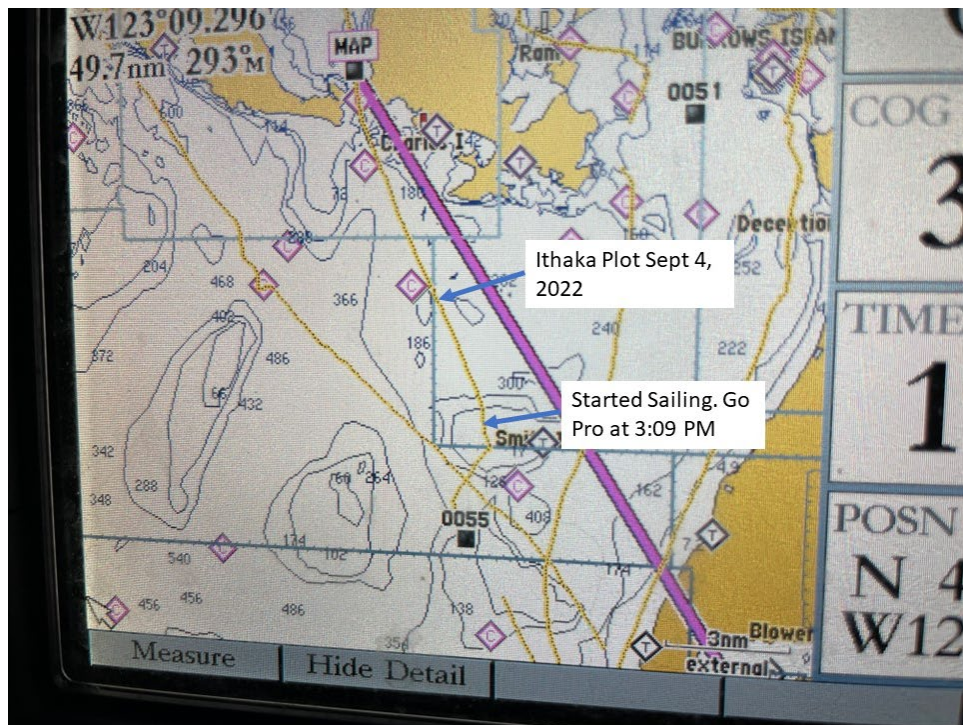
Figure 1: View of slide provided by David Swartz.

Figure 1 in this presentation is a photograph of the GPS receiver on Ithaka. The yellow markings are the tracks from previous trips. The notated track is from September 4th. This was confirmed by the track traveling from Friday Harbor, through Cattle Pass, the deviation from a straight line off Smith Island, rounding the red buoy off Pt. Wilson and the track continuing to Pt. Townsend.

All other yellow tracks are from previous unrelated trips. The solid purple line is an artifact of the GPS plotting a course from Cattle Pass to Junita Bay north of Kirkland Washington where Ithaka was physically when the photo was taken.

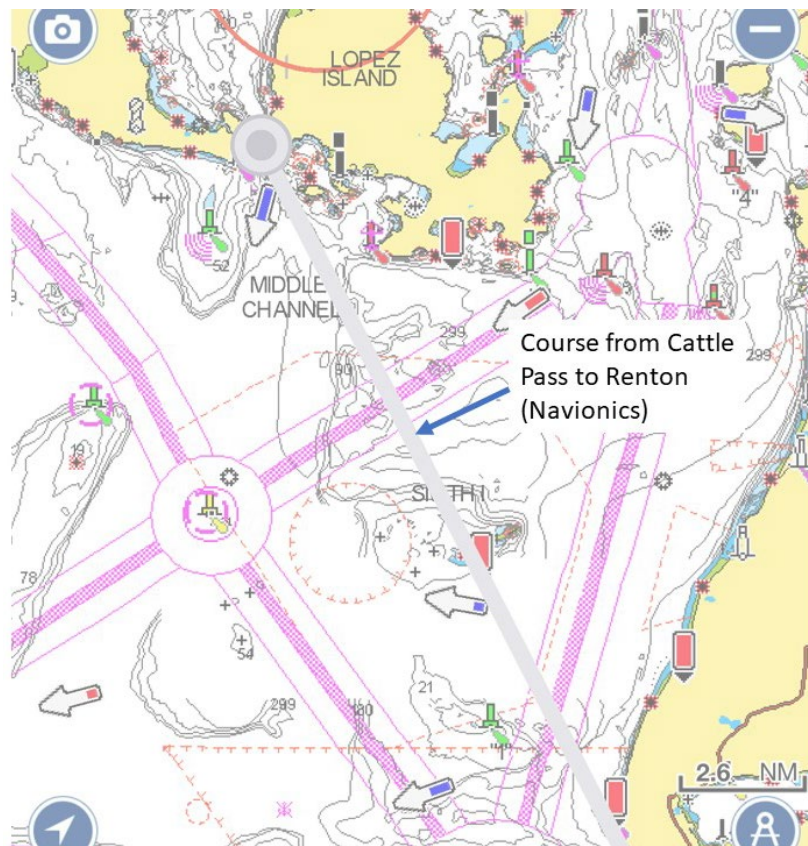
Figure 2: View of slide provided by David Swartz.

Figure 2 is a hypothetical course from Cattle Pass directly to Lake Washington/Renton. This is notated in Grey. This was produced using the Navionics marine charting application.

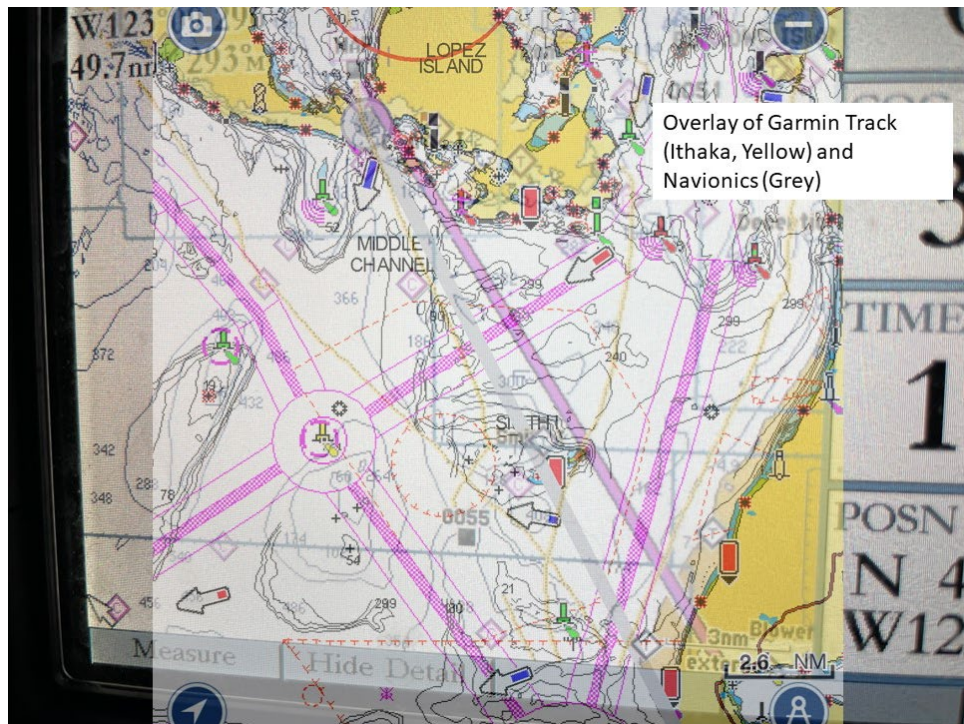
Figure 3: View of slide provided by David Swartz.

Figure 3 is an overlay of the two plots. I have attempted to manually scale both plots the same while preserving the aspect ratio. Core reference points are the south end of San Juan Island, Smith Island, and the yellow traffic separation scheme center channel marker. By overlaying these two charts you can see that our course (yellow) is like the theoretical course that may have been flown between Friday Harbor and Renton.

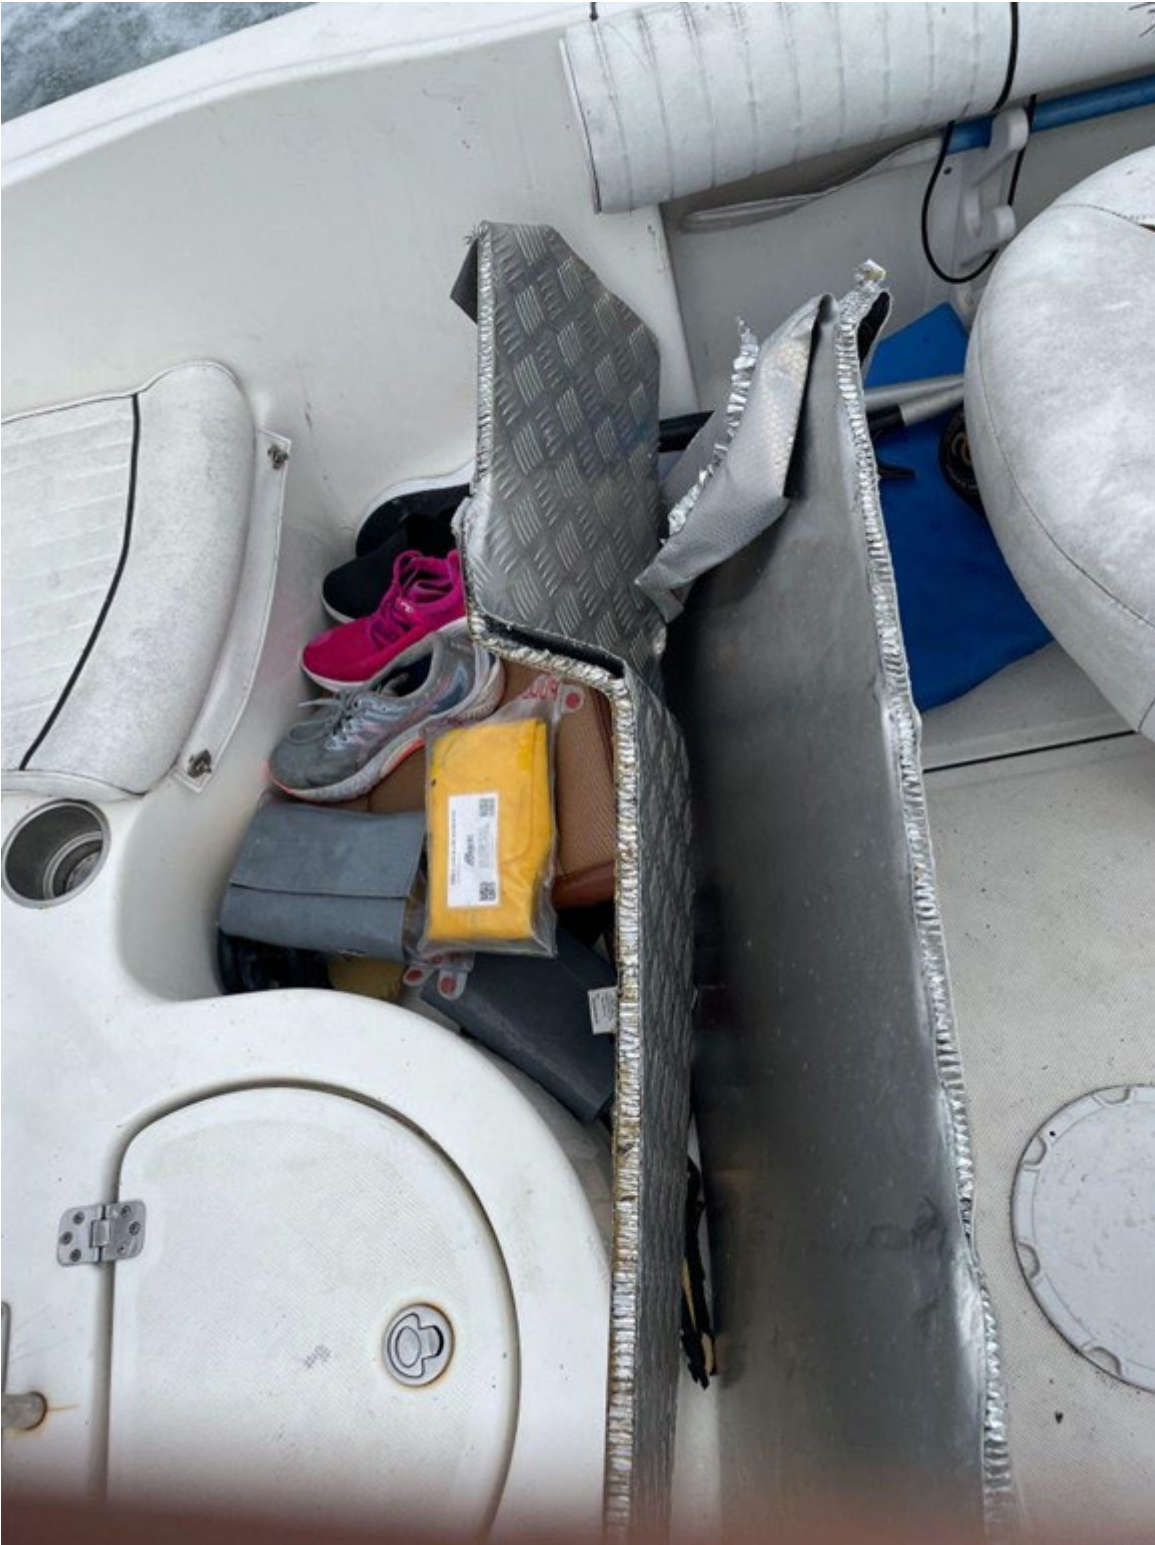
Figure 2: View of recovered debris (photo courtesy of William Canlis)

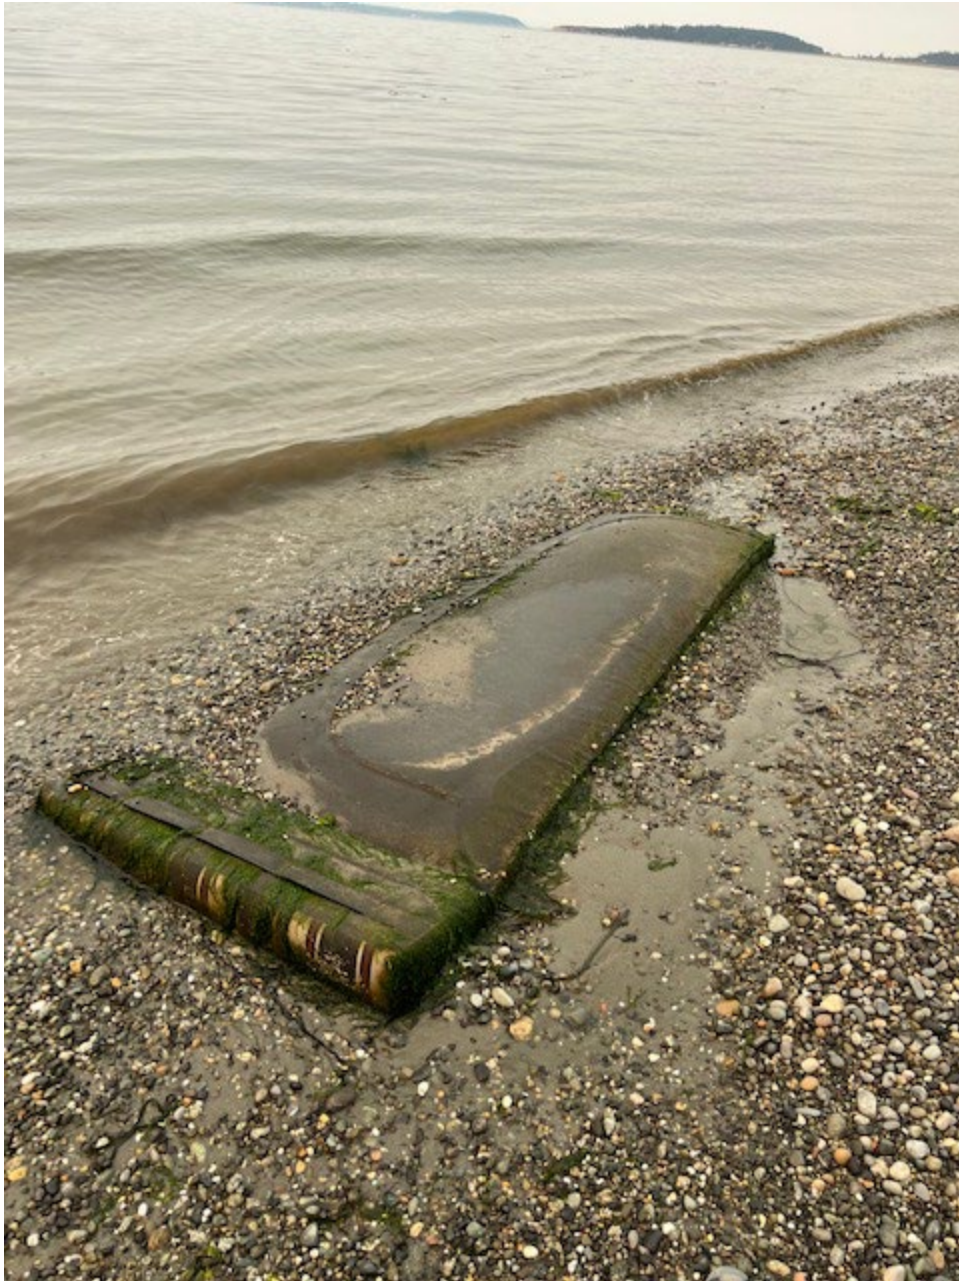
On September 10, 2022, at about 1000 am local, while walking the beach near her residence on Admiral Cove, she observed some debris on the beach. The beach area has been very clean and seldom has any debris. Concerned it maybe airplane debris, she notified the Seattle Times in an effort to alert the NTSB.

Figure 1: Picture of debris, picture (photo curtesy of Bonnie Rice)

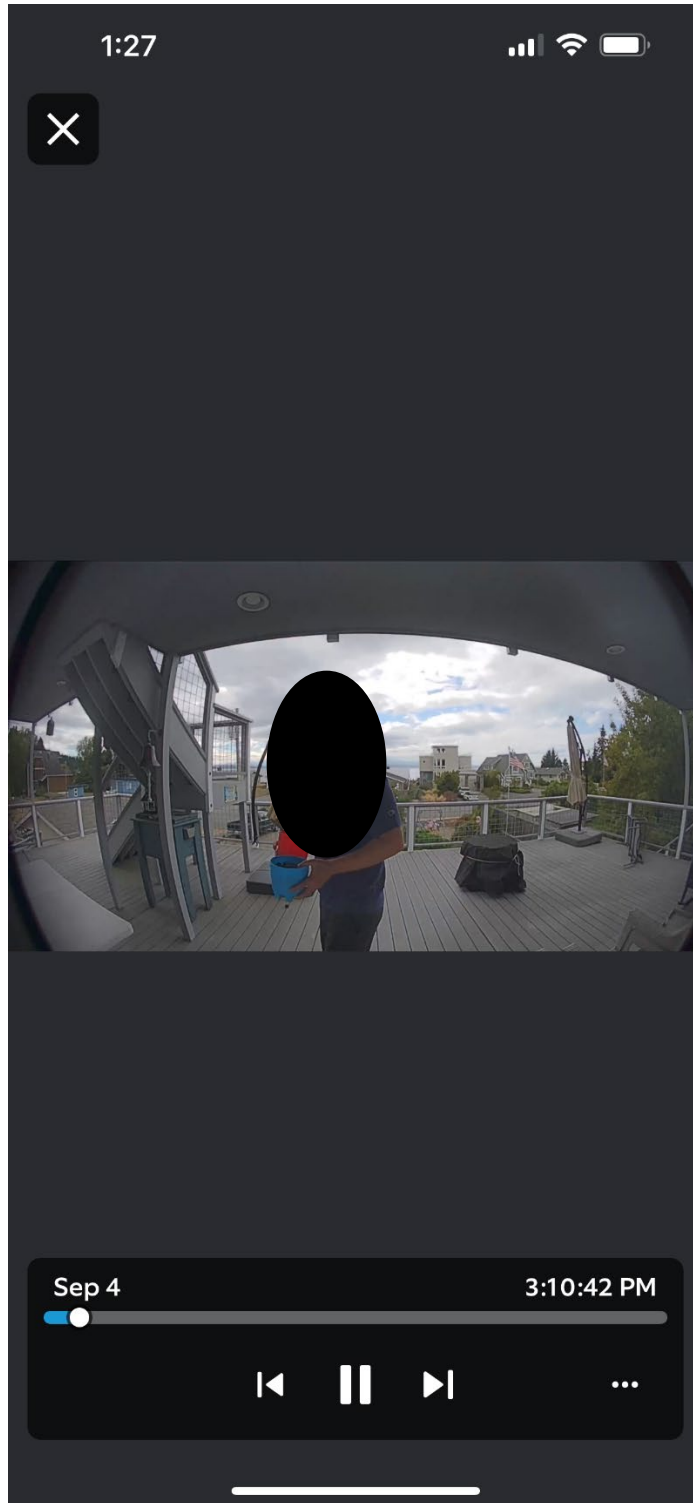
On September 3, 2022, while at his residence, he heard a loud noise, similar to a firework. Initially he believed it to be a firework, however he looked out his window and observed several boats gathering in a central area. At the time of the event, he believed he observed a boats mast sinking into the water.

Figure 1: View of ring video picture (courtesy of witness)

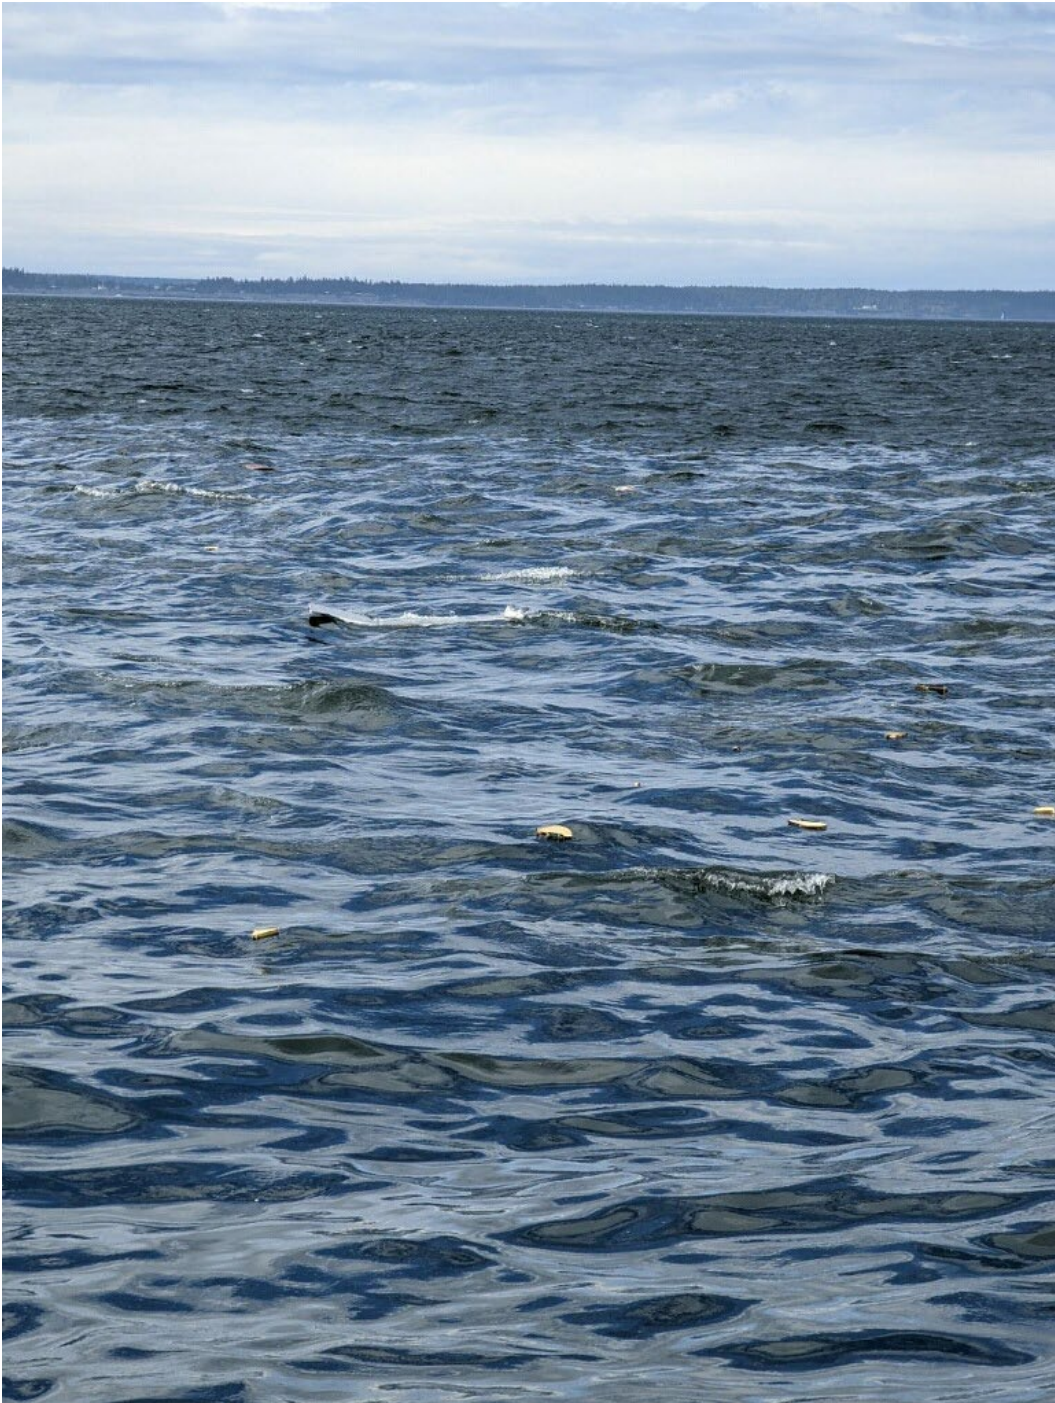
Figure 2: View of debris in water (courtesy of Nathan Jansen)

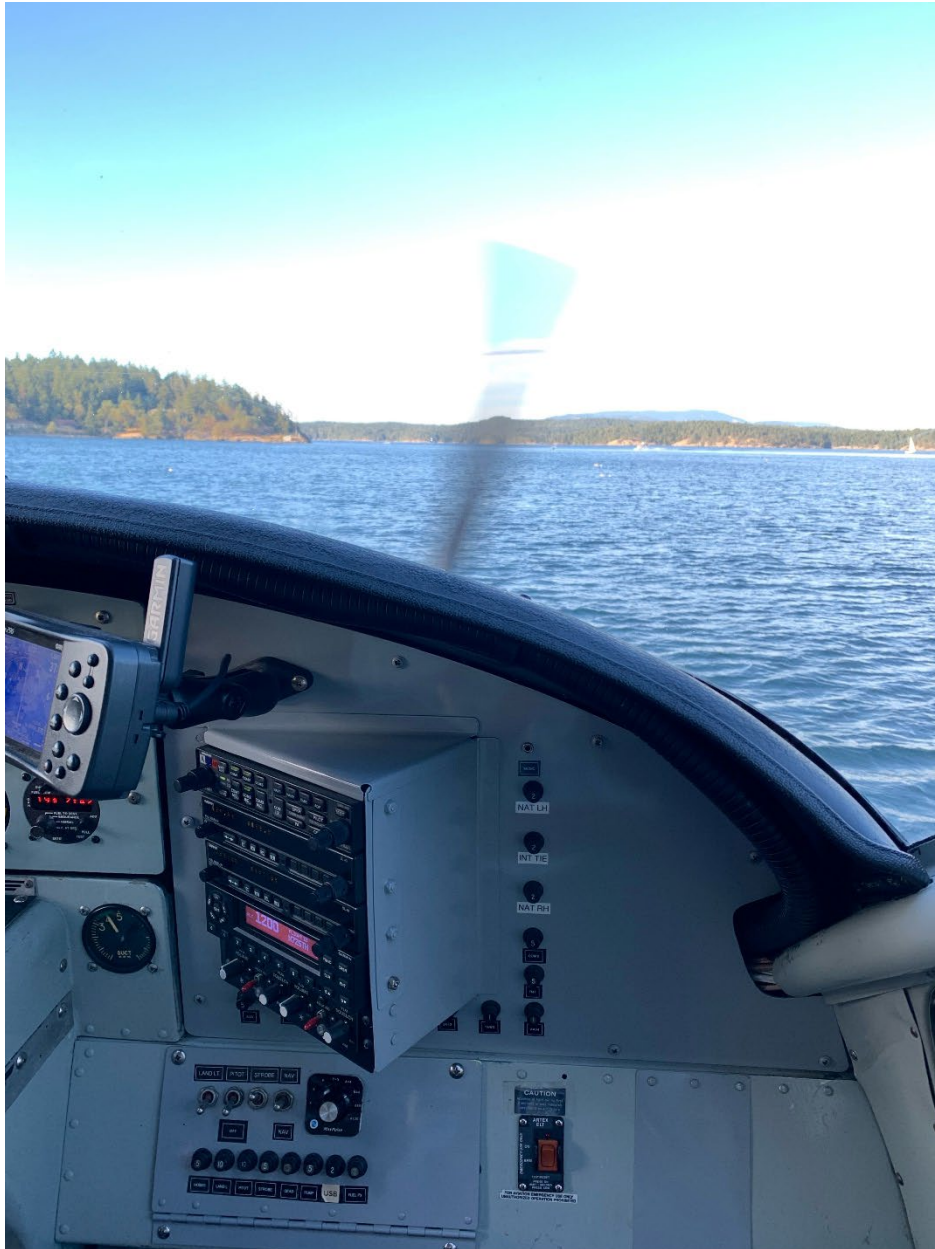
The only anomaly she noted was a red light that was illuminated throughout the flight. She did note that the pilot was very quiet and did not really say much during the flight. In addition to the airplane flight instruments, she observed the pilot use a mobile device, which she believed was to assist in navigation. The overall flight was very smooth and uneventful.

Figure 1: View of the accident airplane cockpit area (courtesy of witness)
