National Transportation Safety Board

ERA23LA334

WRECKAGE EXAMINATION

Location: Hickory, North Carolina
Date: August 13, 2023
Time: 1128 EDT
1528 UTC
Airplane: Scoda Aeronautica Ltda, Super Petrel LS

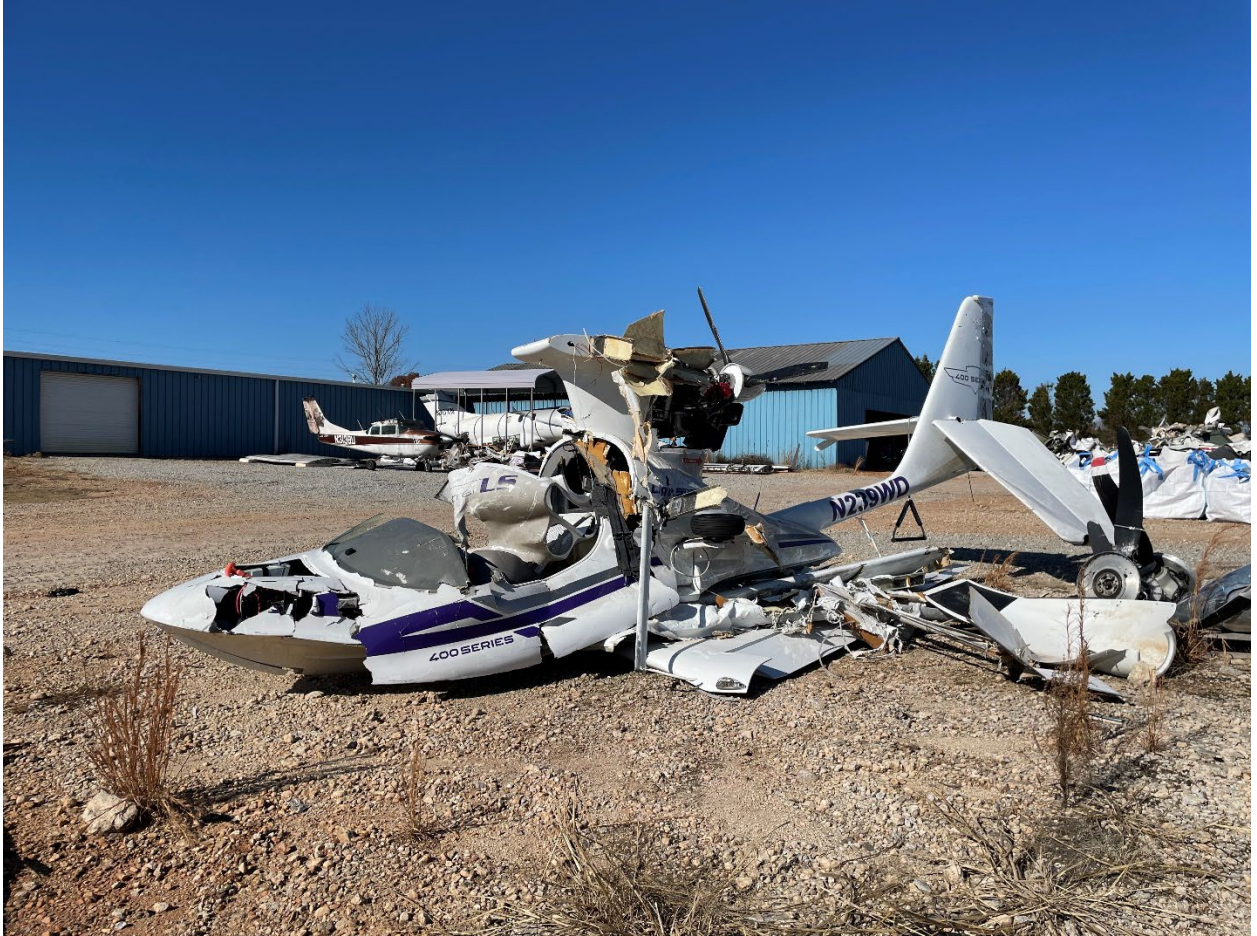
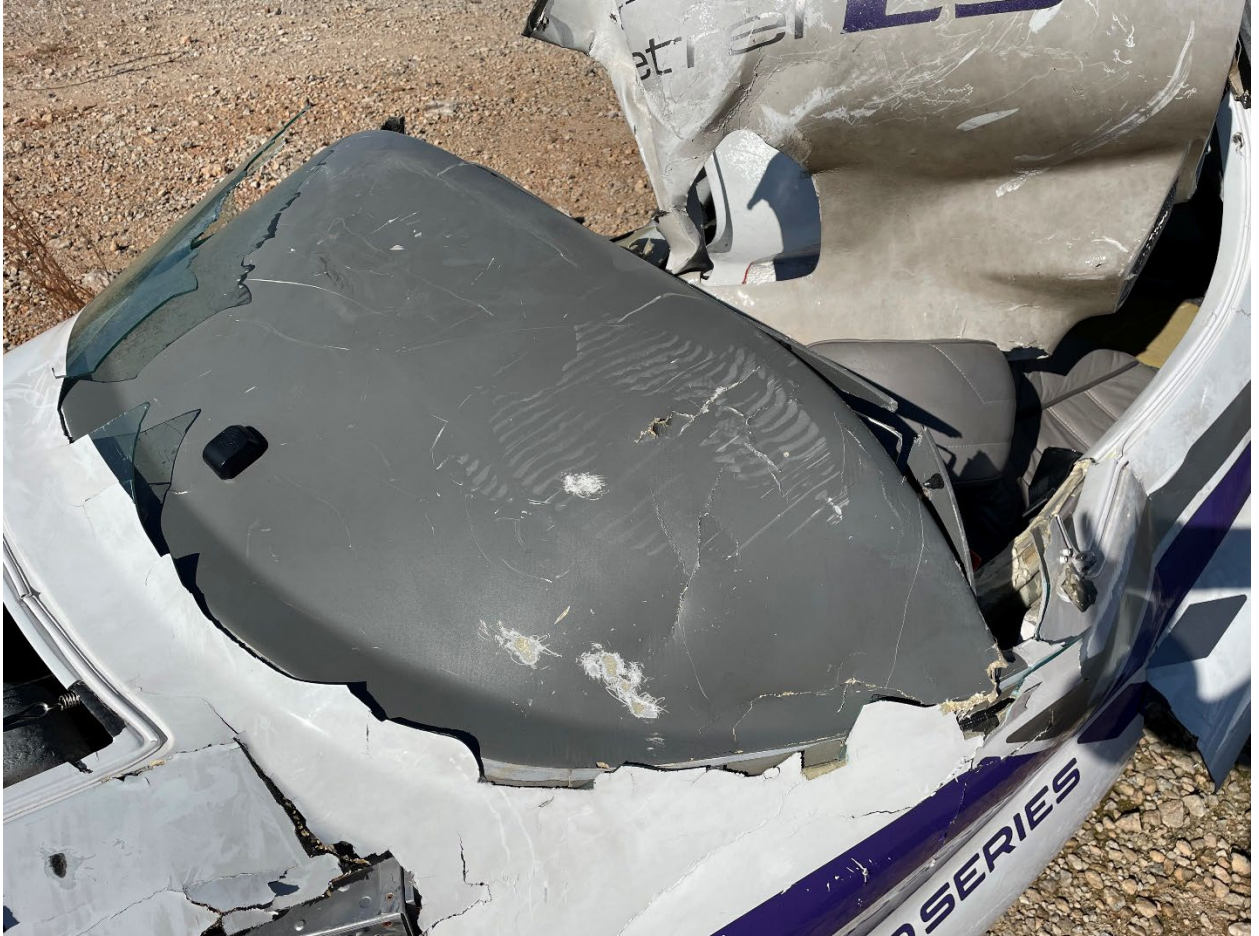
The airplane was examined on December 6, 2023, at Atlanta Air Salvage, Griffin, Georgia. The airplane was composed of mostly composite structure. The Plexi-glas windshield/canopy was missing due to impact damage and the entire cockpit area was exposed. The wings were separated from the airframe and sitting under the fuselage. The empennage and tail section were intact, but the left horizontal stabilator was bent down from impact. Striations consistent with contact with a power line cable were observed embedded on the left side of the dashboard. Flight control continuity was established for both horizontal stabilizers by manual manipulation of both control sticks. Continuity was confirmed to the wing root area for both wings when the control sticks were moved. The rudder pedals were partially jammed due to impact, but some movement was achieved to the rudder when the pedals were manipulated. A light coat of soot was observed on the engine pylon, cowling, spinner, and portions of the fuselage. Deep gouging and striation marks were observed on the top left area of the fuselage out toward the wing root and also continued down the left side of the fuselage. The left wing had separated outboard of the wing root from impact and composite material was melted and shriveled along the inboard portion of wing. Heat damaged composite wing material was also observed hanging from where the wing had separated from the airframe. The right wing had been removed from the wing by salvage personnel and was sitting under the airplane. It appeared intact and was not examined.

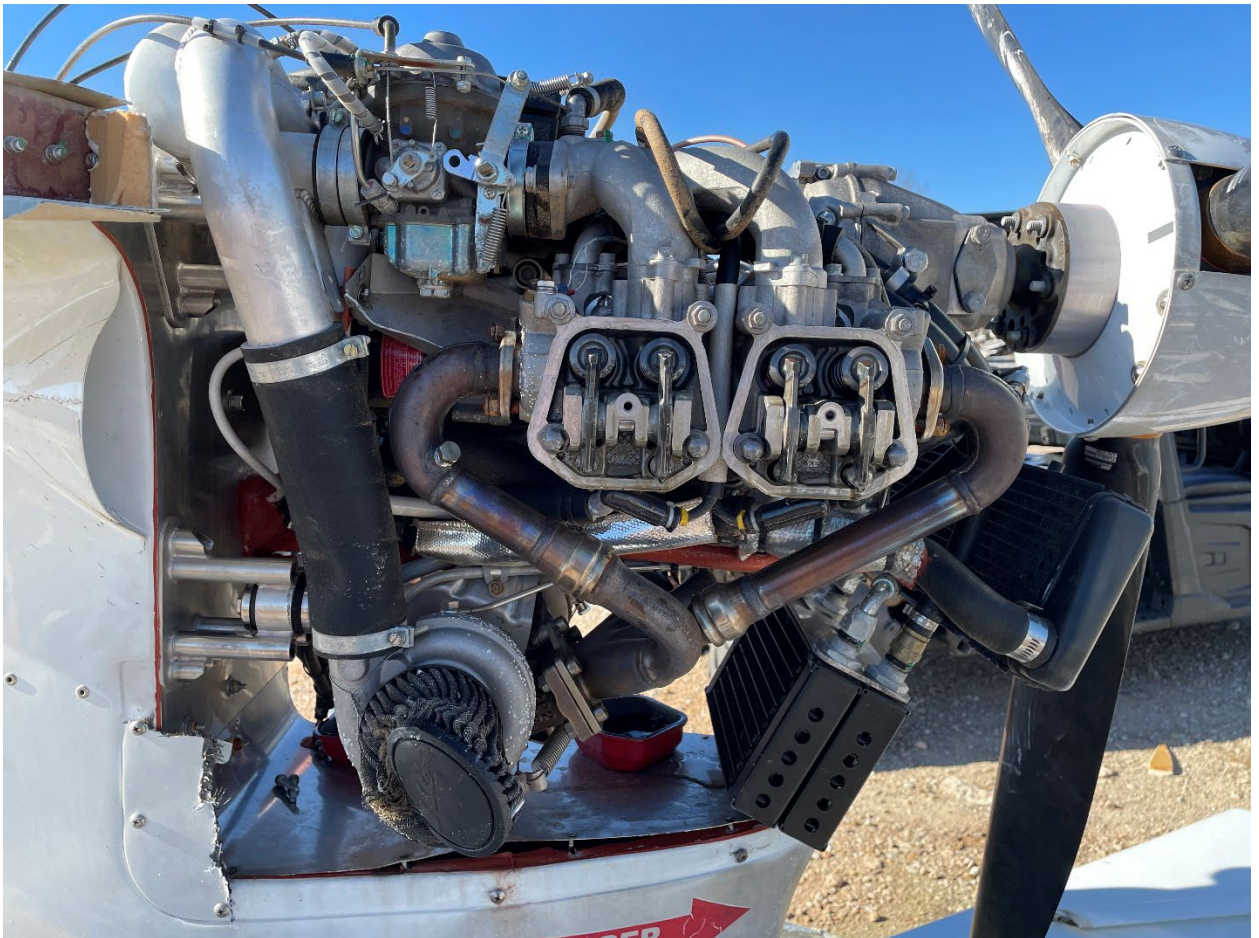
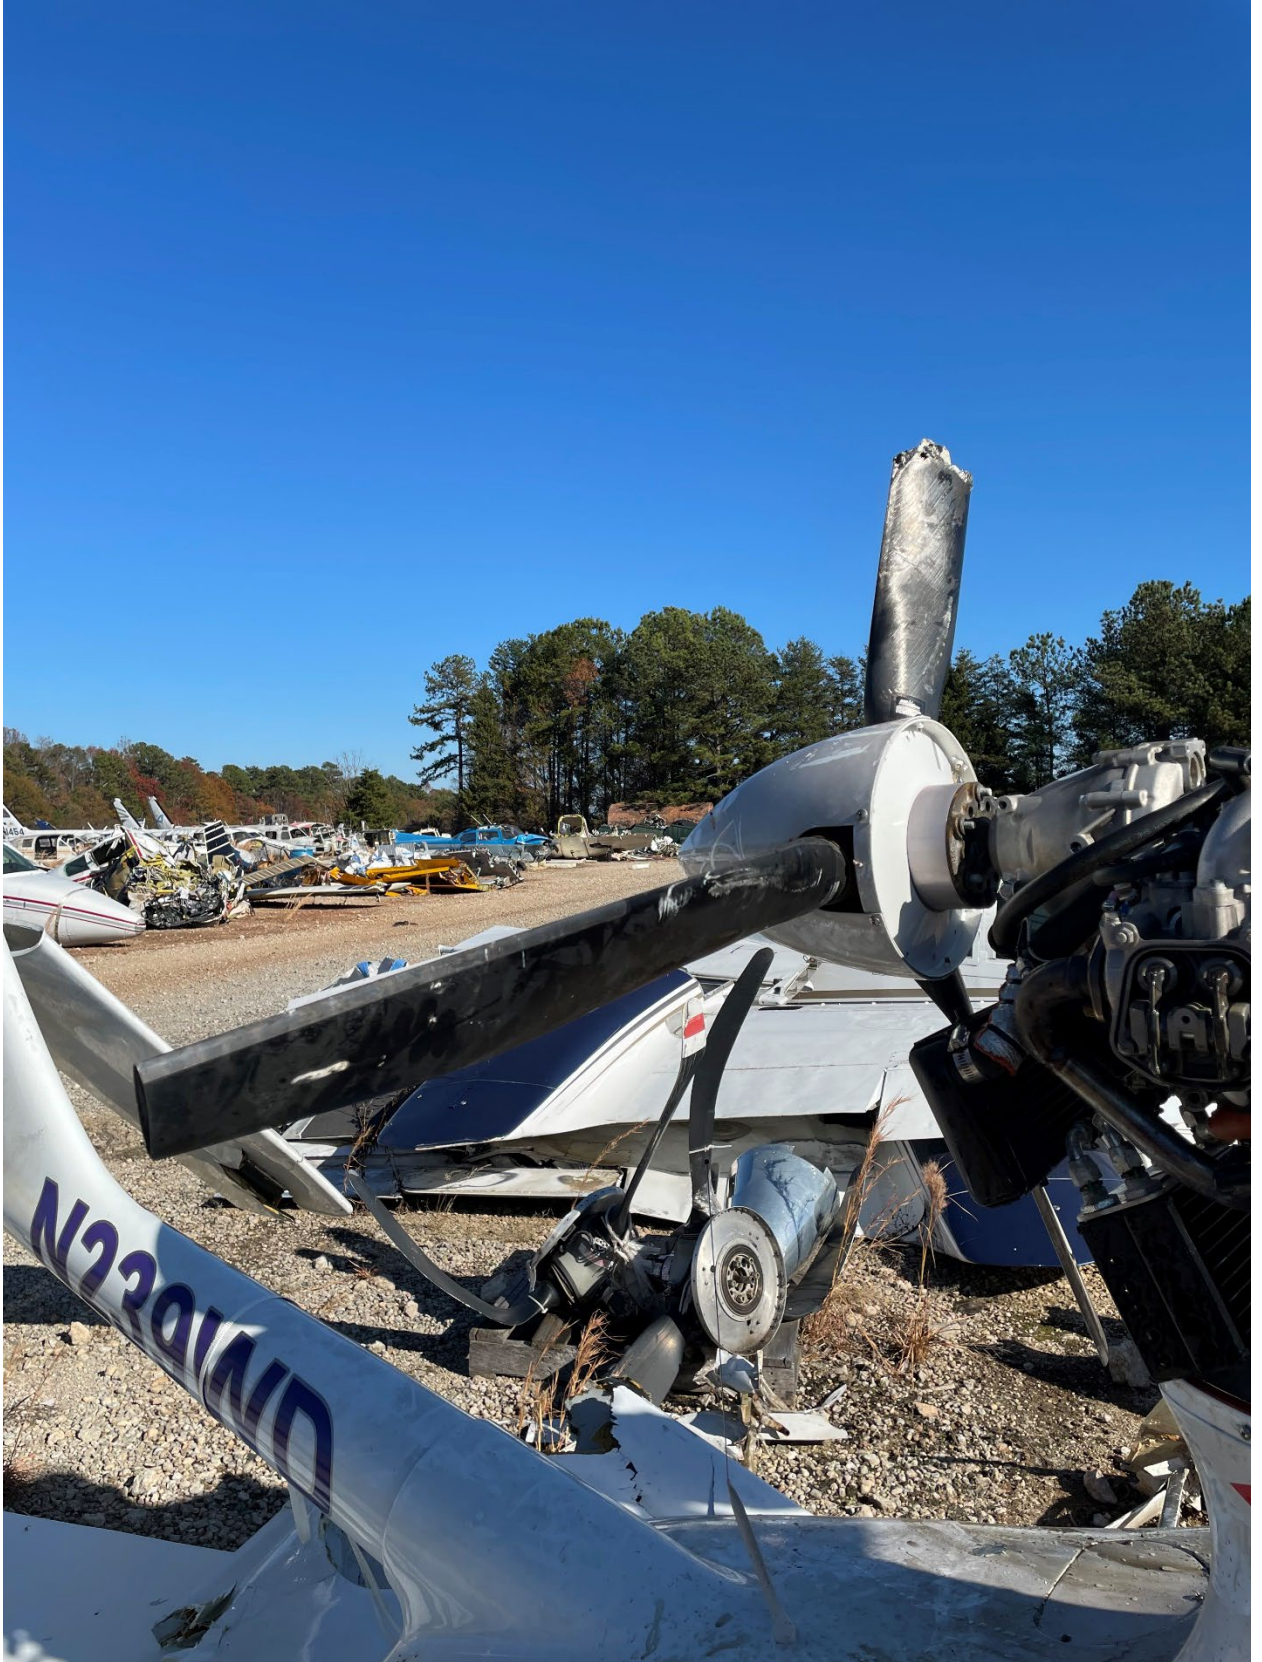
The engine remained secured to the engine pylon and was undamaged. The three bladed propeller remained secure to the engine. And all three blades were secure to the hub. The outer half of one blade was missing and the remaining portion of blade exhibited some gouging. The other two blades were intact and exhibited gouging. The top spark plugs, and valve covers were removed. The engine was manually rotated via the propeller. Valve train continuity and thumb compression were established on each cylinder. The spark plugs appeared light gray in color. The electronic ignition system was not examined.

No mechanical deficiencies or malfunctions were observed that would have precluded normal operation of the engine or airframe.
