National Transportation Safety Board

ERA23FA046

WRECKAGE EXAMINATION SUMMARY

Location: Southington, Ohio
Date: October 28, 2022
Time: 1243 Eastern Daylight Time
Airplane: Zenith CH 750 Cruzer

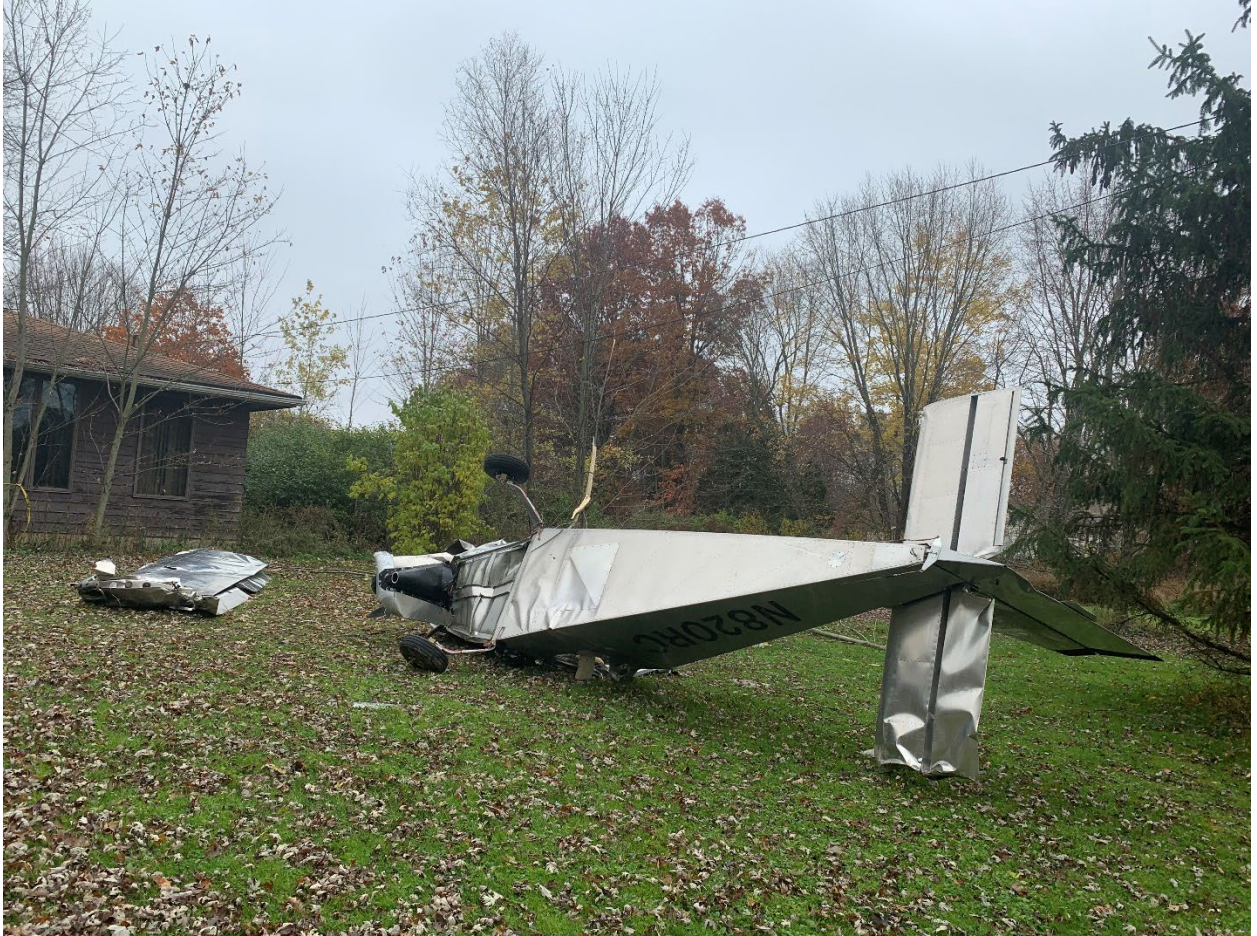
The airplane came to rest in a residential yard about 1,125 ft from the approach end of runway 22 at Warren Airport (62D), Southington, Ohio. All major components of the airplane were located in the vicinity of the main wreckage. An odor similar to gasoline was noted at the accident site.

Figure 2. View of airplane at accident location.

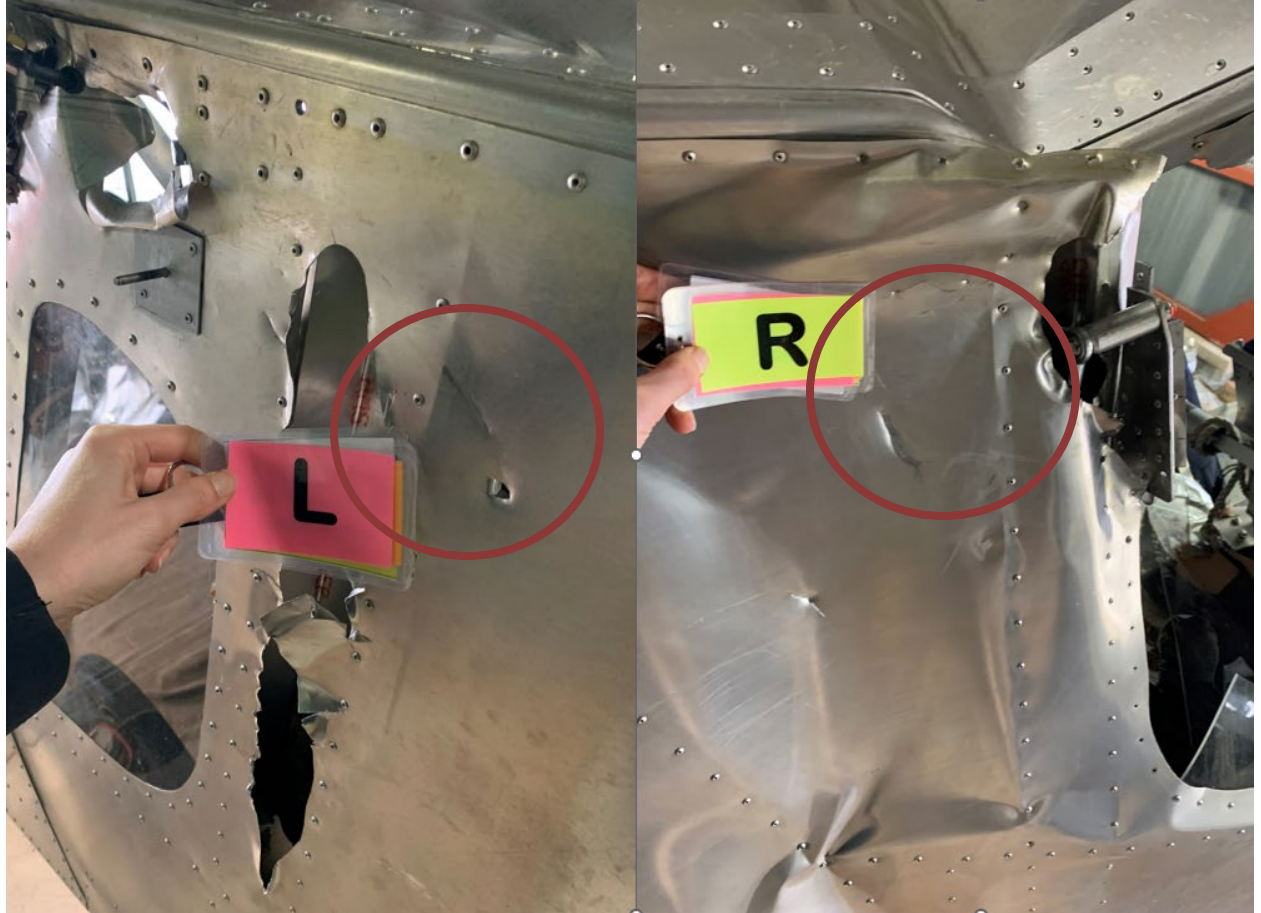
The fuselage remained intact. The empennage remained attached to the fuselage. Flight control continuity was confirmed from the controls in the cockpit to the elevator and rudder. Flight control continuity was confirmed from the control stick in the cockpit to the right aileron, and from the control in the cockpit to the base of the left wing. The control rod from the base of the left wing was stripped from the connection point, however, there were impact marks on the fuselage where the flaperon contacted the fuselage during the impact sequence. Furthermore, the contact signatures on both sides of the fuselage were similar.

Figure 3. View of contact marks from the inboard flaperon. The orange circle notes the impact mark.

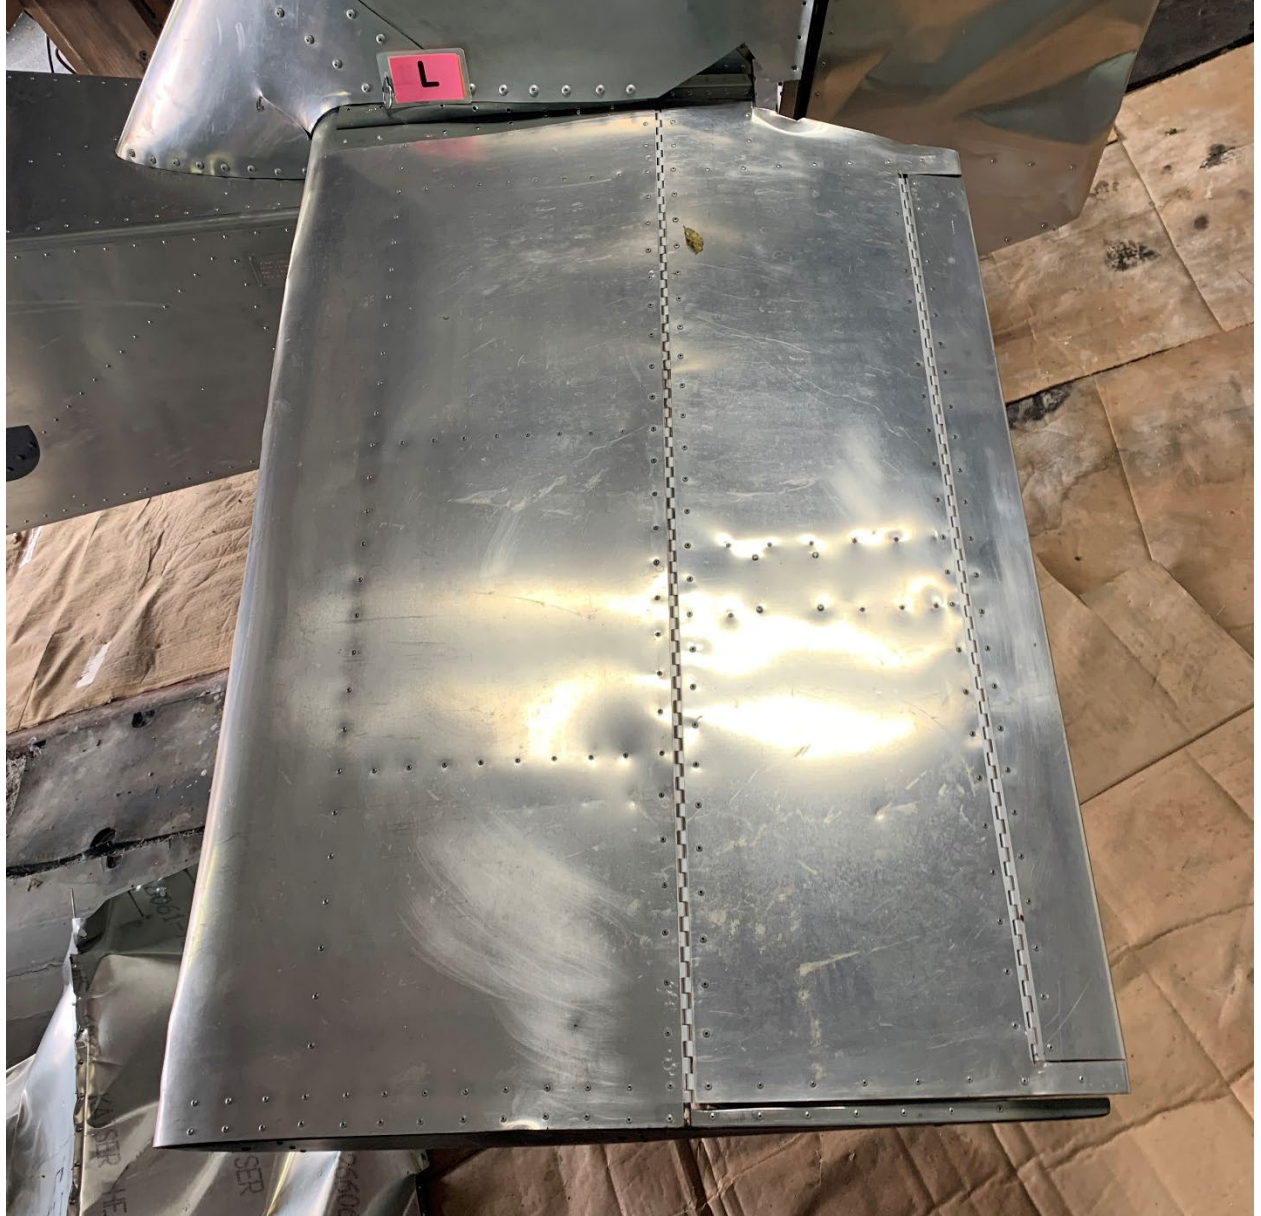
The left horizontal stabilizer remained attached to the empennage. The leading edge exhibited small dents. The left elevator remained attached to the left horizontal stabilizer and the trim tab remained attached to the left elevator.

Figure 4. View of left horizontal stabilizer, left elevator, and trim tab.

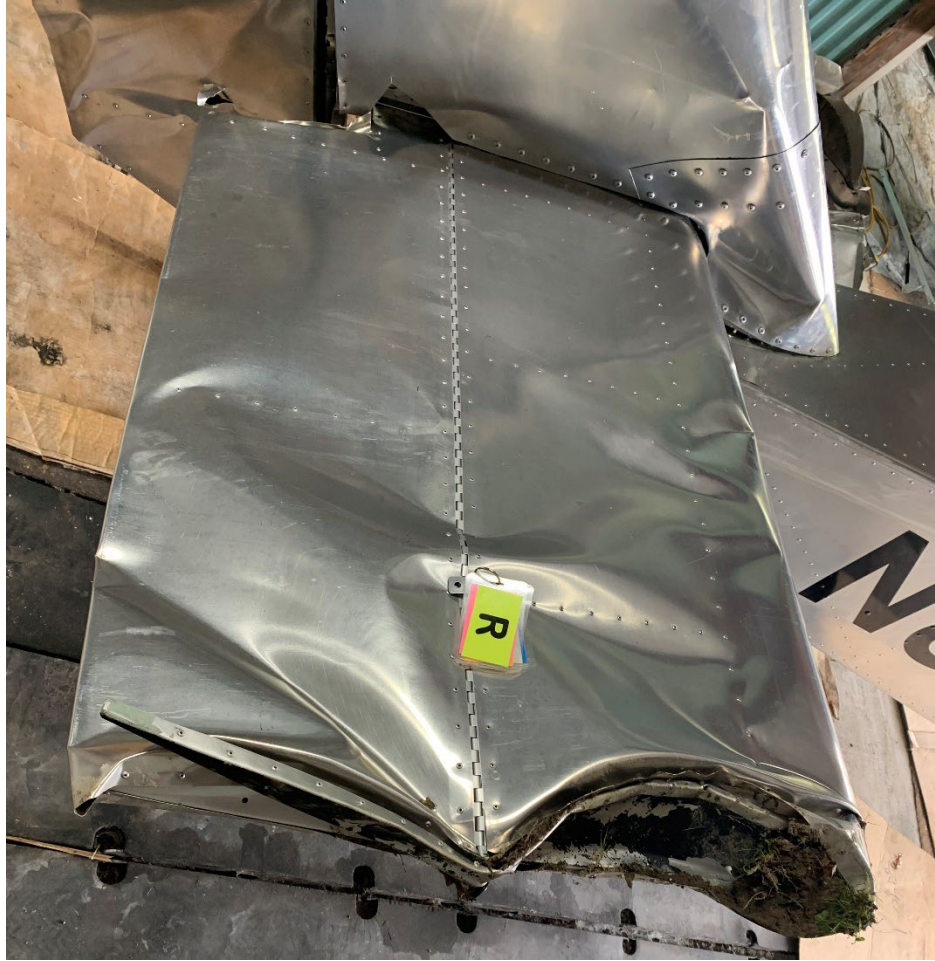
The right horizontal stabilizer remained attached to the empennage and the outboard tip was impact damaged. The right elevator remained attached to the right horizontal stabilizer and the outboard section was wrinkled.

Figure 5. View of right horizontal stabilizer and right elevator.

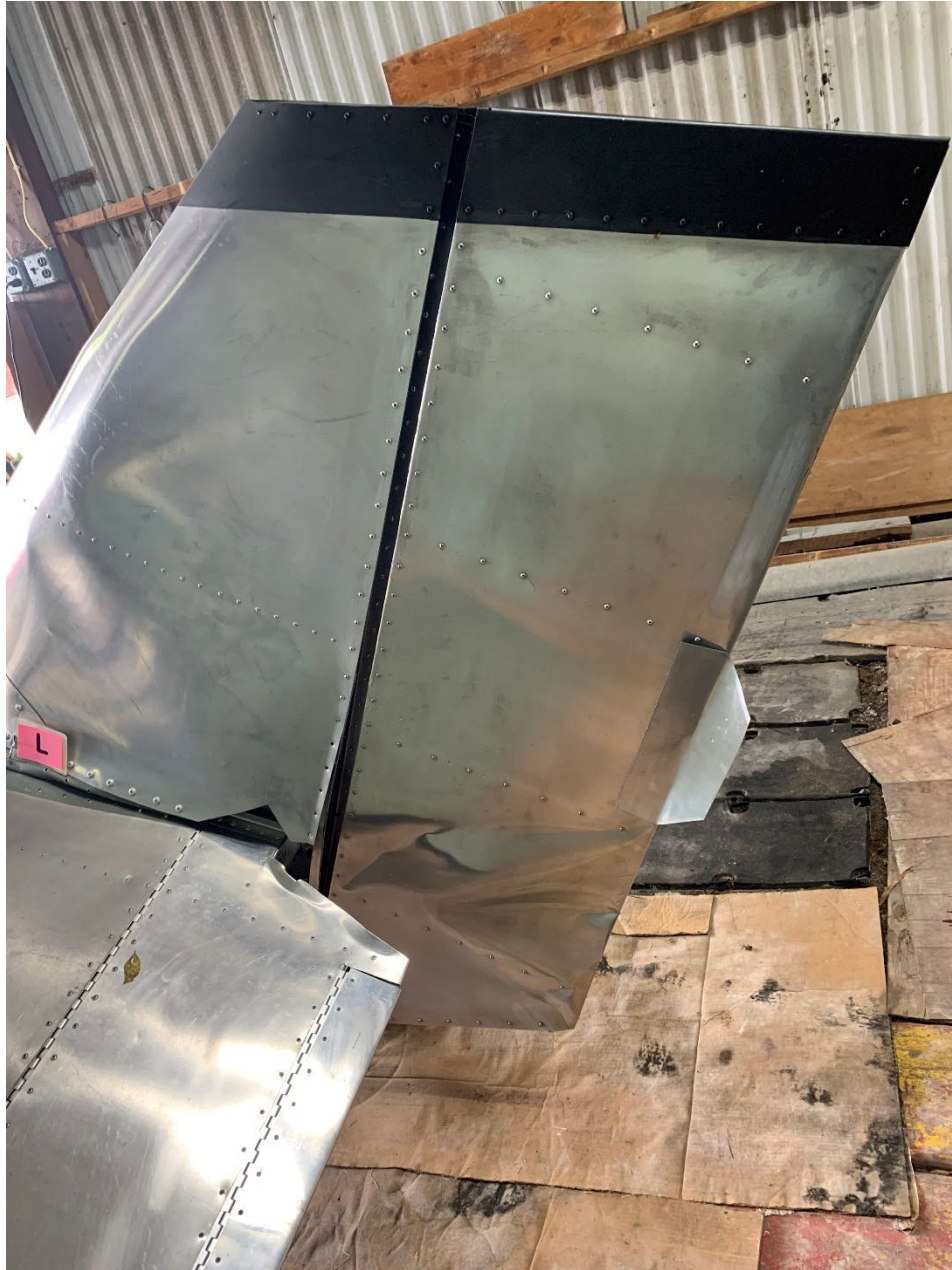
The vertical stabilizer remained attached to the empennage. The rudder remained attached to the vertical stabilizer and was wrinkled.

Figure 6. View of vertical stabilizer and rudder.

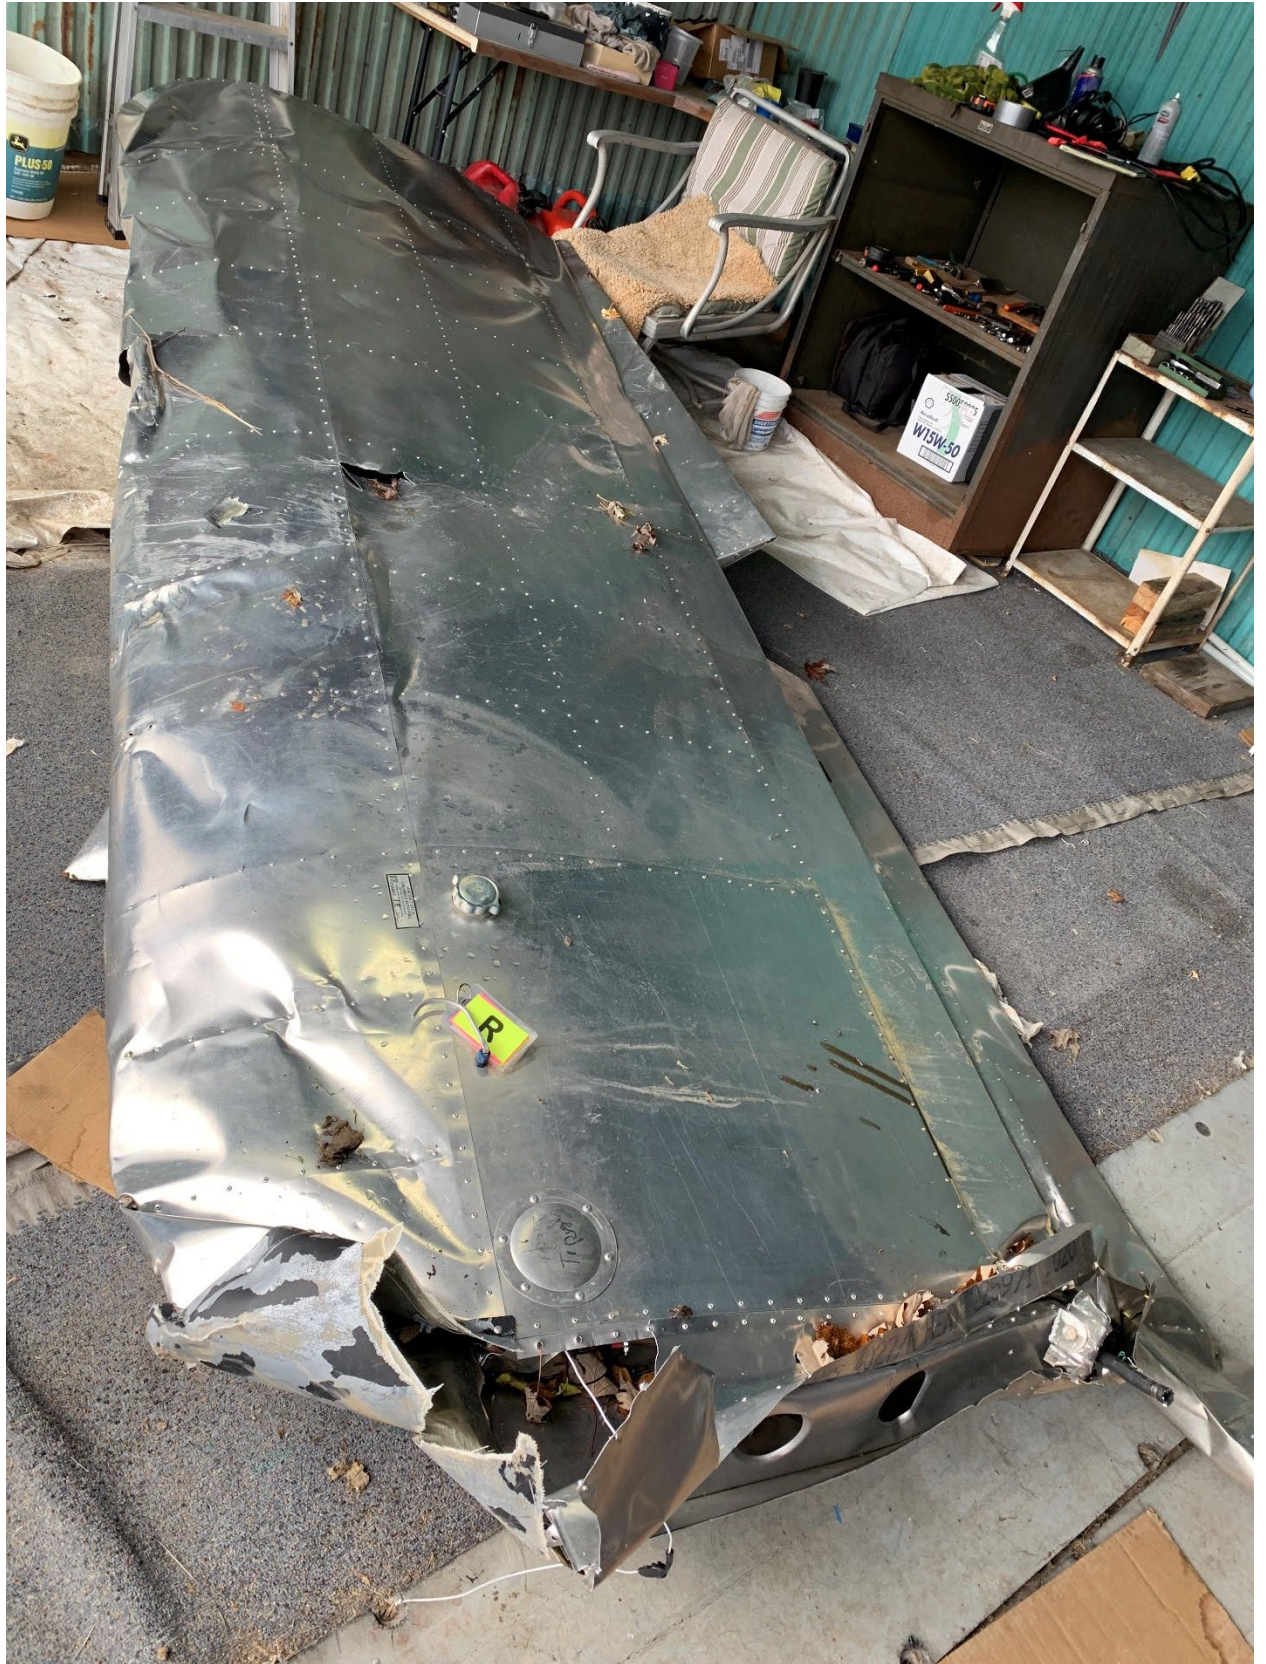
The right wing was separated by first responders. The right inboard flaperon and outboard flaperon remained attached to the right wing at all attach points. The leading edge of the right wing was dented. The inboard section of the right wing was impact damaged as well. The right flaperon flight control attach point remained attached to the aileron pushrod but was impact separated from the flap.

Figure 7. View of right wing after recovery.

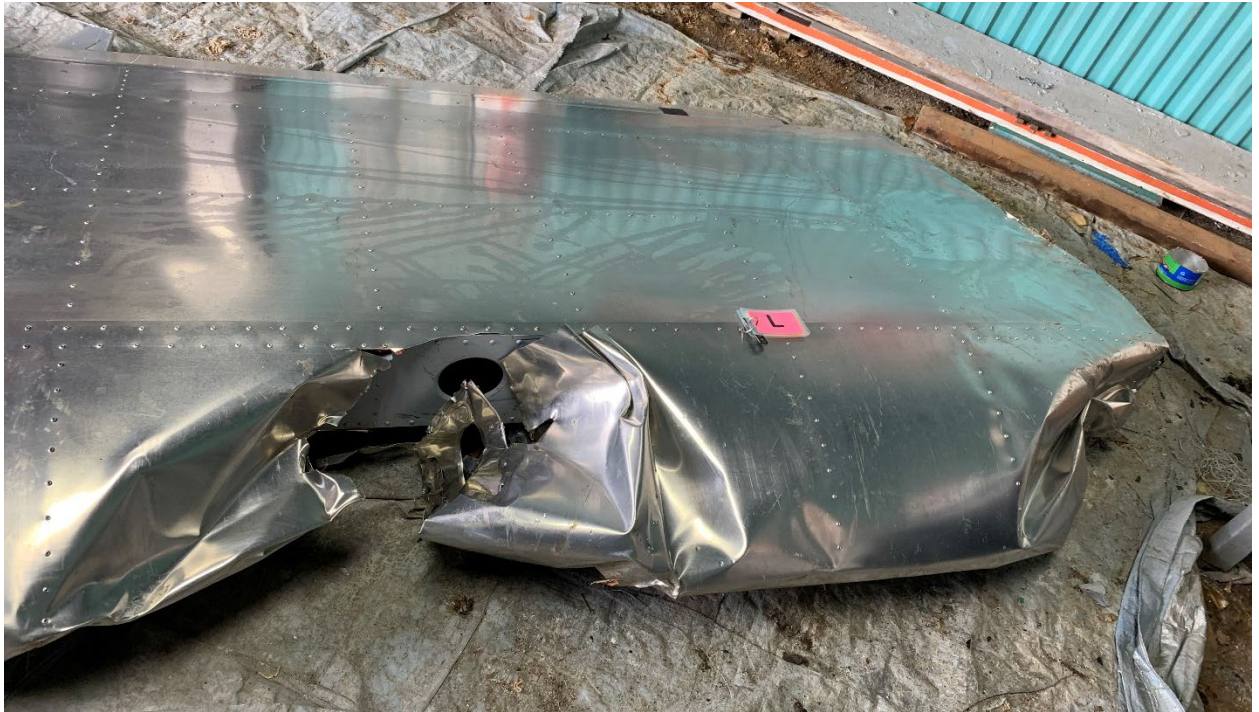
The left wing was cut by first responders. The left inboard and outboard flaperons remained attached to the left wing at all attach points. The left-wing leading edge exhibited a semicircle impact mark that extended from the leading edge of the left wing to the spar and contained organic tree material. Furthermore, the forward section of the left wing tip was impact damaged. The forward inboard section of the left wing was impact crushed as well. The fuel cap remained in place and secure. The left flaperon flight control attach point was separated from the push rod and both sides were retained for further examination.

Figure 8. View of left wing semicircular impact damage and wing tip damage.

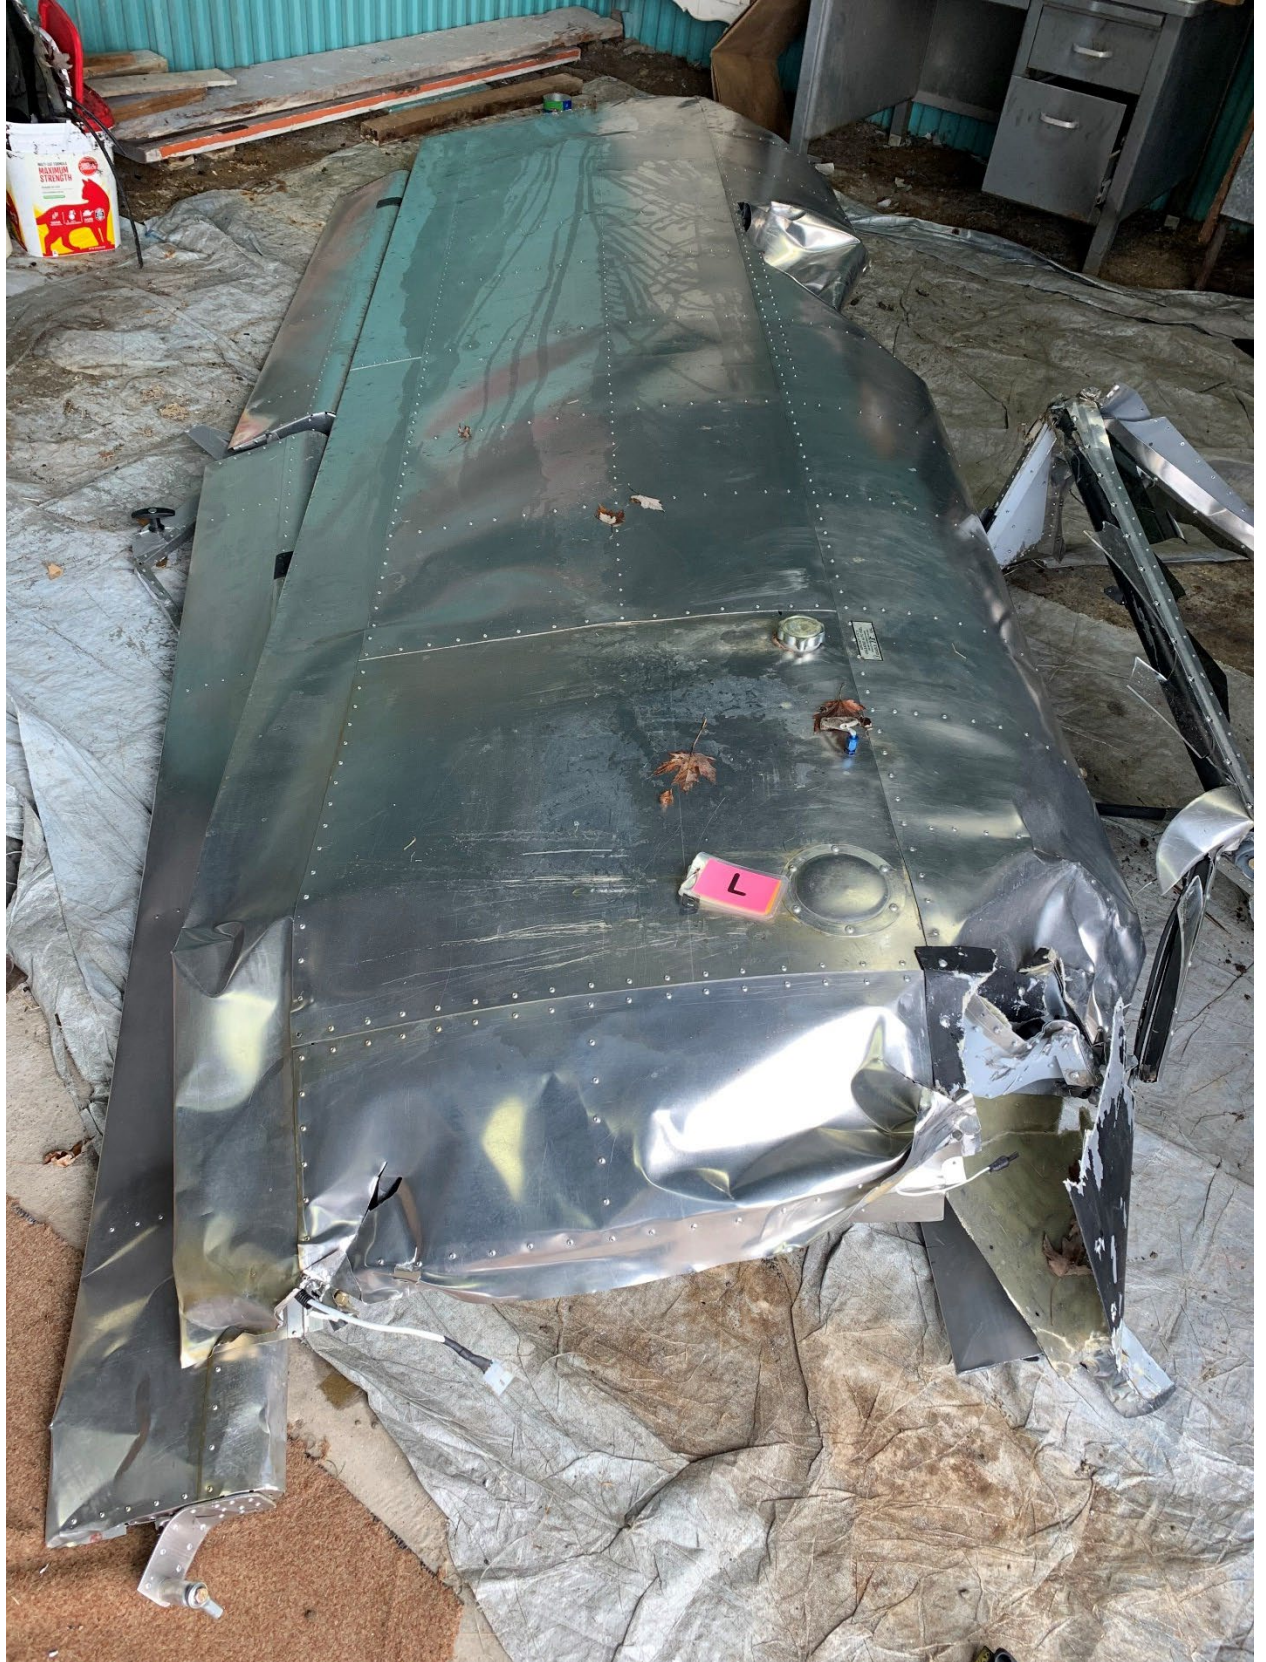
Figure 9. View of entire left wing after recovery.

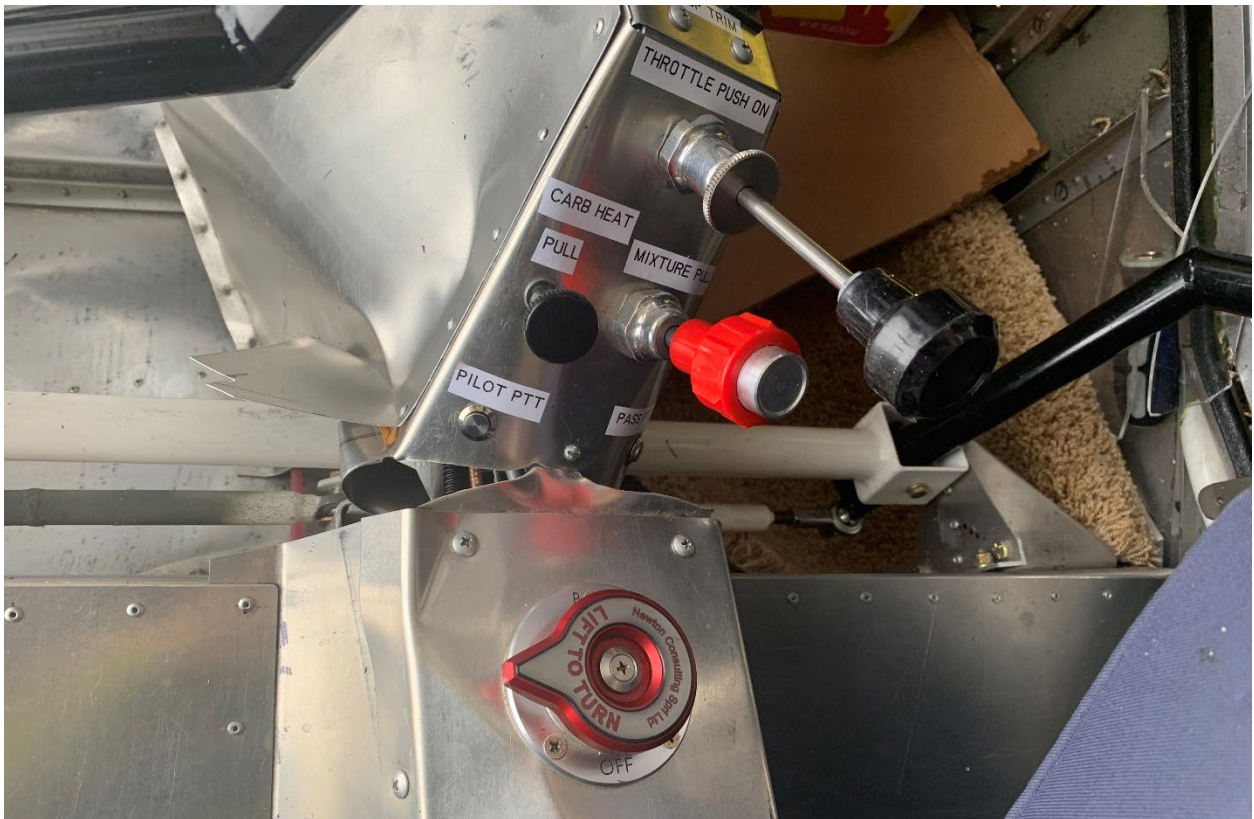
The cockpit was intact. The plexiglass roof section was shattered and located along the debris path. The throttle was in the idle position and the mixture was in the full rich position. The carburetor heat was in the OFF Position. The fuel selector indicated the left tank was selected.

Figure 10. Engine control positions.

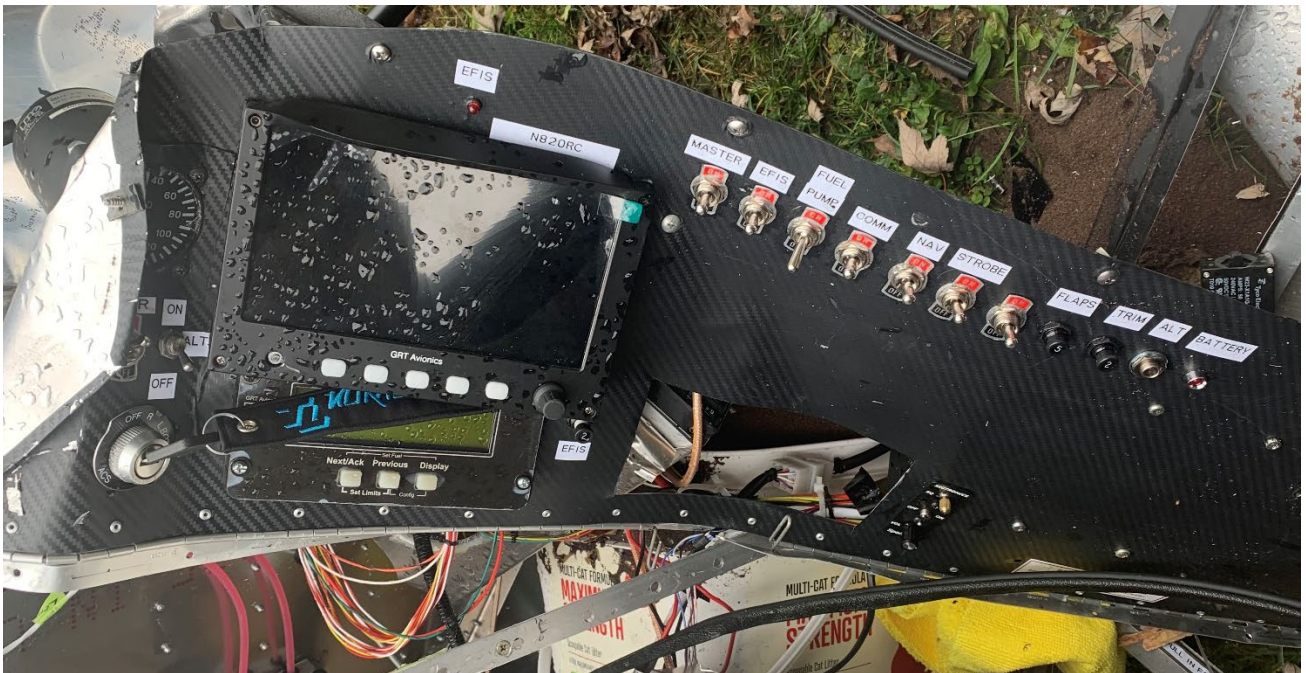
MASTER - ON
EFIS - ON
FUEL PUMP - OFF
COMM - ON
NAV - ON
STROBE - ON

MASTER - ON
Alternator - OFF

The ignition was in the BOTH position.

Figure 11. Panel Switch Positions.

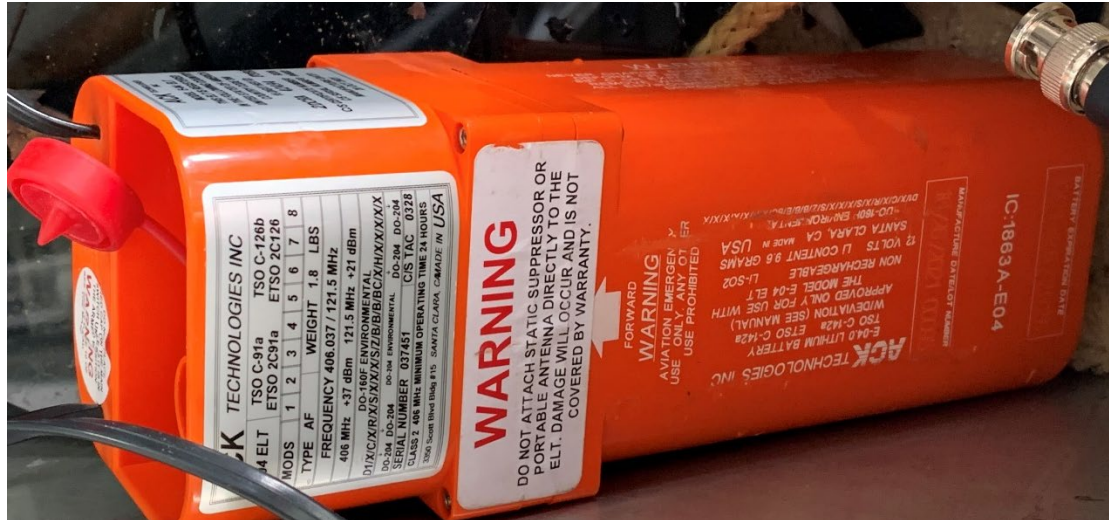
The ELT was located in the aft of the airplane in the OFF position. When asked, none of the first responders turned the ELT to the OFF position after the accident.

Figure 12. View of ELT

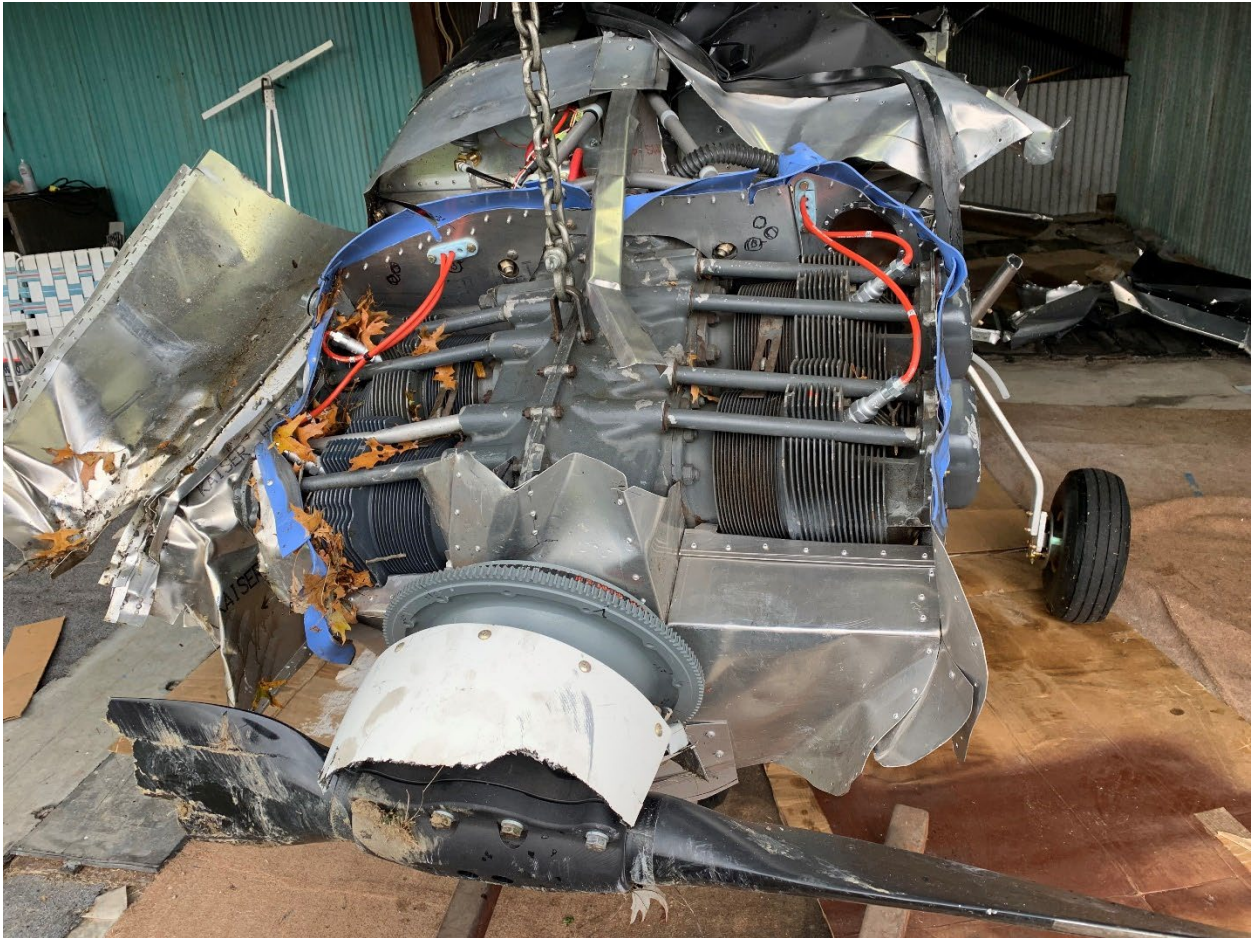
Figure 14. View of engine after airplane was recovered.

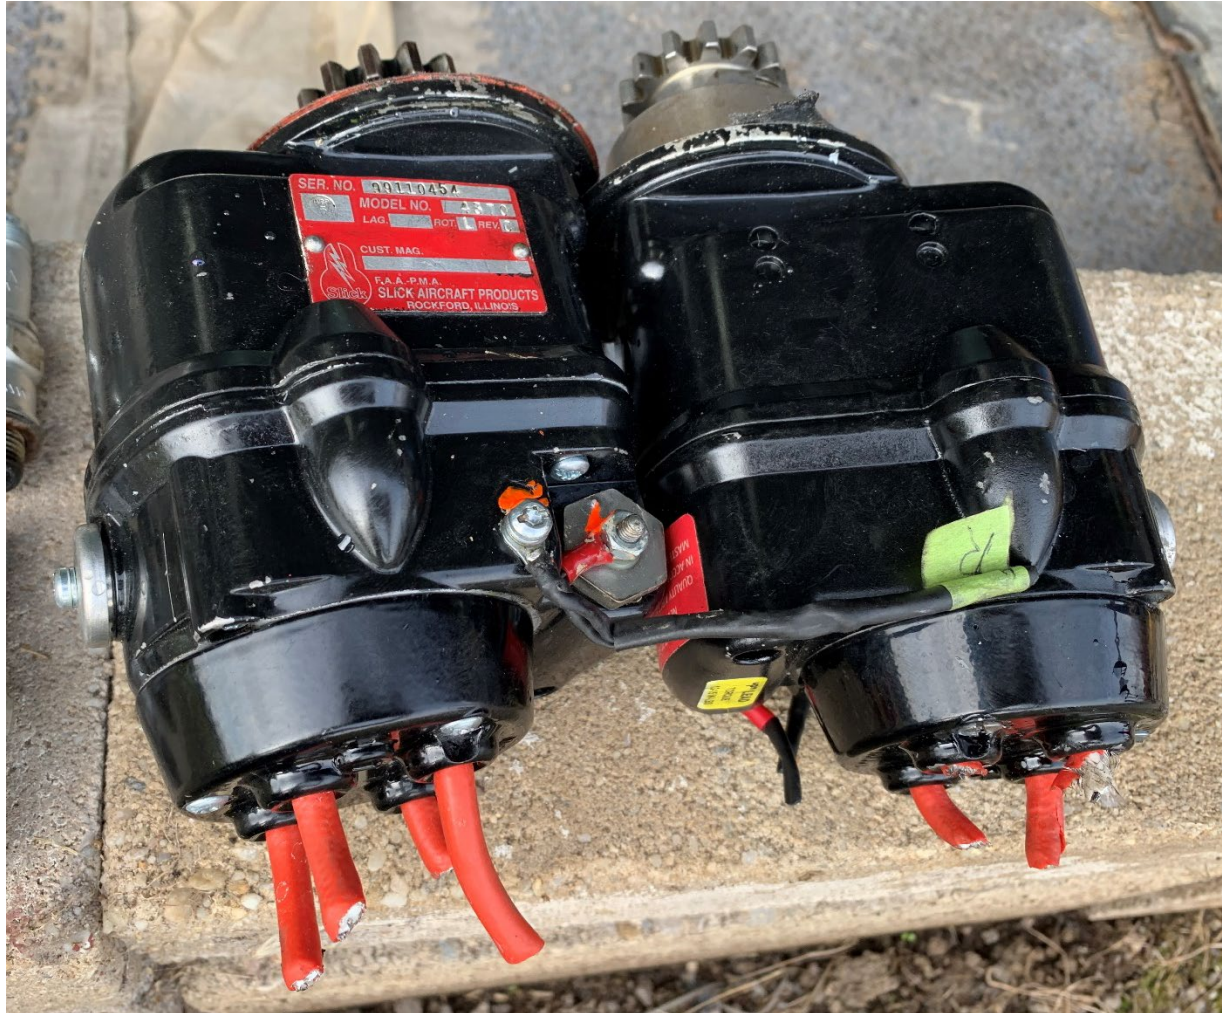
Both magnetos remained attached to the accessory section of the engine. Each were turned by hand and produced spark on all towers. Magneto timing was checked and no anomalies were noted.

Figure 15. View of both magnetos removed from engine.

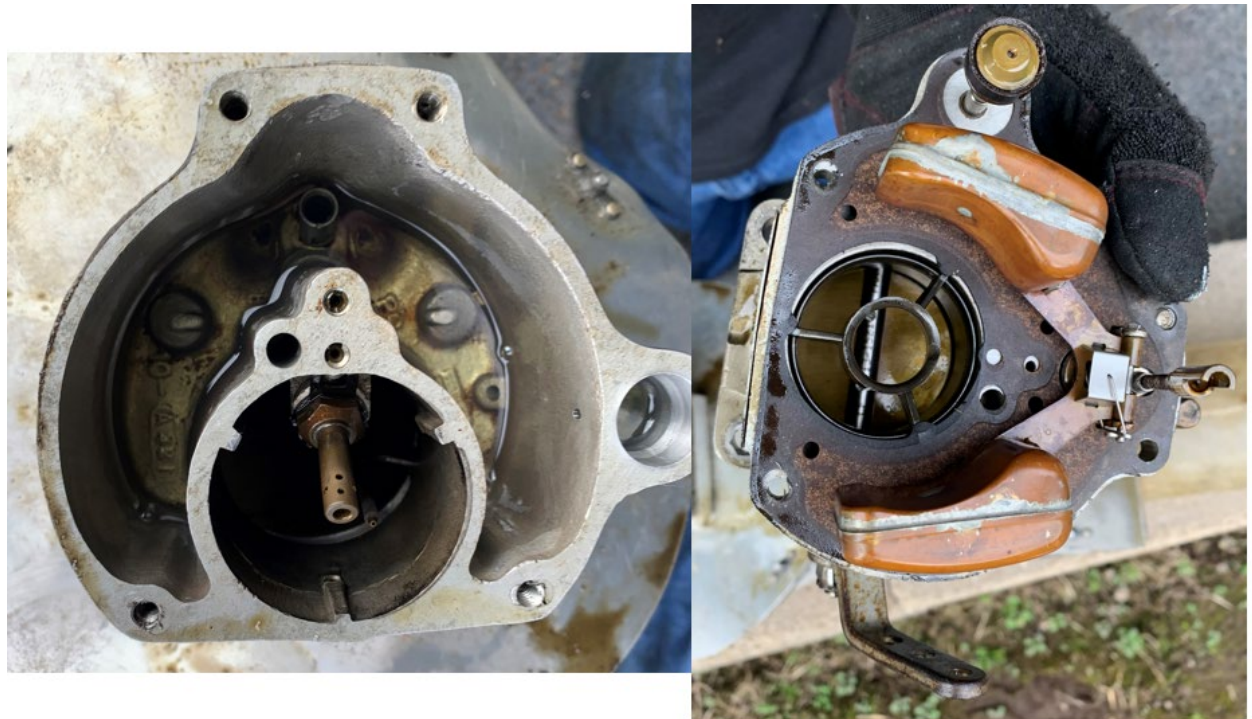
The carburetor remained attached and secure to the engine. It was removed and disassembled for further examination. The accelerator pump could be operated by hand, the butterfly valve moved freely, and the carburetor was not equipped with a fuel inlet screen. Fuel was noted in the carburetor bowl. The fuel was tested with water finding paste and no water was noted. The carburetor floats were examined and not damaged.

Figure 16. View of Disassembled Carburetor.

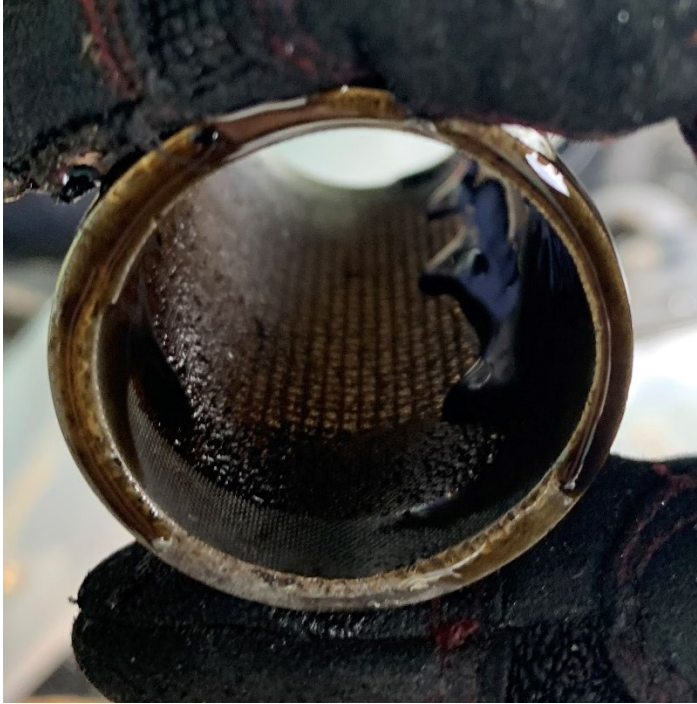
There was oil in the engine. The oil pressure screen was removed and a small amount of debris was noted, but the screen was not obstructed. The oil suction screen was removed from the engine and no debris was noted. The oil dip stick remained in the oil filler neck, but the filler neck was impact separated at the base.

Figure 17. View of oil pressure screen.

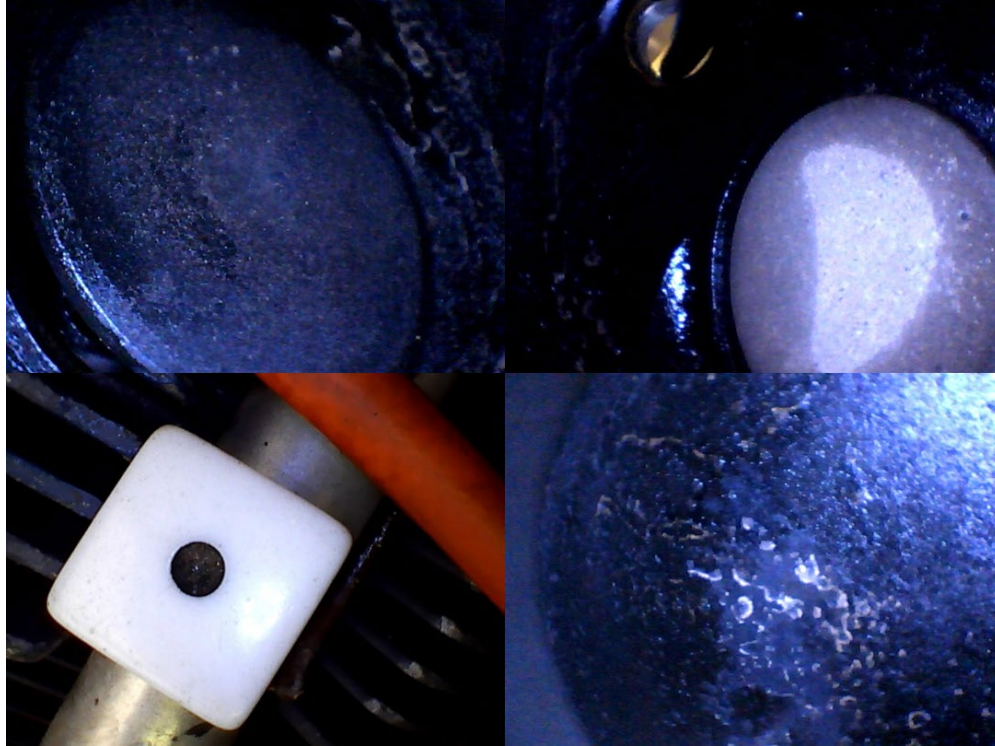
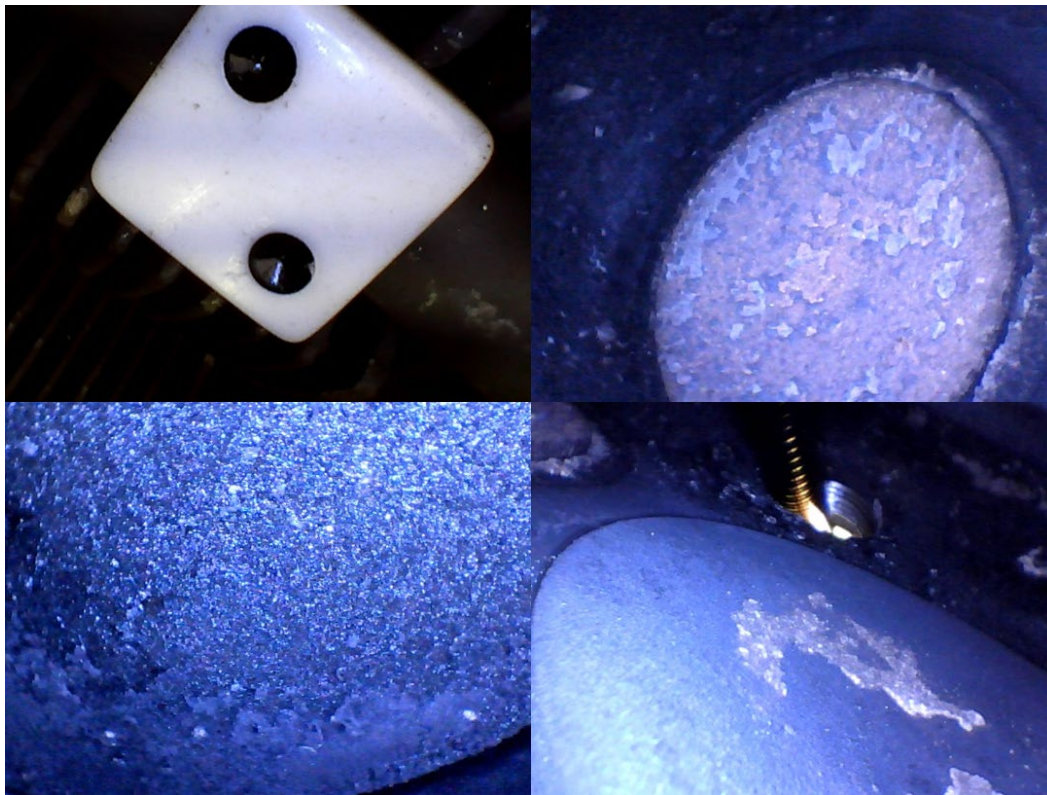
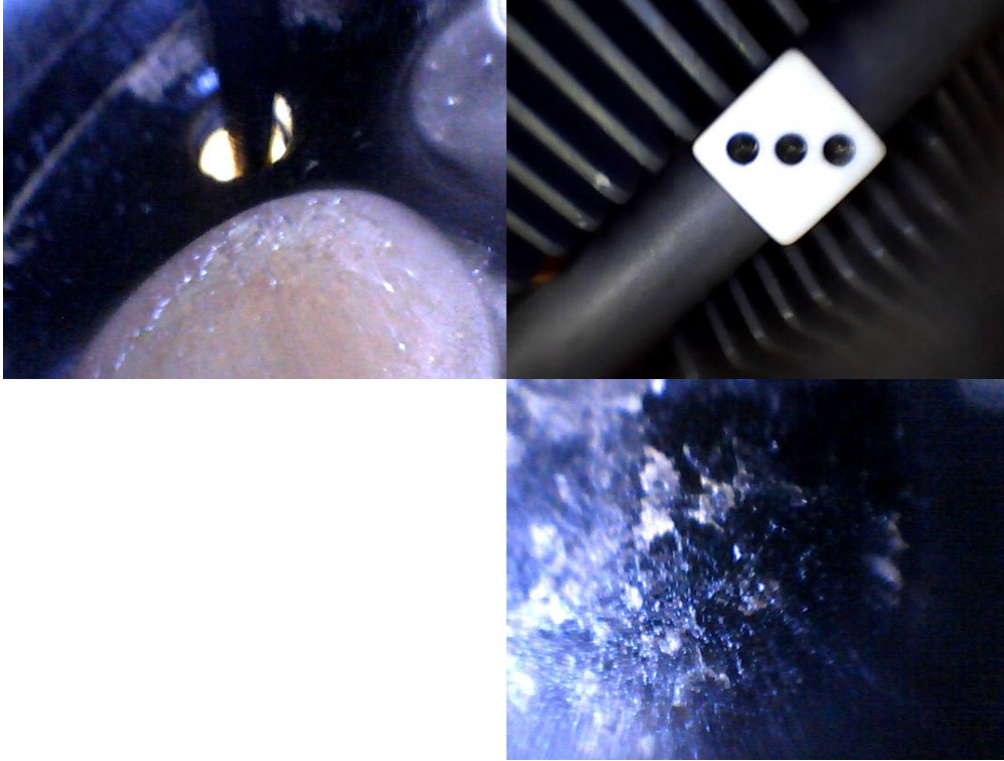
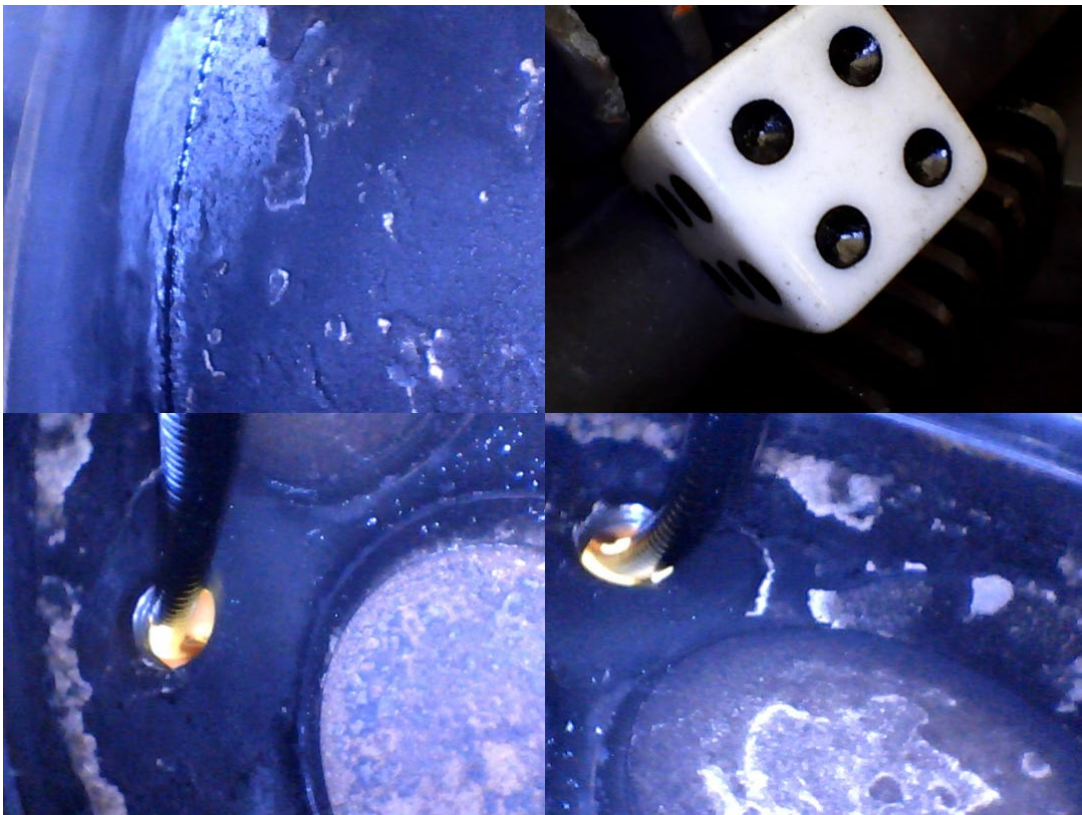
The propeller was rotated by hand through 360° of motion and crankshaft and valvetrain continuity was confirmed. Thumb compression was noted on all cylinders. The cylinders were examined by a lighted boroscope, and no anomalies were noted.

Figure 18. View of piston face and valves from Cylinder No. 1.

Figure 19. View of piston face and valves from Cylinder No. 2

Figure 20. View of piston face and valves from Cylinder No. 3. Note you can see both valves in the top section of photograph.

Figure 21. View of piston face and valves of Cylinder No. 4.

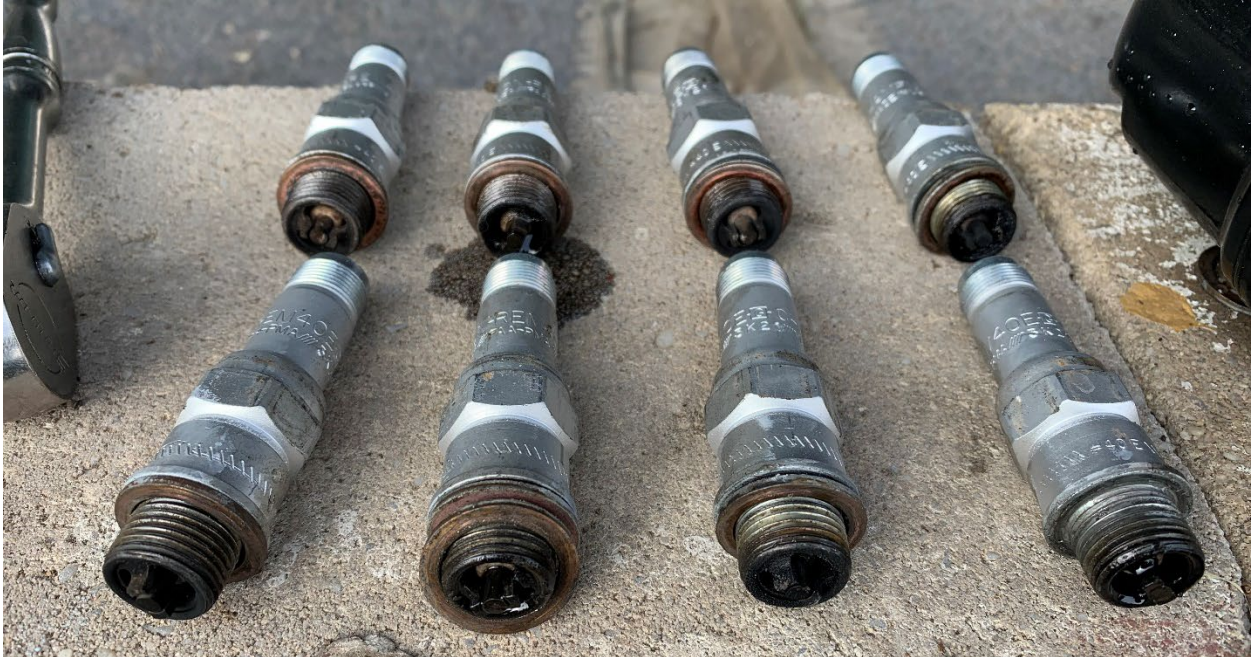
The spark plugs were removed from each cylinder and examined. All electrodes exhibited normal wear and were carbon fouled. The top spark plug in the No. 1 cylinder and both spark plugs in No. 3 cylinder were oil soaked from the wreckage orientation.

Figure 22. View of all spark plugs removed from engine.
