National Transportation Safety Board

ERA23FA046

WRECKAGE EXAMINATION SUMMARY

Location: Southington, Ohio
Date: October 28, 2022
Time: 1243 Eastern Daylight Time
Airplane: Zenith CH 750 Cruzer

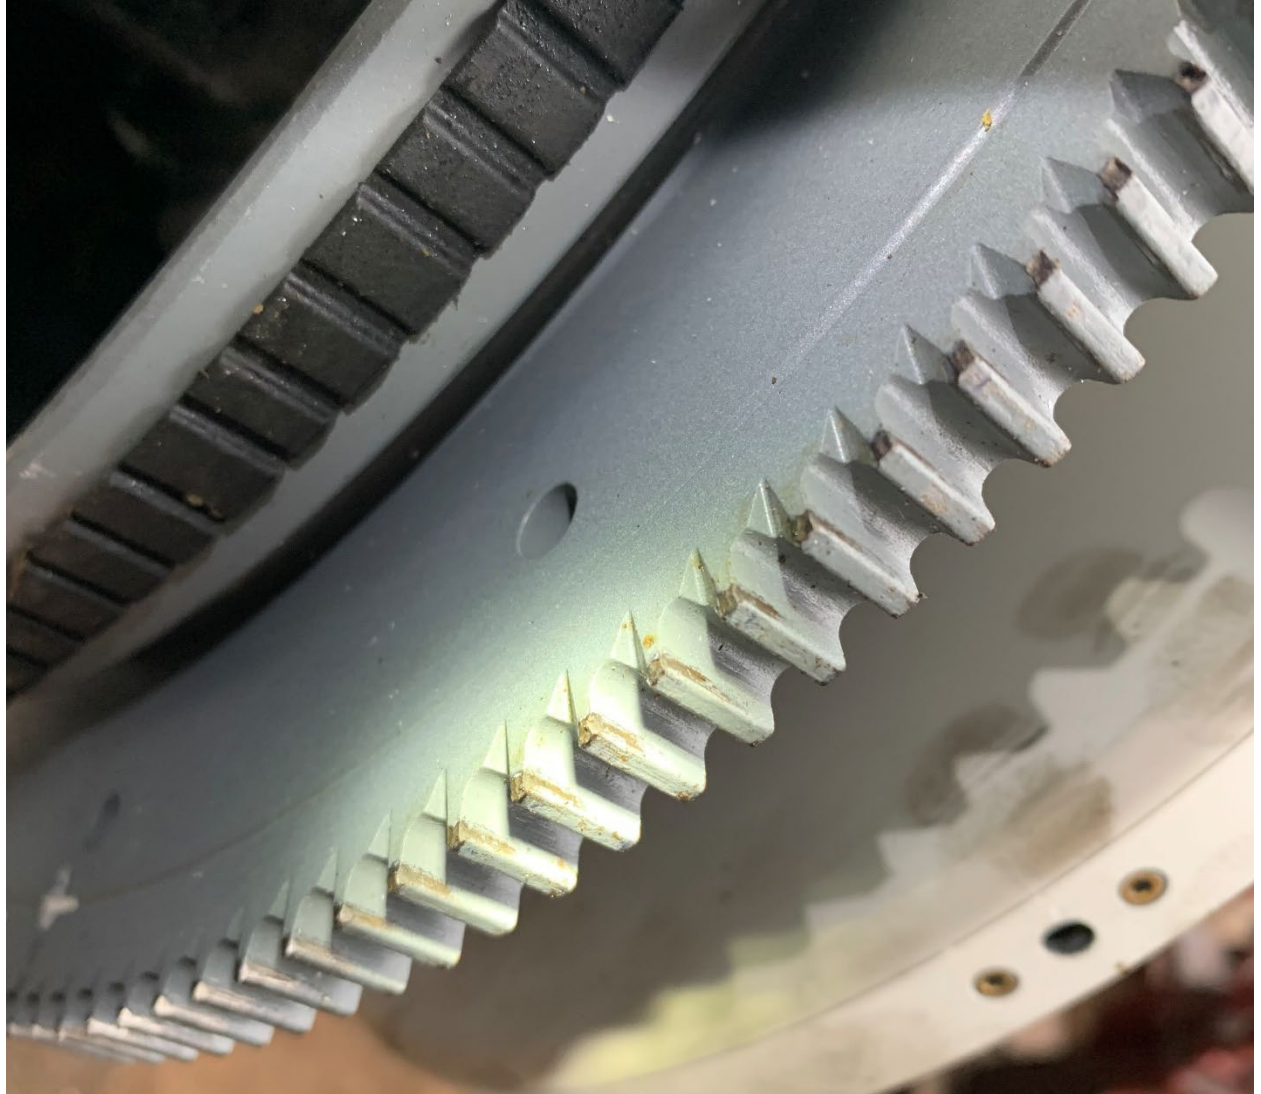
The starter remained attached to the engine. The starter ring gear exhibited impact damage on multiple gear teeth.

Figure 23. Starter ring gear teeth damage.

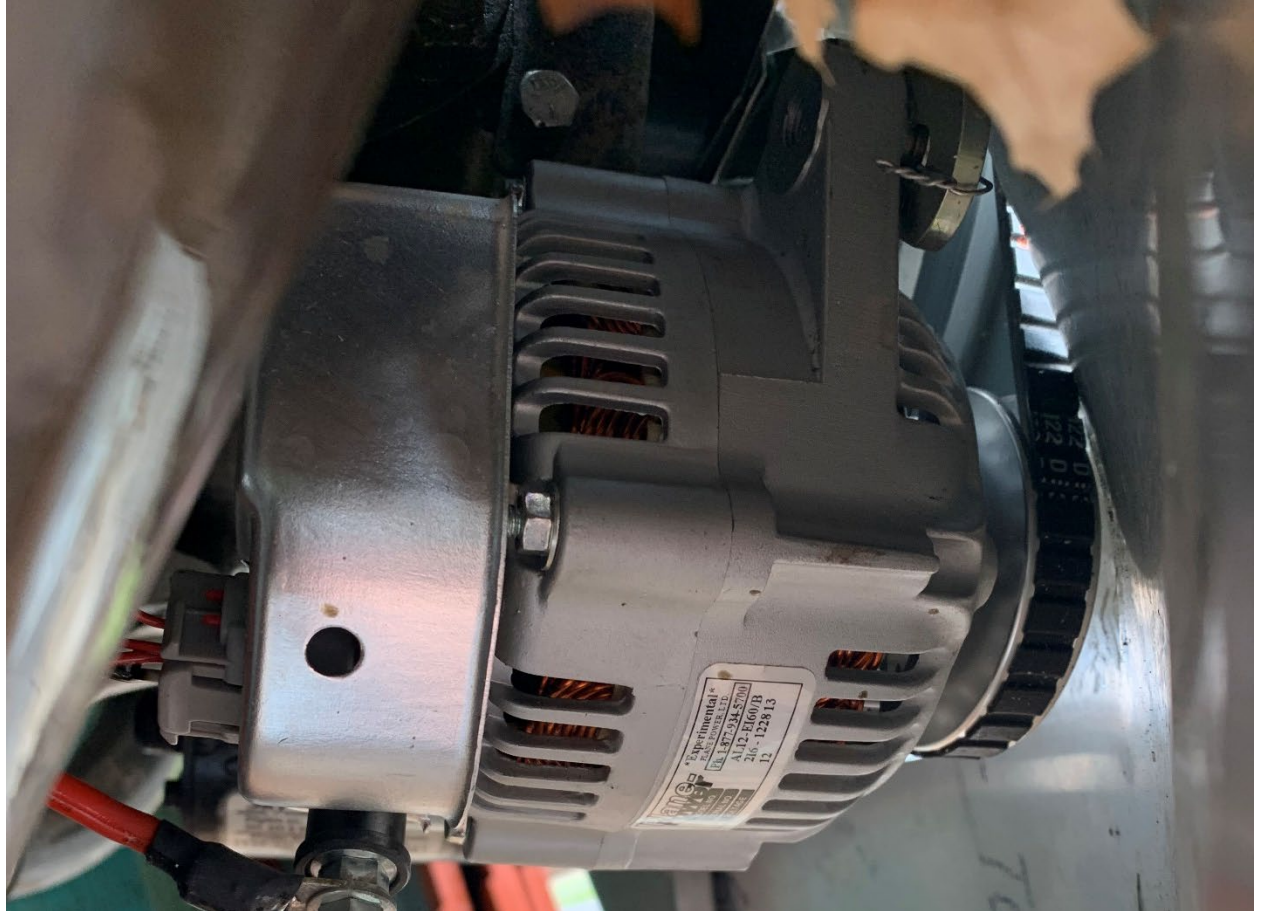
The alternator remained attached to the engine.

Figure 24. View of alternator attached to engine.

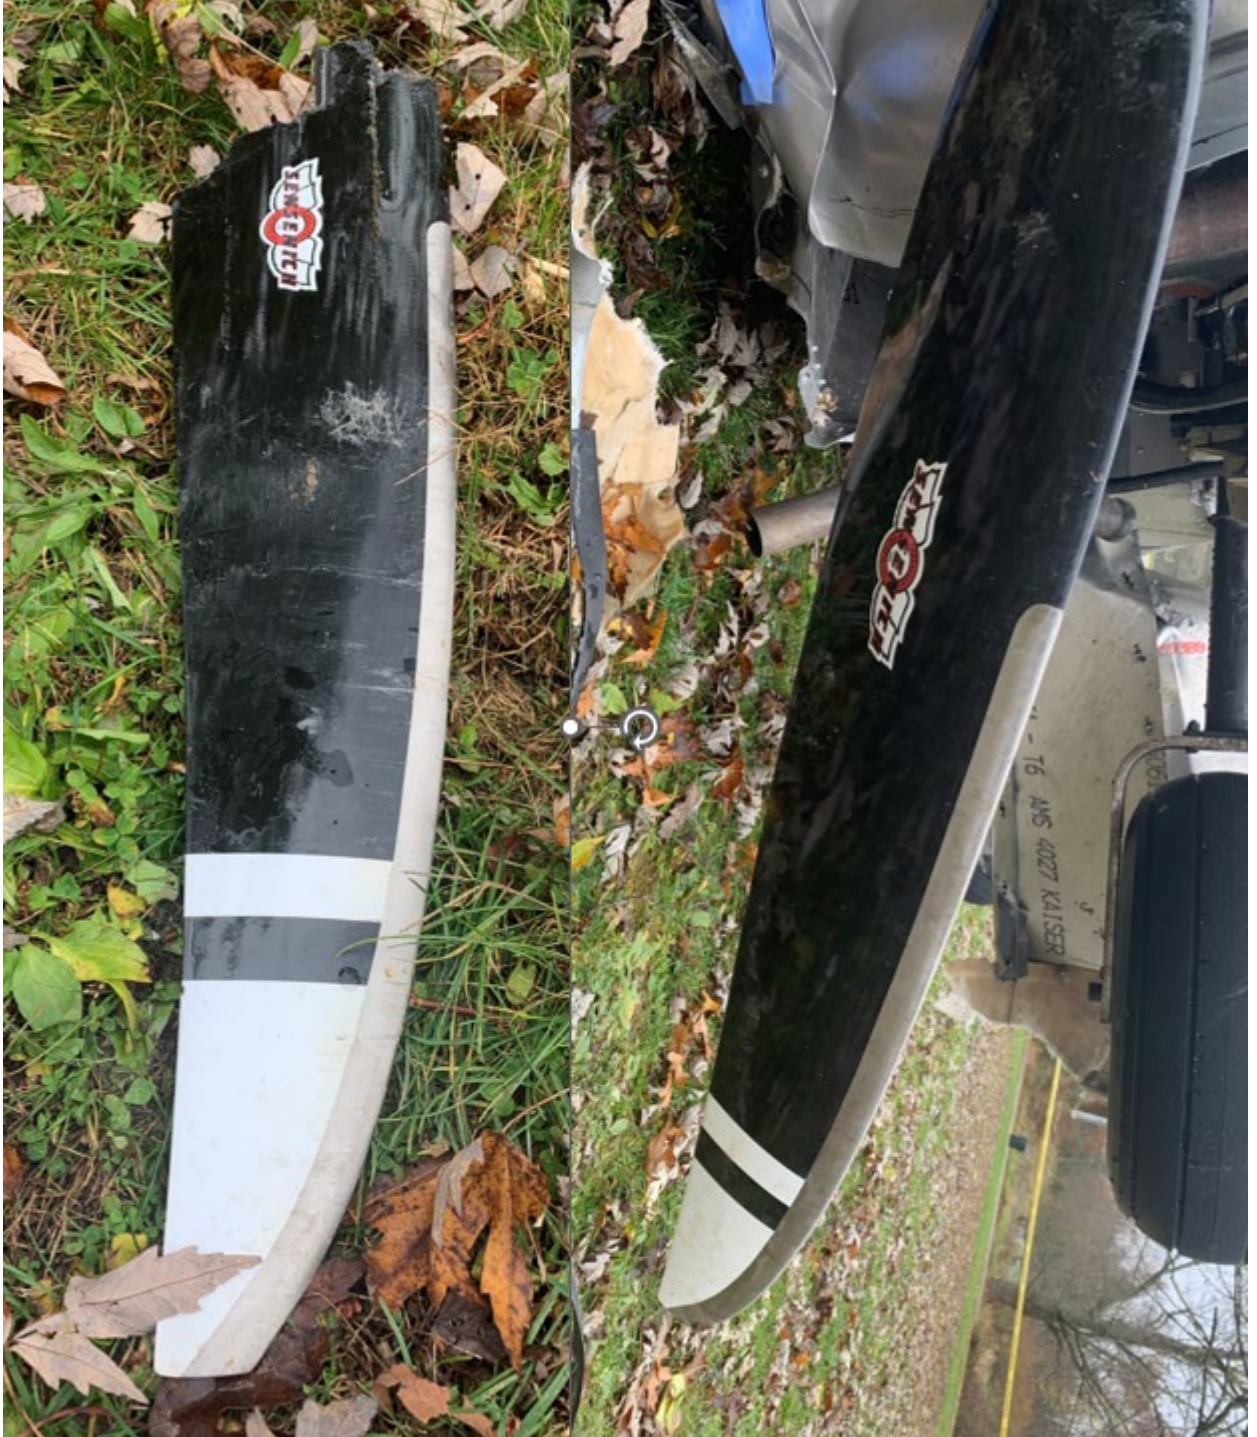
The propeller hub remained attached to the crankshaft. One blade remained attached to the hub and exhibited light chordwise scratching. The other blade was impact separated, located in the vicinity of the main wreckage, and exhibited light chordwise scratching. The ground was cut in the vicinity of the separated propeller blade.

Figure 25. View of propeller blades.
