# National Transportation Safety Board

ERA23FA033

## **WRECKAGE EXAMINATION SUMMARY**

Location: Keene, New Hampshire  
Date: October 21, 2022  
Time: 1845 EDT  
2245 coordinated universal time (UTC)  
Airplane: N8020R, Beech A24R

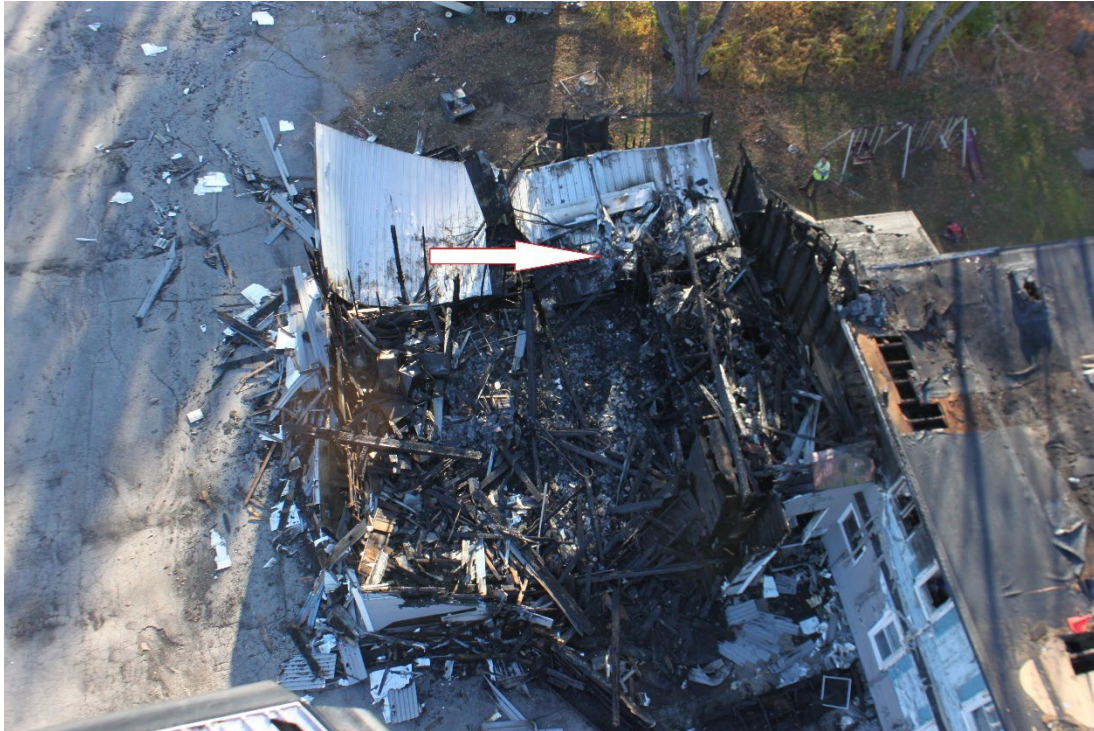
Examination of the accident site revealed extensive heat and impact damage to the storage building and its contents and its metal roof, several of the apartments, and its roof. Inspection of the metal roof which was displaced from its normal position revealed it contained red paint transfer oriented on a magnetic heading of 021°. The red paint transfer was located to the right side of the energy path. Two parallel slash marks on the metal roof were oriented 66 inches apart, though the scars were not oriented in a direction consistent with the direction of flight.

**Figure 1: Aerial Photograph of Accident Site. Arrow Points to Aft Empennage.**

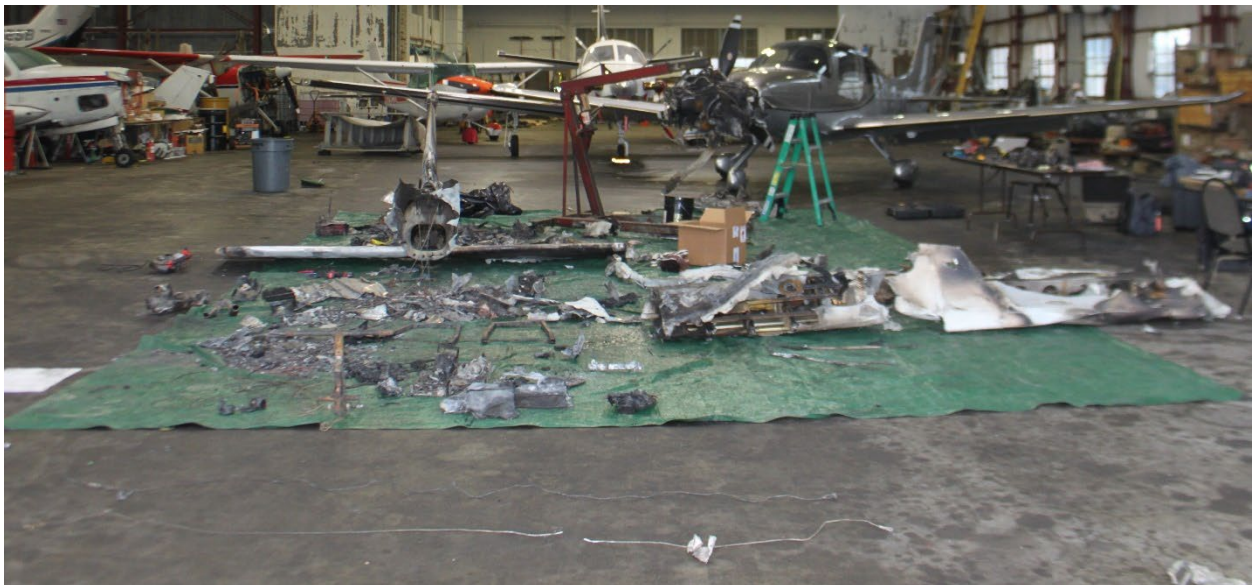
Examination of the wreckage revealed the cockpit, cabin, right wing, portion of the left wing, and forward portion of the aft empennage were nearly consumed by the postcrash fire to approximately fuselage station 250.00.

**Figure 2: Image of Reconstructed Wreckage.**

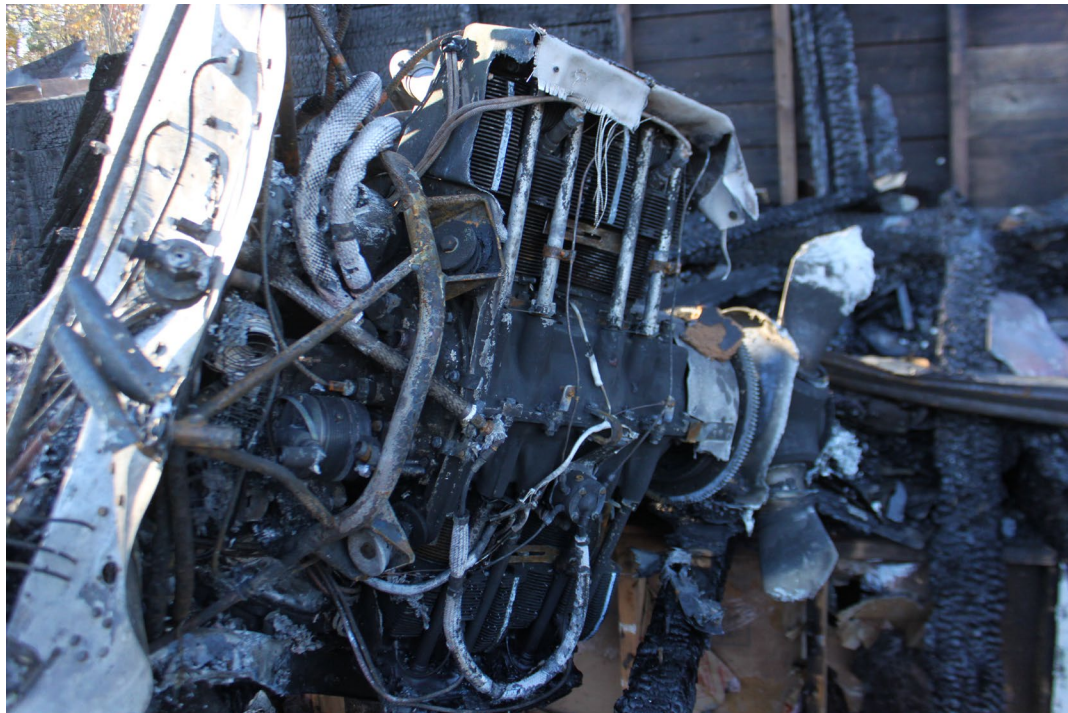
The aft portion of the aft empennage, heat-damaged sections of the left wing, pitot tube, and melted aluminum were found on top of the metal roof. Additional wreckage debris was found among the building debris. The engine with attached propeller was resting on its right side forward of the aft empennage. No bird remains was found among the wreckage. A 1.5 inches diameter tree limb located on the ground beneath a tree immediately adjacent to the accident site had a 45° slash thru nearly 1/2 diameter.

**Figure 3: Aerial Photograph of Close-Up of Engine Assembly with Attached Propeller at the Accident Site.**

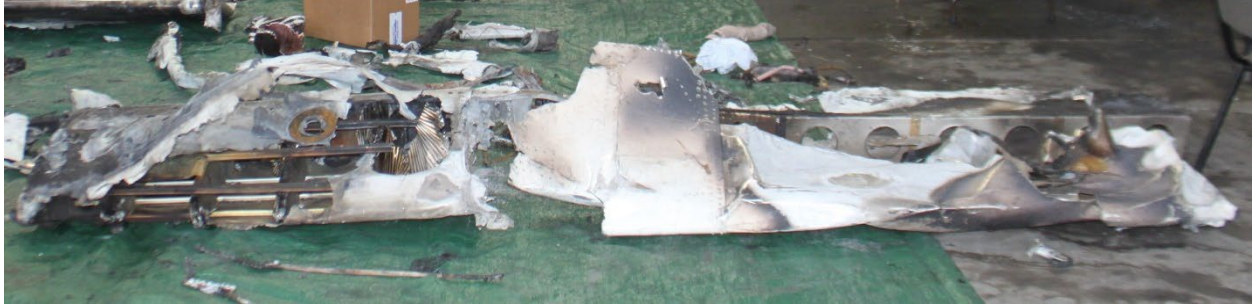
Examination of the left wing revealed it was fragmented. The pitot tube and landing gear were separated from the structure; the pitot tube was clear. The landing gear actuator was located and was measured to have an 11 inches extension; the actuator was capable of movement by hand. The fuel tank outlet screen had melted material adhering to it and the fuel tank was breached; no fuel was observed.

**Figure 4: Cropped Image of Remains of Left Wing in Foreground.**

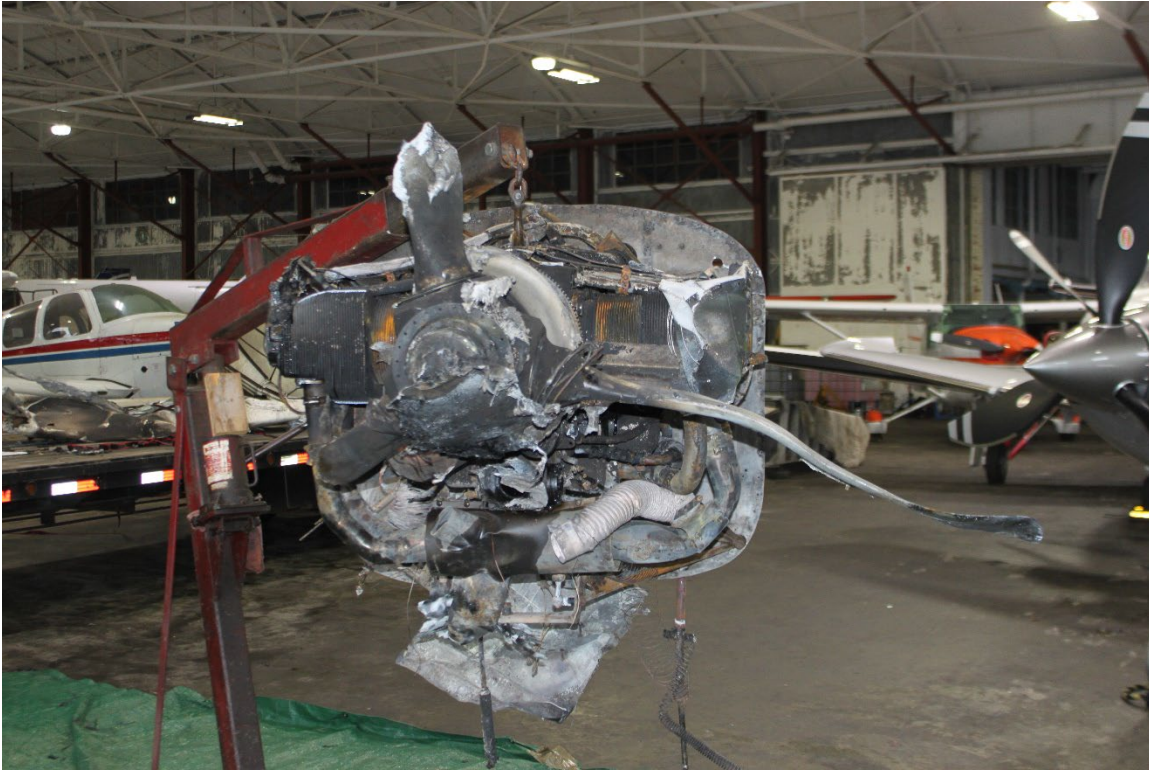
Examination of the engine revealed it sustained heavy fire damage.

**Figure 5: Frontal View of the Engine Assembly with Attached Propeller and Firewall.**

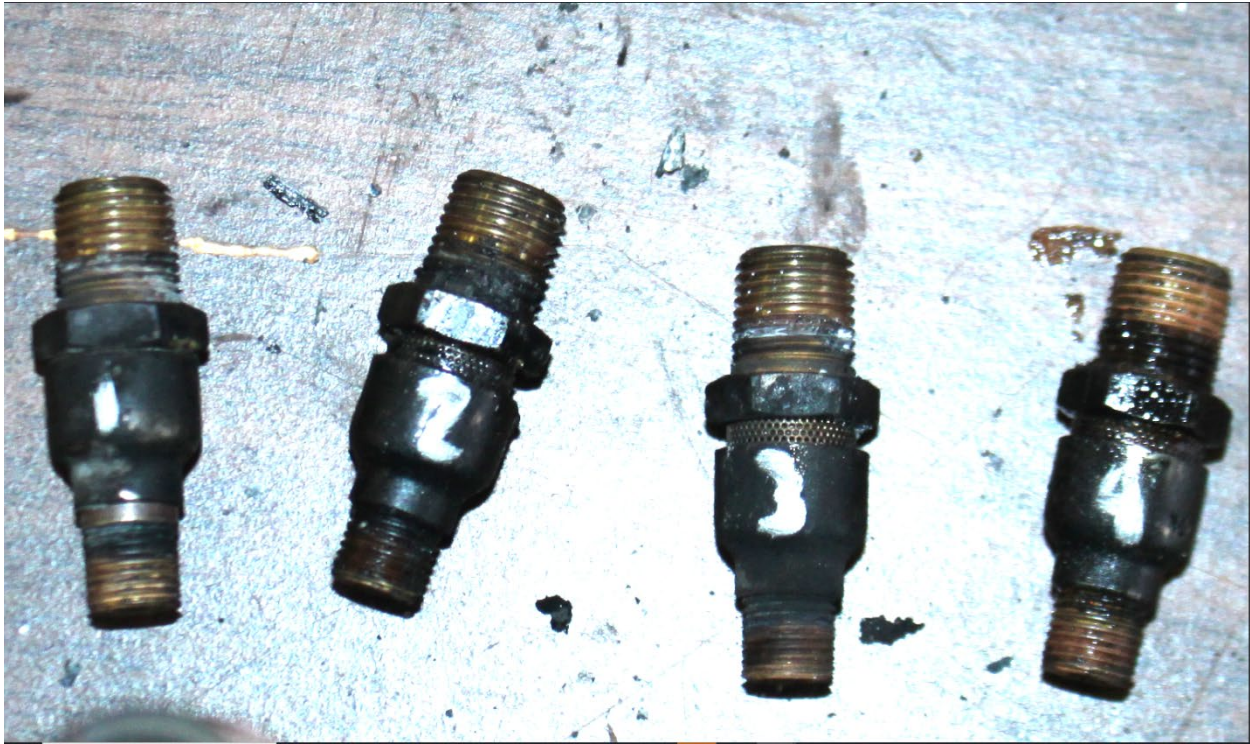
flow divider remained attached to the top of the engine. The injector lines from the flow divider to the injectors were all secured. The unit was exposed to thermal forces and the data plate was not legible. The fuel injector nozzles remained installed in their respective cylinder heads. They were removed for further examination and none had the inserts or restrictors installed.

**Figure 6: View Following Removal of Fuel Injector Nozzles.**

Nozzles 1 and 3 had oil in the units from the resting position of the engine at the mishap location, while the Nos. 2 and 4 were found unobstructed when removed. Nozzles 1 and 3 were unobstructed when light air was pushed through to remove the liquid oil. The fuel injector nozzles without inserts, fuel injector lines, and servo fuel injector were retained for further examination at a repair station. Refer to Fuel Systems Examination And Testing Summary which is included in the NTSB public docket for the investigation.
