National Transportation Safety Board

ERA23FA200

WRECKAGE EXAMINATION SUMMARY

Location: London, Ohio
Date: April 18, 2023
Time: 1820 EDT
2220 UTC
Airplane: Cessna 172

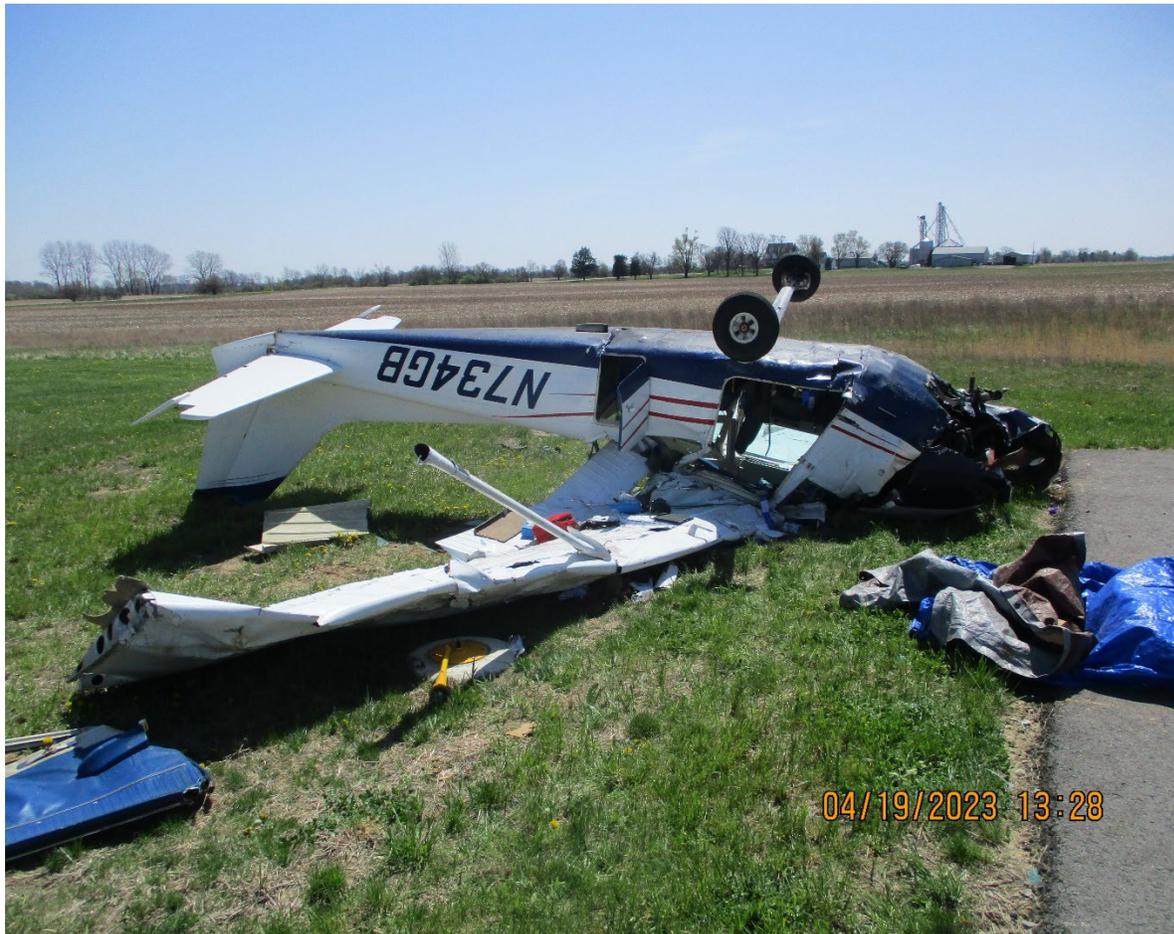
The accident site was located 1 ft from the end of runway 27, inverted and on a magnetic heading of 270°. The airplane impacted left wing low, nose down, and near vertical attitude. The engine and propeller were compressed aft and up into the fuselage. The instrument panel was fractured in several places and no useful information could be used. The propeller spinner was crushed flat against the propeller. The carburetor was fractured off the engine and found in front of the wreckage about 5 ft away.
