**Wreckage Examination
NTSB Accident Number
ERA22FA343**

Location:	Andalusia, AL
Date:	July 29, 2022
Time:	1502 CDT
Aircraft:	Eurocopter AS 350 B2
Registration	N124LN

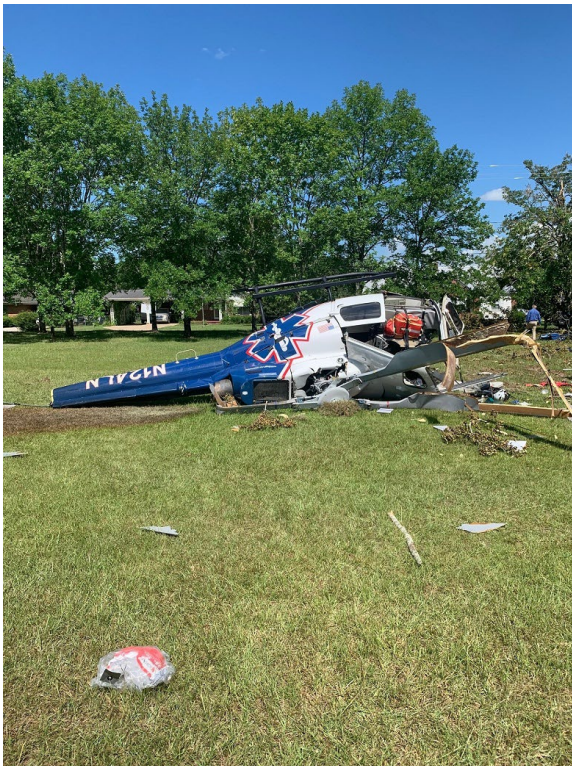
Witnesses in the field stated that the helicopter flew overhead about 300 ft above ground level, nosed up 90° or more, before turning left and impacting trees, powerlines, and the ground.
