WRECKAGE EXAMINATION
NTSB Accident Number
ERA23FA194

Location:	Andrews, NC
Date:	April 15, 2023
Time:	1039 EDT
Aircraft:	Velocity
Registration	N2357

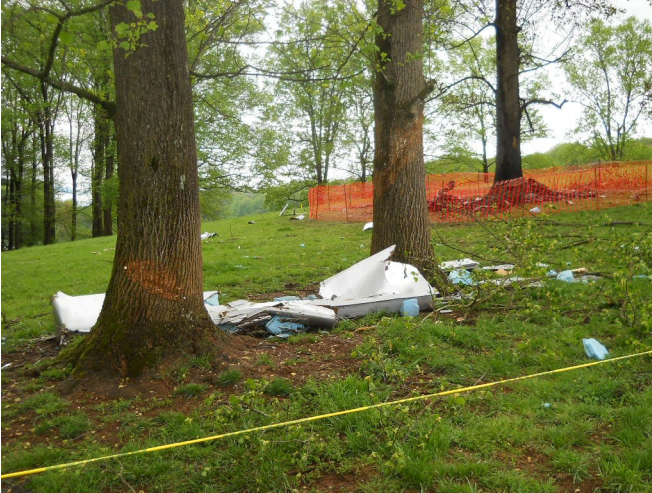
The wreckage came to rest inverted, oriented about a 075° magnetic heading, and an approximate 50-ft debris path was observed. The left wing was separated, resting against a tree inverted at the beginning of the debris path. The main wreckage was consumed by fire at the end of the debris path. No cockpit controls or instrumentation was identified. No seats or restraints were identified.

The left aileron and left rudder separated were recovered near the left wing. The right wing and canard remained with the main wreckage and were consumed by fire. The flight controls consisted of control rods and push-pull tubes. Flight control continuity and trim continuity could not be verified due to fire damage.

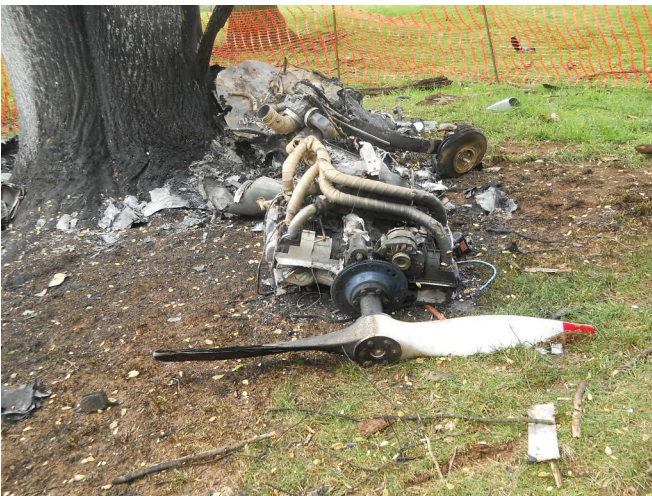
The engine came to rest inverted, separated from the airframe. The two-blade propeller remained attached to the hub. One blade appeared undamaged while the other blade exhibited charring and tip separation. The top spark plugs were removed; their electrodes were intact and light gray in color (The Nos. 1 & 3 electrodes were oil soaked). Borescope examination of the cylinders did not reveal any anomalies. The crankshaft was rotated via an accessory gear drive. Crankshaft, camshaft, and valve train continuity were confirmed to the rear accessory section of the engine, and thumb compression was attained on all cylinders. Both magnetos had separated from the engine. One magneto was recovered and it produced spark at all leads when rotated via electric drill. The other magneto was not located. Due to thermal damage, the fuel system could not be tested. The turbocharger wastegate was found in an approximate half-open position. The alternate air valve was not located.
