WPR22FA331

WRECKAGE EXAMINATION

Location: Shafter, California
Date: September 2, 2022
Time: 1100 Pacific daylight time
Airplane: N5943, Yakovlev Yak-11

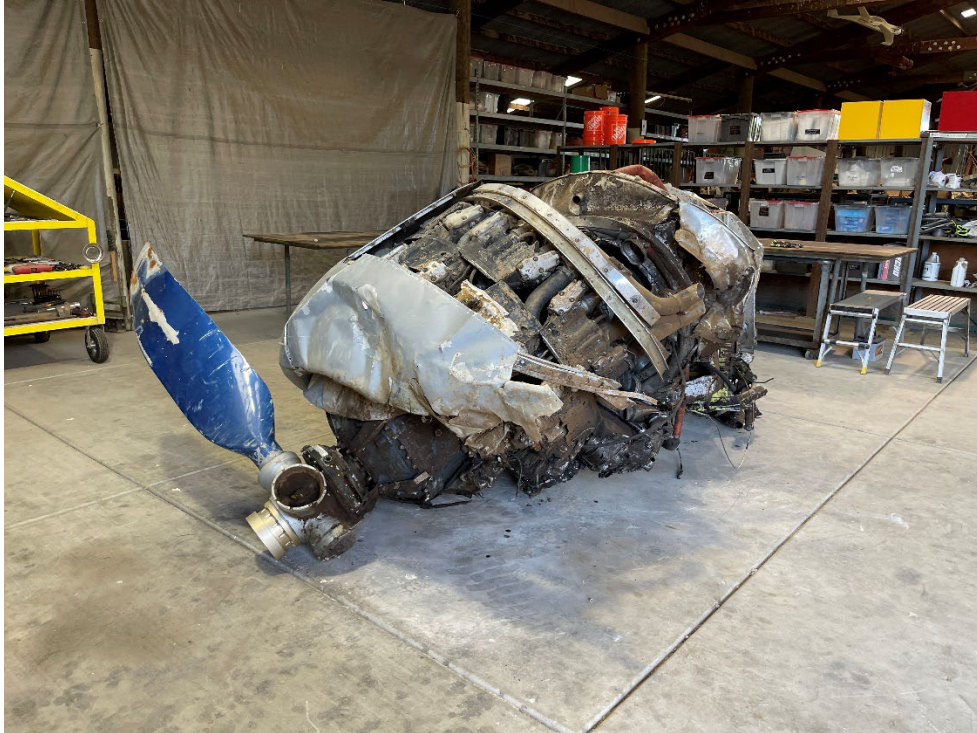
Figure 1: Recovered engine, propeller, and forward portion of the fuselage.

The engine, a Pratt & Whitney R2800 "Double Wasp" CB3 remained attached to the airframe, however, it was separated into 2 sections, consisting of the main case/front case, cylinders, and the blower/accessory section. The engine was removed from the airframe for further examination.

One of the three separated propeller blades exhibited "S" bending with chordwise striations on the cambered side of the propeller. The second propeller blade was bent and curled aft, opposite direction of rotation. The third propeller blade was relatively straight and exhibited chordwise striations on the cambered side of the blade and leading edge polishing throughout its span. The fourth propeller blade, which remained attached to the propeller hub, was slightly bent aft near the blade tip, and exhibited unidirectional striations on the cambered side of the blade.
