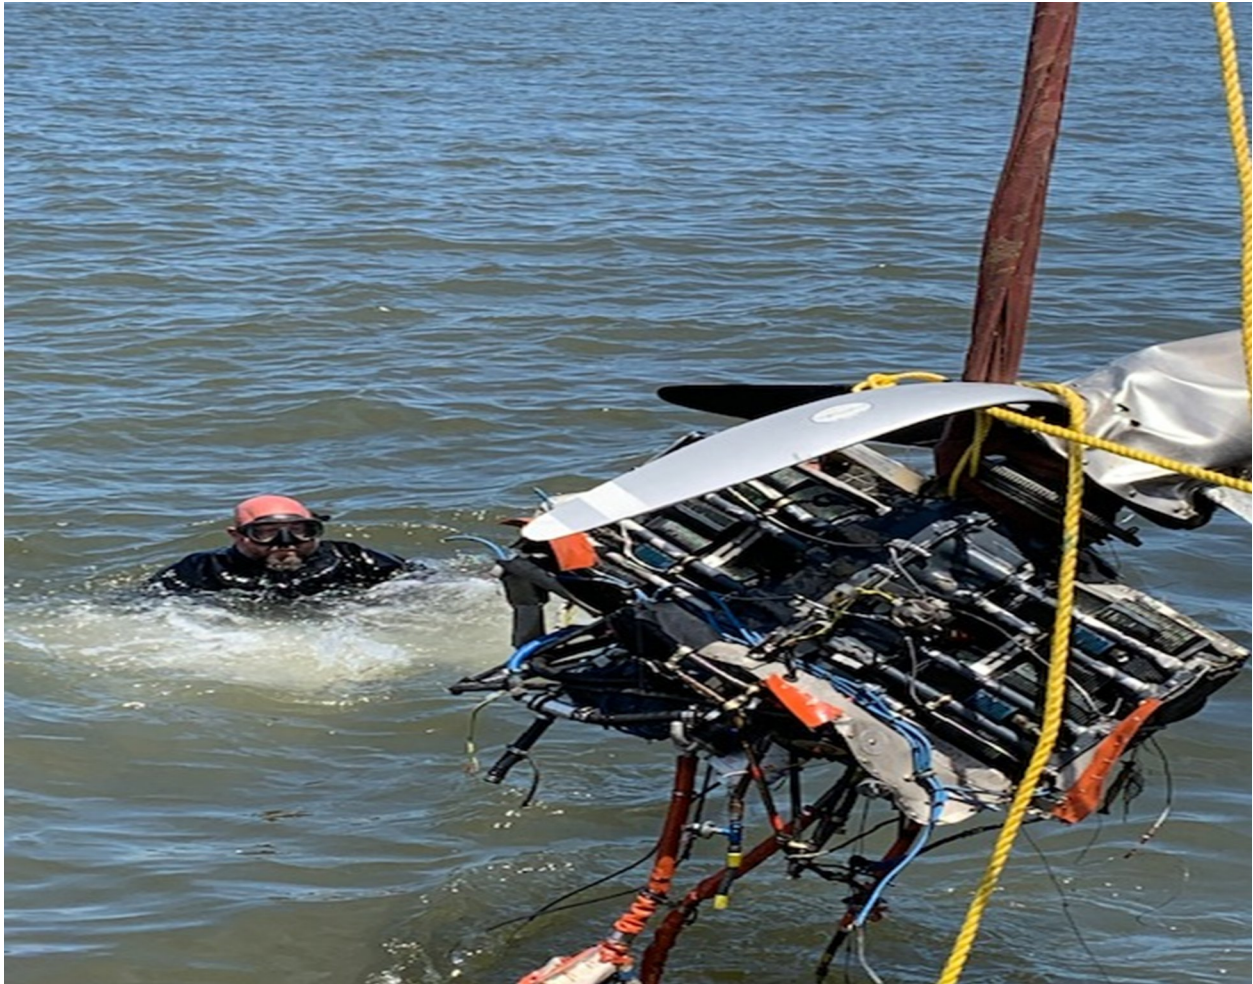
Image 11 –Photograph of the salvage diver in the water as the engine and prop are recovered.

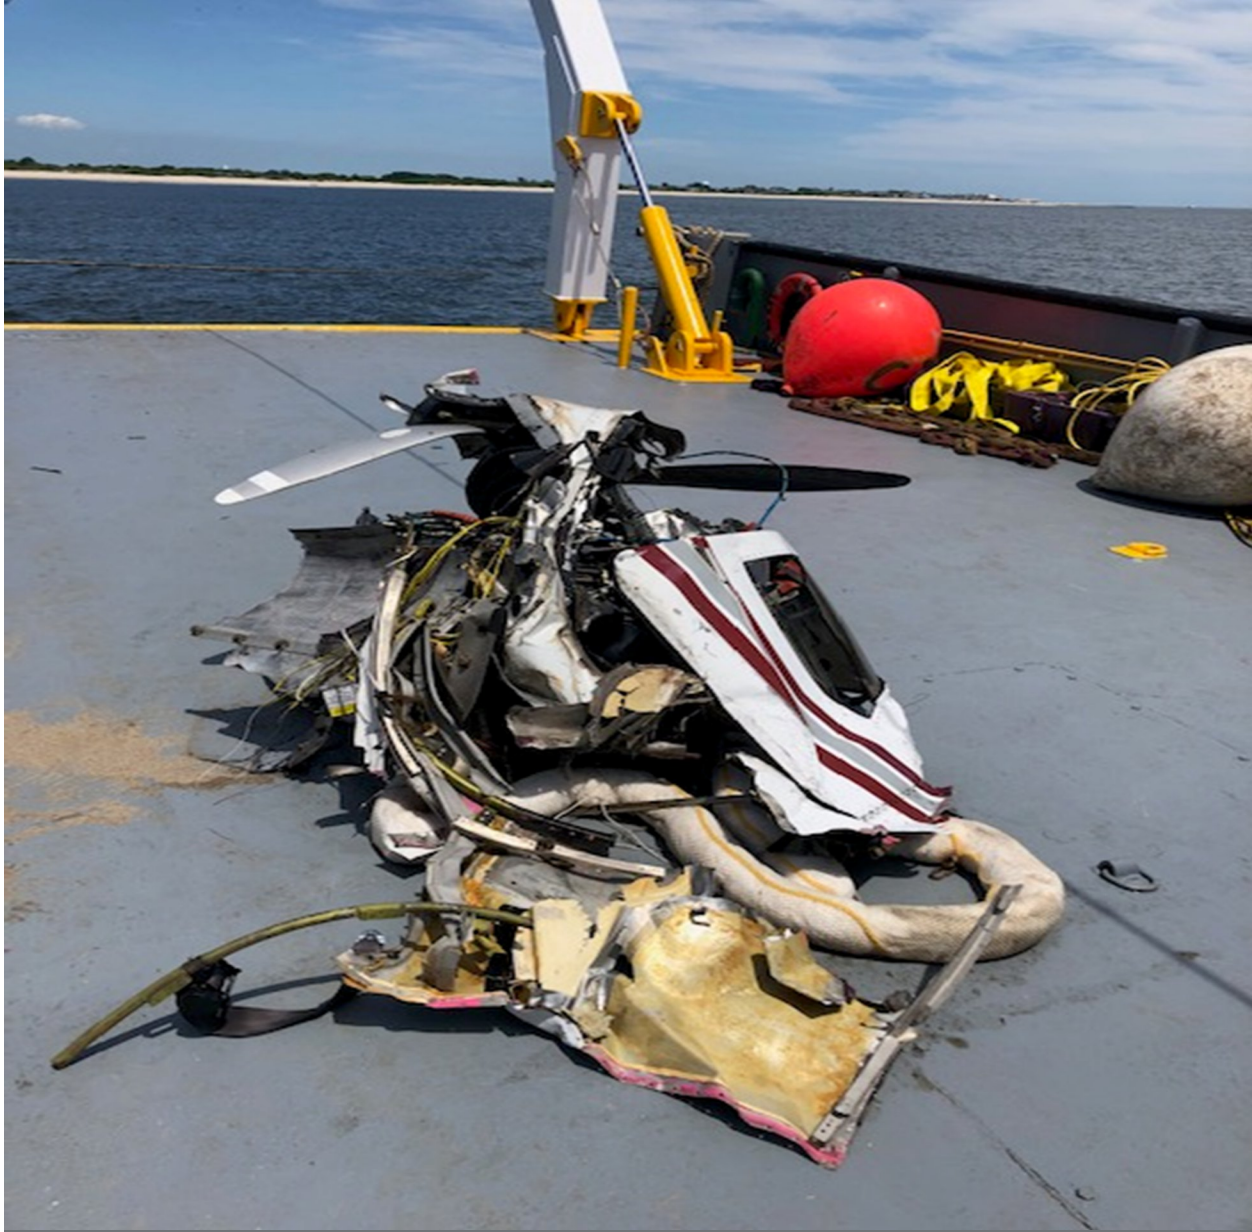
Image 12 –Photograph of the first pieces of the aircraft that were recovered.

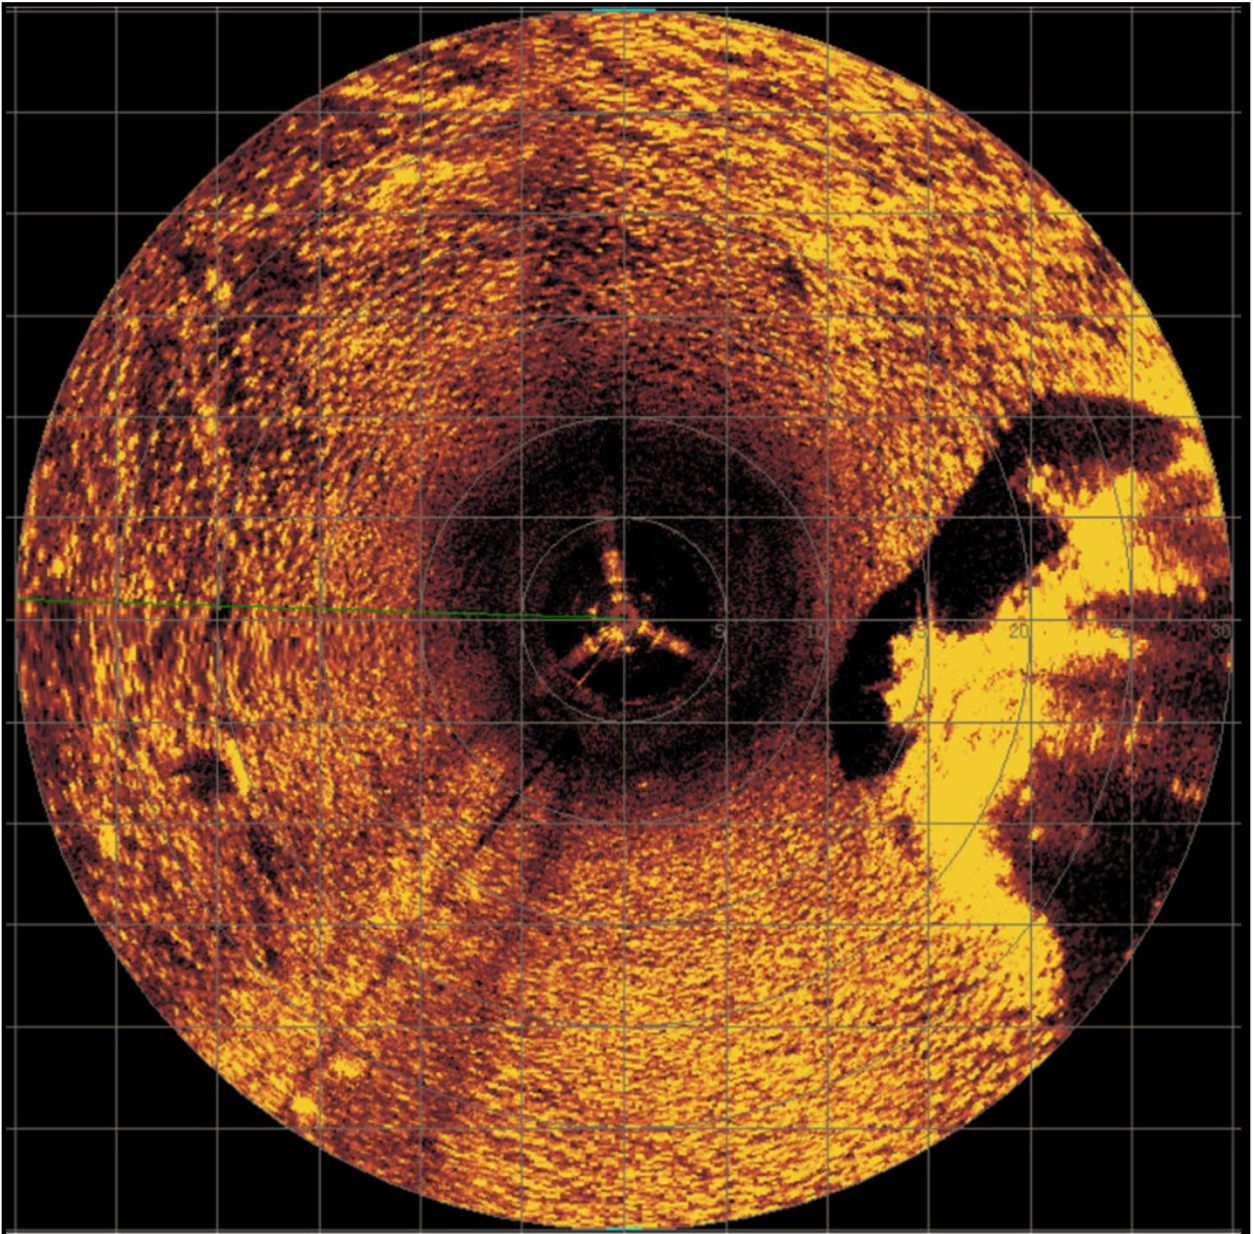
Image 13 –Photograph of Hudson Engineers real time scanning sonar showing the sonar tripod in the center, the diver at approximately 100 and the wreckage at approximately 3:00

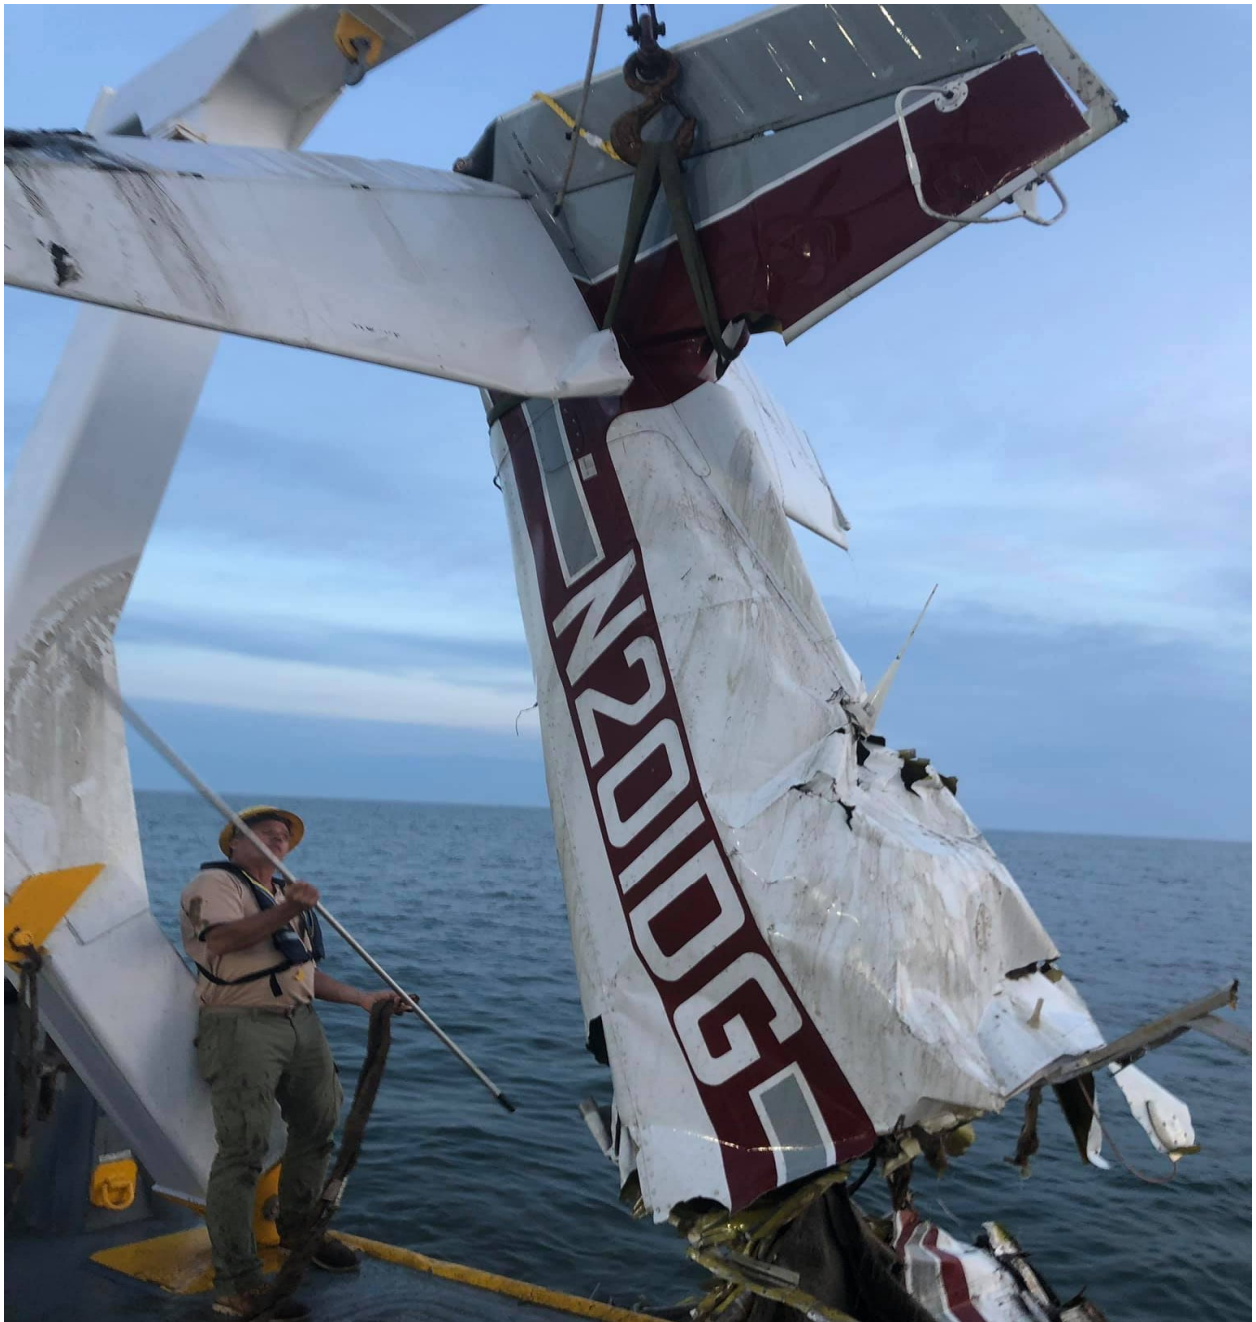
Image 14 – Photograph of the aircraft recovery with the 25 ton A Frame on the *Northstar Commander*.

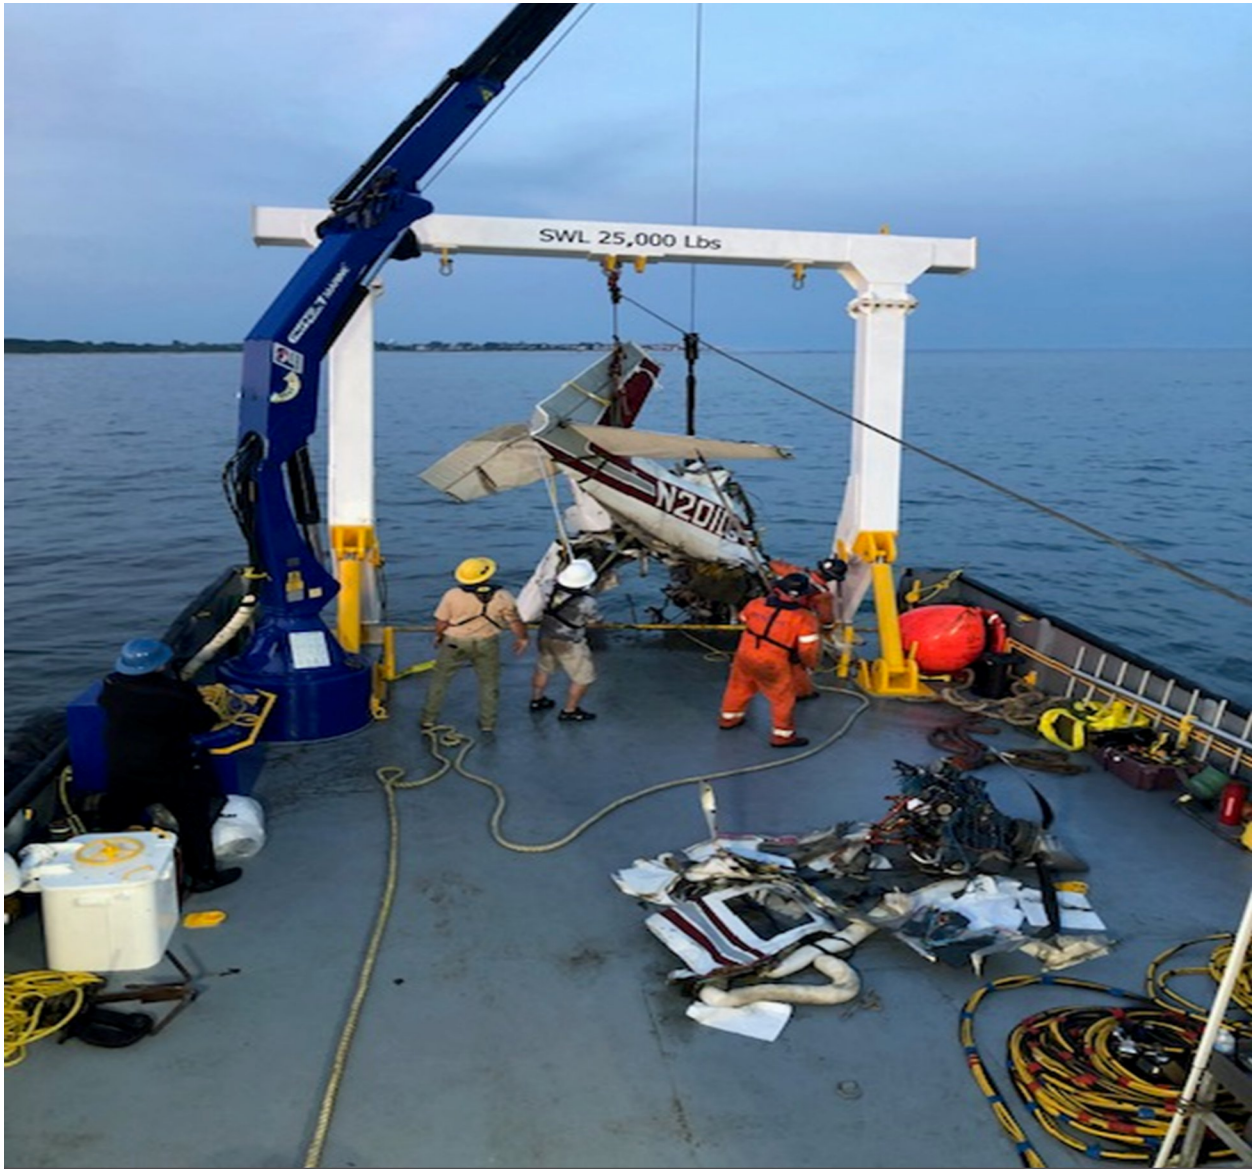
Image 15 –Photograph of the aircraft on the deck of the Northstar Commander

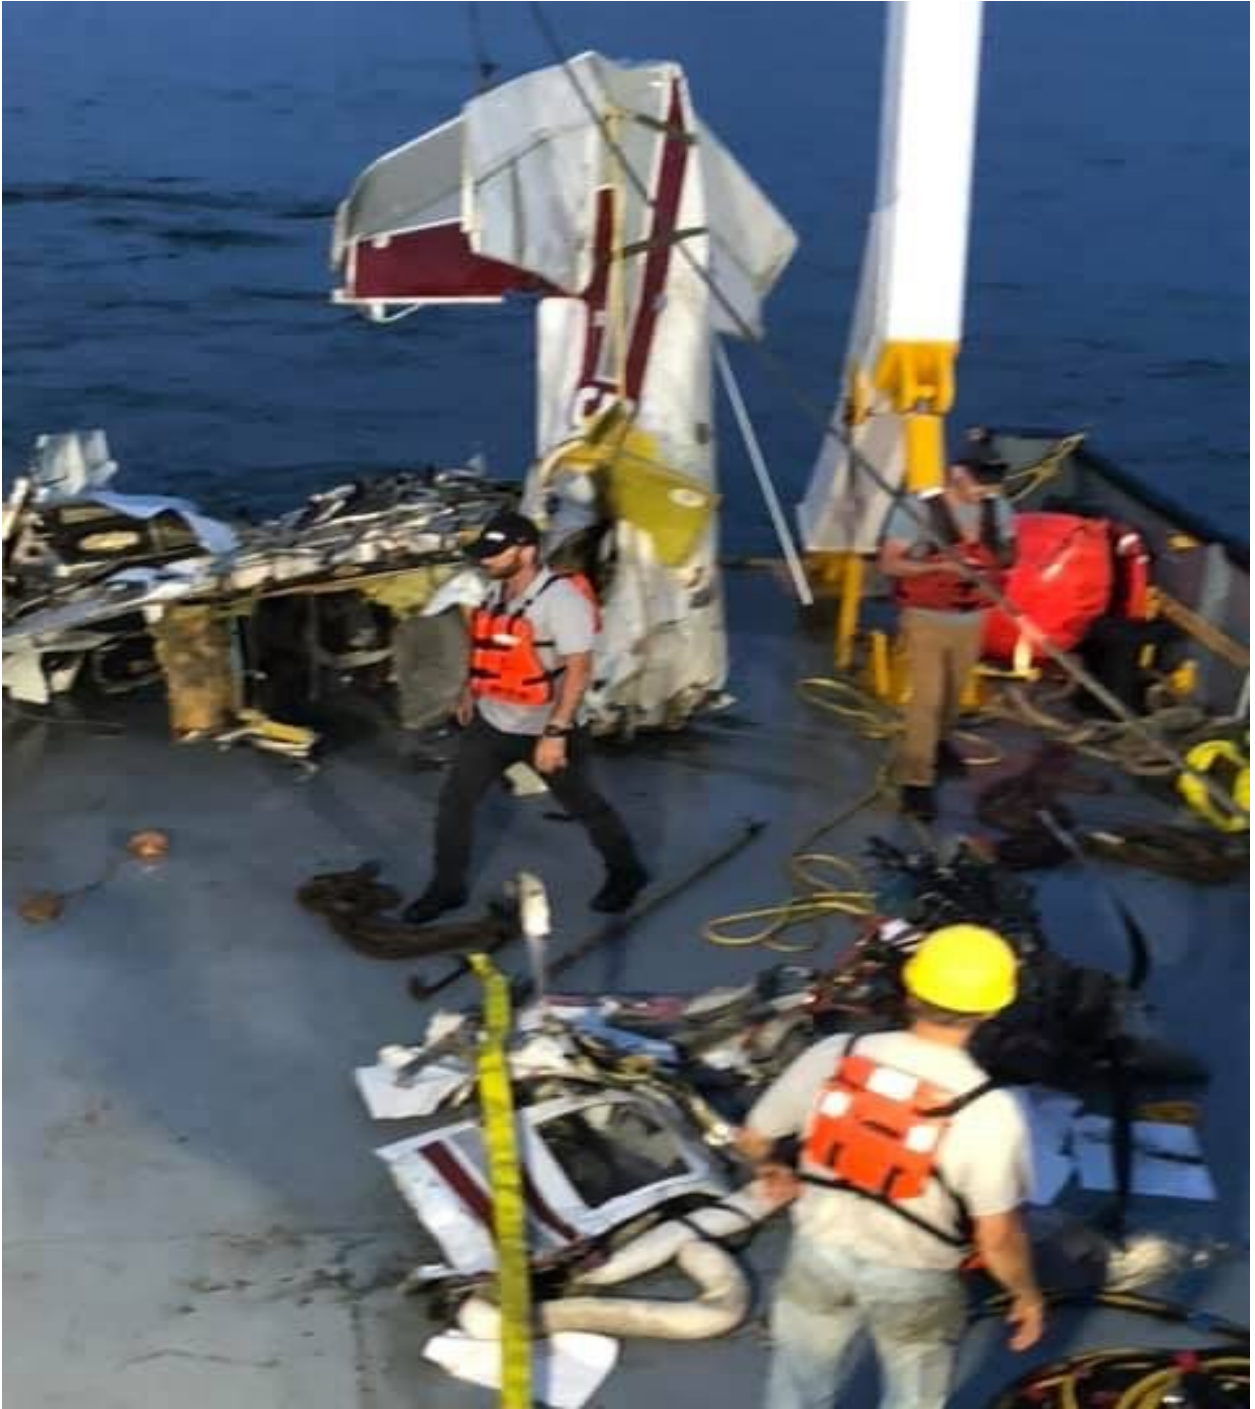
Image 16 –Photograph of the aircraft on the deck of the Northstar Commander.

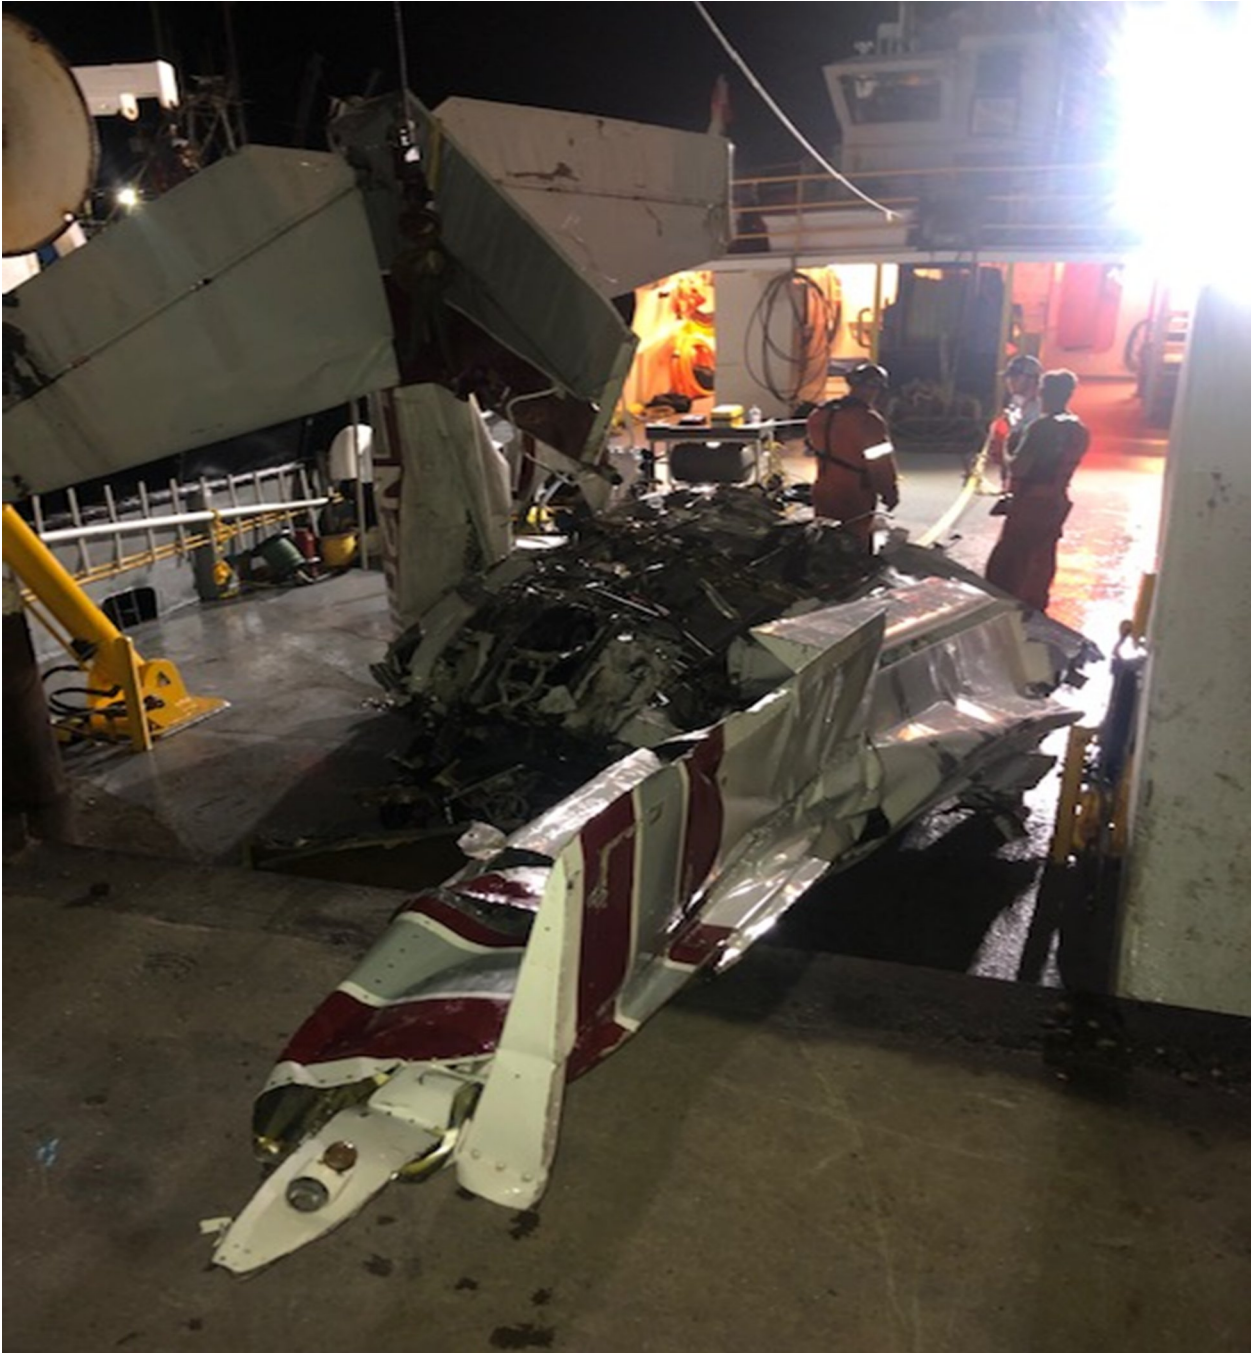
Image 17 –Photograph of the aircraft on the deck of the Northstar Commander back at Lund's Fisheries.

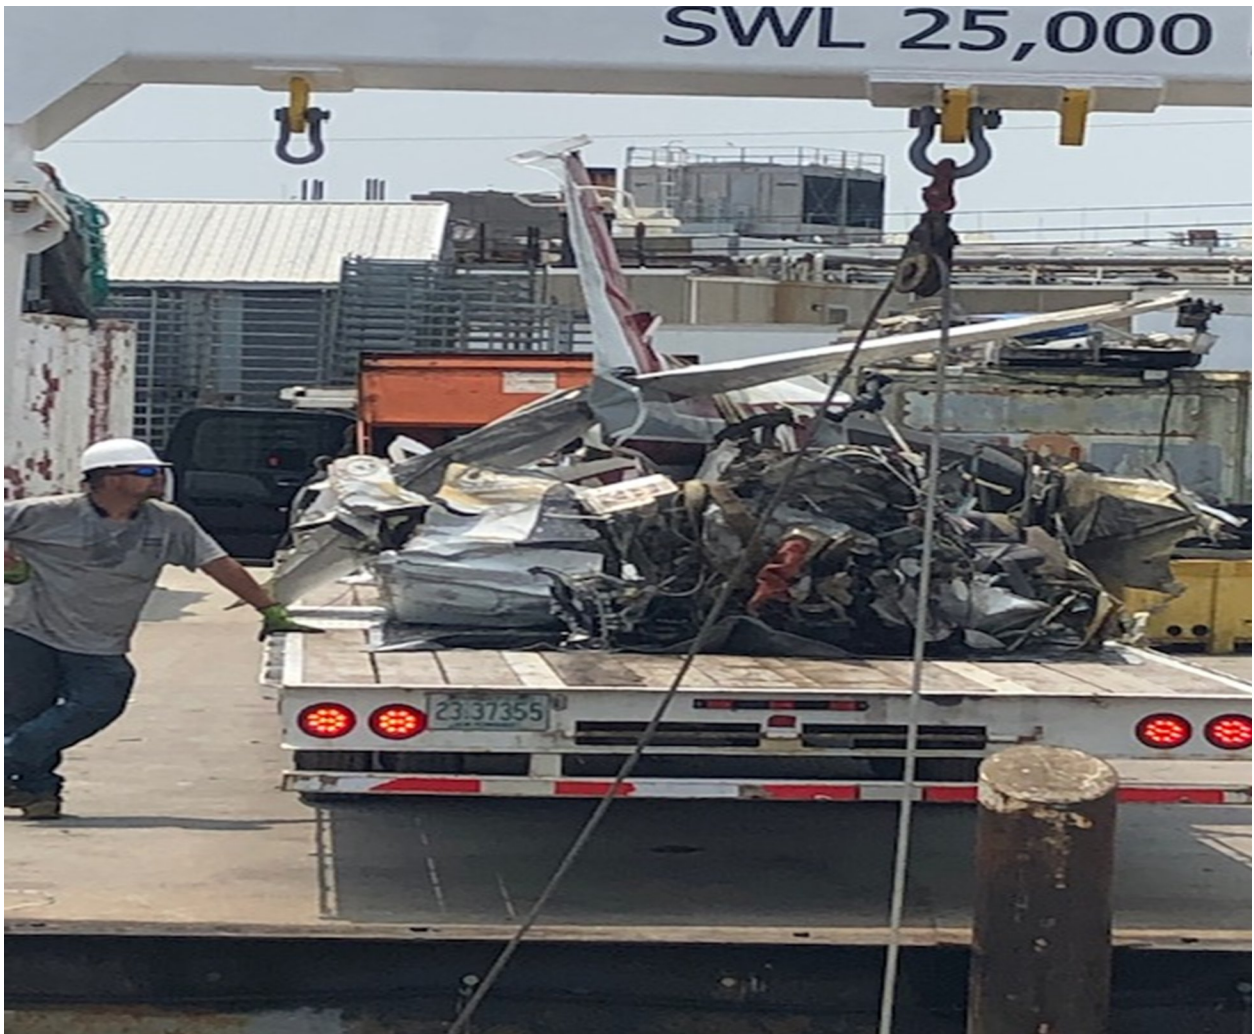
Image 19 –Photograph of the aircraft loaded on transport vehicle.

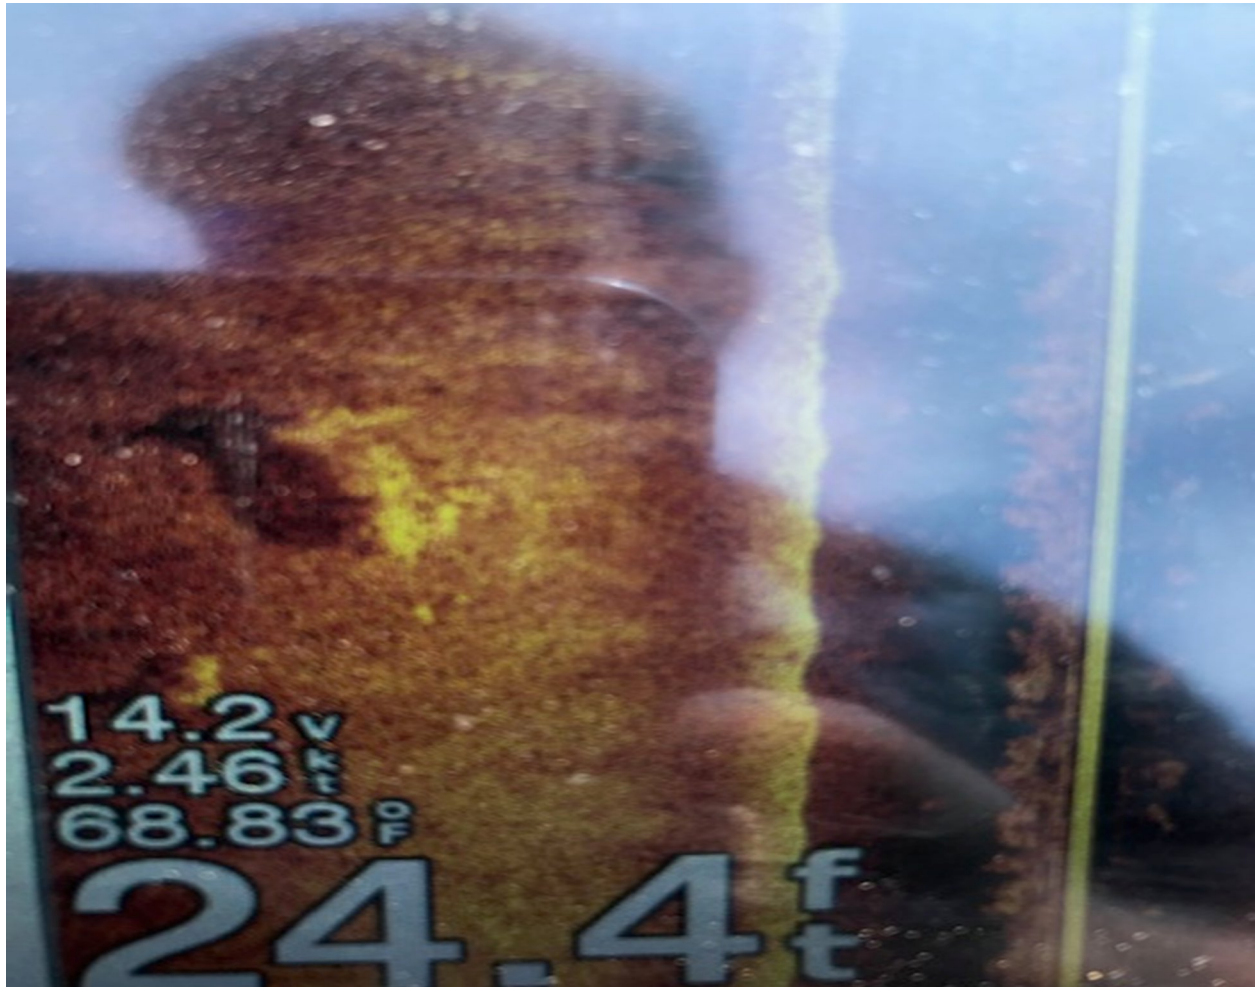
Image 5 –Photograph of the sonar image of the aircraft on the sea floor.
