National Transportation Safety Board

WPR23LA098

WRECKAGE EXAMINATION SUMMARY

Location: Murrietta, California
Date: January 27, 2023
Time: 0837pst
1637gmt
Airplane: N4758C -1979 Cessna T210N

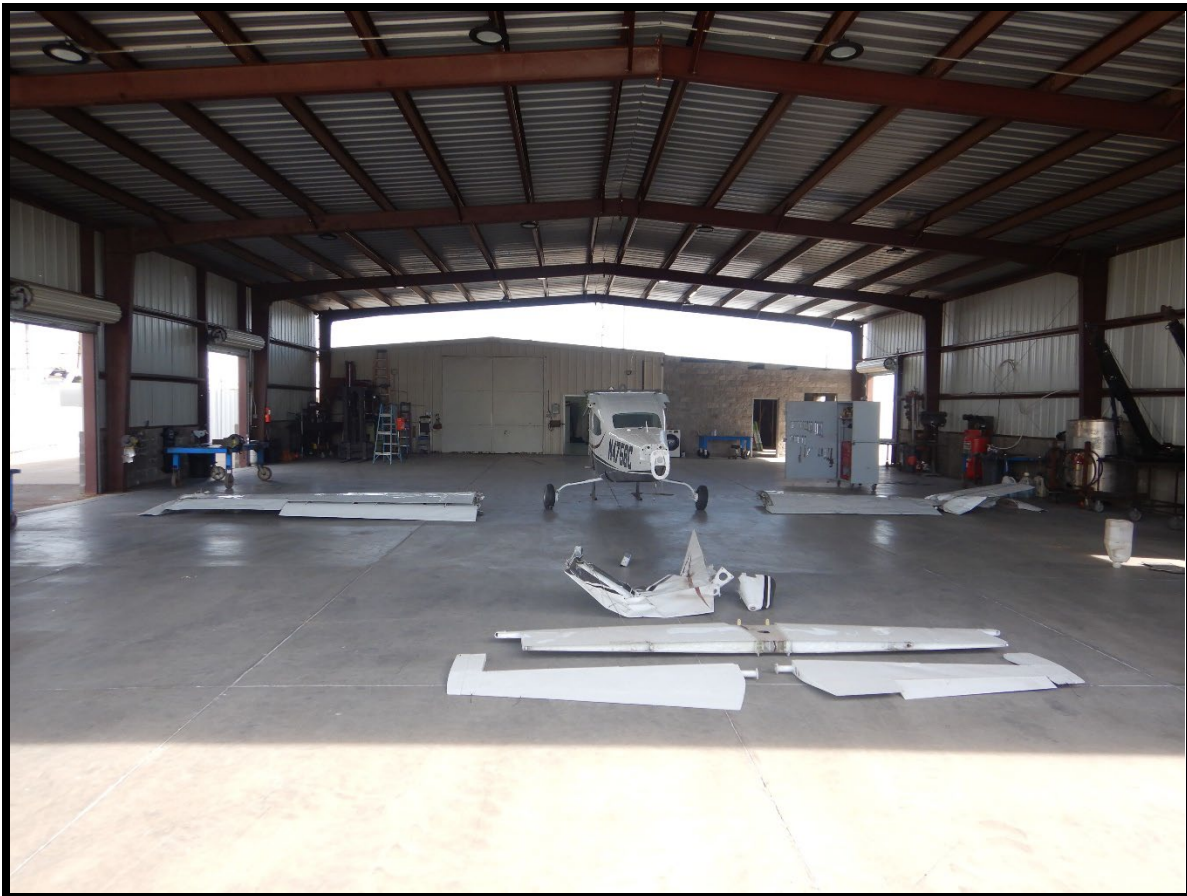
Examination of post-accident photographs revealed that the empennage remained attached to the fuselage but was separated from the fuselage for recovery transport. The vertical stabilizer and rudder remained attached to each other via their respective hinges. They both sustained impact damage and when viewed from the nose of the airplane, were bent to the left, emanating from the top of each structure. The horizontal stabilizer sustained minor impact damage to the left side. The left and right elevator were present, intact, and sustained minor impact damage to the surfaces. The elevator trim tab remained affixed to the right elevator hinge and remained intact.

Figure 1: View of damage to the empennage (Courtesy of NTSB)

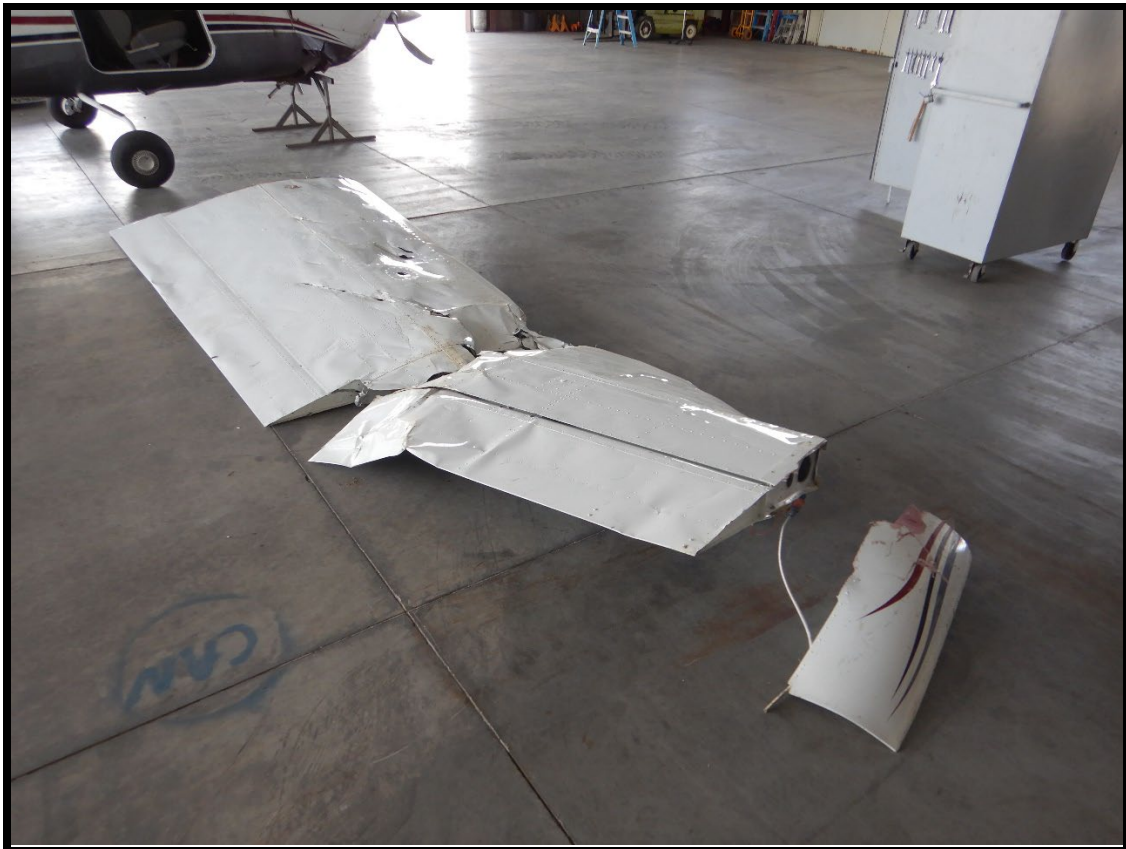
The right wing sustained impact damage to the leading edge and remained attached via the spar, which was fractured near the middle of the wing. The wing tank was breached, and the vented fuel cap was not present. The outboard section sustained crushing signatures emanating from the outboard wing tip, to about the middle of the wing. The aileron and flap remained attached to their respective hinges and sustained impact damage.

Figure 2: View of damage to right wing (Courtesy of NTSB)

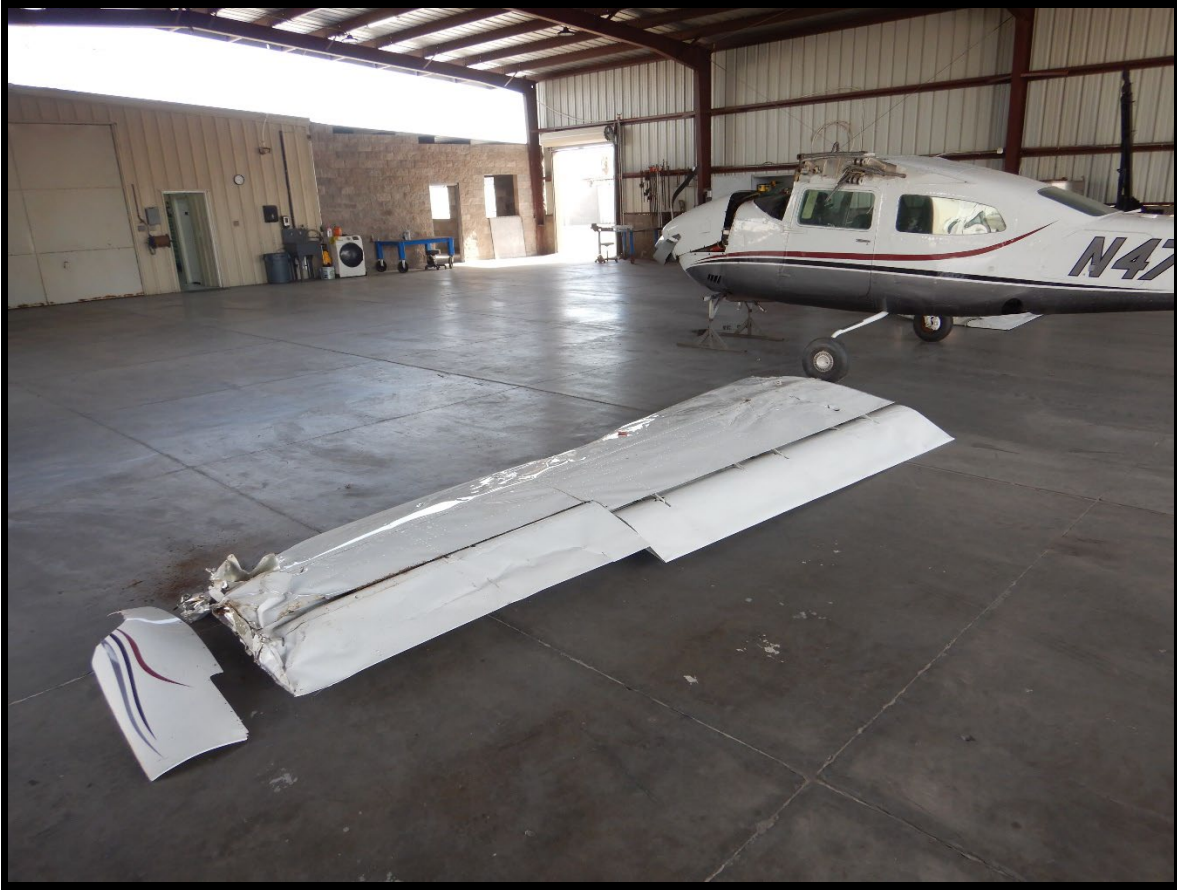
The left wing sustained most of the impact damage to the leading edge and the outboard sections. The center of the wing sustained crushing signatures from the forward to aft surface, and the wing tank was breached. The vented fuel cap was present and unremarkable. The outboard section sustained crushing signatures emanating from the wing tip and about 10 percent of the outboard section of the wing, including the outboard section of the aileron which remained attached to its respective hinges, had folded underneath the wing. The flap remained attached to its respective hinges and sustained minor impact damage.

Figure 3: View of damage to left wing (Courtesy of NTSB)

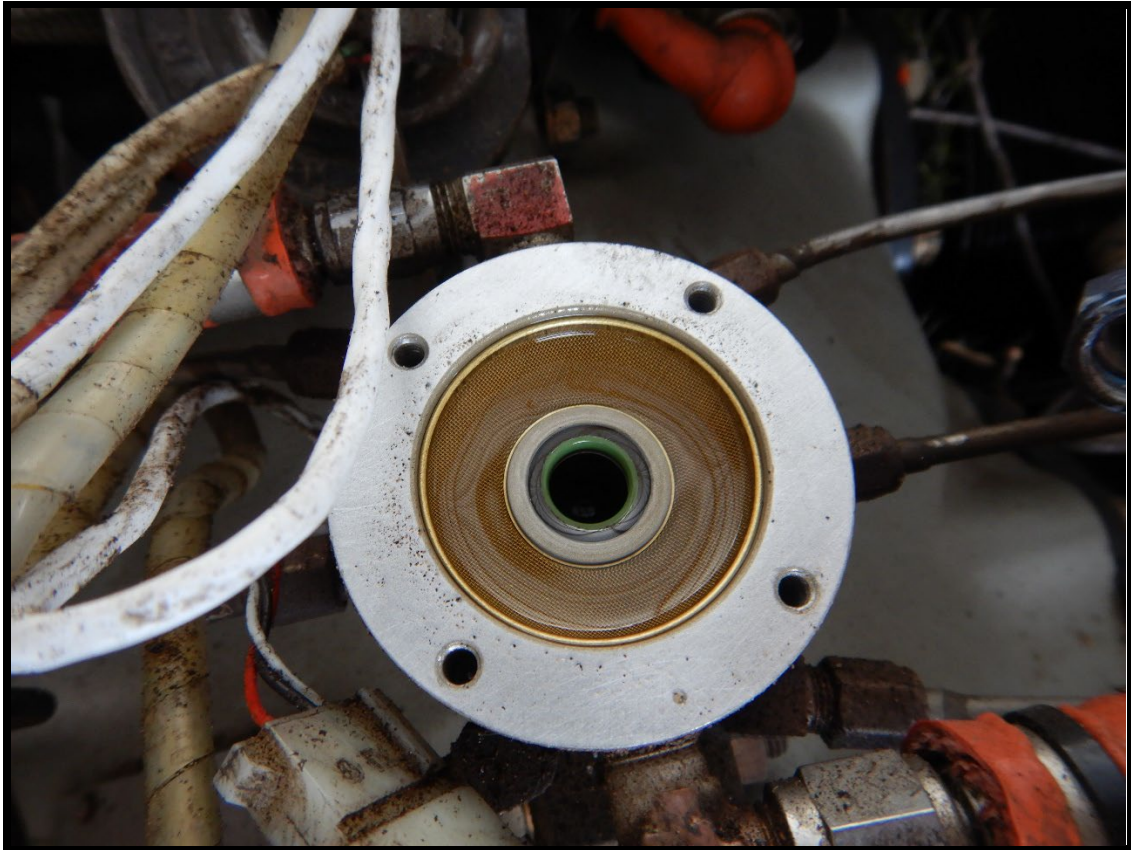
Manifold valve was disassembled, and fuel was present in its cavity. The diaphragm was undamaged, and the inlet screen was clear of debris.

Figure 5: View of fuel manifold with clean screen and fuel present (Courtesy of NTSB)

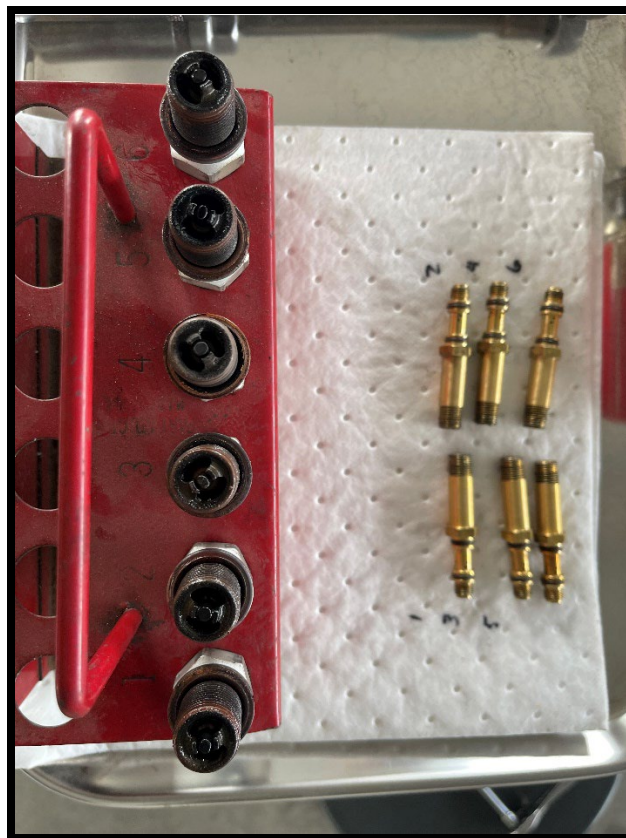
The lower spark plugs were removed, and their electrode areas had a dark residue, and the electrode areas had a (normal-worn out) wear condition consistent with the Champion Aviation Service Manual. The No. 2 lower spark plug electrode area was oil soaked.

The fuel nozzles were removed from the cylinders and were clear of obstructions.

Figure 6: Image of bottom spark plugs and fuel injectors (Courtesy of NTSB)

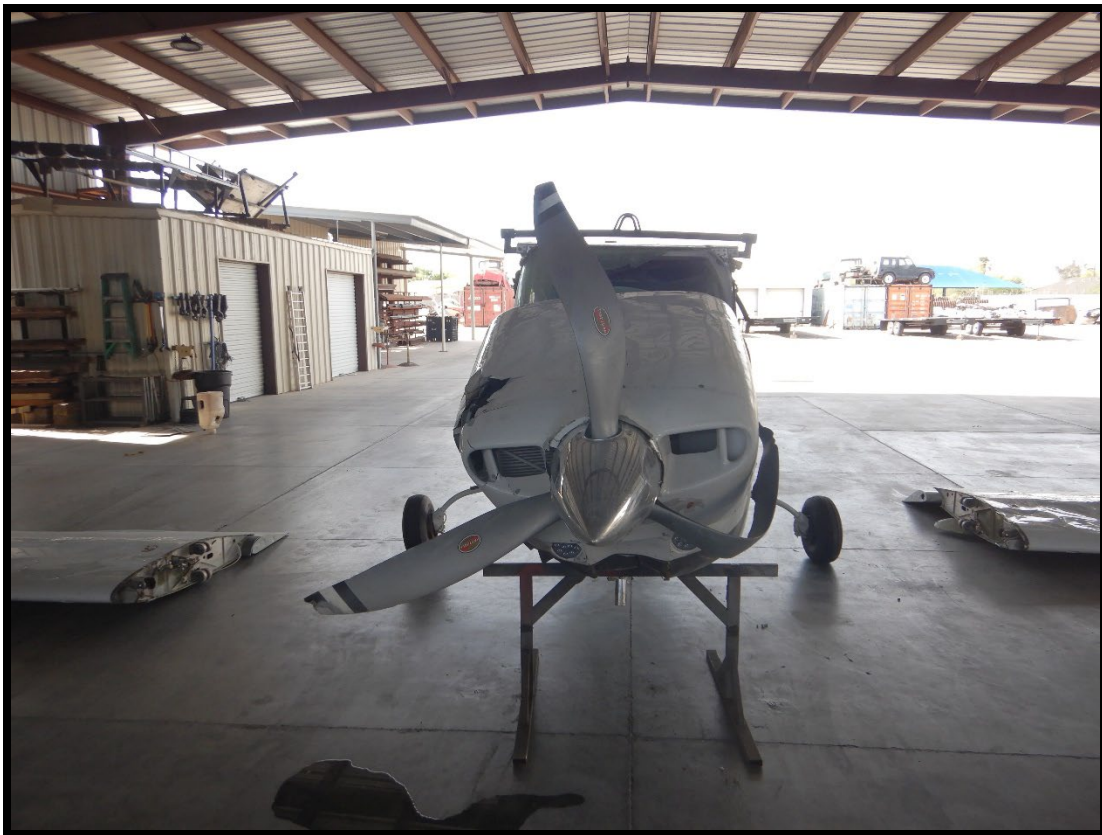
The propeller assembly remained attached to the engine and had impact damage to each of its three blades. The blades were bent aft and had multidirectional scuffing. Some material was missing from two of the blades. The spinner had crushing on one side. The propeller assembly was removed and replaced with a 2-bladed propeller in preparation for an engine test run.

Figure 7: View of the damage to propeller blades (Courtesy of NTSB)
