NATIONAL TRANSPORTATION SAFETY BOARD

Y-SAS SYSTEM EXAMINATION

WPR22FA101

Location: Newport Beach, CA
Date: February 19, 2022
Aircraft: MD Helicopters/500N/N521HB
NTSB IIC: Elliott Simpson

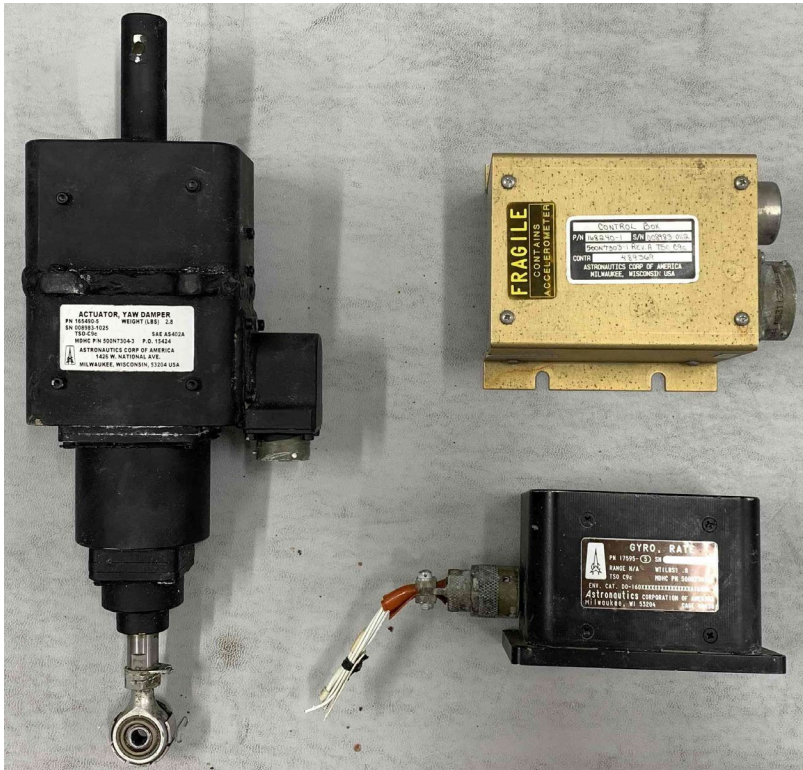
Figure 1 – Examined components

Examination of the Y-SAS components was conducted at the facilities of Astronautics Corporation of America, in Oak Creek, Wisconsin on May 4, 2022. All components exhibited evidence of water infiltration and corrosion (figure 1).

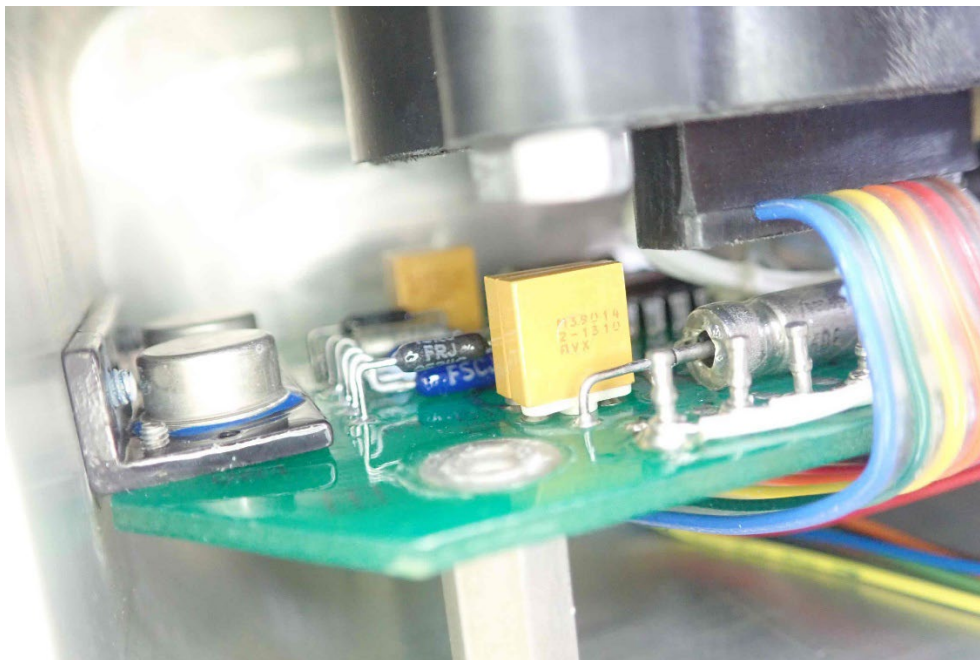
Figure 2 – Rate Gyro PCB

The lid was removed, and the unit internally examined. The printed circuit board (PCB) and all components were intact and appeared undamaged. There was evidence of water intrusion, demonstrated by white corrosion deposits around the bolt threads, bolt heads, and standoffs at the intersection with the case (figure 2). The PCB appeared covered in a conformal coating and did not exhibit evidence of corrosion (figure 2).

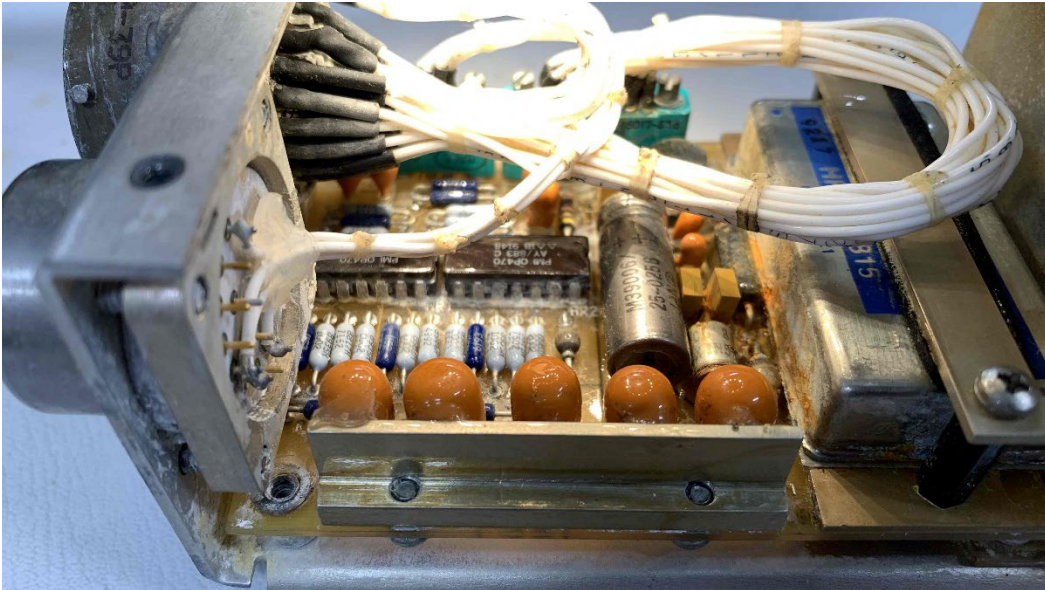
Figure 3 – Yaw Damper Controller

The unit appeared externally undamaged and was coated in white corrosion-like deposits. The lid was removed, and the unit internally examined.

There was evidence of water intrusion, demonstrated by white and rust-colored corrosion deposits around multiple components on the PCB, wires, bolt threads, bolt heads, and standoffs (figure 3). Two diodes, located next to the DC to DC regulator, displayed evidence of corrosion that appeared to have penetrated inside of their cases.

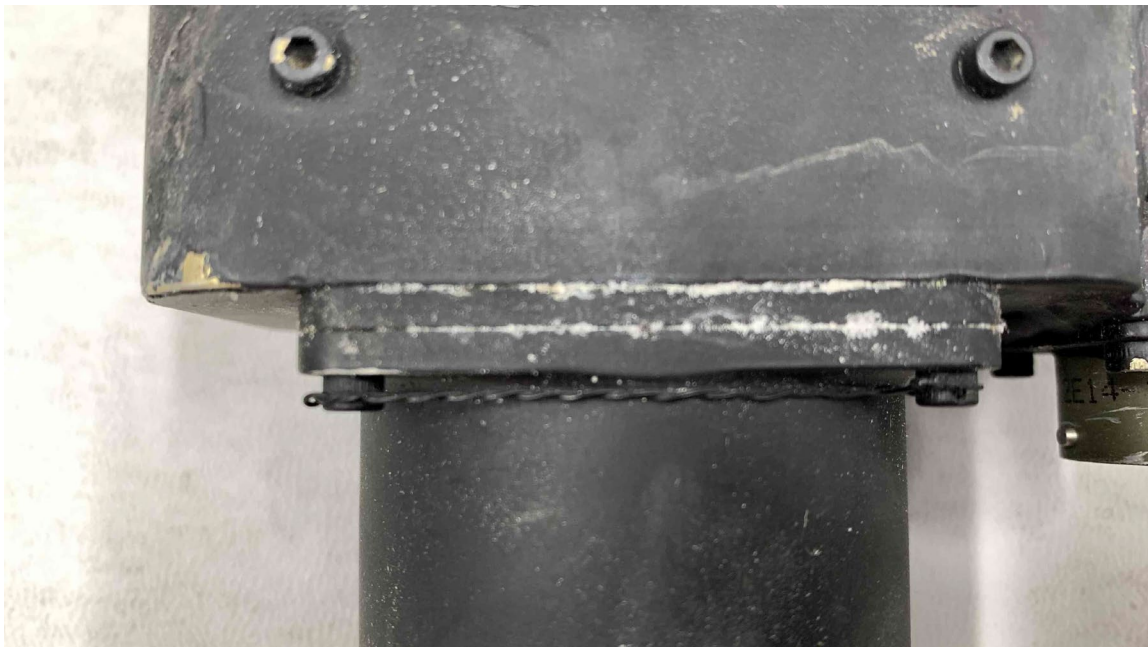
Figure 4 – Linear Actuator outer case

The exterior of the unit appeared undamaged, with white corrosion deposits at the various section of the case seals (figure 4) and at the heads of the case screws. During examination, water was observed to weep from one of the lower case screws. The output shaft exhibited an extension of 0.599 inches, the nominal, neutral, “zero” position value was 0.45 inches.

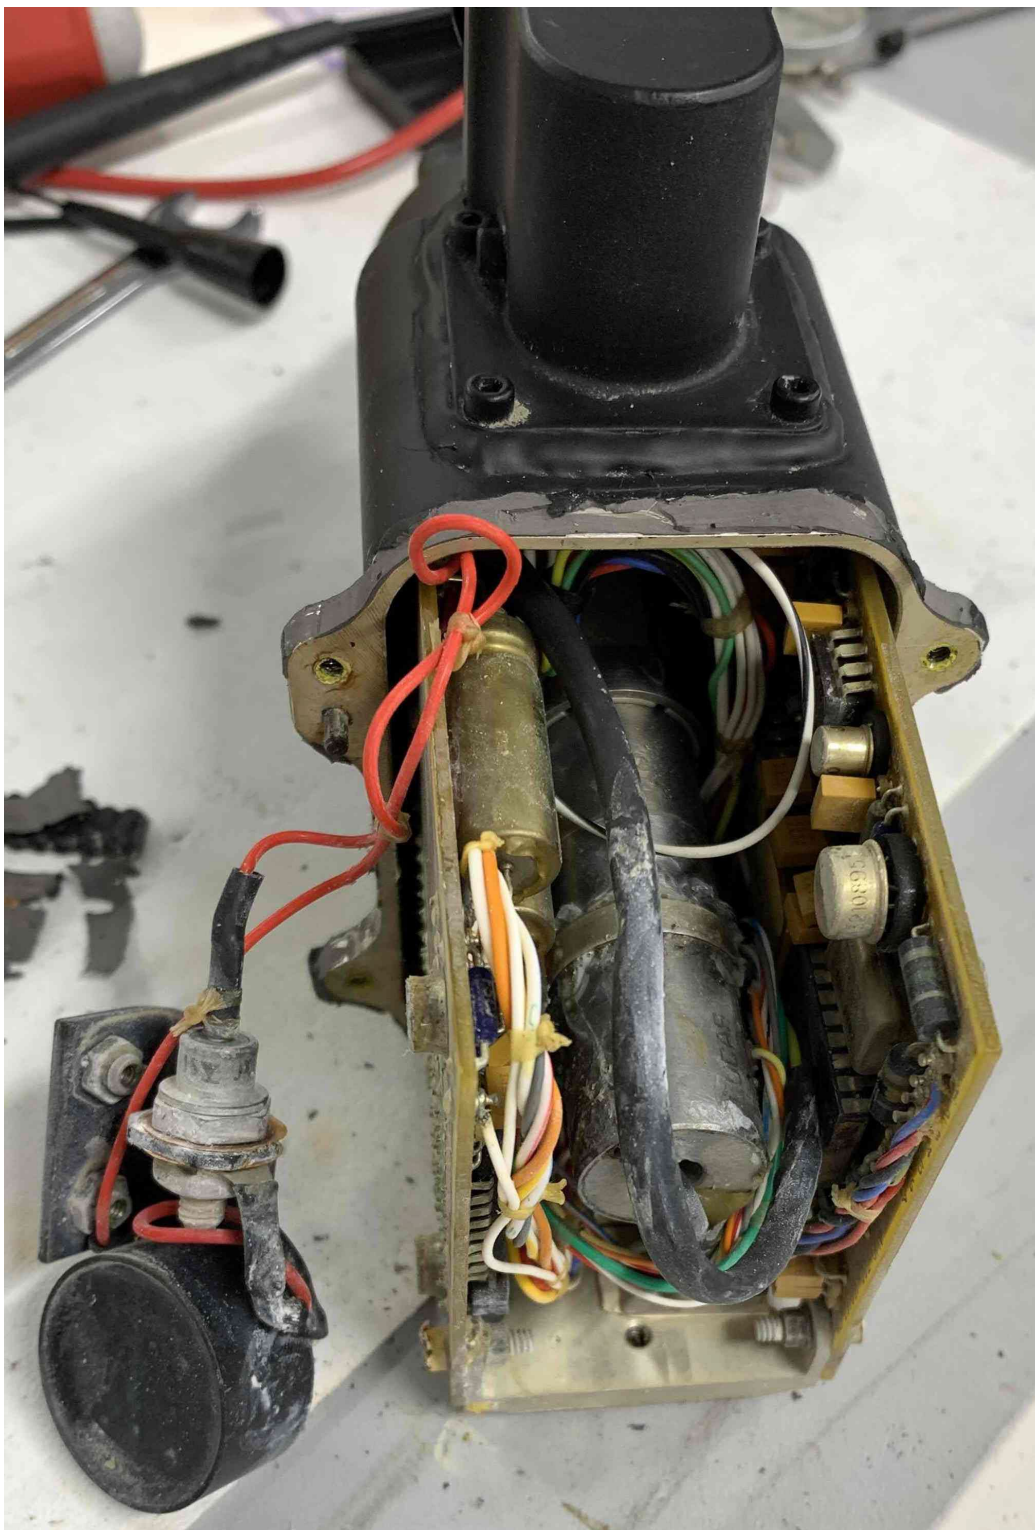
Figure 5 – Linear Actuator PCB and LVDT case

The entire unit was then disassembled, and corrosion was observed within the circuit board and motor housings, and the external case of the LVDT unit (figure 5). The motor’s rotor was removed, and green corrosion-like deposits were present on its outer surface (figure 6). The corresponding stator winding assembly was damp and similarly corroded (figure 7).

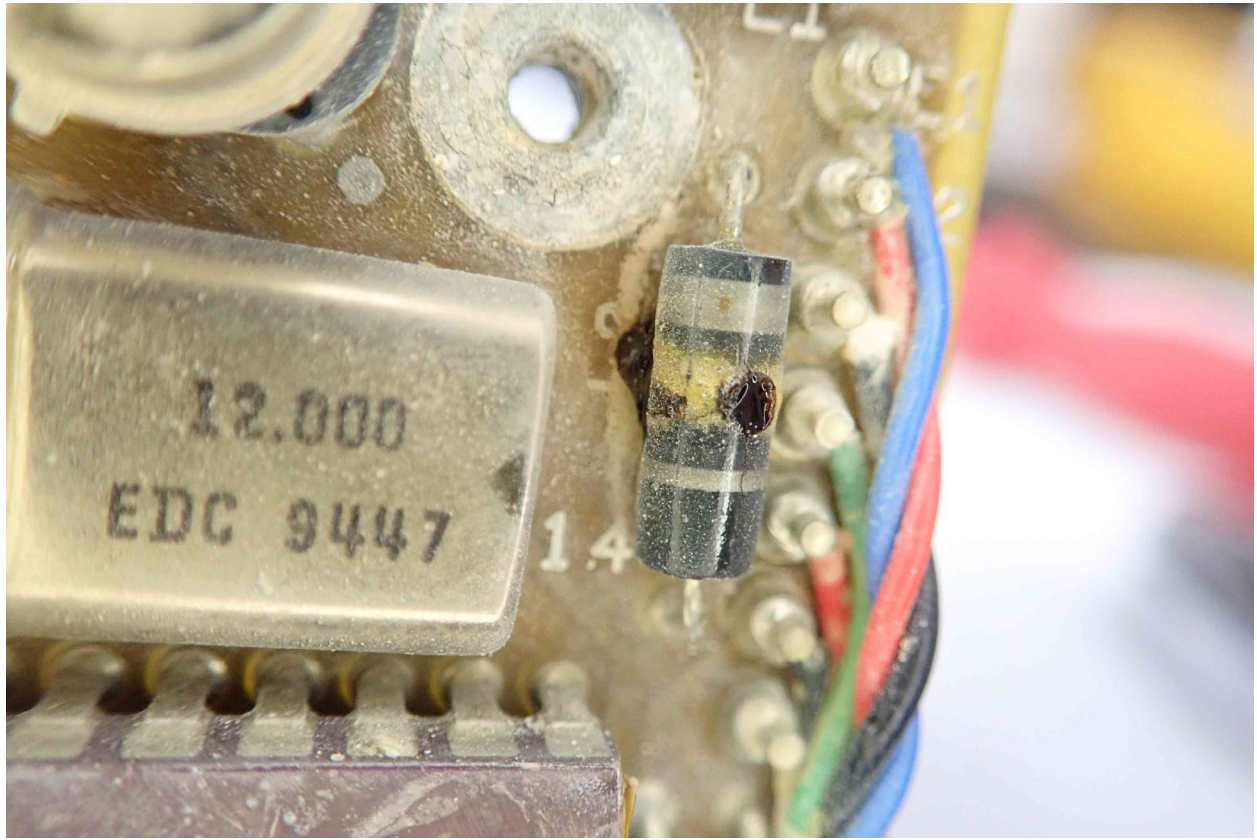
Figure 8 – L2 inductor

Examination of the circuit boards revealed that the L2 inductor exhibited a longitudinal crack and appeared to be emitting dark-brown deposits out of the crack, and at its base (figure 8). According to the circuit diagram, L2 is a 15 μ H inductor, configured to supply +15 Vdc power to a 5v 7805 series regulator (VR1). The regulator in turn supplies 5 Vdc to the 8795 series microcontroller (U2).

The resistance across the inductor was measured at about 39 ohms, and the output side of the inductor was measured to be 600 Kohms to ground.
