# Frigate Marine Services

Barge 71

On November 18 and 19, 2019 Frigate Marine Services attended an Inspection of the Barge 71 to inspect for damages sustained during an allision with the Buckroe Beach, Hampton, VA pier due to heavy and severe weather conditions.

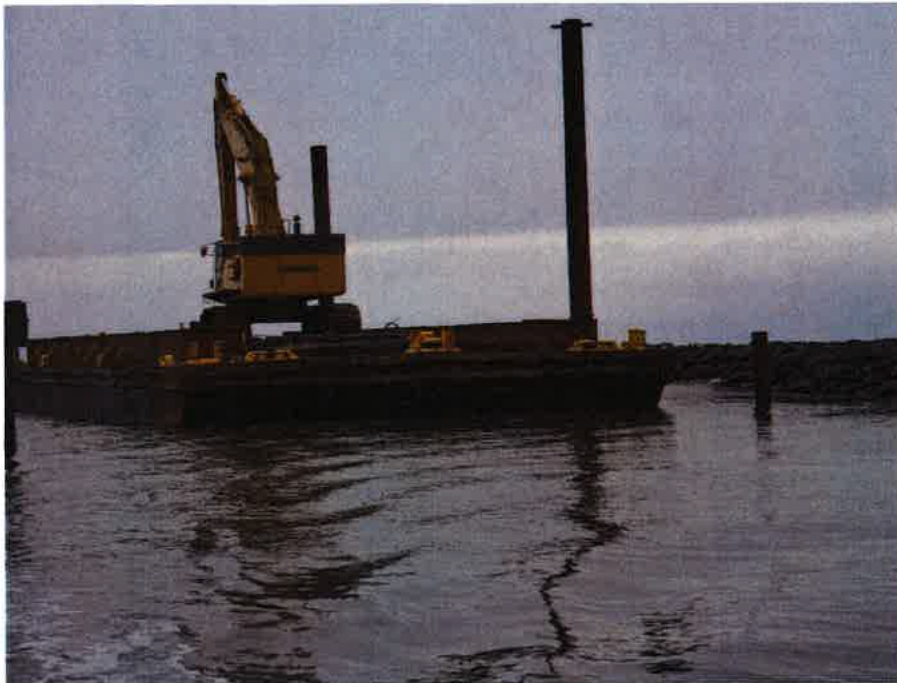
It was reported and sighted that the barge hit the pier along the stern and side of the barge.

**Port stern corner that hit pier**

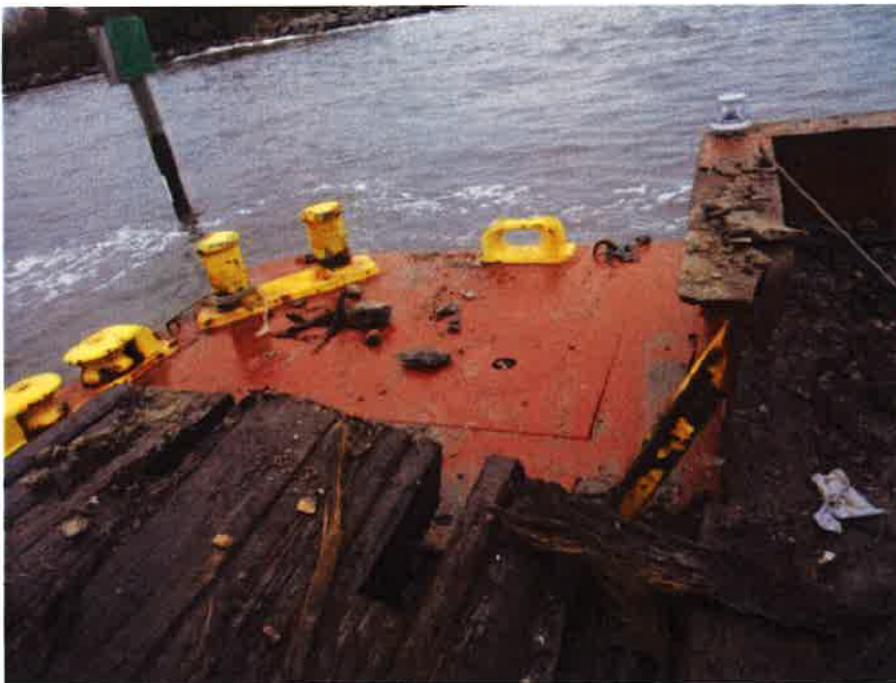
**Port side**

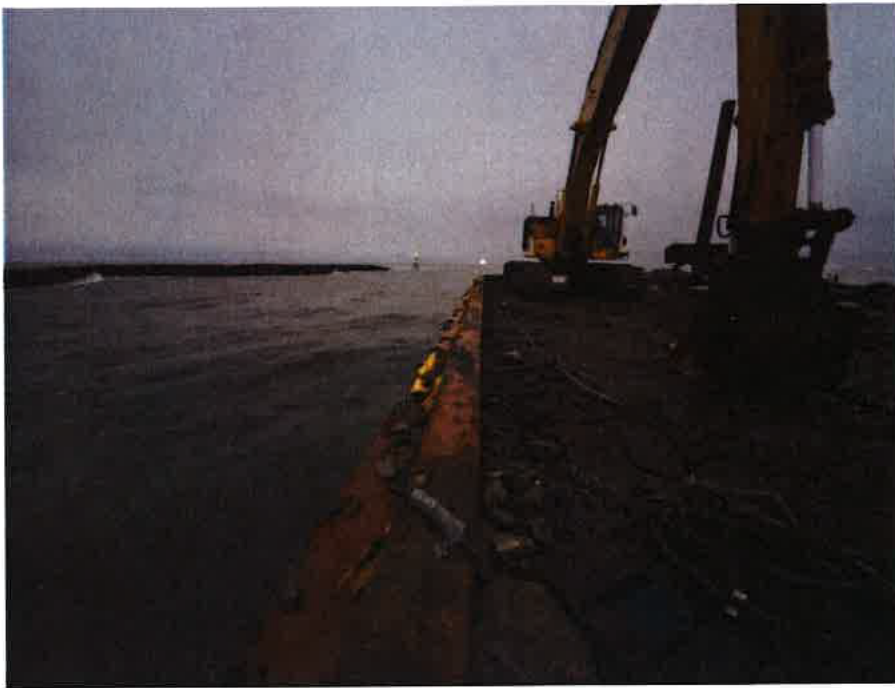
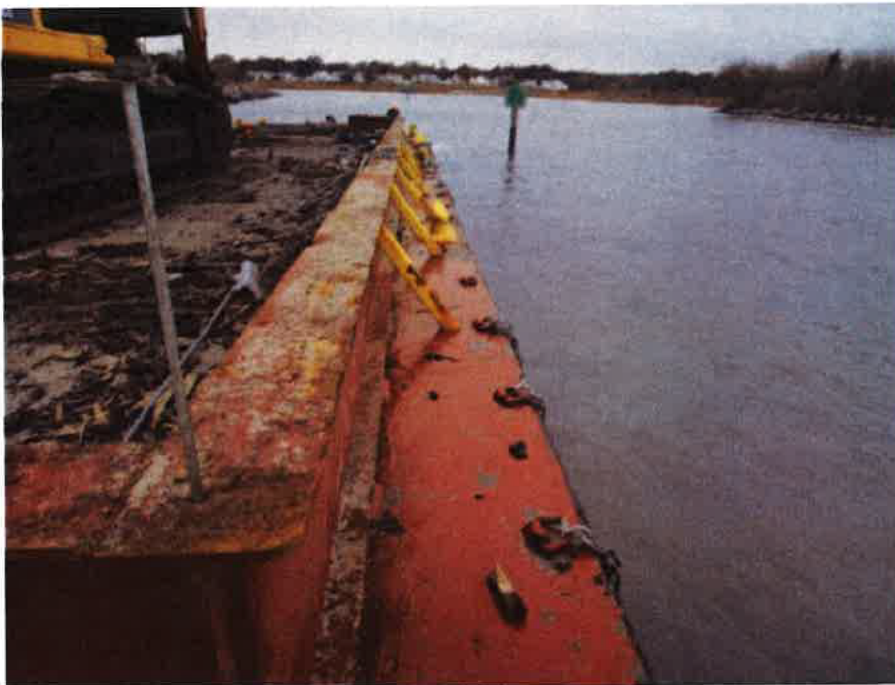
- Stern Rake was breeched and full of water

**Starboard stern rake deck breech**

The deck breeches sighted have been welded up to prevent further water intrusions from the deck.

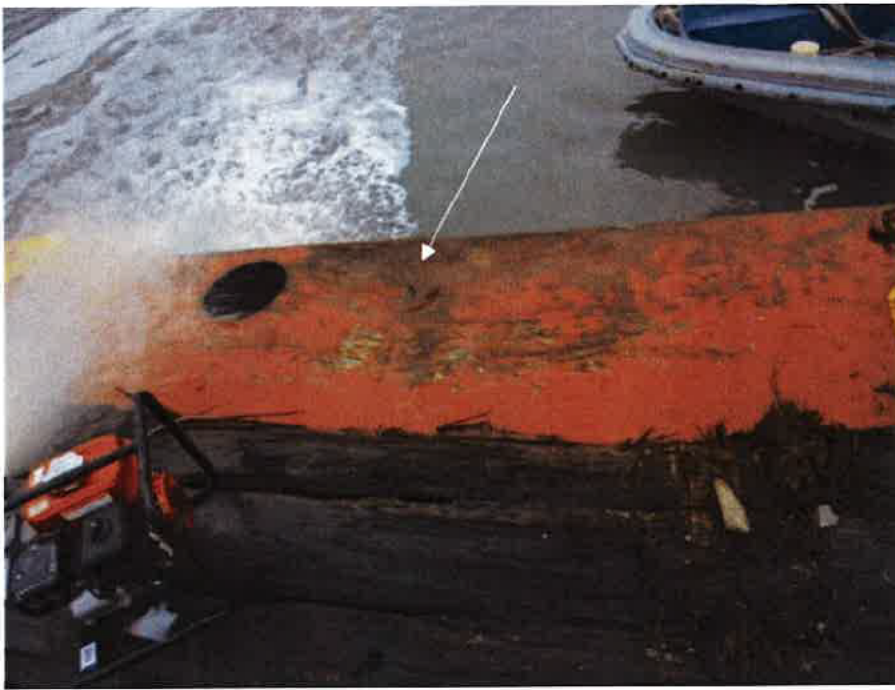
- Void 2 deck breeched was and the void was full of water

**Starboard Void 2 full of water. Water did not drain out when barge was pumped**

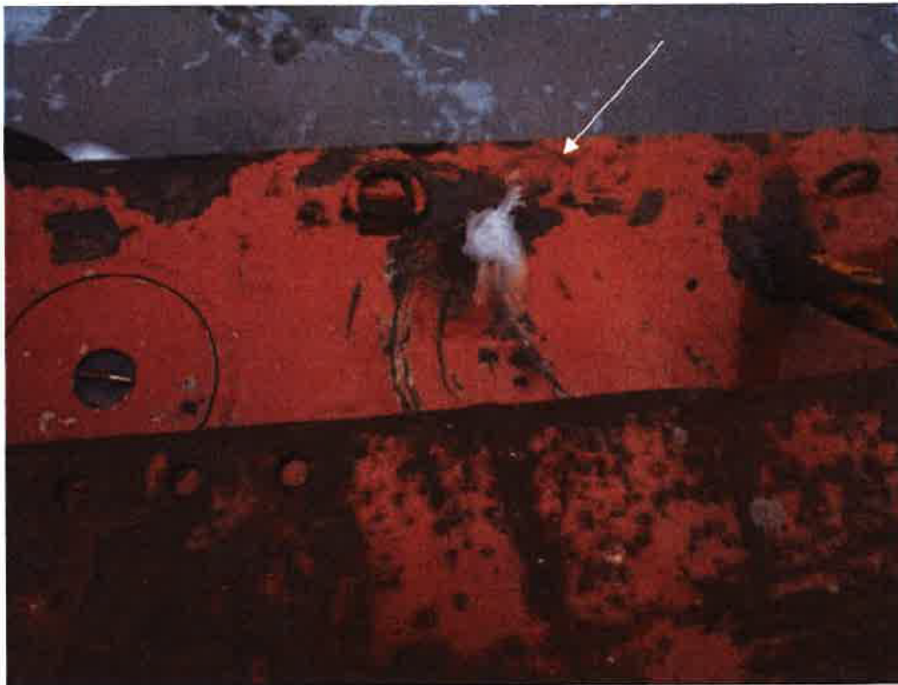
In voids rake, 1, 2, & 3., there were vertical frames and hull frames that were distorted in areas of the heavy insets.

Hull plating is upset in voids rake, 1, 2, & 3.,

**Void 2 upset hull plate, twisted framing**

It is the opinion of the surveyor the barge will need to be hauled out of the water for further inspection to the hull plating.

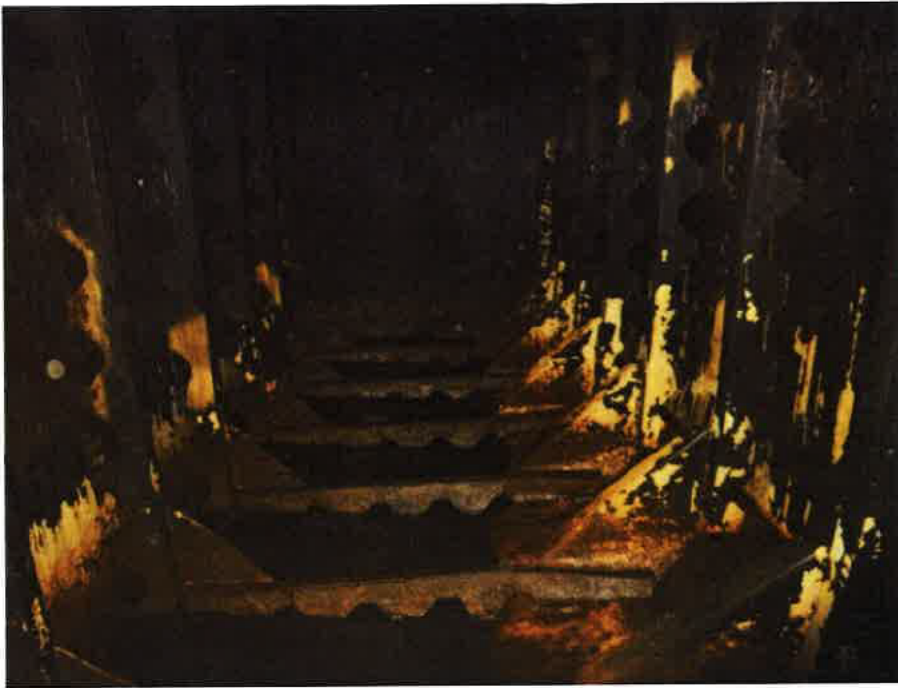
**Void 3 upset hull plate, twisted framing**

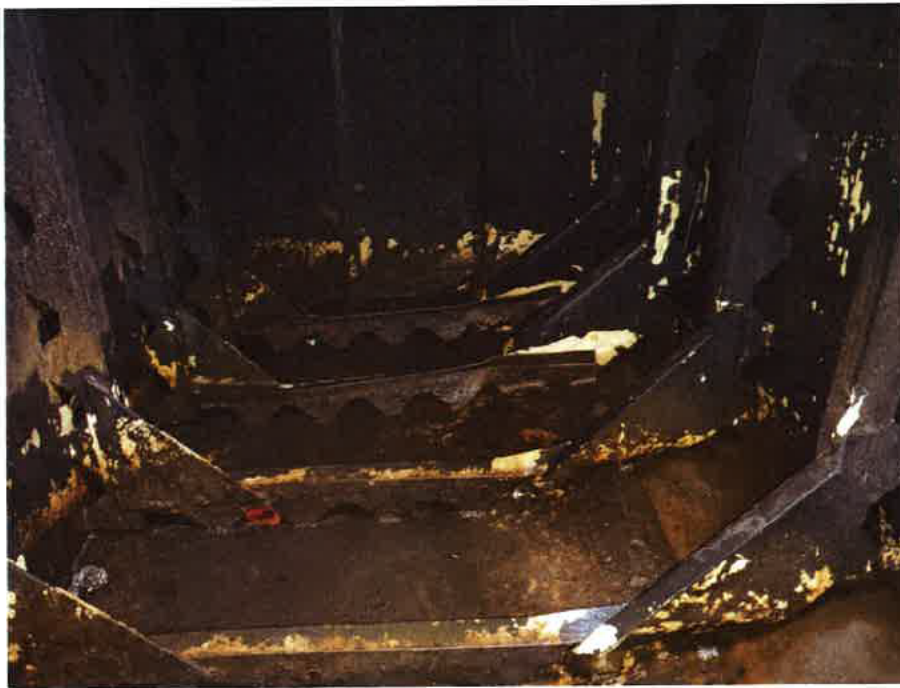
Along the port bilge radius, heavy insets were sighted in voids rake, 1, 2, & 3.

**Hull Radius Void 3 insets and distorted framing**

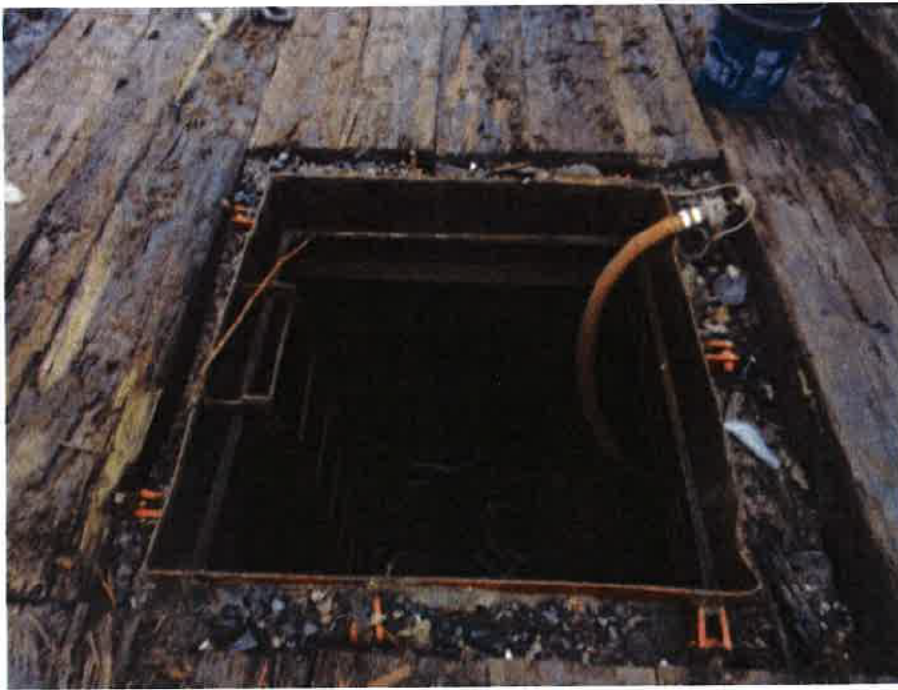
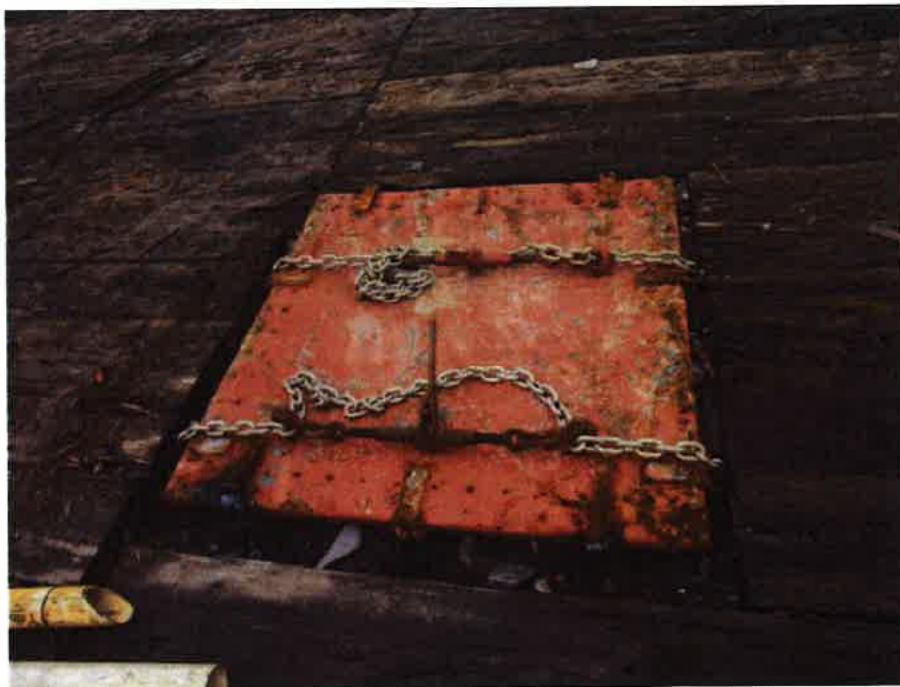
**Repaired Deck Breech**

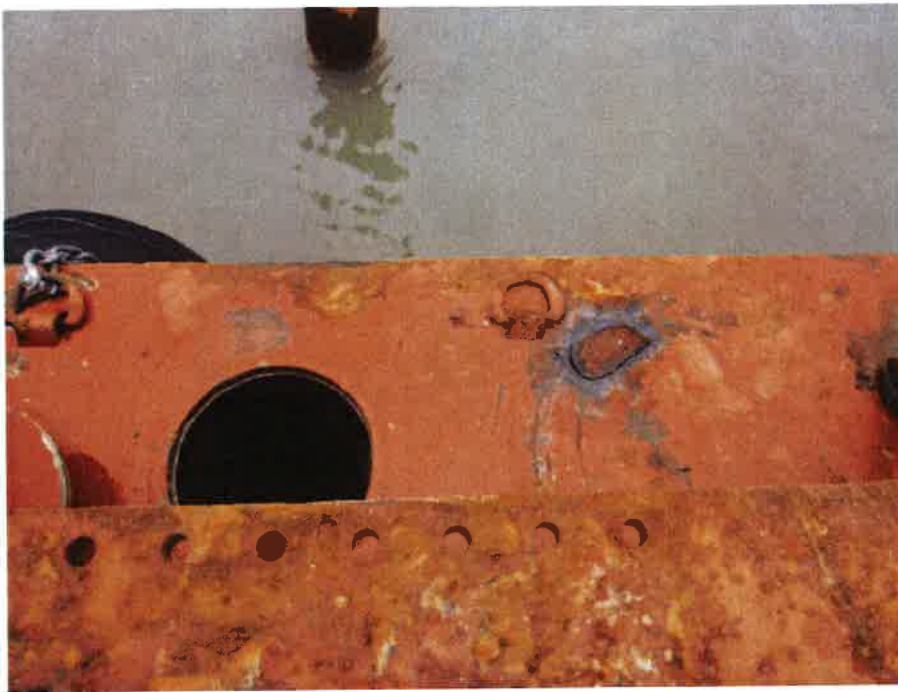
**Repaired Deck Breech**

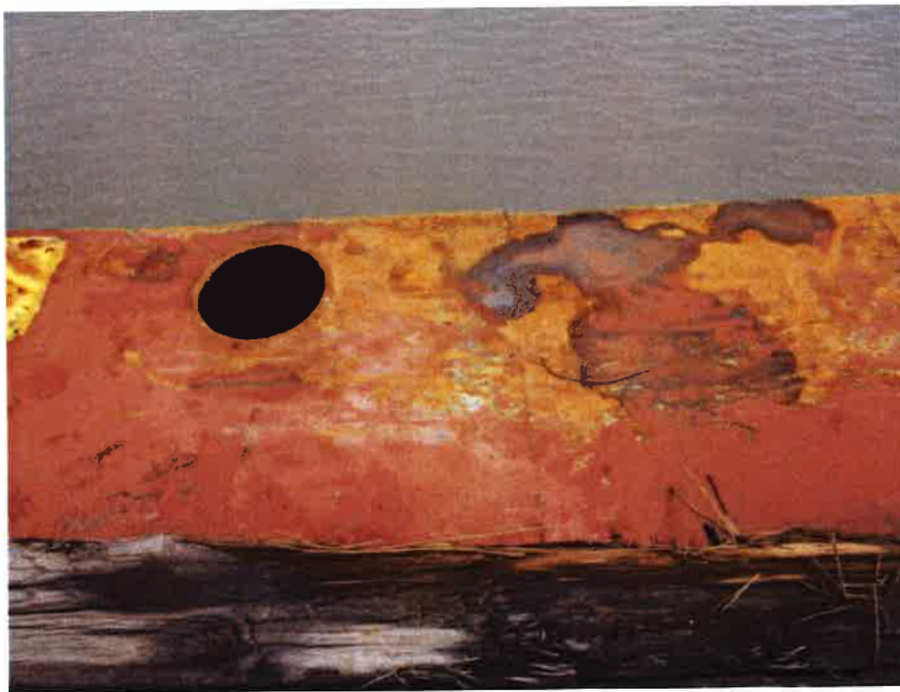
**Deck Breach found at 2<sup>nd</sup> inspection, to be repaired**
