# National Transportation Safety Board

WPR21FA265

## INVESTIGATION MATERIALS SUPPLEMENT

Location: Albany, Oregon  
Date: 07/09/2021  
Time: 2051 Pacific standard time  
Airplane: Northwing Mustang 3

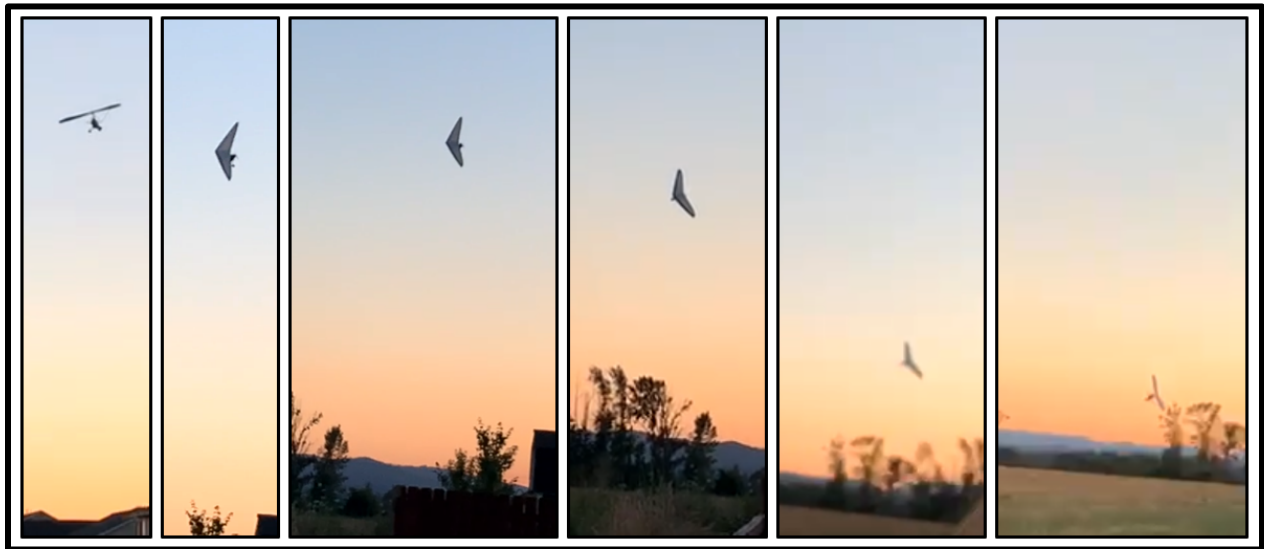
*Figure 3: Excerpts of the Video Prior to Impact*

Several witnesses on the ground recorded the airplane maneuvering on their mobile phone devices. A review of those videos disclosed that the airplane banked to the left to a near 90° turn. The left wing continued to drop down and the aircraft descended toward the ground as the turn tightened. The aircraft impacted the terrain in a left-wing low attitude (see picture 2).

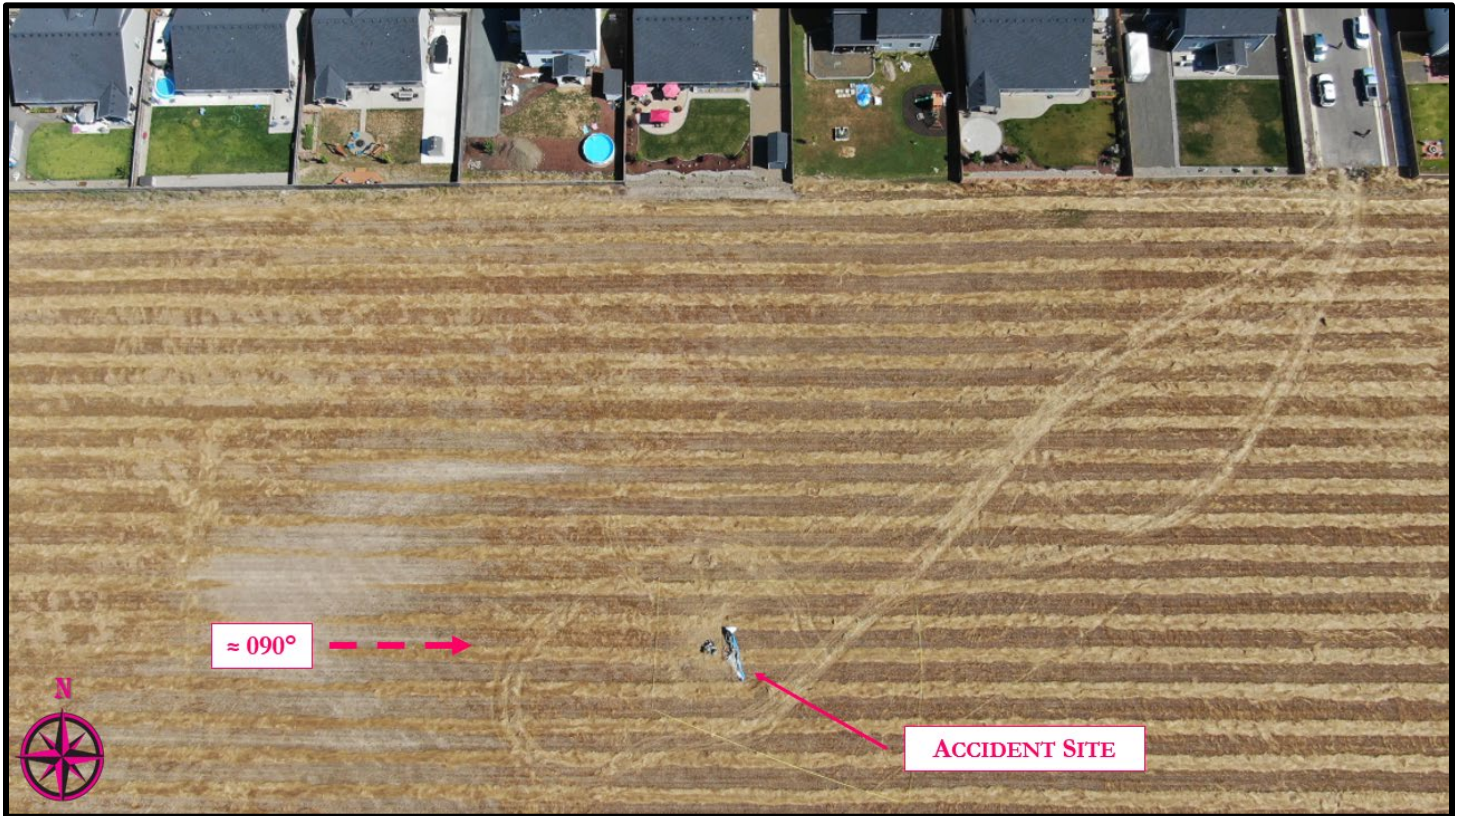
Figure 7: Accident Site Overview

On-site examination of the aircraft, including the flight controls, structure and engine, revealed no evidence of any mechanical anomalies. Ground scars and the orientation of the wreckage were consistent with the aircraft impacting the ground in a nose-low attitude. No manufacturing anomalies were noted with the aircraft. The wooden propeller assembly was shattered and exhibited signatures consistent with the engine producing power at the time of impact. The flying wires were separated at the nose; the wires were sent to the NTSB Materials Laboratory for examination. Below includes photos of the wreckage.
