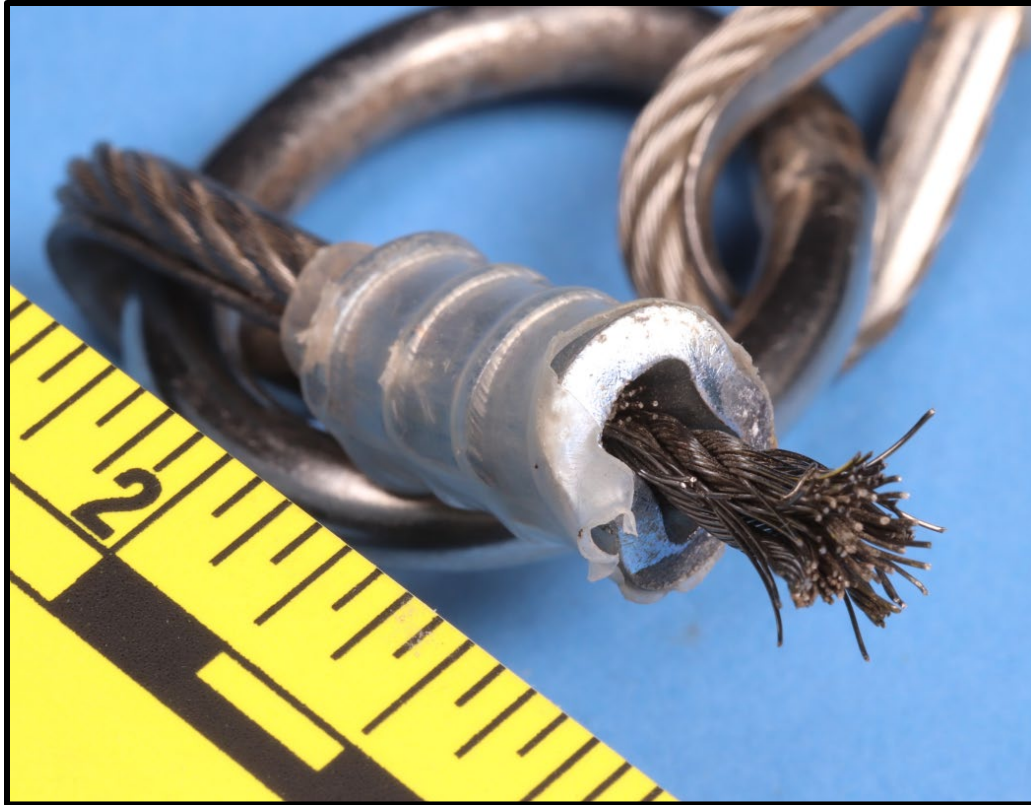
Figure 2: Cable End

The trike cable from the subject investigation was examined using an optical stereomicroscope. Attached pictures show an overall view of the submitted cable, the fracture at the crimped sleeve, and the mating side of the fracture. The cable fractured where the cable intersected the crimped sleeve for the cable end. Individual fractured wires showed necking deformation and chisel-like features consistent with ductile overstress fracture. No evidence of preexisting damage such as fatigue or corrosion were observed.
