## EXAMINATION NOTES

### WRECKAGE AND IMPACT

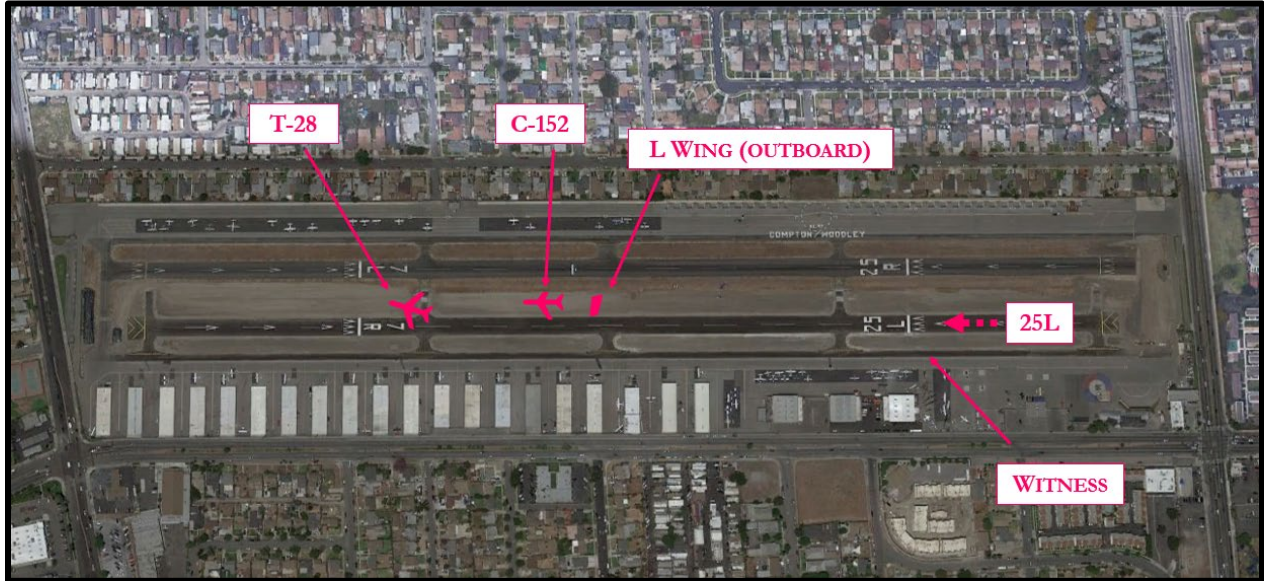
Figure 1: Wreckage Distribution

The C-152 came to rest on the north side of runway 25L, about 150 feet west of the left outboard wing. The T-28 was 450 feet further west from the C-152. The collision between the airplanes occurred at the “1/2” runway remaining sign. The marks on runway revealed no indications of braking by the T-28 prior to the collision.

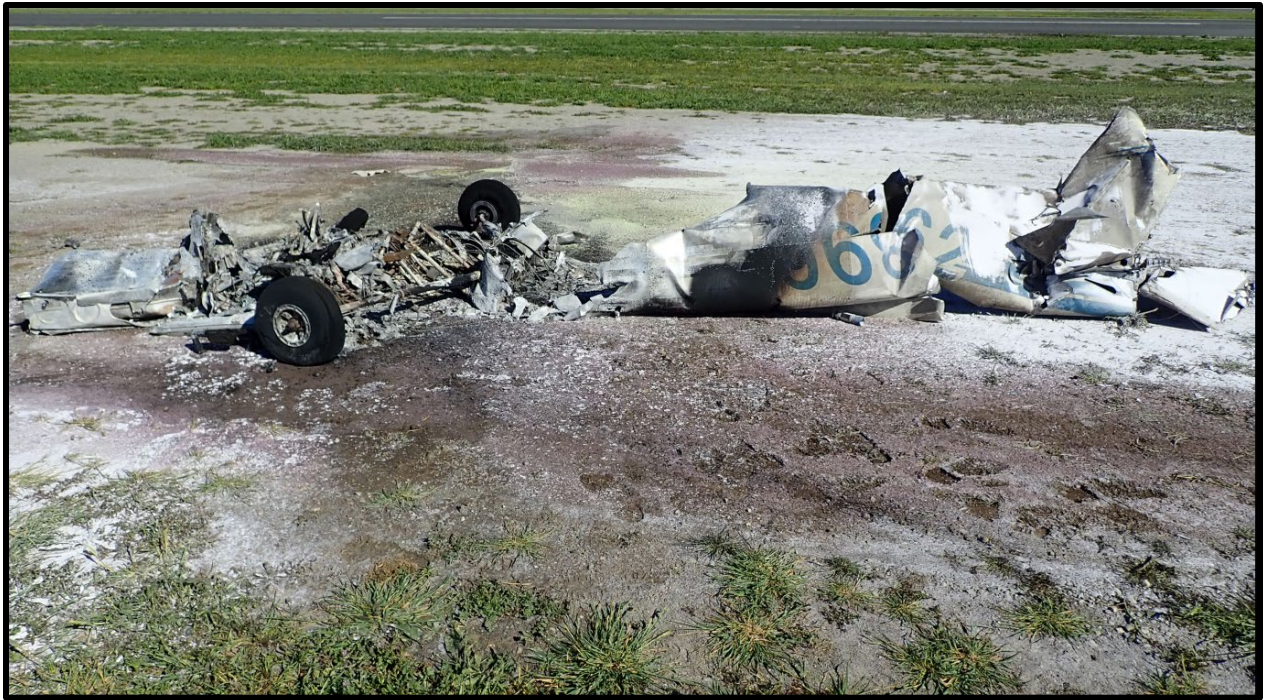
*Figure 3: Cessna Wreckage*

The C-152 was consumed by fire. The T-28 had damage to the lower right nose cowling. A portion of the nose cowling and inboard left flap were entrapped on the right wheel pant of the T-28.

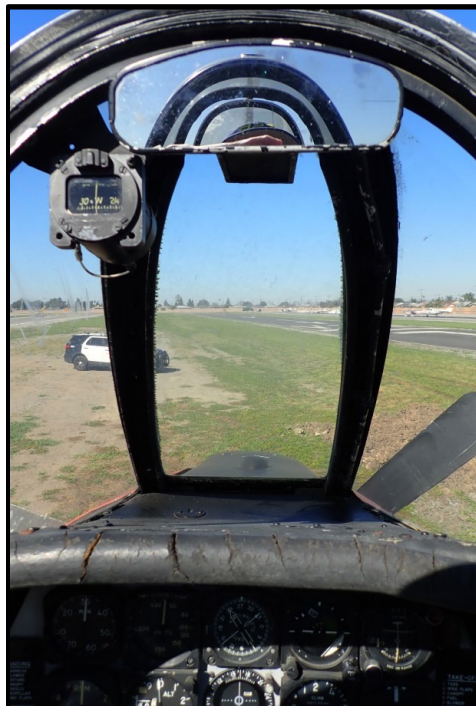
Figure 6: Cockpit View

The T-28 pilot's seat forward visibility was unobstructed with two thick black seams in front. The windshield exhibited a light coating of dark soot and fiber consistent with post-impact fire.

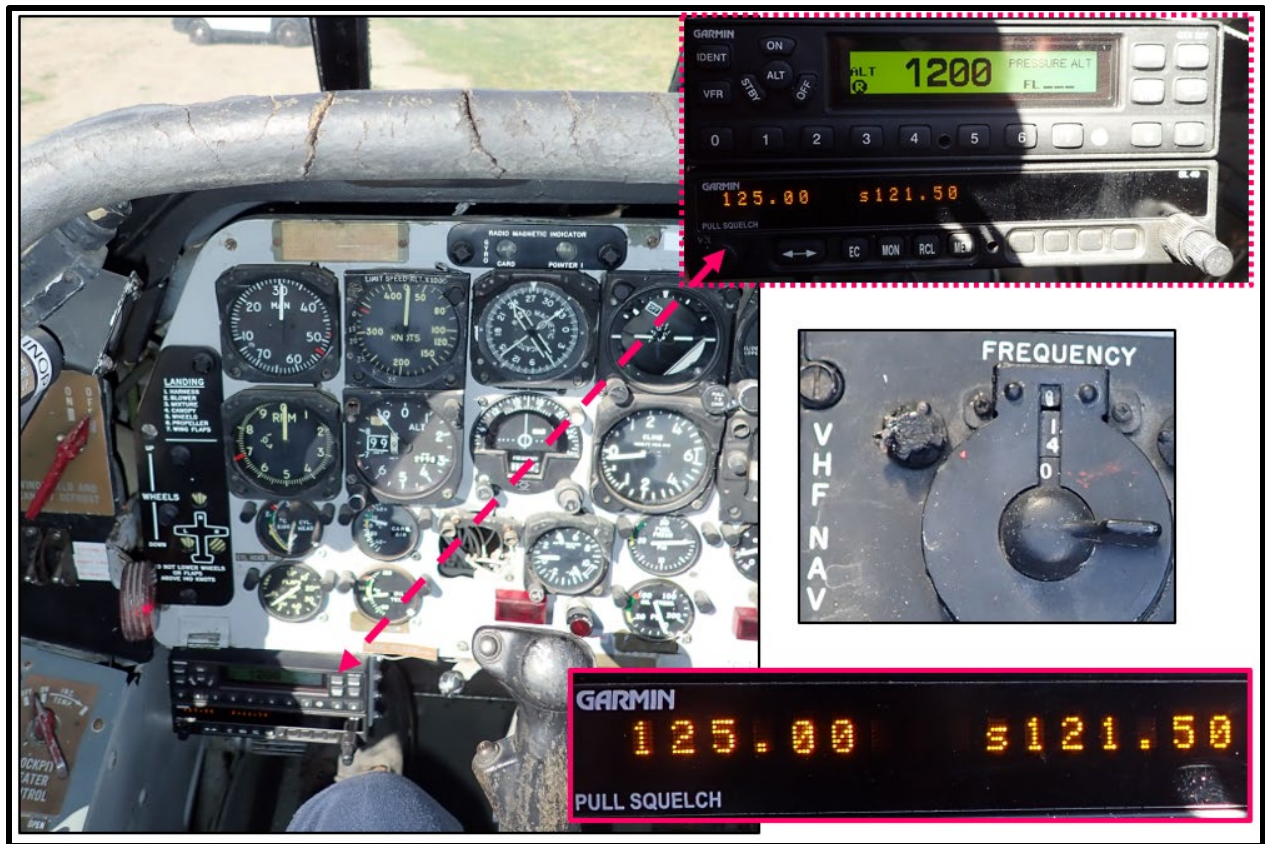
Figure 7: Radio Setup in T-28

to the bottom of the panel. After the electrical system was powered on, the investigator observed that the active radio frequency was 125.00 and the standby frequency was 121.50. The CTAF for Compton was 123.05 and at Whiteman (the departure airport) was 135.00; the ground control frequency at Whiteman was 125.00. The aircraft emergency frequency is 121.5 MHz. Commonly referred to as GUARD, this frequency is reserved for emergency communications for aircraft in distress, as well as the frequency utilized by earlier generation ELT's as a means of locating downed aircraft.

When positioned in the pilot seat in the T-28, investigators noted that the radio frequencies were partially obscured from the pilot's field of vision. To completely read the frequency screen, the pilot would have to drop their head left and lower their eyesight. While in a normal flying position, an investigator (of similar height of the T-28 pilot) could only see the bottom half of the frequencies.

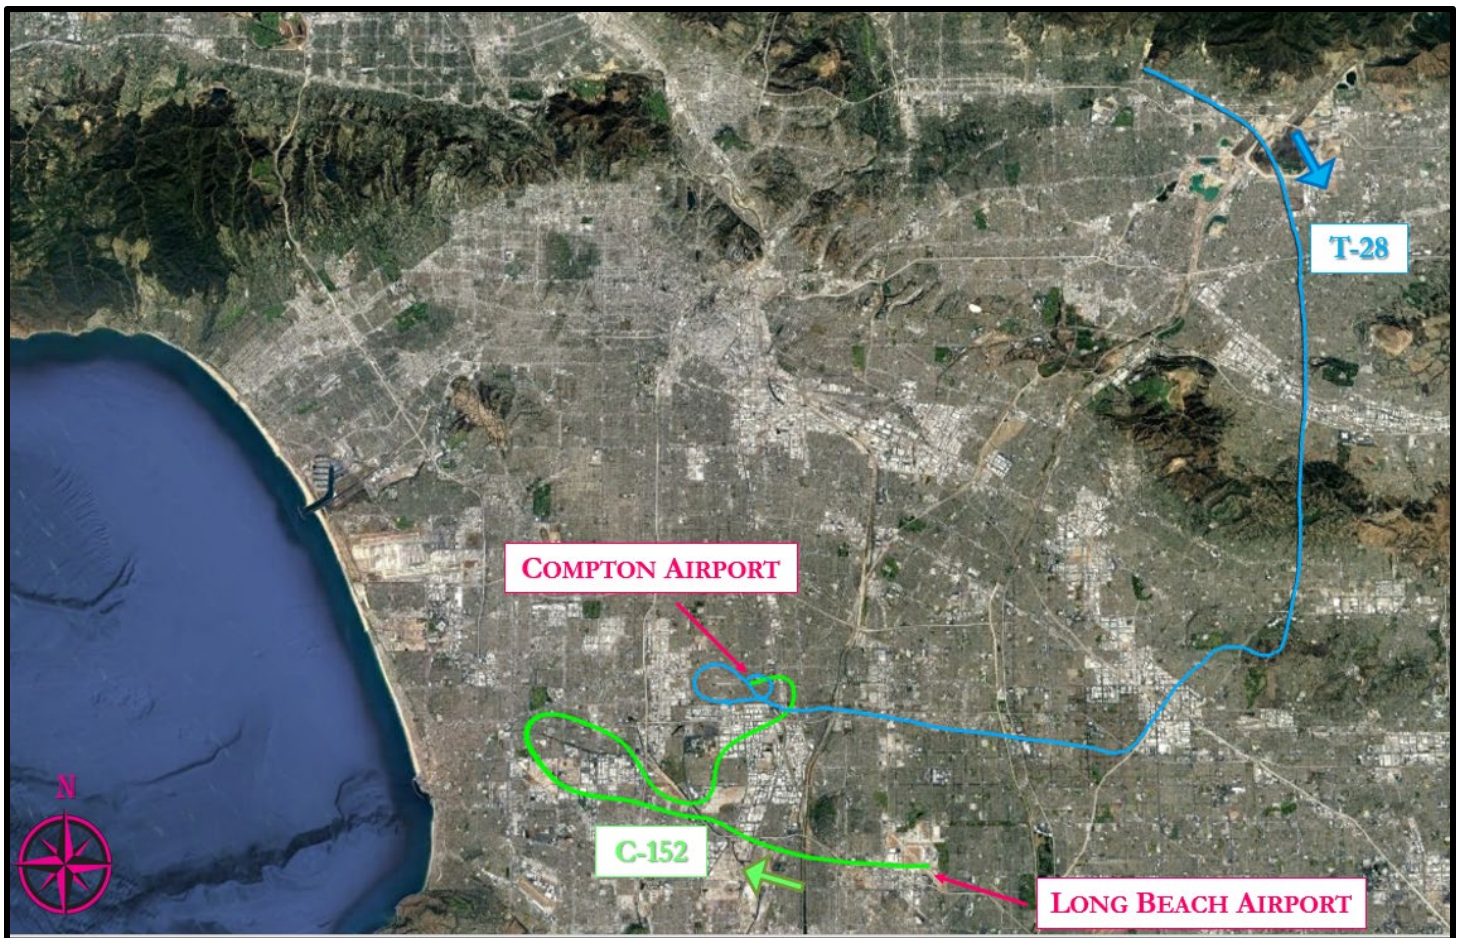
Figure 9: Radar Data of Both Airplanes

Recorded radar data covering the area of the accident was examined for the time frame, and two discreet secondary beacon code targets were observed that matched the anticipated flight track of the T-28 en route from Whiteman to Compton and the C-152 en route from Long Beach to Compton.

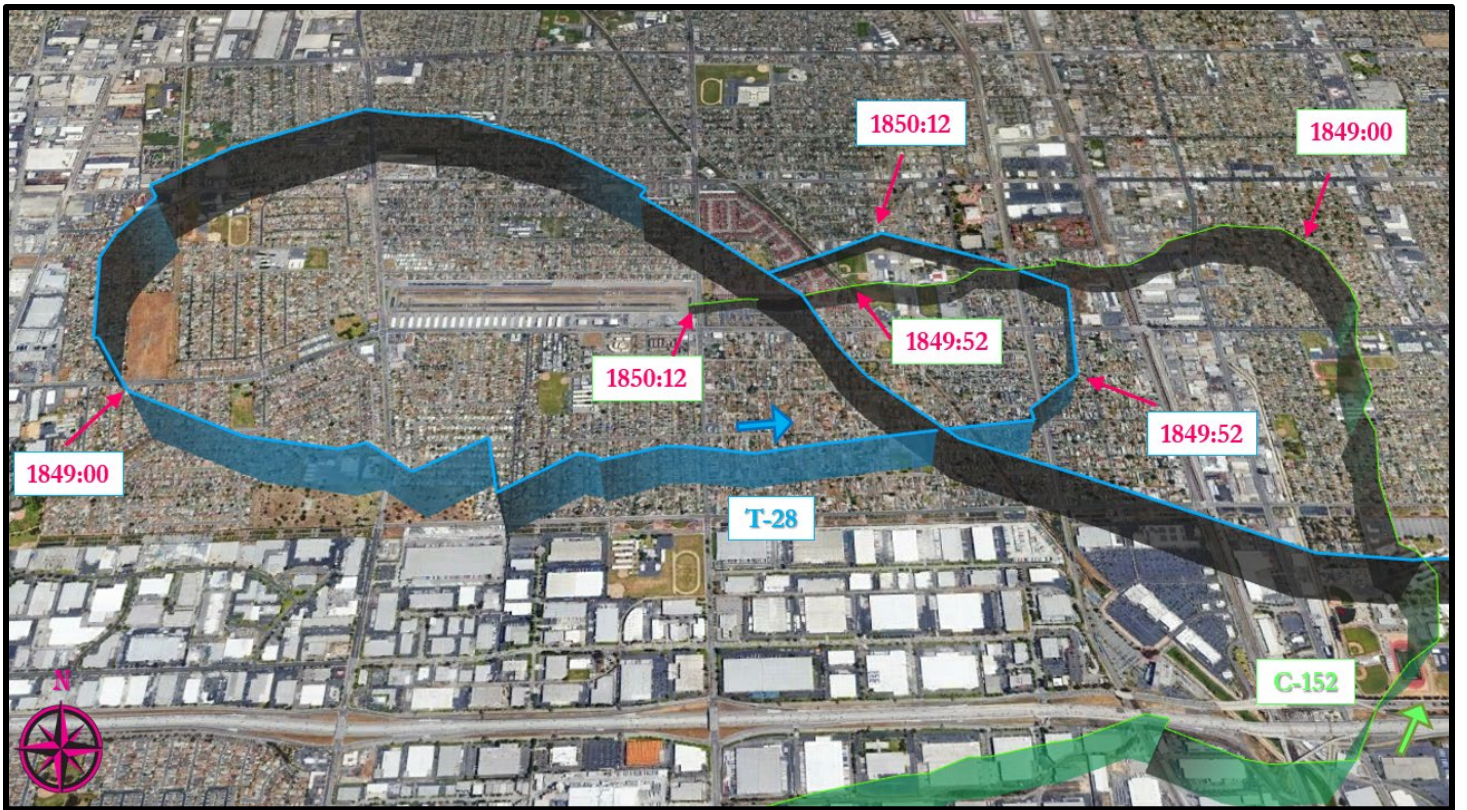
Figure 10: Radar Data at Compton

The radar data from Long Beach to Compton consisted of about 19 minutes of returns from 1831:47 to 1850:14. The returns were consistent with the C-152 departing the airport and heading northwest, continuing in that direction for about 5nm west of Compton Airport at which point it turned right heading southeast. The track then turned north and at 1847:33, adjoined the left downwind about 950 feet agl. The returns showed a northerly track again starting about 1848:11 and then a westerly track about 1848:58 until it ended at the airport perimeter at 1850:12; this was consistent with the C-152 making a base and final leg of the traffic pattern to runway 25L. The radar data consistent with the T-28 starts around Monrovia, California and proceeds to Compton containing about 13 minutes of returns from 1837:36 to 1850:20. The returns were consistent with the T-28 approaching Compton from the east. As the returns approached the airport, they were consistent with the airplane then circling the airport at an altitude of about 700-750 feet above ground level (agl) starting at speeds over 170 kts and while adjoining a left base for runway 25L reduced down to 130 kts.

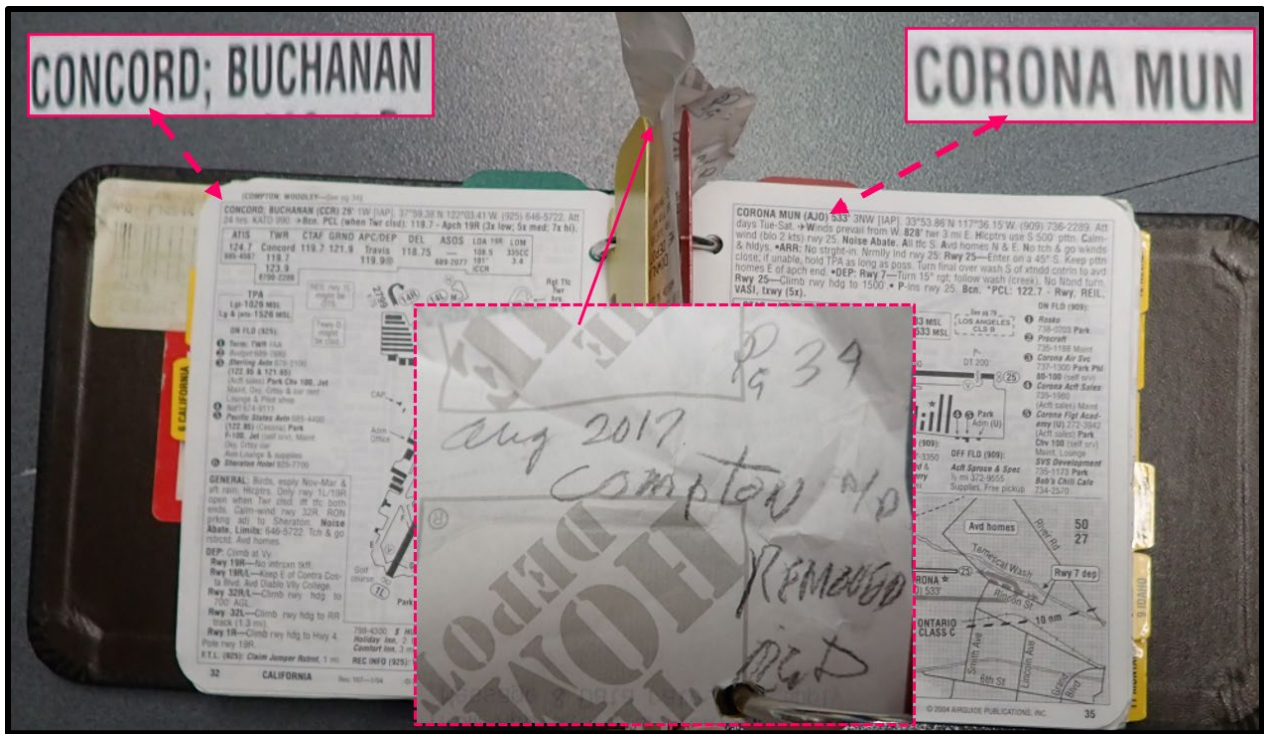
Figure 14: Airport Directory in Airplane

The T-28 pilot, stated that he used his "Flight Guide" book for determining airport frequencies. Examination of the actual guide found at the airplane revealed that the Compton and Whiteman pages were both missing, and that a paper note in place of the Compton page read, "Pg 34, Aug 2017 Compton a/d removed".
