Ercoupe MEMORANDUM

SUBJECT: Fuel System Operation

ERCOUPE SERVICE BULLETIN NO. 36

SERVICE BULLETIN NO. 24B

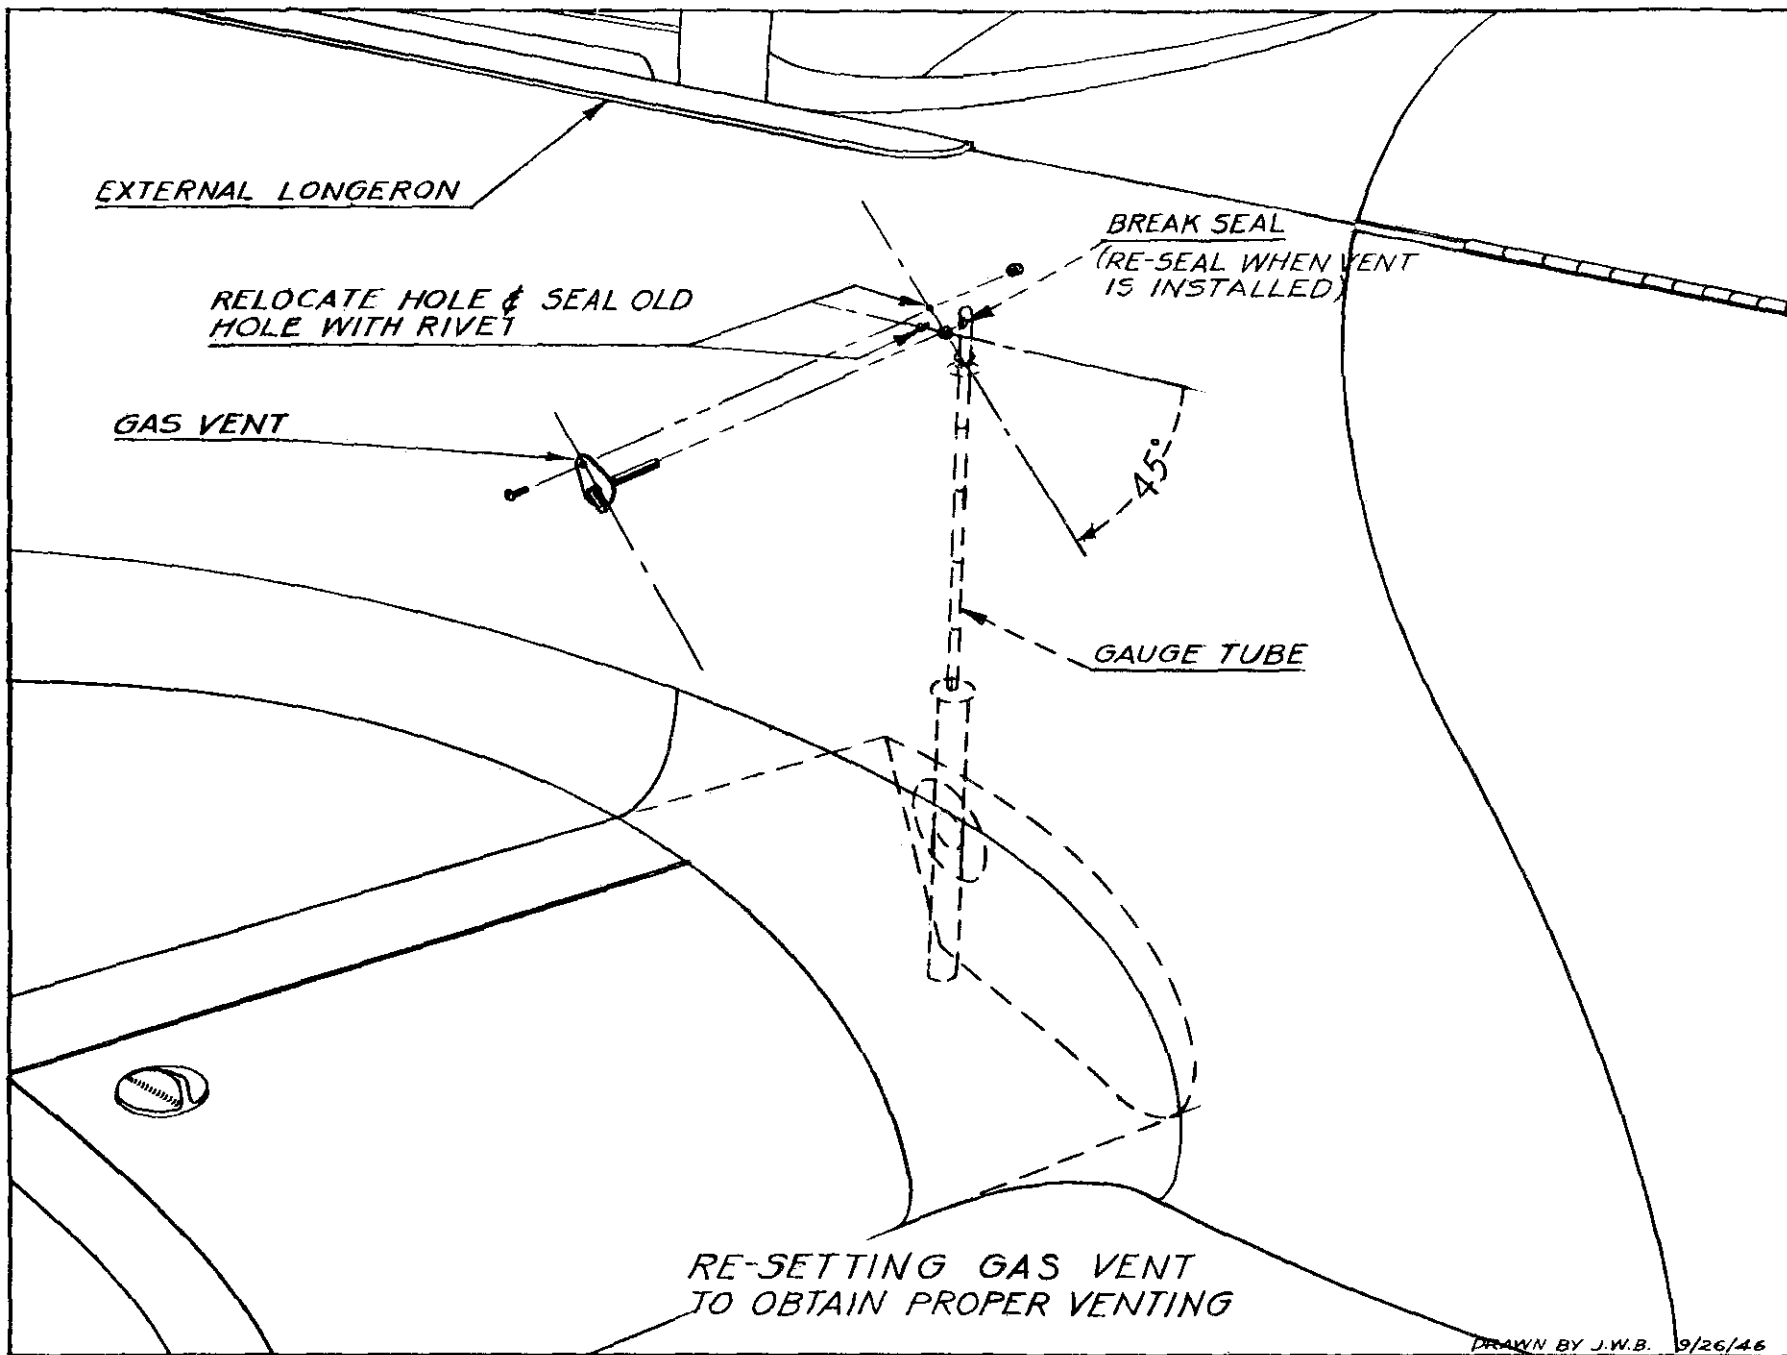
FIG. #1

it consists of a float type indicator, encased in a plastic tube. It is marked full, half full, and empty. This gage may give false readings due to improper venting, chiefly the error is reading half full in flight when more than half full of gas. This can be remedied on Ercoupes Serial Numbers 513 to 2623, by complying with the following procedure:

1. Remove 6 x 32 screw and nut which attaches vent to the right side of the fuselage.
2. Break the vent loose from the gage tube by turning the vent.
3. Realign the vent, by lowering the forward end, until it lies in a position from 40° to 45° with relation to the external longeron.
4. Drill a No. 28 hole through the fuselage skin, using the vent plate as a guide.
5. Insert the same 6 x 32 screw that was removed in operation No. 1.
6. Reseal vent to plastic gage tube by using clear nitrate dope, or any suitable cellulose cement. (See illustration No. 1.)
7. Close the original hole with a rivet.

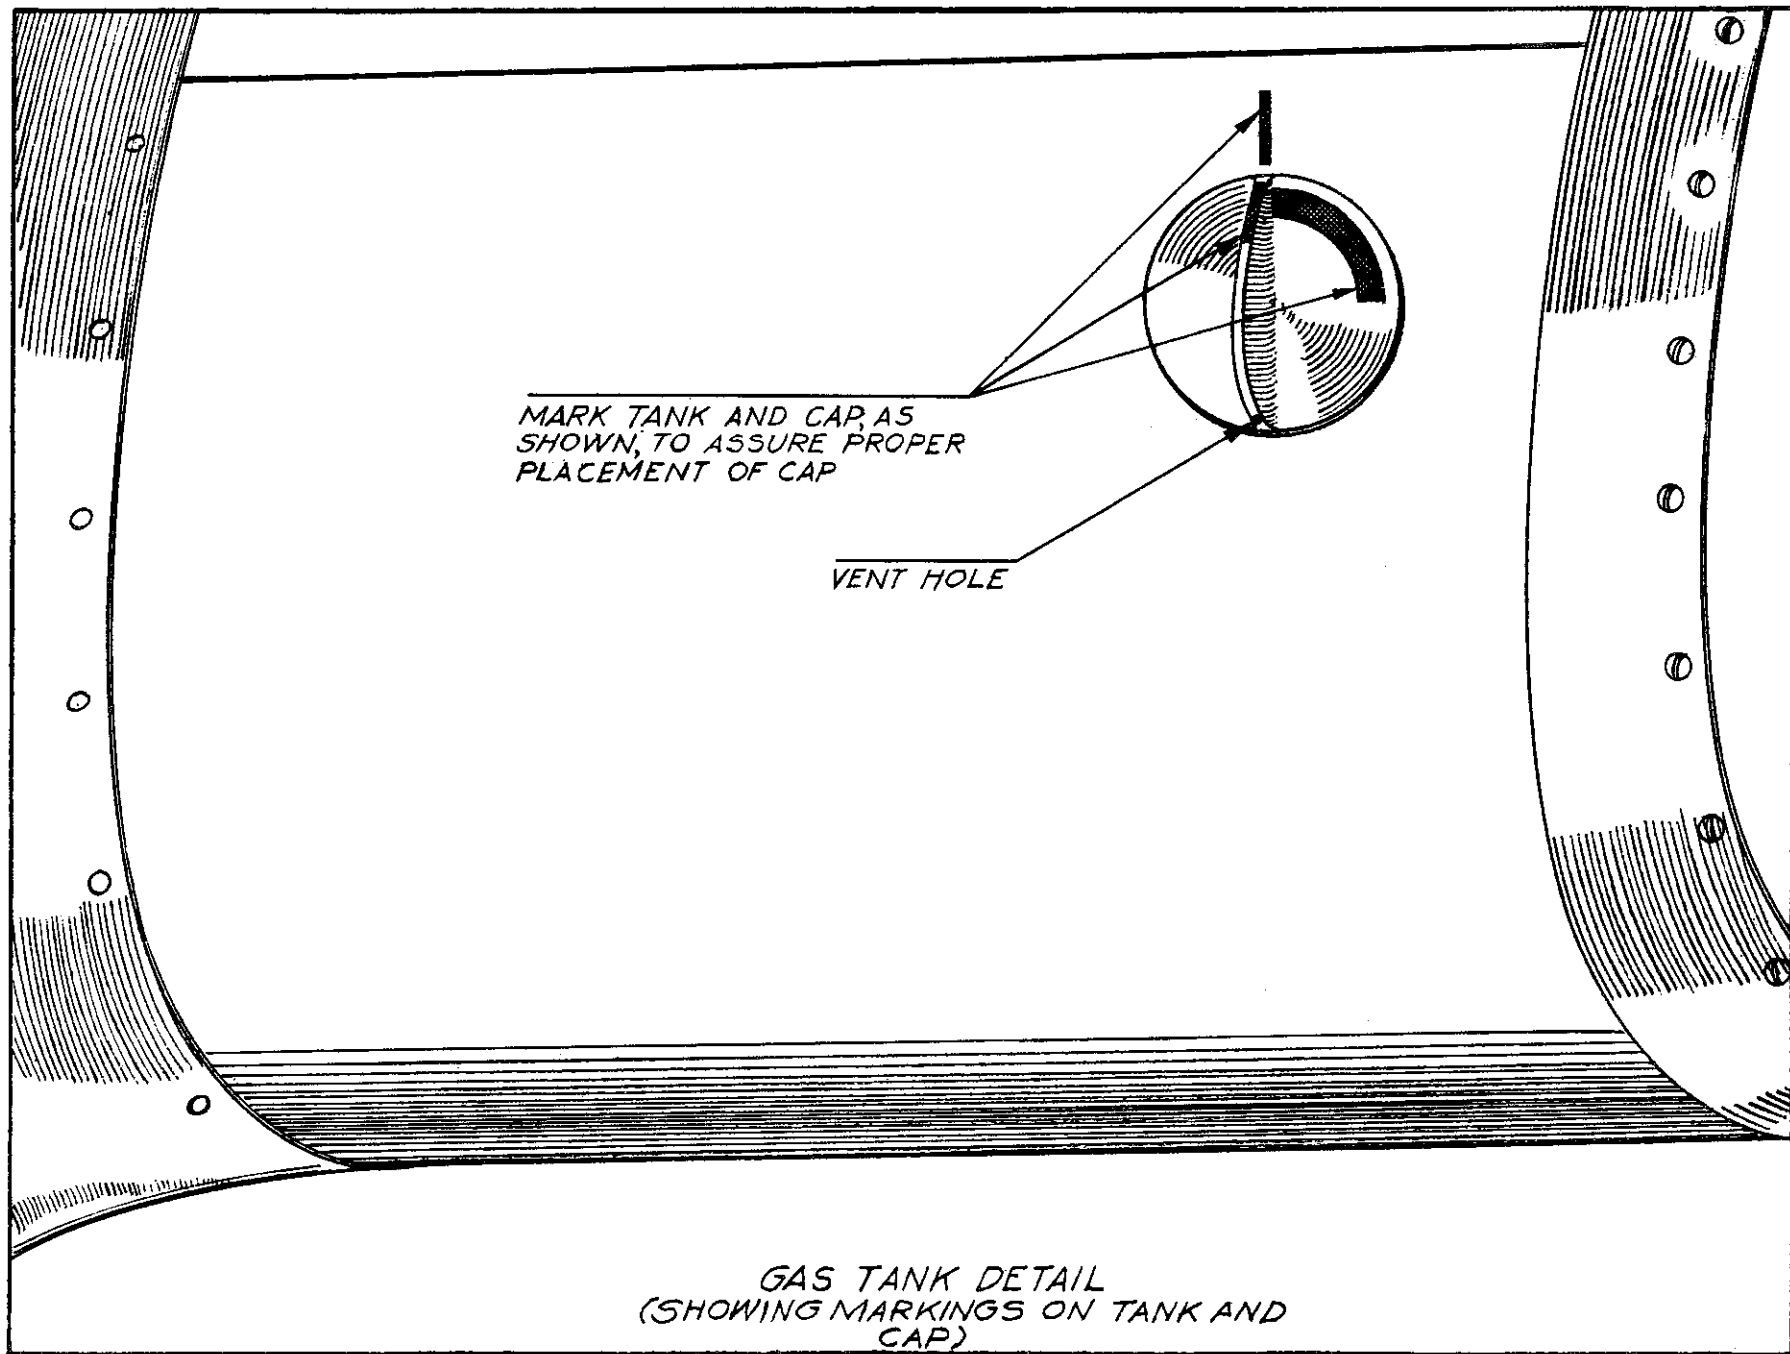
FIG. # 2

9. It has been the experience of some Ercoupe owners and operators that line mechanics put the wing tank caps on backwards. To prevent malfunctioning of the fuel system, it is imperative that the caps be put on the tanks with the vent hole to the front. This provides venting of each wing tank and will prevent syphoning or unequal flow of the fuel. Unequal flow may result in the fuel pump being unable to transfer all of the fuel from the wing tanks to the fuselage tank.

10. It is recommended that the wing tank cap be marked in a manner to indicate proper positioning. A painted red line on the wing behind the cap to match a painted sector on the cap should be used. The painted sector on the cap should extend from the point of engagement to the locked position, as indicated on accompanying sketch No. 2.
