Magneto Inspection Report

NTSB Docket WPR21LA171

NTSB Case Number	WPR21LA171				
Date of Accident	4/21/2021				
Aircraft Registration	N2989P				
Aircraft Make	Consolidated Aeronautics Lake				
Aircraft Model	LA-4-200	Hours TT	N/A		
Aircraft S/N	NA				
Engine Make	Lycoming	Hours SMOH	N/A		
Engine model	IO-360-A1B				
Engine S/N	L-19989-51A				
Component Information		Part Number	Serial Number	Kelly O/H	Kelly Components
Left Magento Make	Bendix	10-349365-9	A230735	No	No
Right Magneto Make	Bendix	10-349305-1	A226860	No	Yes Capacitor
Date of Examination	10/14/2021				
Participants					
Zoe Keliher, NTSB					
Harry Fenton, Kelly Aero					
Tim Davis, Kelly Aero

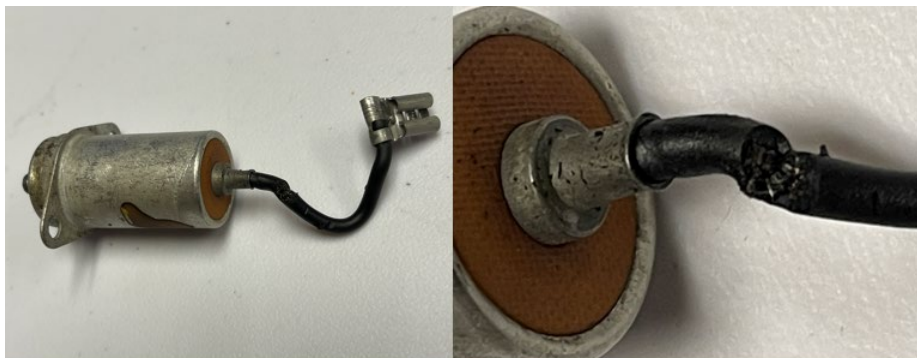
The 10-349365-9 was then configured with the capacitor with the cut lead wire that was original to this magneto.

When run with the damaged capacitor and the operating contact points from the 10-349305-1 magneto, spark was strong and consistent at 150, 1000, and 2700 RPM.

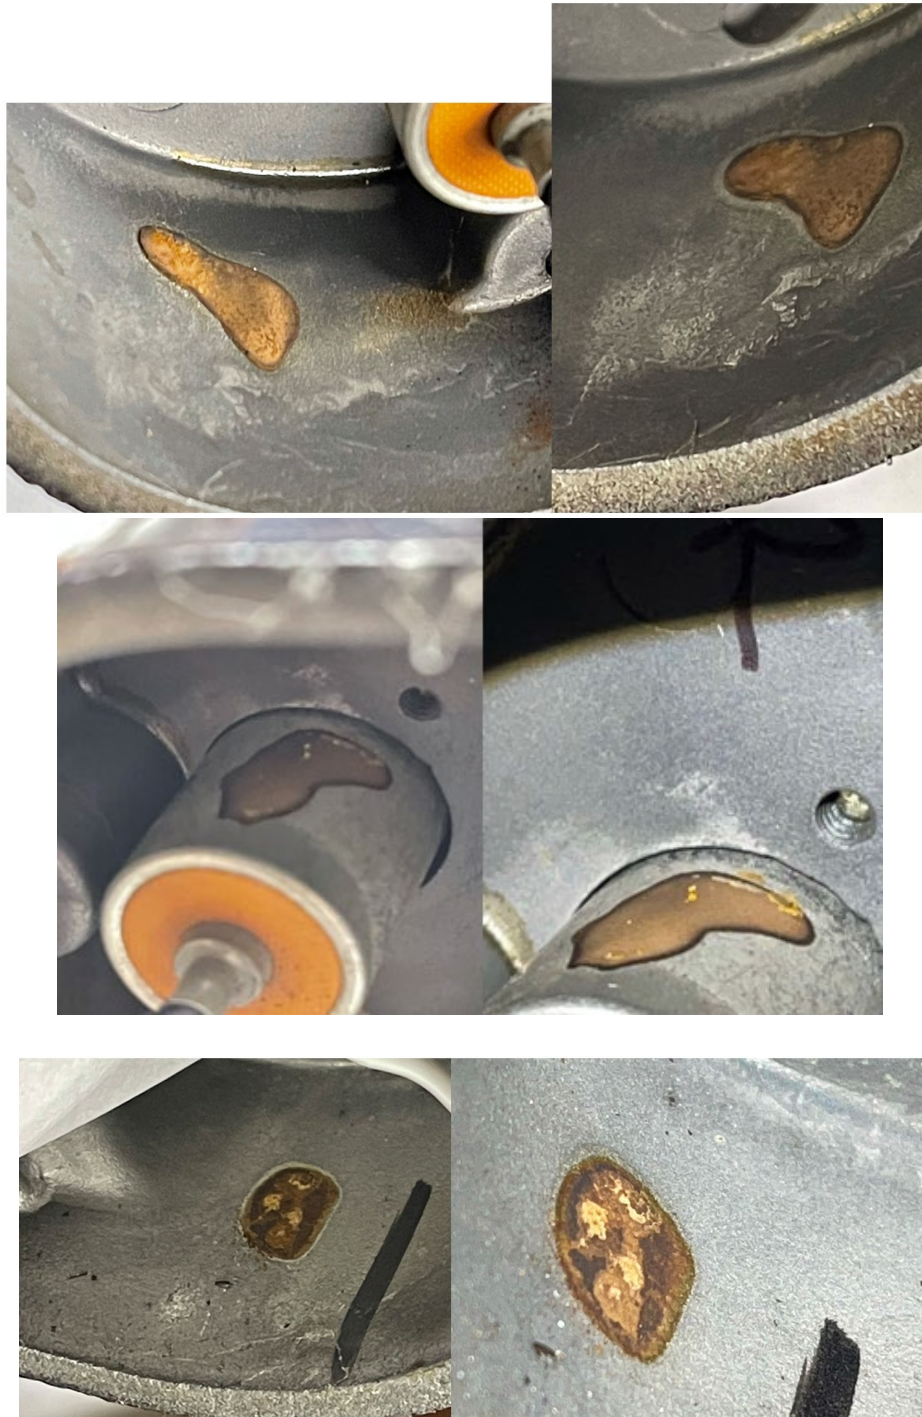
Both magnetos were completely disassembled for inspection. Two small areas of discoloration were noted in the left and right magneto housings and one area of similar colored material was observed on the capacitor body installed in the 10-349365-9 magneto. The discoloration appeared to be mineral deposits, and were not obviously consistent with oxides or exfoliation attributable to magnesium corrosion, but had the appearance of dried mineral or chemical deposits.

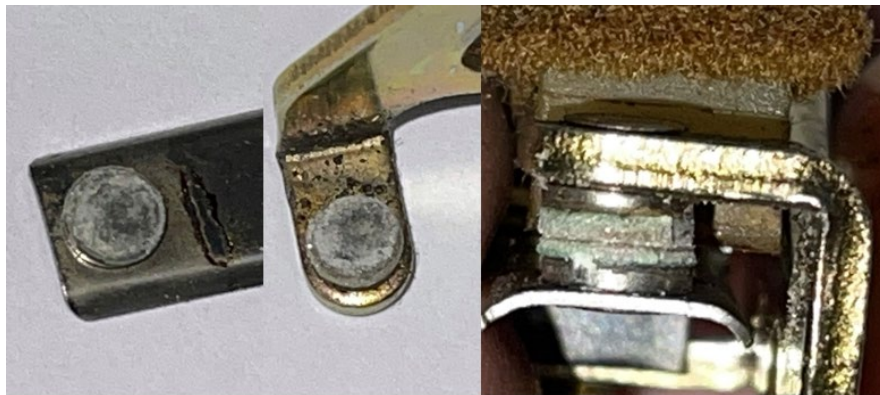
The contact points were disassembled and inspected using a 60X inspection microscope. The tungsten contact point heads are an assembly of a tungsten wafer and reinforcing steel backing material, fastened with a copper braze process. The tungsten contact assembly is secured to the contact base and spring by a material upset process similar to the upset of a rivet. The worked end of the rivet is compressed in height to increase the diameter and grip to secure the tungsten to the point base or spring. The tungstens of both sets of contact points were observed to be secured tightly with no discoloration of the worked end of the tungsten.

The contact point tungsten of the 10-349365-9 magneto exhibited surface discoloration degradation consistent with oxidation to the top layer of the tungsten assembly which functions as the discharge point for electrical energy. It is undetermined if the oxidation was due to an external corrosive material or due to galvanic reaction of the various materials of the tungsten contact head assembly, or a combination of both external and internal material degradation factors.

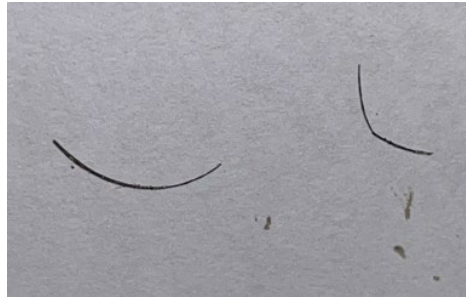
Two small crescent shaped pieces of material approximately 1" long and the diameter of a human hair were found on the hub of the coupling, but there were no observable witness marks, evidence of component damage, or evidence of material loss to magneto components to indicate that this material was significant. One of the pieces was attracted to the magneto magnet and assumed, indicative that the material was ferrous.

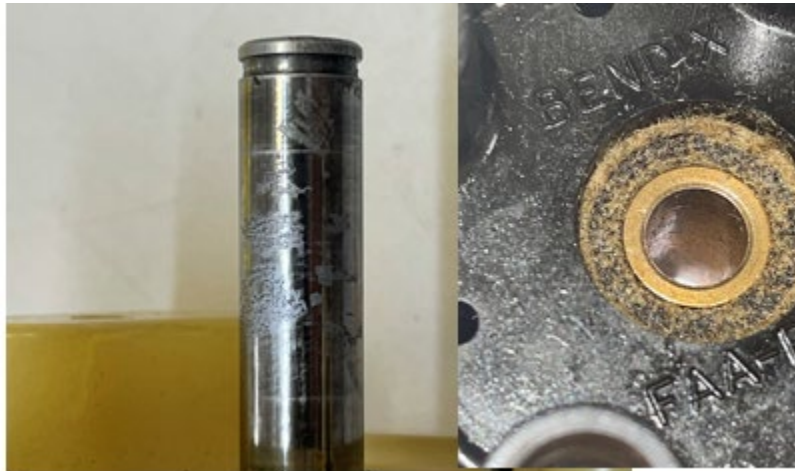
The distributor block was disassembled and observed to be in good serviceable condition, with electrode wear and surface deposits consistent with normal operation. The distributor gear shaft and mating surface of bearing internal to the distributor block showed corrosion anomalies. The pitting appeared to be a result of corrosion. The shaft and bearing were absent of any indications or rotational impressions which would have resulted from sustained FOD interference between the shaft and the bearing.
