## WRECKAGE AND IMPACT

On May 01, 2019, about 1100 Pacific daylight time, a Cessna T182P, N7302S, experienced a loss of power and collided with a powerline while making an emergency landing to grassy marsh in Mill Creek, California. Air Carriage, Inc.,<sup>1</sup> the registered owner, was operating the airplane under the provisions of 14 *Code of Federal Regulations* (CFR) Part 91. The certified flight instructor (CFI) and front-seated passenger sustained serious injuries; the rear-seated pilot-rated passenger sustained fatal injuries. The airplane sustained substantial damage. The personal local flight departed from Chino Airport, Chino, California, about 1010. Visual meteorological conditions prevailed and no flight plan had been filed.

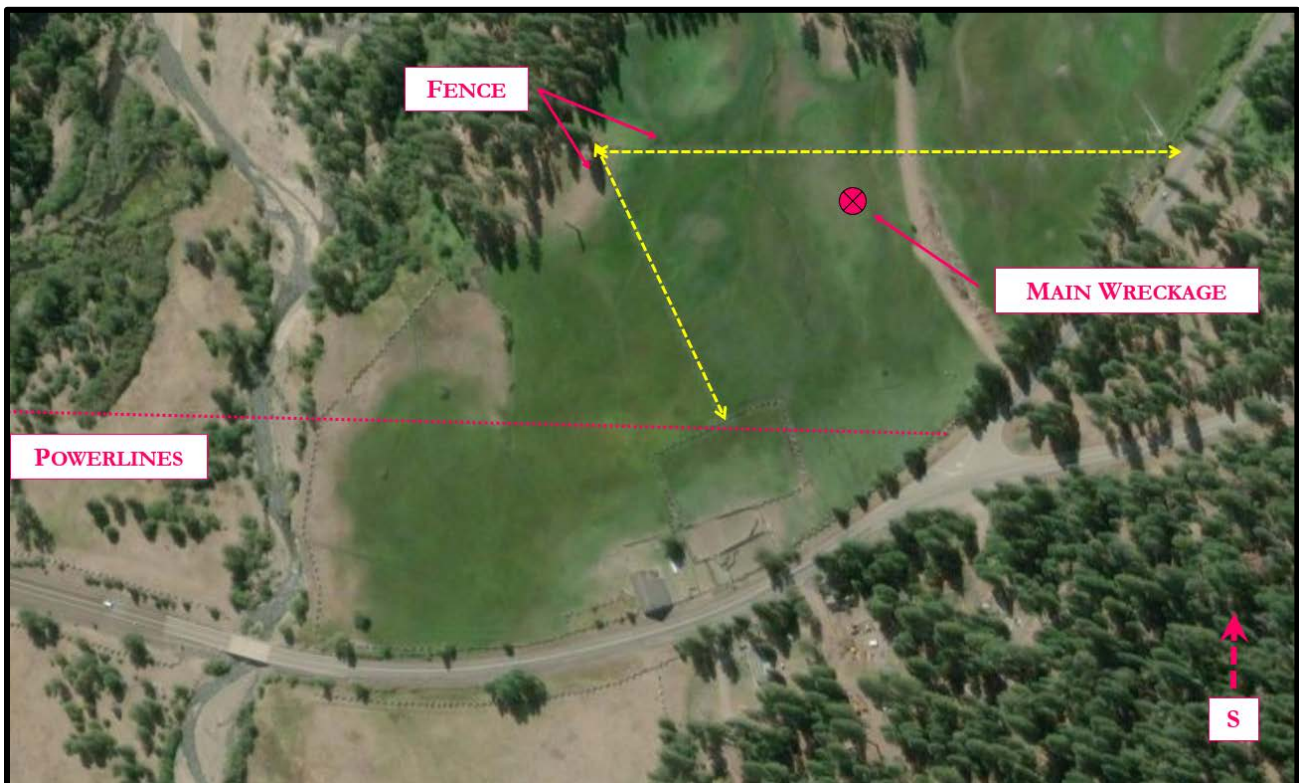
While aligning with the snow patch, the pilot noticed a grassy meadow and decided that would be a better option because there was no snow coverage. He retracted the flaps and made a right turn toward the meadow aiming to have enough altitude to clear the treetops. He planned to flare the airplane immediately after clearing the four-foot fence that stretched northwest-southeast across the field. After the airplane passed over the treetops, he extended the flaps again and continued toward the fence. The pilot suddenly saw powerlines immediately ahead and attempted to maneuver the airplane in a dive underneath them. The airplane contacted the wires and spun from the impact coming to rest inverted.

Picture 03: Main Wreckage in Reference to the Powerlines

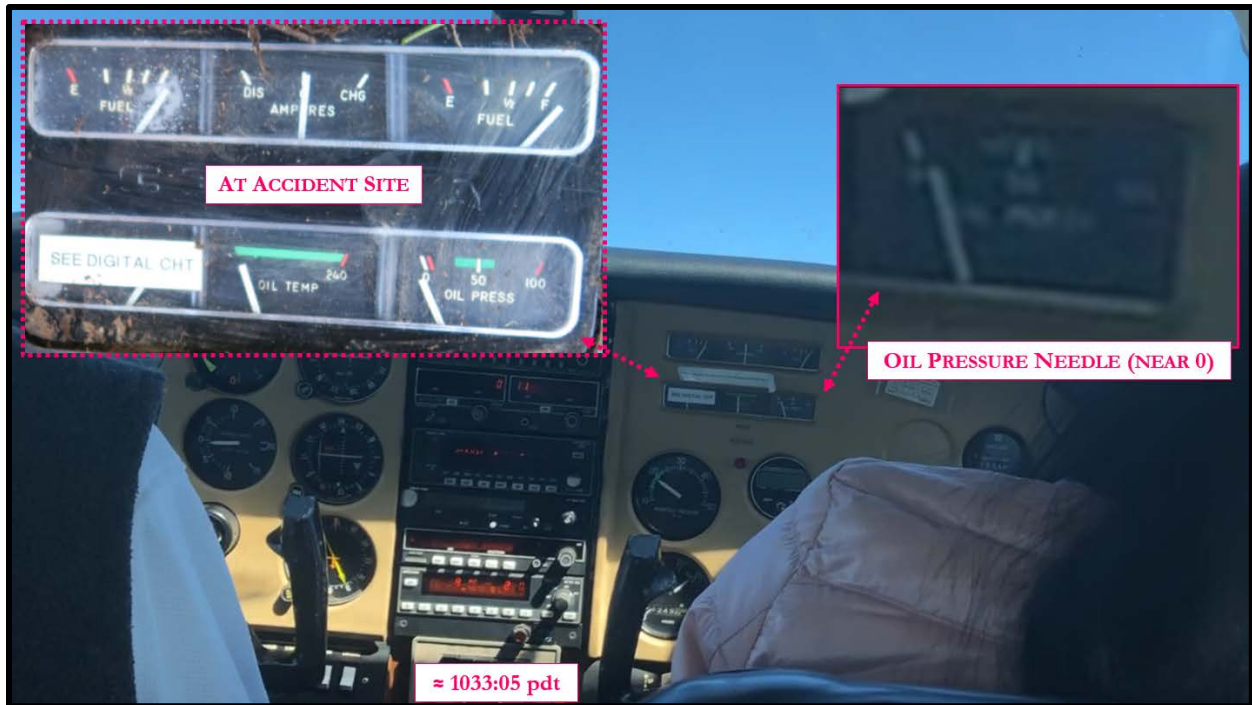
The rear-seated passenger’s cellular phone<sup>2</sup> contained photographs and a video of the flight. The 24-second video, beginning at 1032:43, captured part of the cockpit. Images revealed that the engine oil pressure gauge was indicating near 0 psi and the tachometer read 4249.7 hours.<sup>3</sup> The engine pumps about 4 gallons of oil per minute. The last photograph on the phone was taken at 1038:16 when the airplane was north of Mount Lassen.

Picture 04: Video Image Showing the Engine Oil Pressure Gauge

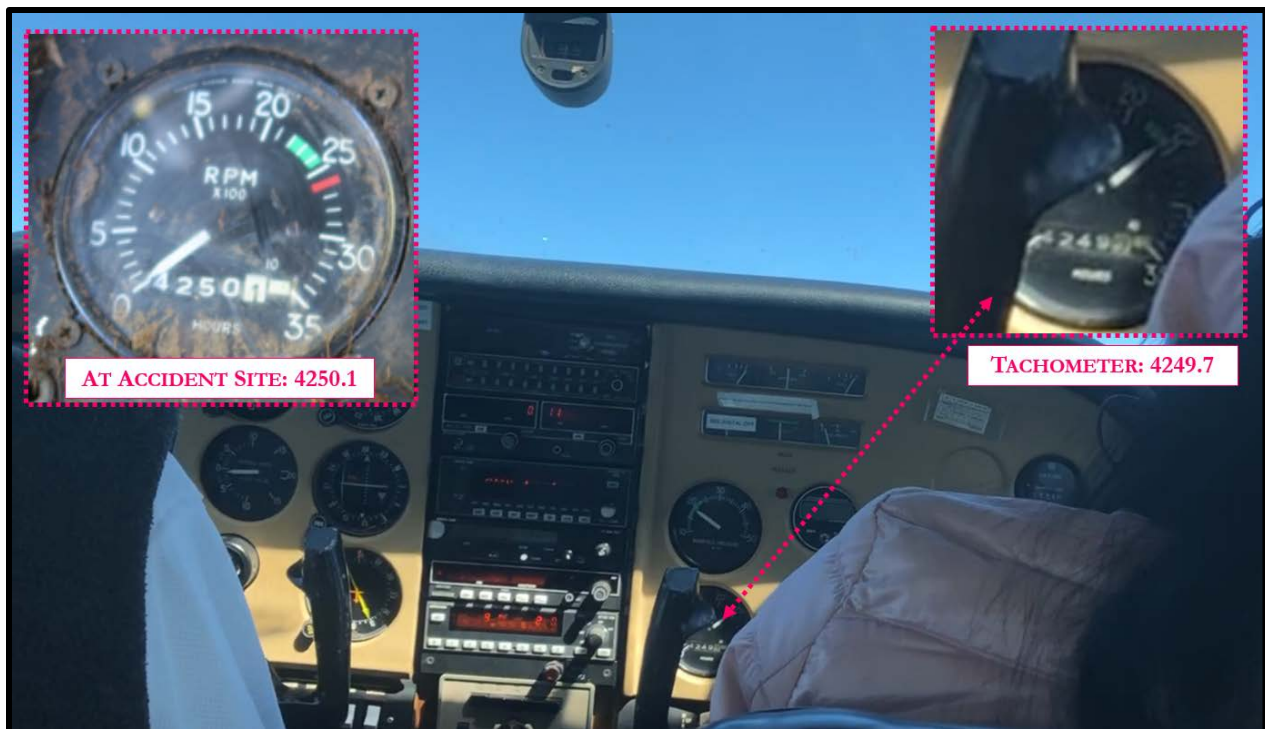
Picture 05: Video Image Showing the Tachometer

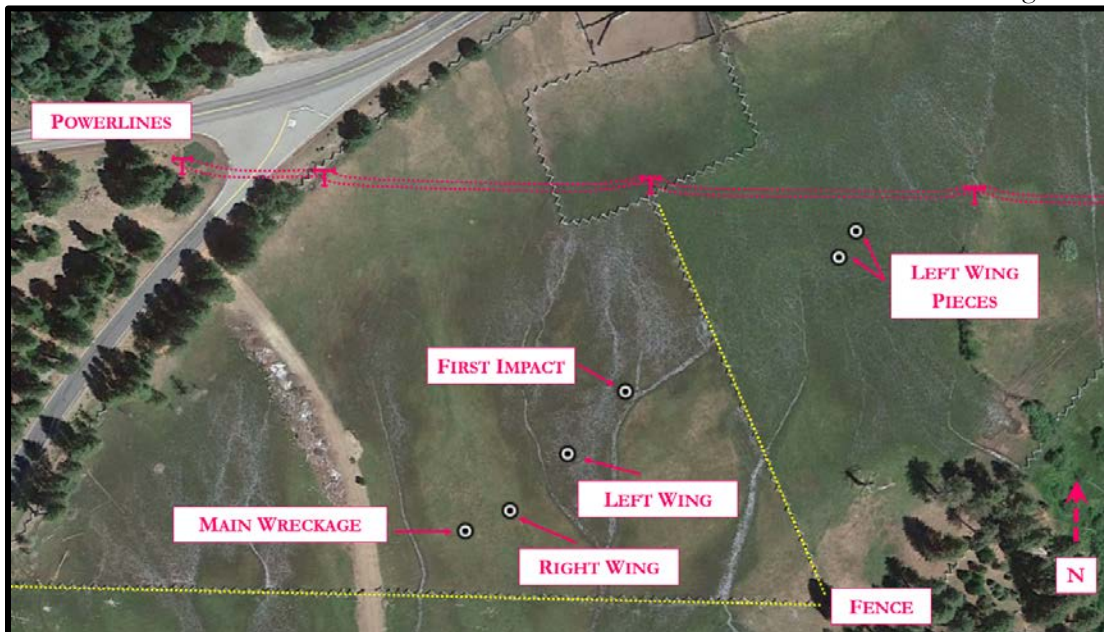
The accident site was located in marshy terrain about 37.5 nautical miles from the destination airport at the following coordinates: 40°21'38.10"N / 121°30'39.90"W . In character, the terrain was composed of soft, wet grassy marsh. The wreckage was found distributed over a 565 foot distance on a median magnetic bearing of about 230°. Powerlines, two parallel wires about 20 feet in height and oriented east-west, stretched across the field. There were several fence structures, about 4 feet in height, two of which bordered the debris field; one fence located on the south end of the debris field was oriented east-west and the other oriented northwest-southeast was oriented in between the wires and the main wreckage.

Picture 07: Debris Field

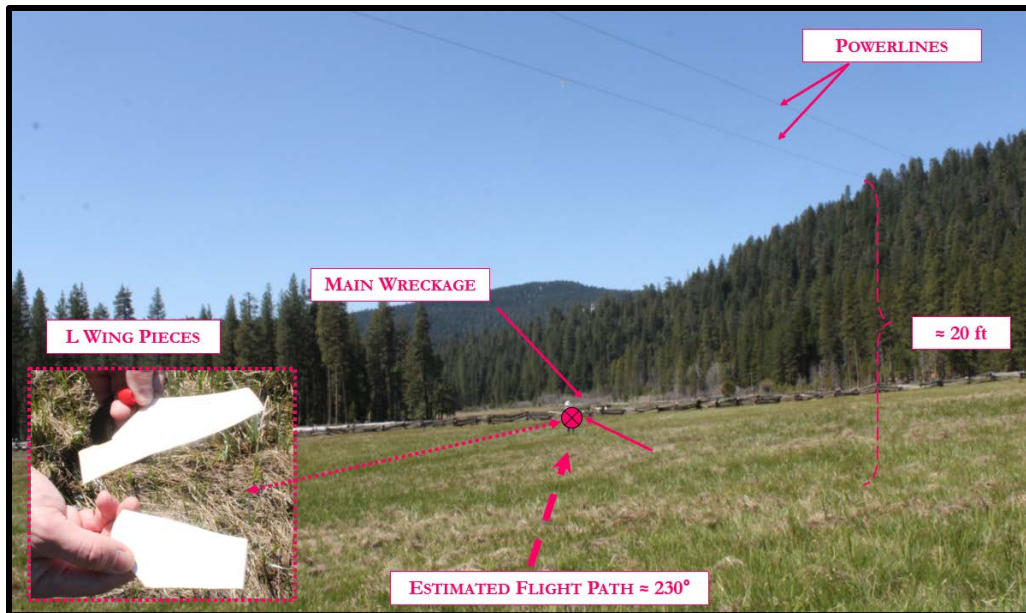
The first identified pieces of debris were pieces of the fairing from the left-wing strut and located about 40 and 70 feet from the powerlines. The towers supporting the wires were about 375 feet apart.

Picture 08: First Identified Debris

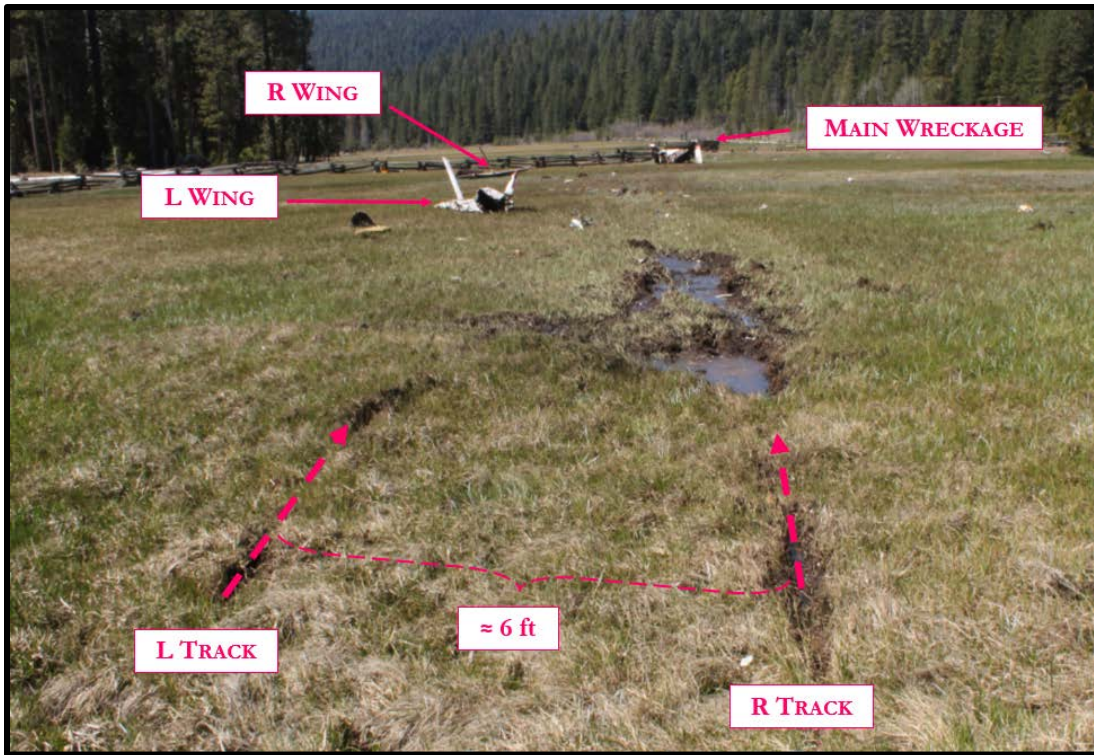
The first identified points of contact consisted of disrupted mud and grass in the marsh making up the far northeastern end of the debris field. The markings started as two nearly parallel indentations in the vegetation and dirt spaced about 6 feet apart. There were deep craters after the indentations and disrupted grass that continued southwest toward the main wreckage. The craters were consistent in size and orientation to that of vertical stabilizer and rudder, consistent with the airplane impacting terrain inverted.

Picture 10: Ground Scars in Debris Field

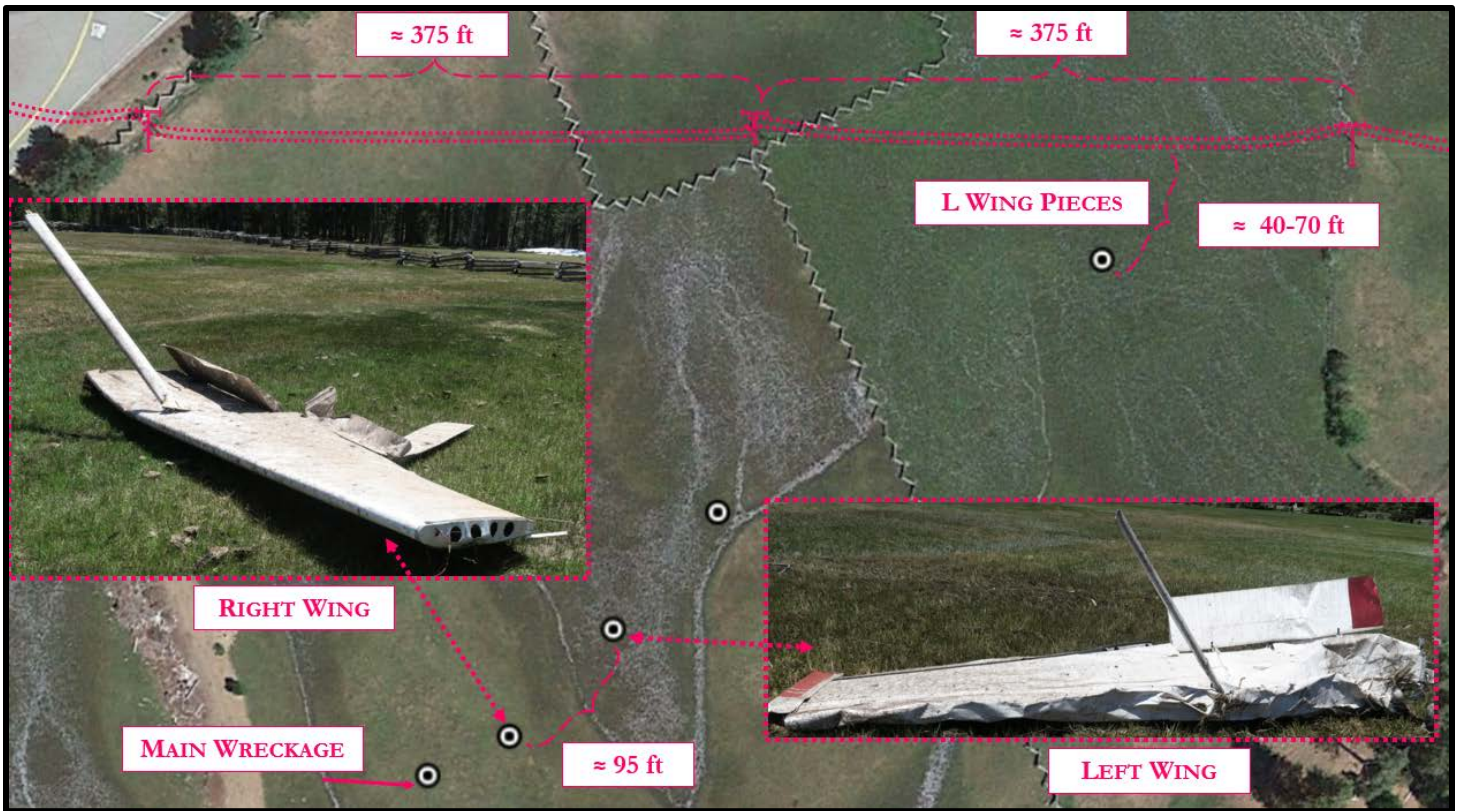
The left wing was about 460 feet from the powerlines and came to rest inverted. The right wing, also inverted, was about 95 feet further along the debris field from the left-wing. Along the debris field were several pieces of the internal engine components consisting of a portion of a connecting rod and fragments of piston. Additionally, in the debris field there were portions of the upper fuselage, window frame, personal items, attitude indicator, outboard left horizontal stabilizer, and wing pieces.

Picture 11: Main Wreckage Referencing Wings

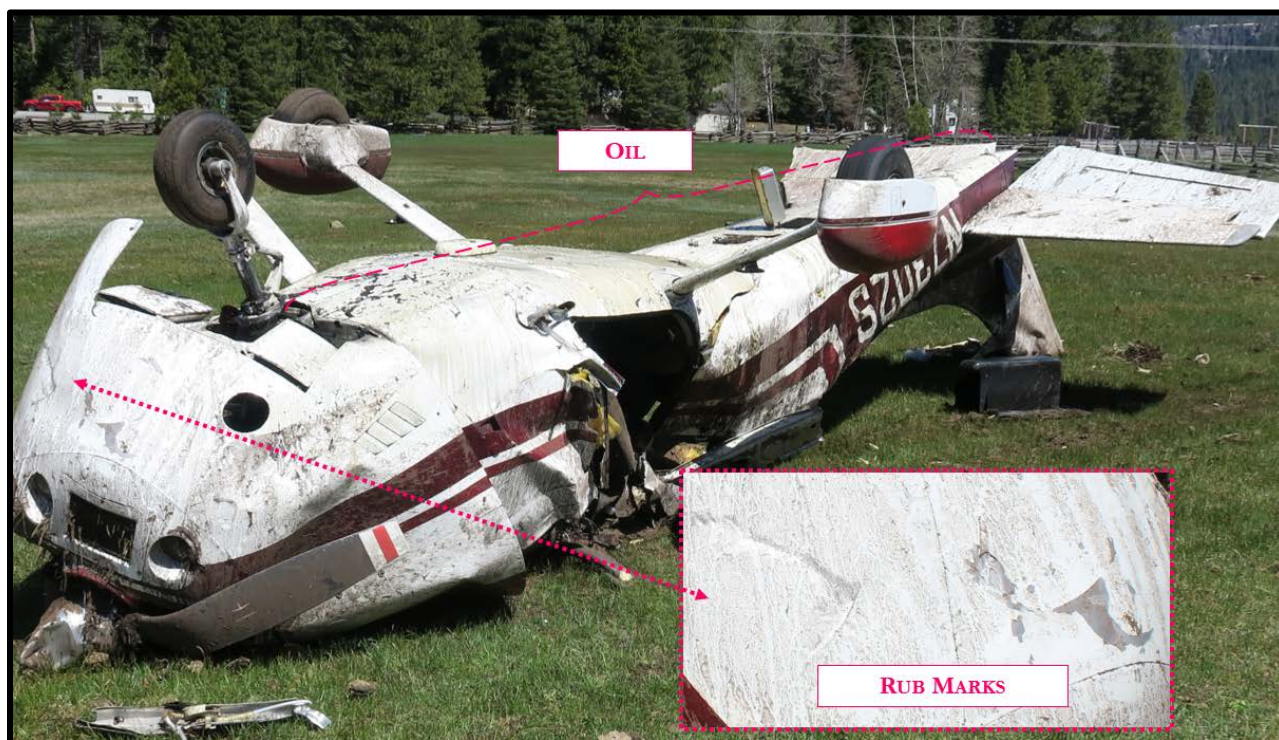
The fuselage came to rest inverted. A 2.5-foot portion of the left-wing strut remained attached to the fuselage and the fracture surface was consistent with the fracture surface on the portion attached to the left wing. The doors had been removed by first responders. There was an oil sheen on the entire belly of the fuselage and lower surface of the horizontal stabilizer and elevator control surfaces. The lower left cowling contained a rub mark consistent with contact with a wire.

Picture 13: Main Wreckage Referencing Oil and Rub marks

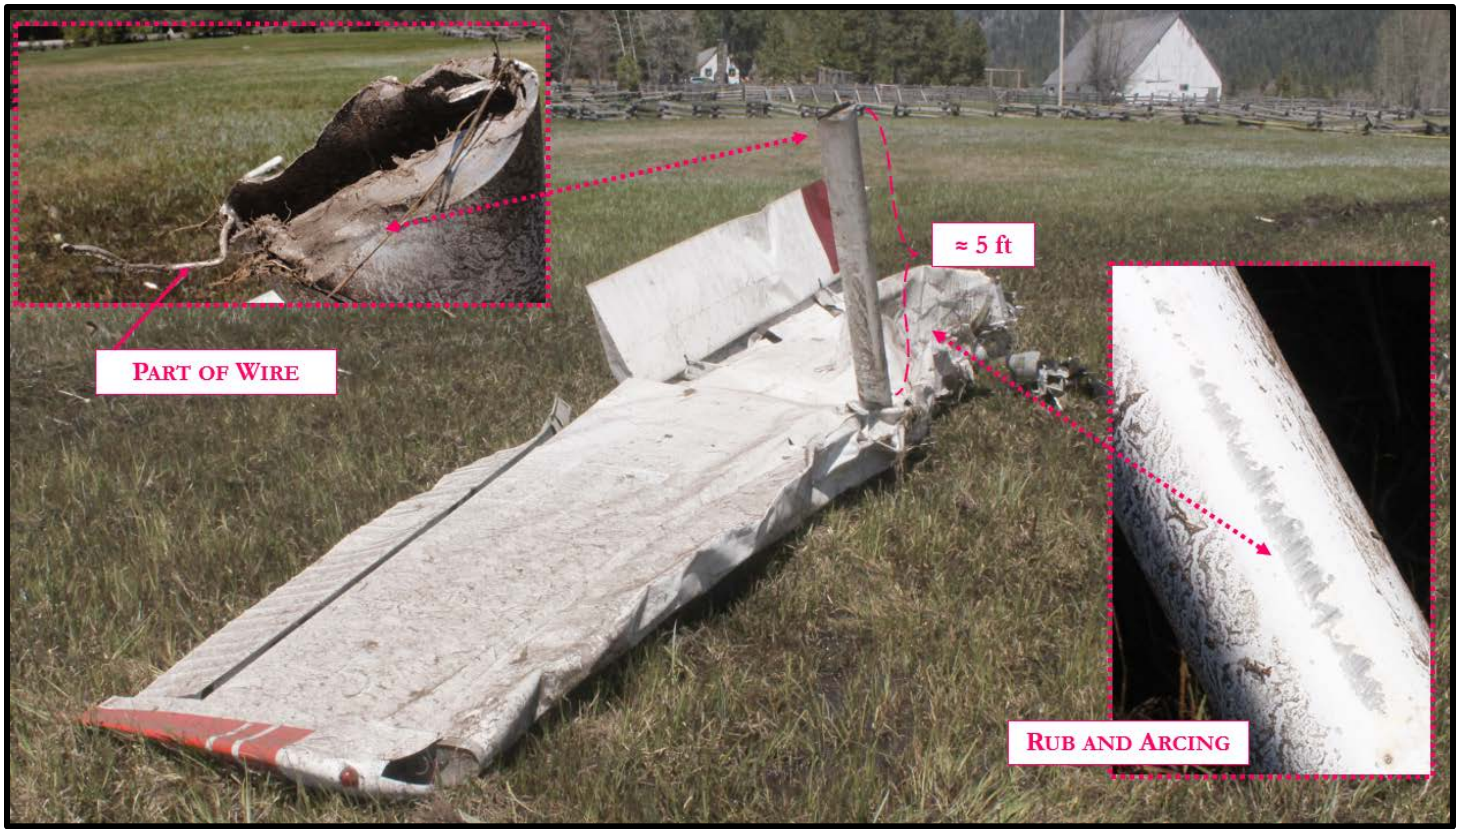
The left wing had the aileron and flap control surfaces attached at their respective attached points. The leading edge exhibited crush damage along the entire length with the inboard section significantly crushed more aft. The upper 5 feet of wing strut remained attached to the wing. On the leading edge of the wing strut were numerous rub marks and small holes consistent with arcing. The area where the separation of the strut occurred contained a small metal wire in the fracture surface was consistent with having been sliced apart. The fuel cap remained engaged in the wing. The crush damage to the inboard of the wing had damaged the bladder of the fuel tank. On the top of the wing

Picture 14: Lower Left Wing

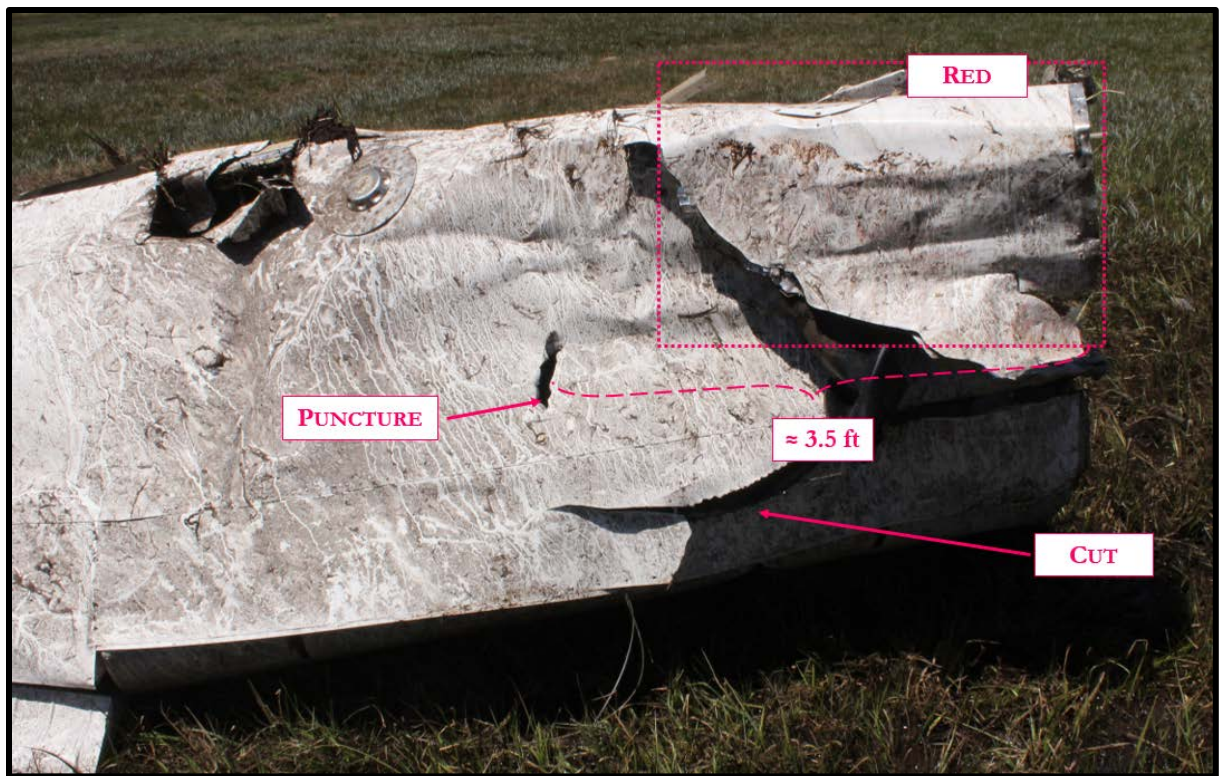
there was a red color inboard and a puncture about 3.5 inches inboard consistent in size and placement to the wing making contact with the antenna on the upper cabin. The was cut parallel to the leading edge, consistent with the aileron cable being attached at impact.

Picture 15: Upper Left Wing

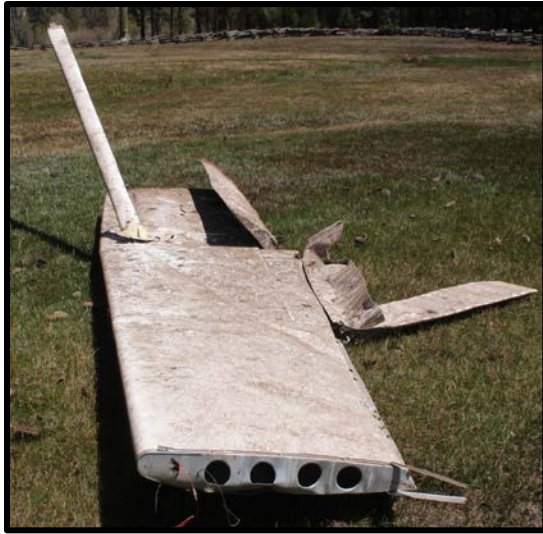
The right wing had the flap control surface attached at its respective hinges. The aileron had folded on itself and only remained attached to the inboard attached points. The wing contained a liquid consistent in odor and appearance with Avgas. According to the Cessna representative, the flap actuator indicated there was 20° the flaps extended.

Picture 16: Right Wing

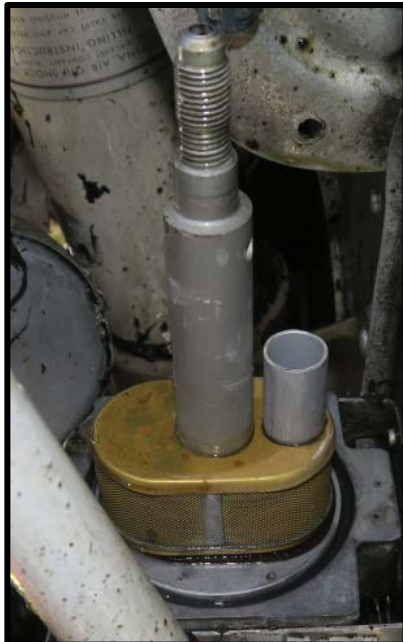
Fuel system continuity could not be established due to impact. Liquid consistent in odor to that of 100LL Avgas was present in the right wing tank, in the fuel strainer and in the carburetor. The fuel selector valve was found in the "RIGHT" position. There was no evidence of debris in the strainer. The fuel screens in the wing tanks were clean of debris.

Picture 18: Strainer With Fuel

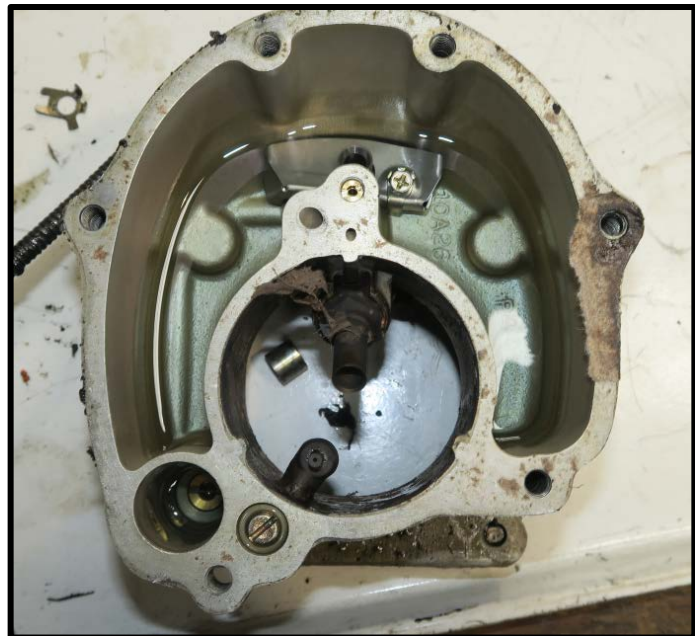
Picture 19: Carburetor Bowl with Fuel

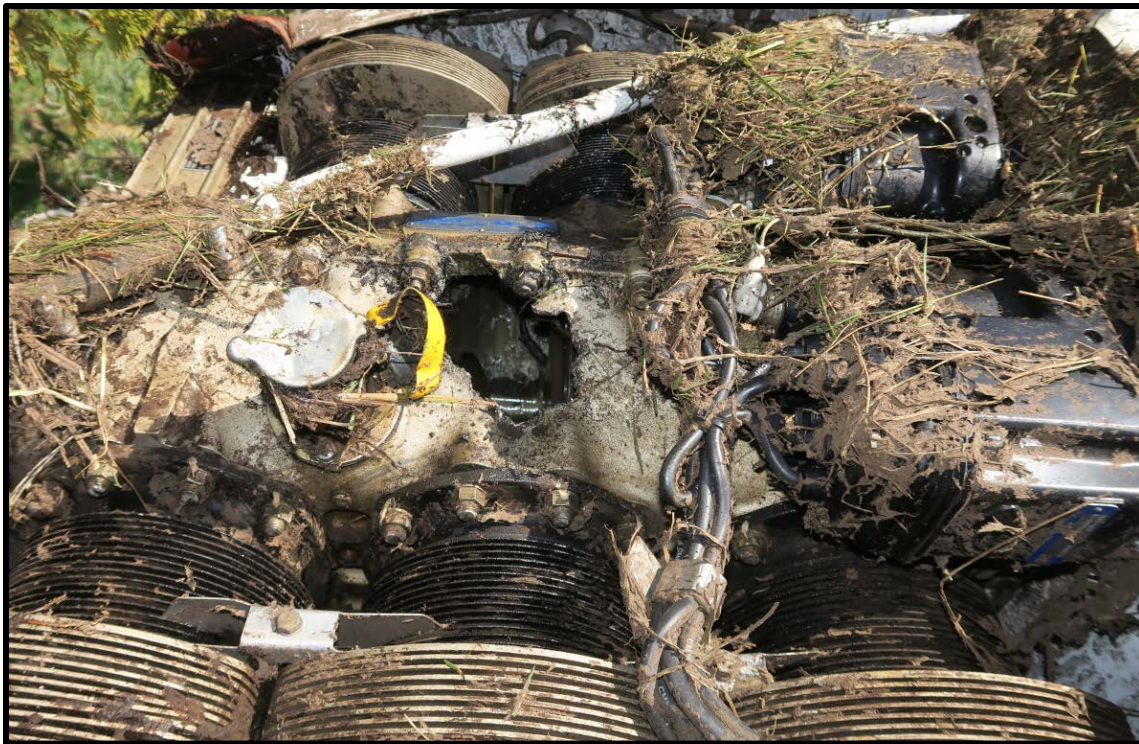
An external examination of the engine revealed oil staining on the firewall. There was a hole in the bottom of the case where the No. 3 cylinder and the push rods were loose. There was additionally a hole in the upper case near the No. 4 cylinder. The internal case was examined by using a lighted borescope through the hole in the crankcase near No. 4 cylinder. The oil sump contained about a cup of visible oil and numerous pieces of the internal components were at the bottom. There were numerous gauges and shiny grooves on the back of the No. 4 piston and the No. 3 piston had rotated and there was no piston pin present.

*Picture 21: Engine Showing Hole in Case*

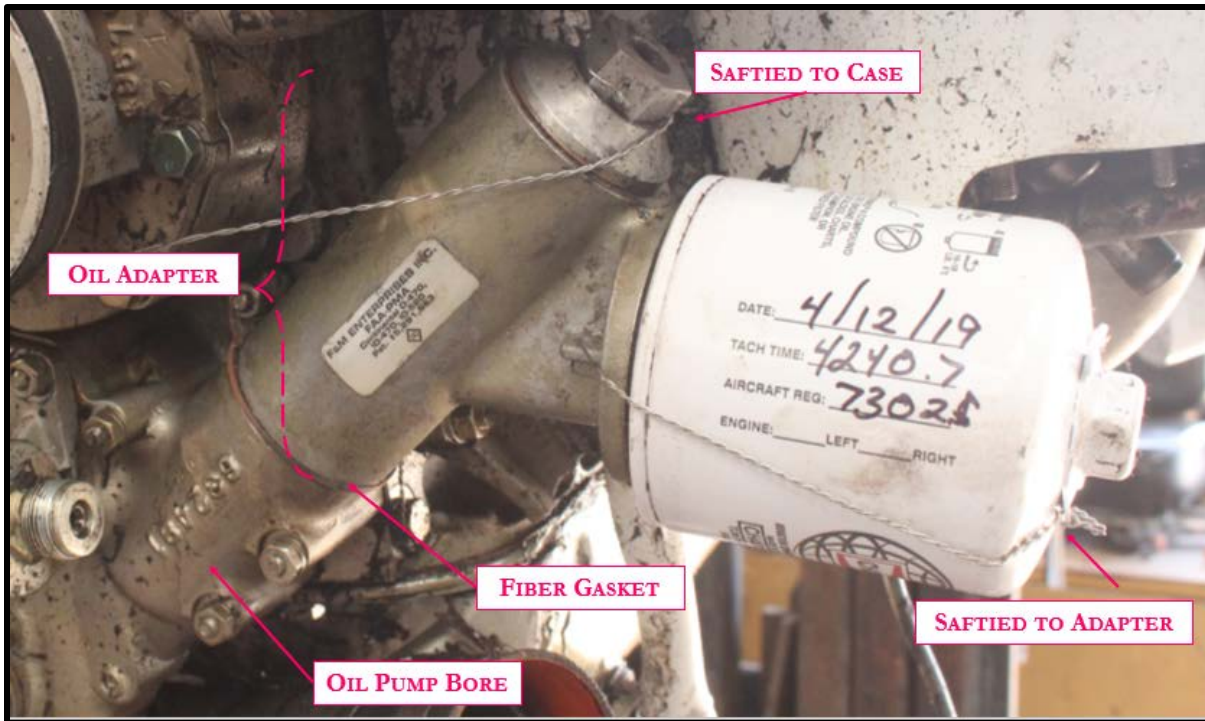
An external examination of the engine at the accident site, revealed that the filter adapter was loose, and the adapter housing could be rotated about the shaft.<sup>6</sup> The crown head of the shaft and the oil filter screen bolt head both remained saftied. There was a concentration of oil in the area of the adapter and adjacent firewall.

Picture 24: *Oil Filter Adapter as Installed on Oil Pump Bore*

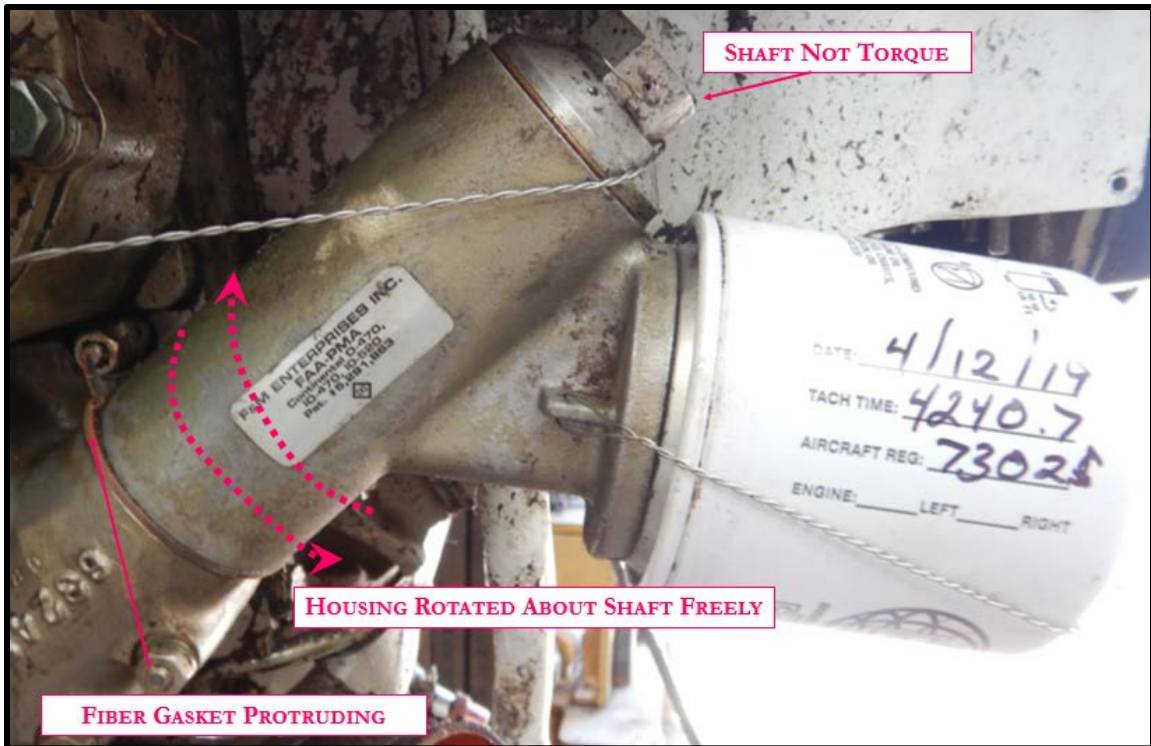
Following recovery, a closer examination revealed that the fiber gasket, located between the oil pump casting and the adapter was protruding with the outside edge extending beyond the castings. Additionally, a tear could be seen in the gasket where the adapter housing abutted the engine case. Investigators removed the safety wire and

attempted to assess the breakaway torque of the adapter. The torque was less than 20 foot-pounds, which was the force set on the torque wrench.

Picture 25: Oil Filter Adapter Could be Rotated Freely

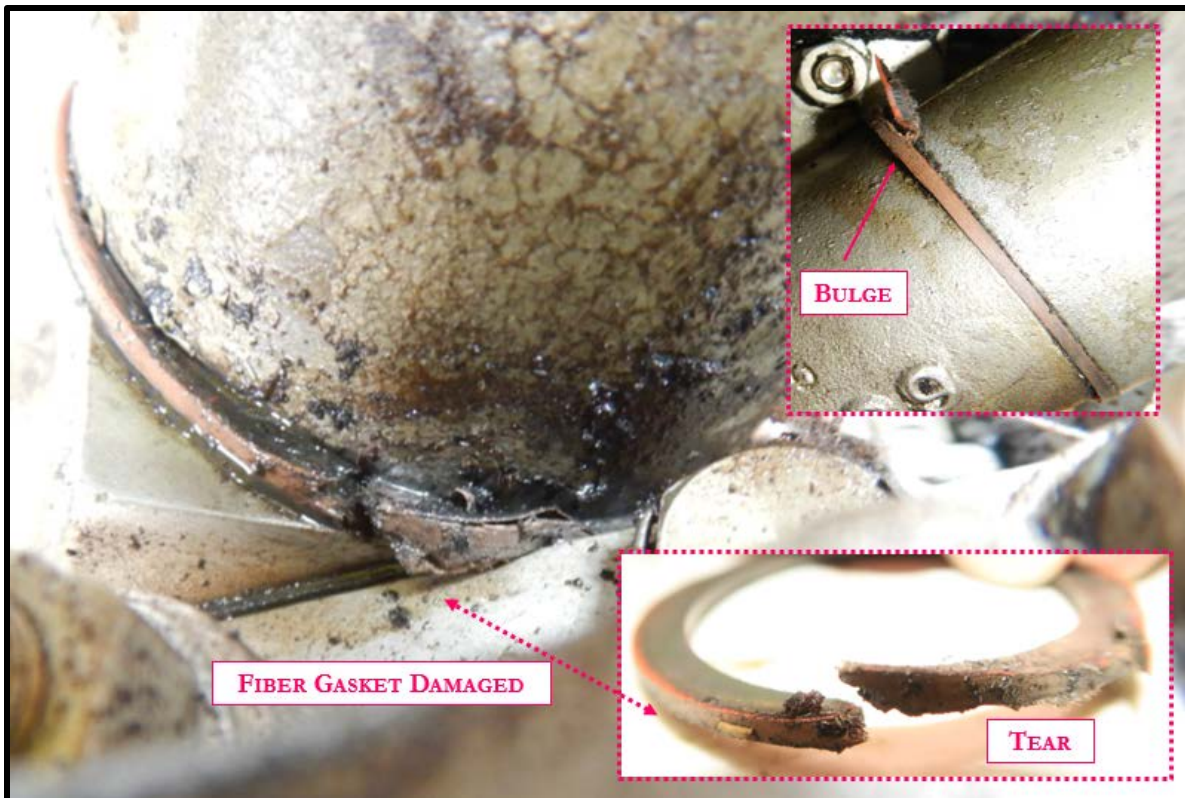
Removal of the adapter revealed that the fiber gasket was completely split. The copper crush gasket was intact. The oil filter was removed and cut open; there were several small metal flakes, but otherwise the pleats were clean from debris.

Picture 26: Fiber Gasket

**CAUTION**.....New gaskets are to be installed anytime the oil filter adapter assembly is removed from the engine and re-installed. Replace gaskets at 300 hours or 3 years whichever occurs first. Refer to the respective F&M Installation Instructions for gasket part numbers.

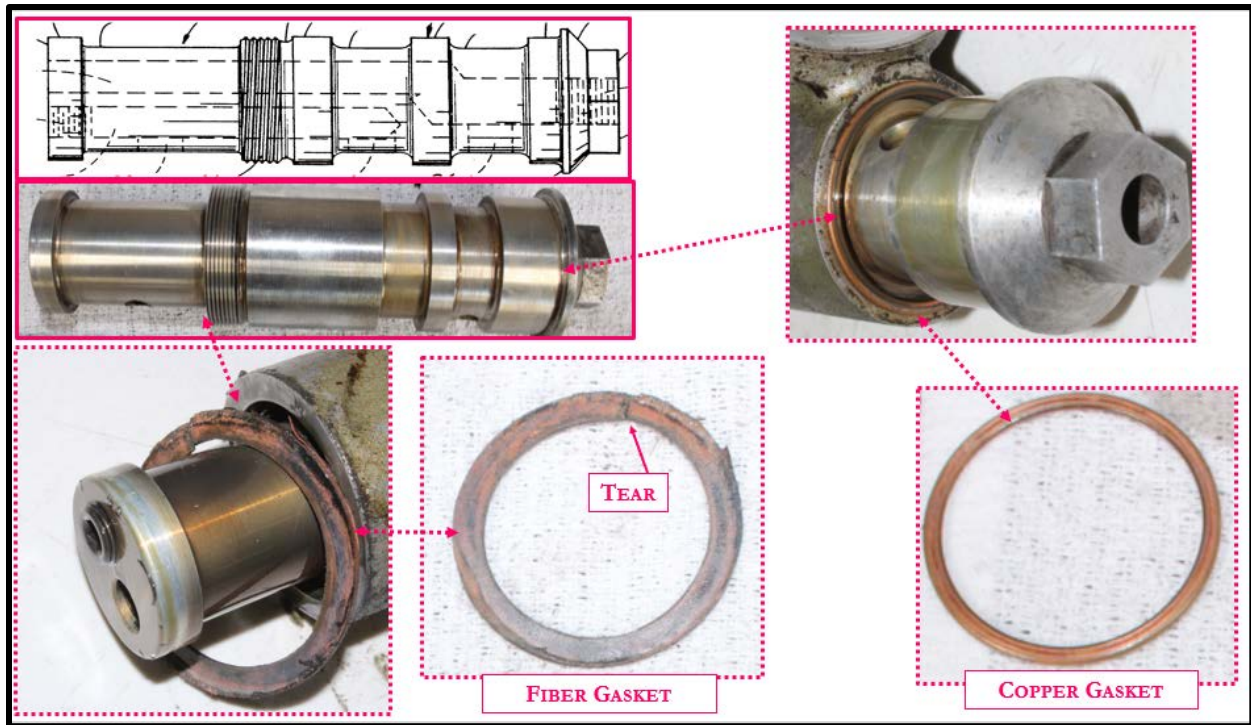
Picture 27: Shaft Showing Gaskets

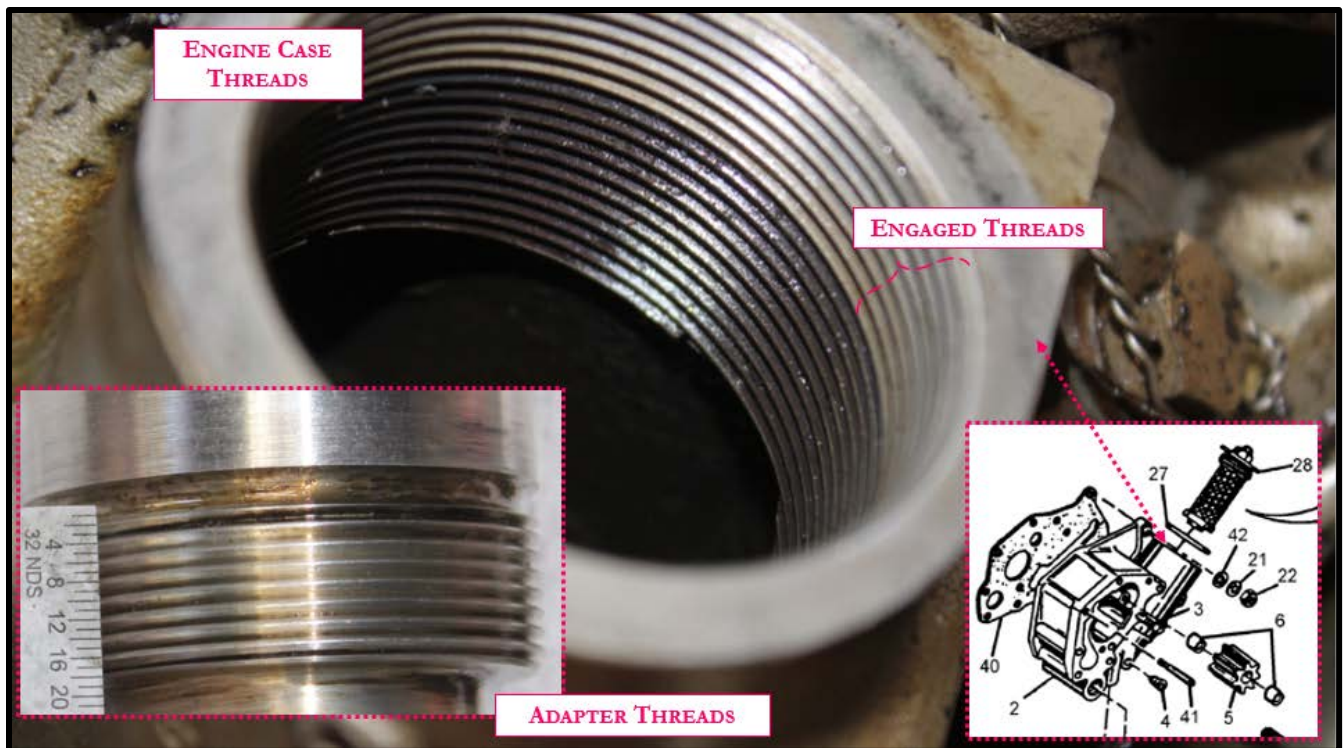
Picture 28: Threads of Oil Pump and Adapter

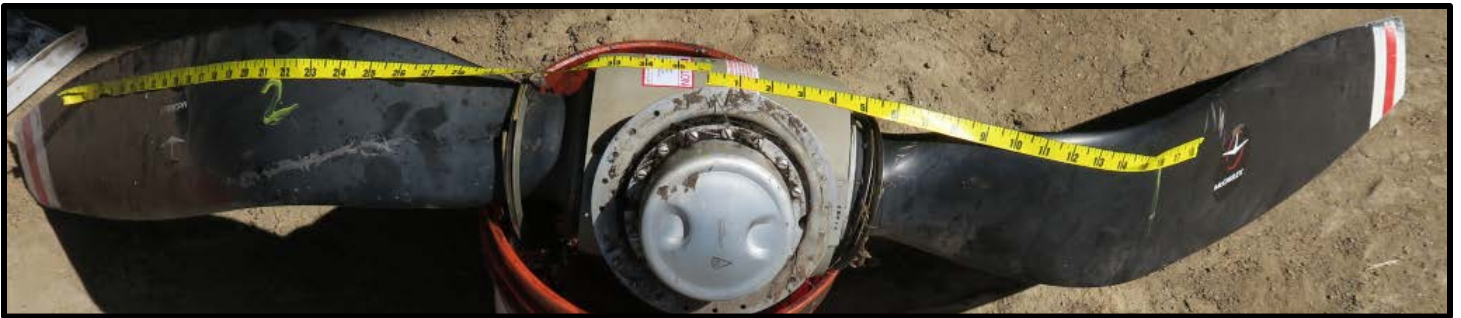
The two propeller blades remained in the hub and were bent aft.

Picture 31: Propeller Blades
