National Transportation Safety Board  
Office of Aviation Safety  
Washington, DC 20594

WPR23FA034

**INVESTIGATIVE SUPPLEMENTAL MATERIAL**

Location: Snohomish, Washington  
Date: 11/18/2022  
Time: 1019 Pacific standard time  
Airplane: Cessna 208B EX Caravan

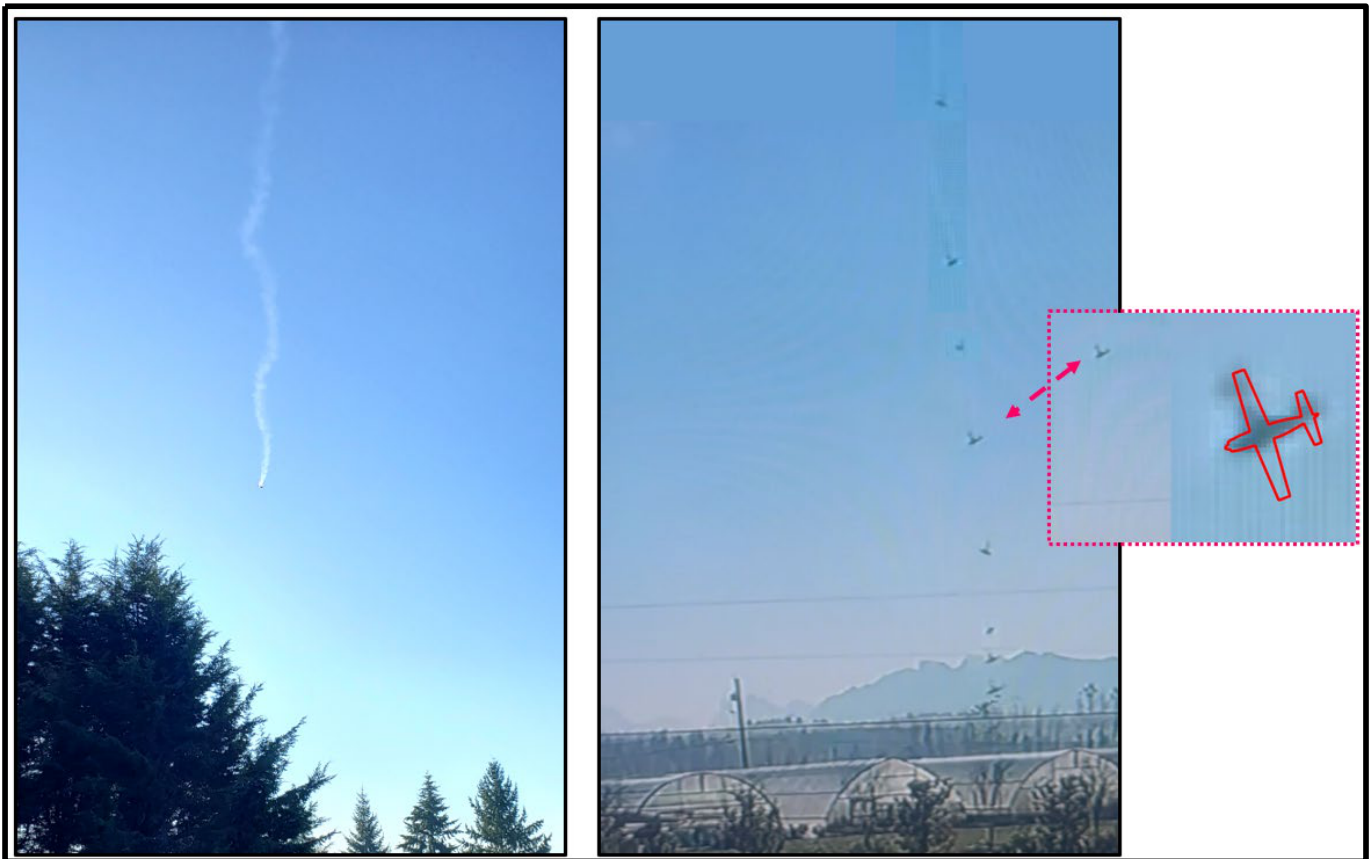
A security camera recorded a poor-quality image of the airplane rotating about its longitudinal axis in nose-low attitude (see Figure 1 below). The video is consistent with showing the fuselage with an intact wing. The airplane is seen rotating about the pitch axis with the intact wing pointed up in trail. The nose is slightly low, the aft fuselage slightly high (see Figure 2 and 3 below) .

Figure 1: Picture from witness and video excerpt (provided by Mr. William Clark)

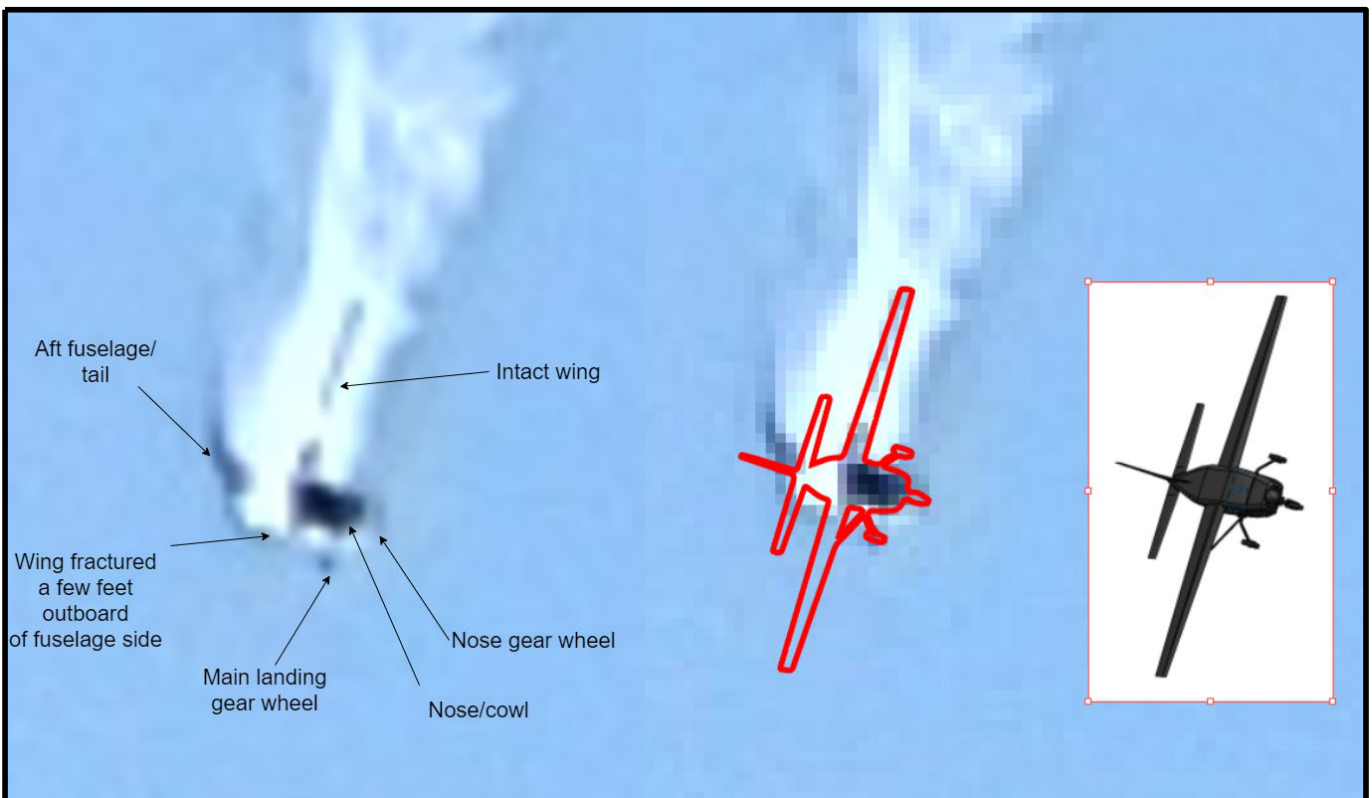
Figure 2: Image from video showing possible signatures of structures (provided by Mr. Gritter)

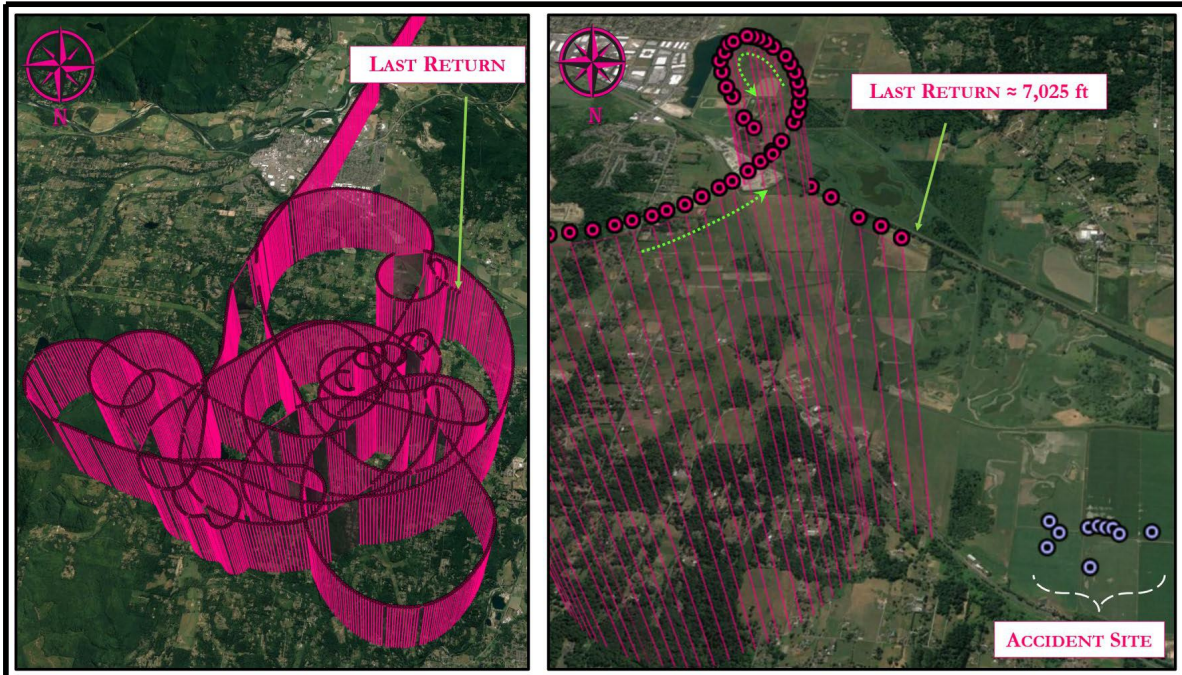
The radar data further shows that the track made a near 360° turn and then at 1019:06, there was a sharp 180° left-turn. The track continued west until the last recorded hit at 1019:18. During the last 12 seconds the track indicated that the airplane's descent rate exceeded 14,000 ft-per-minute (fpm) and gradually lessened to 8,700 fpm at the last hit. The main wreckage was located about 2,145 ft east of the last recorded track data. The right-seat pilot who flew on the day prior to the accident reviewed that track data. He thought that just prior to the accident, they were likely at the second to last maneuver on the card which specified: 96 kts indicated airspeed; flaps in landing configuration; 930 ft-lbs of torque; propeller rpm fully forward; and accelerated 30° bank to the left.

Figure 3: Radar data of maneuvers during flight (left) and last turns (right)

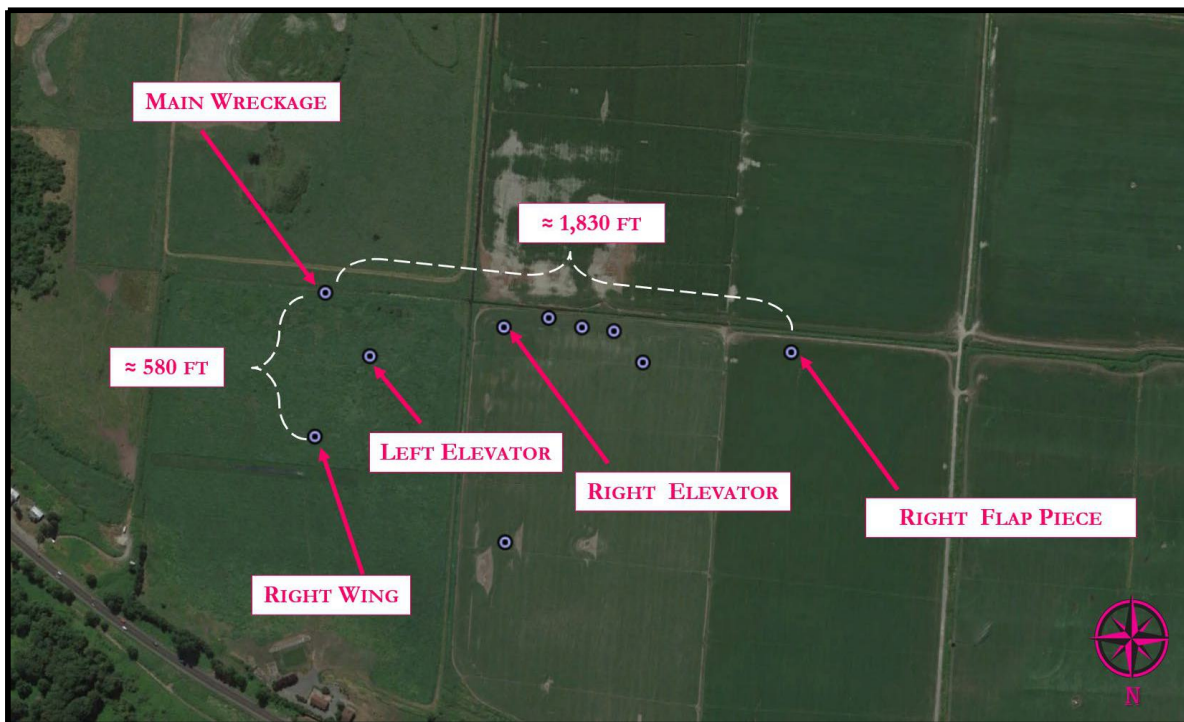
The wreckage was distributed over an approximate 1,830 ft distance on a median magnetic bearing of about 270°. The main wreckage and right wing were located at the beginning of the debris field and about 580 ft apart. The main wreckage, consisting of the engine, cockpit (and cargo pod), cabin, vertical stabilizer, and rudder, was partially consumed by fire. The right-wing strut separated from the fuselage attachment, but remained attached to the wing; the right flap was separated into numerous pieces and scattered among the debris field. The left-wing separated from the fuselage although was located adjacent to the main wreckage; the flap remained attached and was found in the retracted position.

Figure 7: Wreckage Debris Field

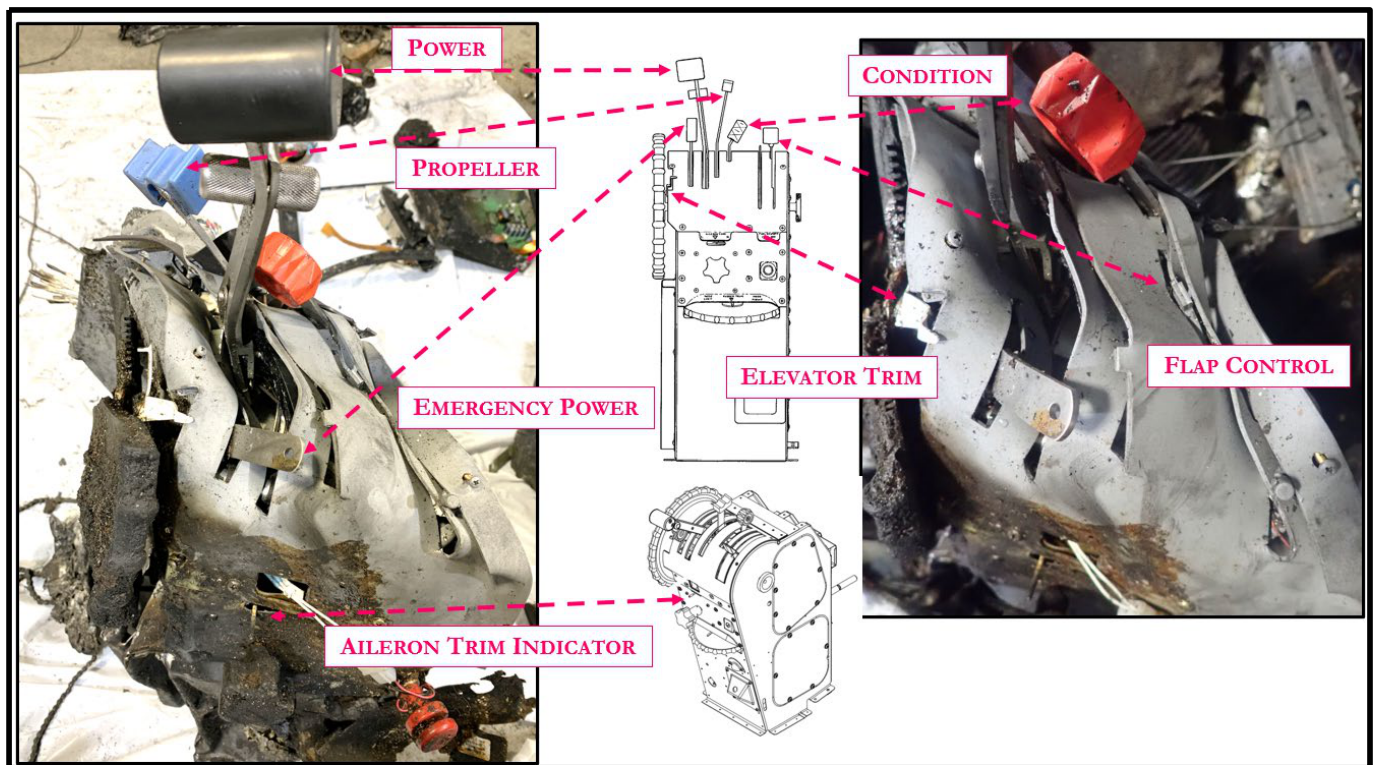
The cockpit pedestal was crushed to the right and trim chains were displaced; the aileron trim was nearly full left. The flap handle and indicator both showed the flaps were in the full down position. The throttle, condition, and mixture levers were all too deformed to determine a reliable position. The fuselage was broken in several sections and sustained right crush deformation. The left portion of the fuselage floor and side wall was consumed by fire.

Figure 8: Cockpit pedestal

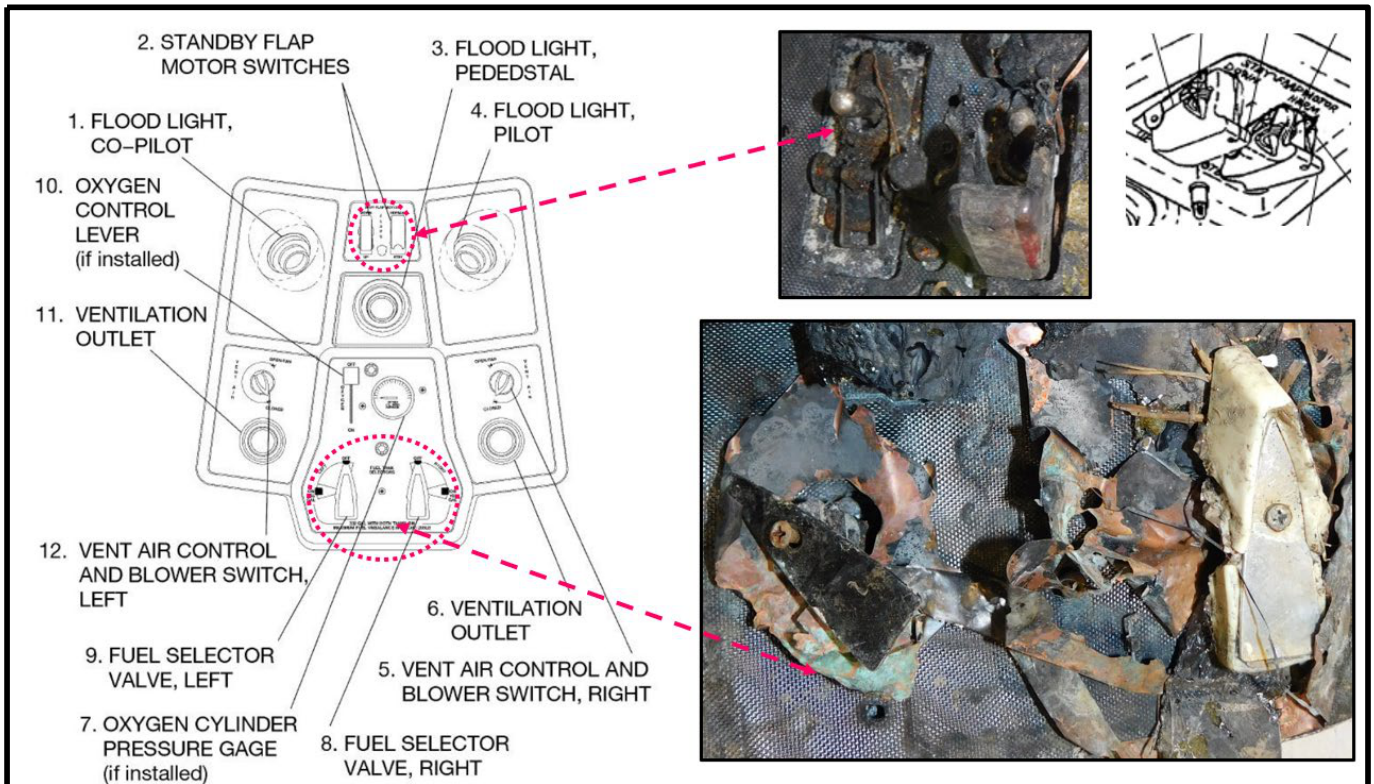
The fuel selector handles were unreliable. Numerous ratchet bodies were found within the molten ash of the wreckage and one appeared to be open. The flap standby switches were burned.

Figure 9: Fuel selectors and standby flap switches

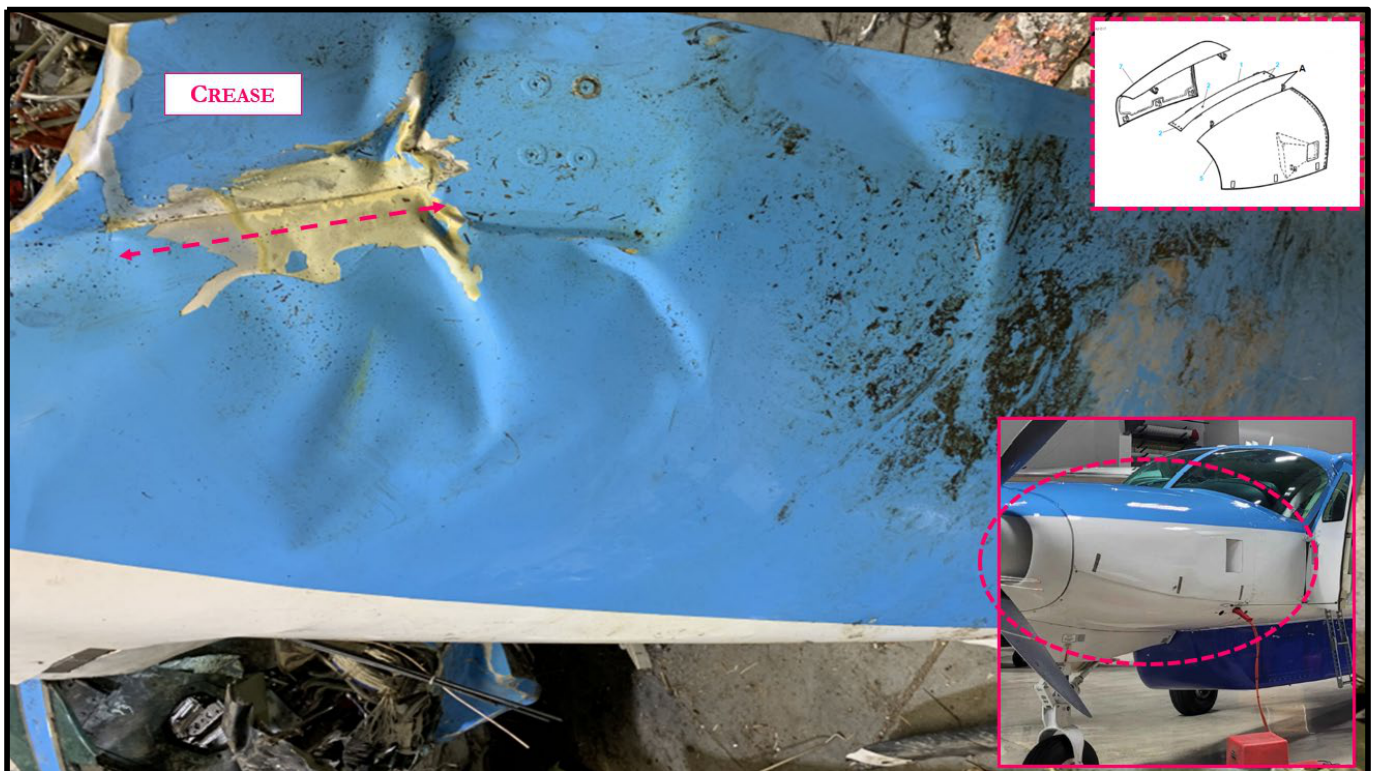
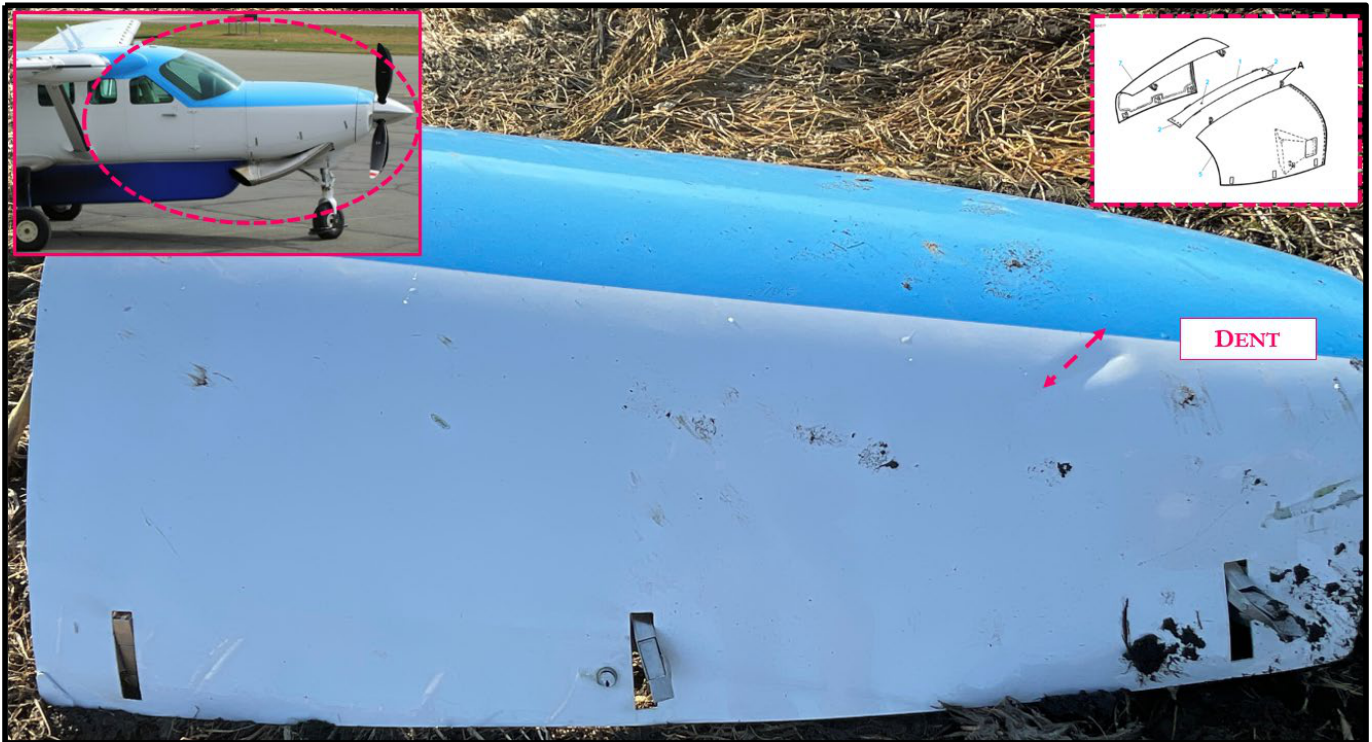
The upper left and right cowling was relatively clean on the inside and the right nose cowling contained a divot about 12" that was oriented along the longitudinal axis.

Figure 10: Left upper nose-cowling

Figure 11: Upper right nose-cowling (photo of the intact airplane provided by Robert Elkelenboom )

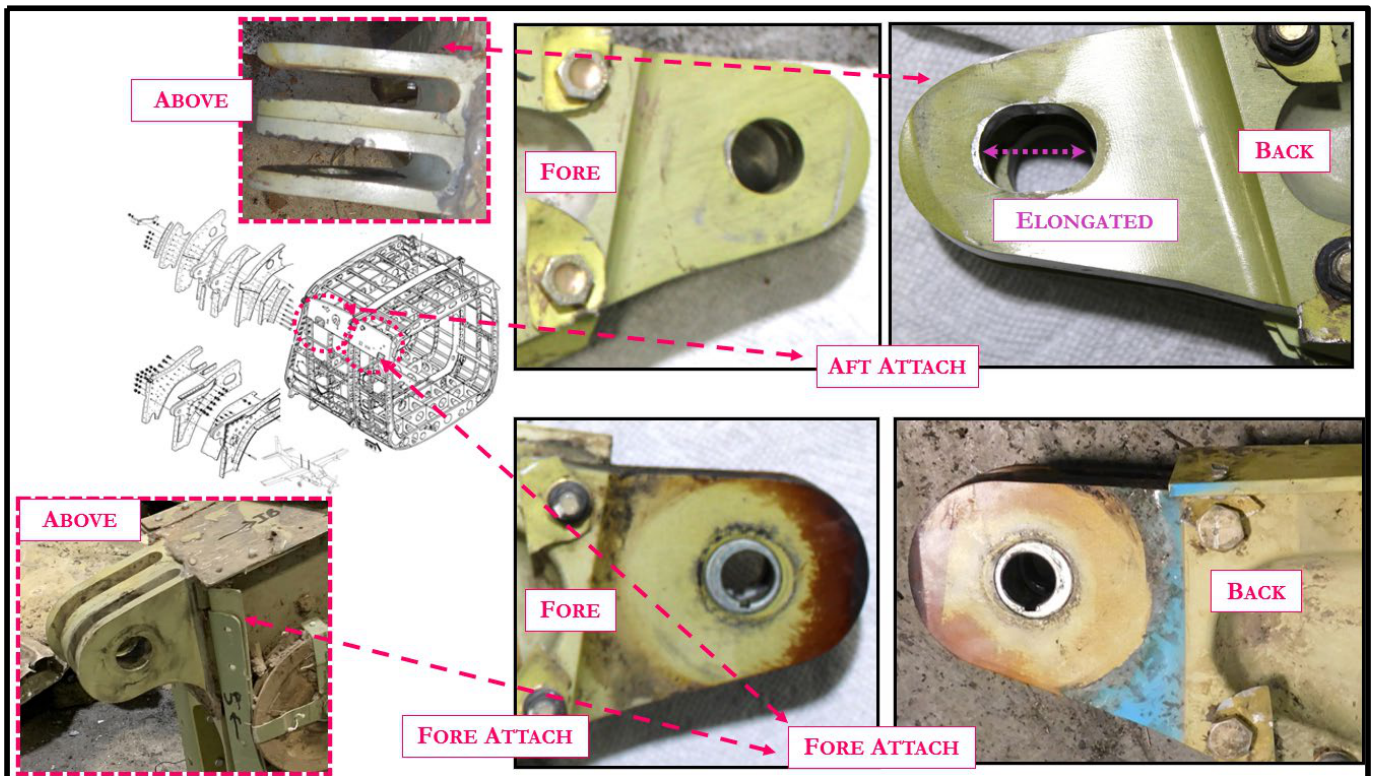
The right-wing forward and aft attach fittings separated from the wing but remained attached to the fuselage forward and aft spar. Both attached points were removed to reveal evidence of forward deformation. The forward spar showed overload deformation in upward and forward direction. The lower aft spar cap was deformed in compression folded upon itself.

Figure 12: Right wing spar attach points

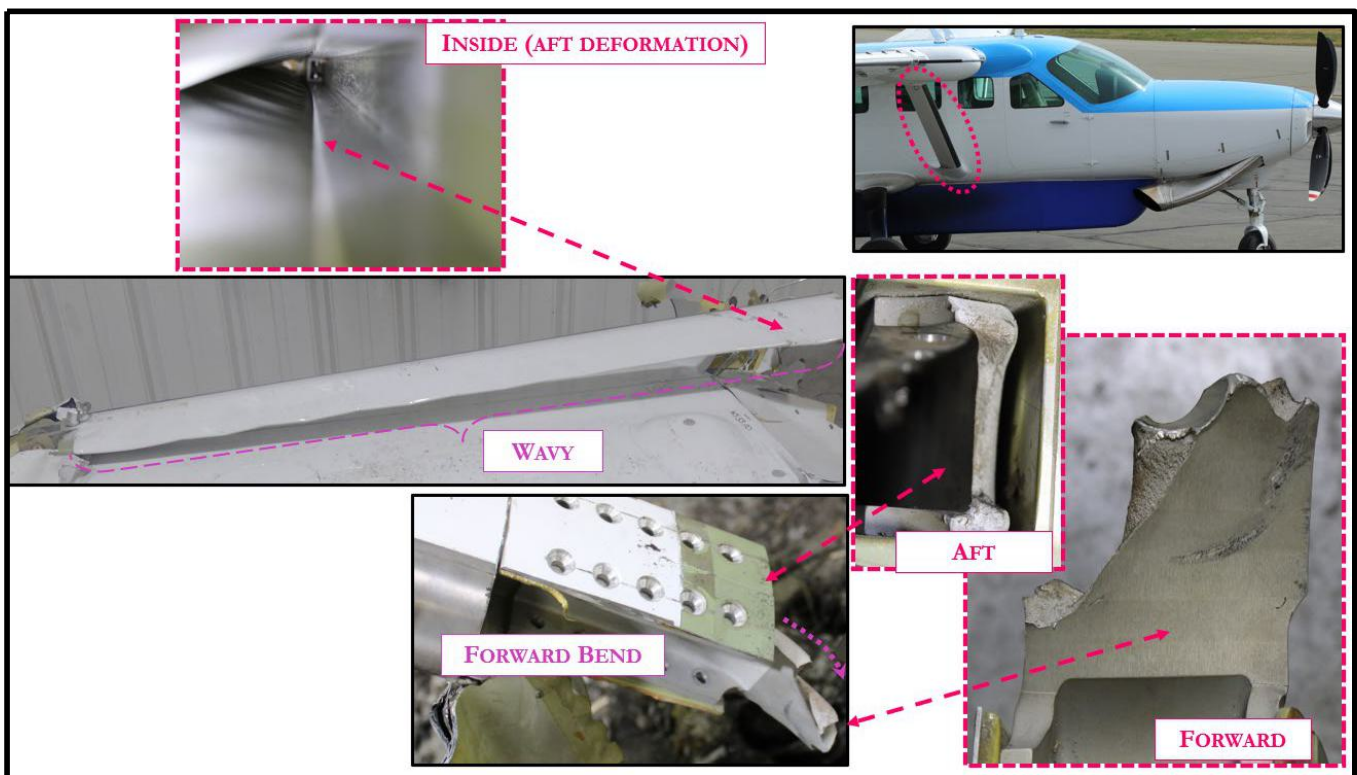
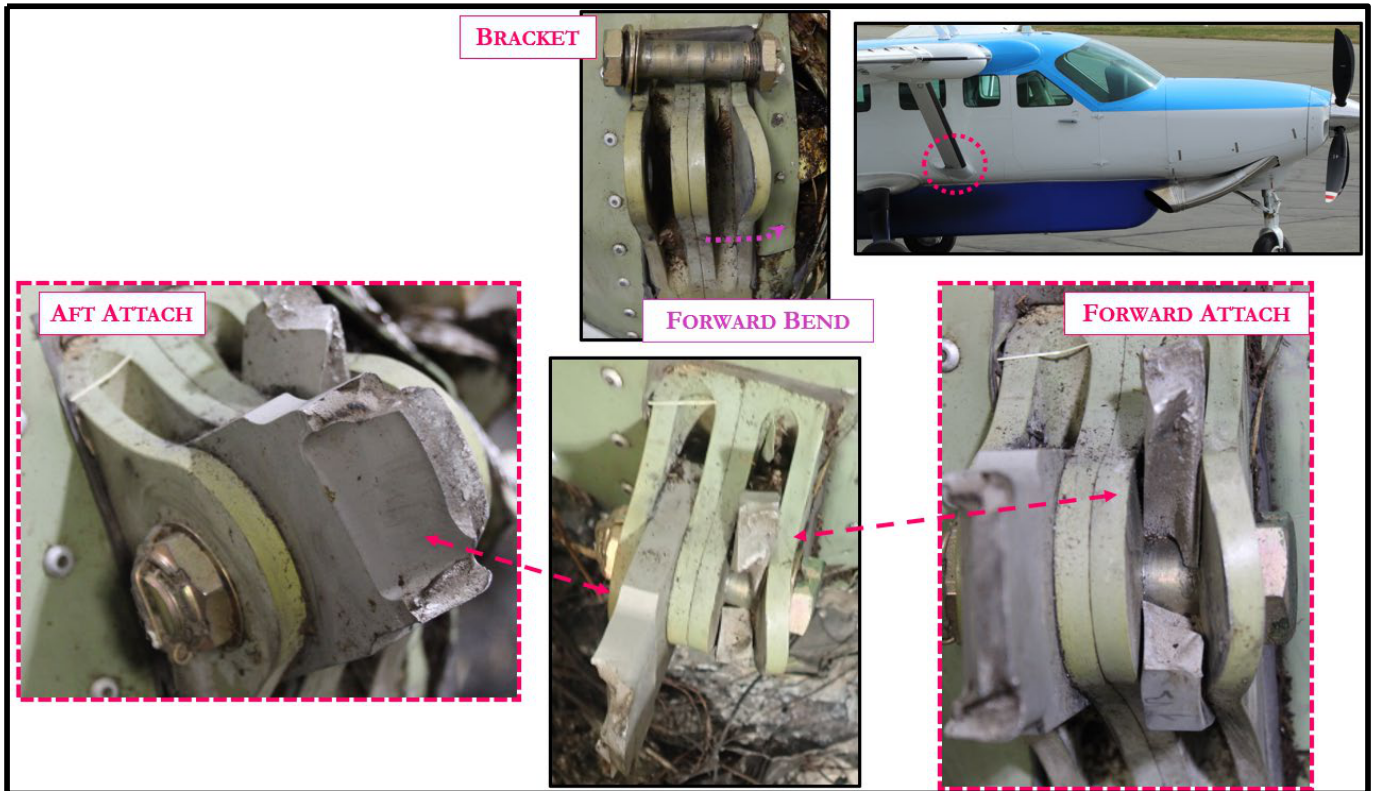
The right upper strut attach point remained affixed. The lower strut attach point was separated at the lower fuselage attach point. The strut trailing edge surface was deformed in a wavy pattern consistent with buckling. Inside the strut showed an appearance of aft deformation. The bottom strut attach point revealed the forward attach was bent forward.

Figure 13: Right wing-strut (photo of the intact airplane provided by Robert Elkelboom)

Figure 14: Right lower wing-strut attach point (photo of the intact airplane provided by Robert Elkelenboom )

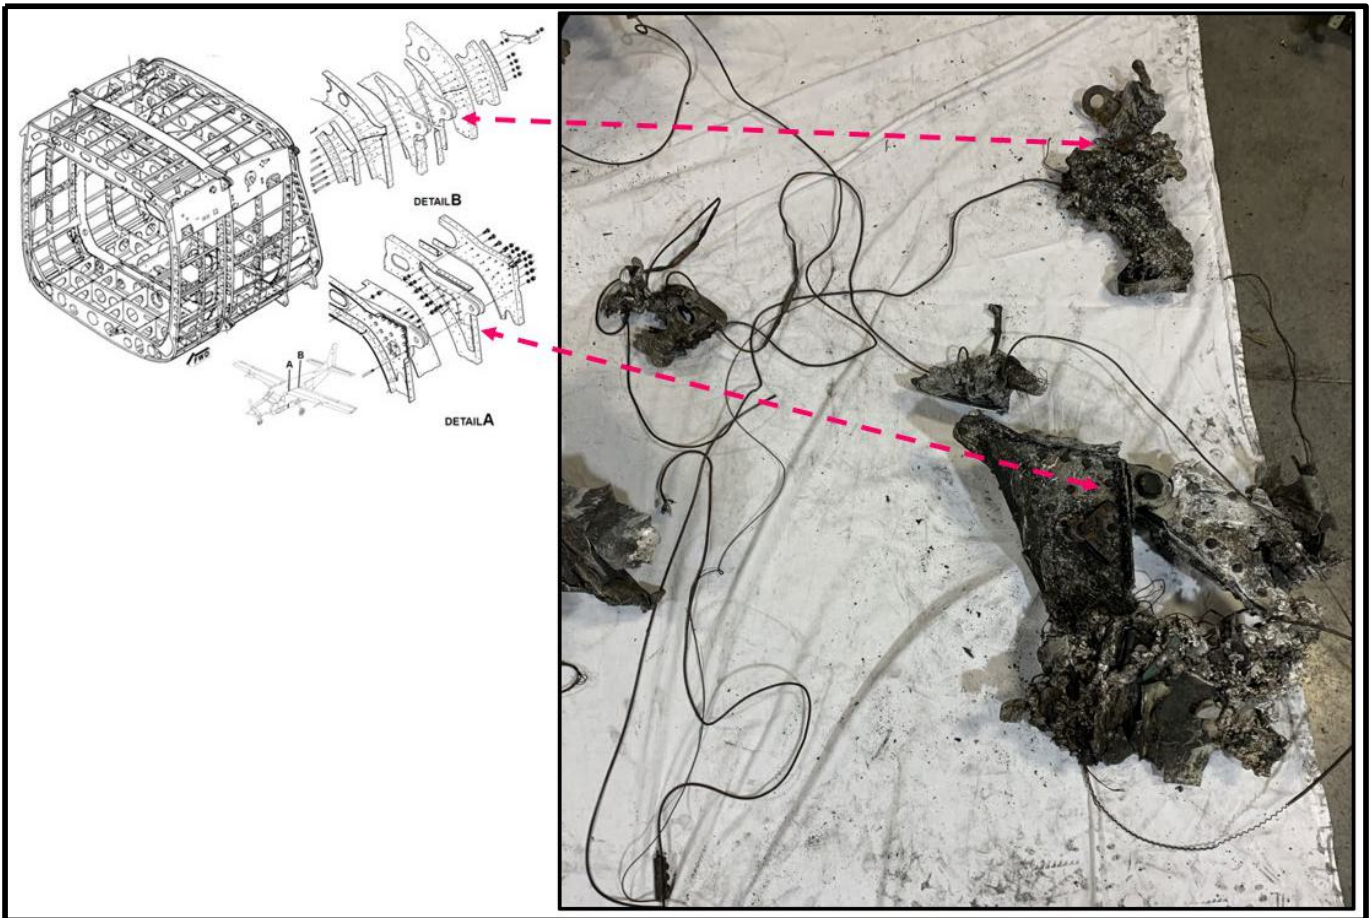
The inboard section of the left wing was consumed by fire and the remainder of the wing came to rest adjacent to the fuselage. The left wing attach points and root area were thermally damaged and only melted pieces remained as identifiable by the robust fittings (e.g., bolt, nut and cotter pin, etc). The aft wing strut attach point was almost completely thermally consumed with melted metal surrounding the bolt.

Figure 15: Left wing spar attach points

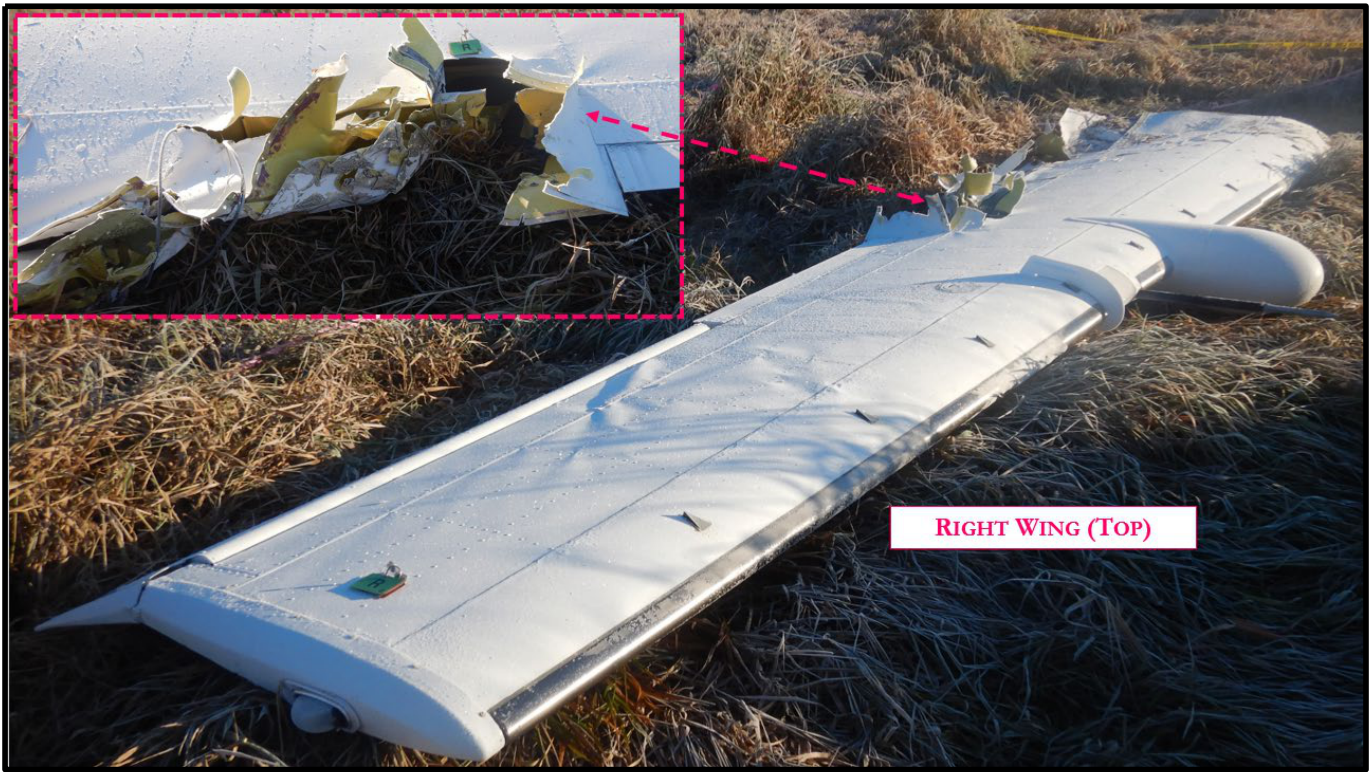
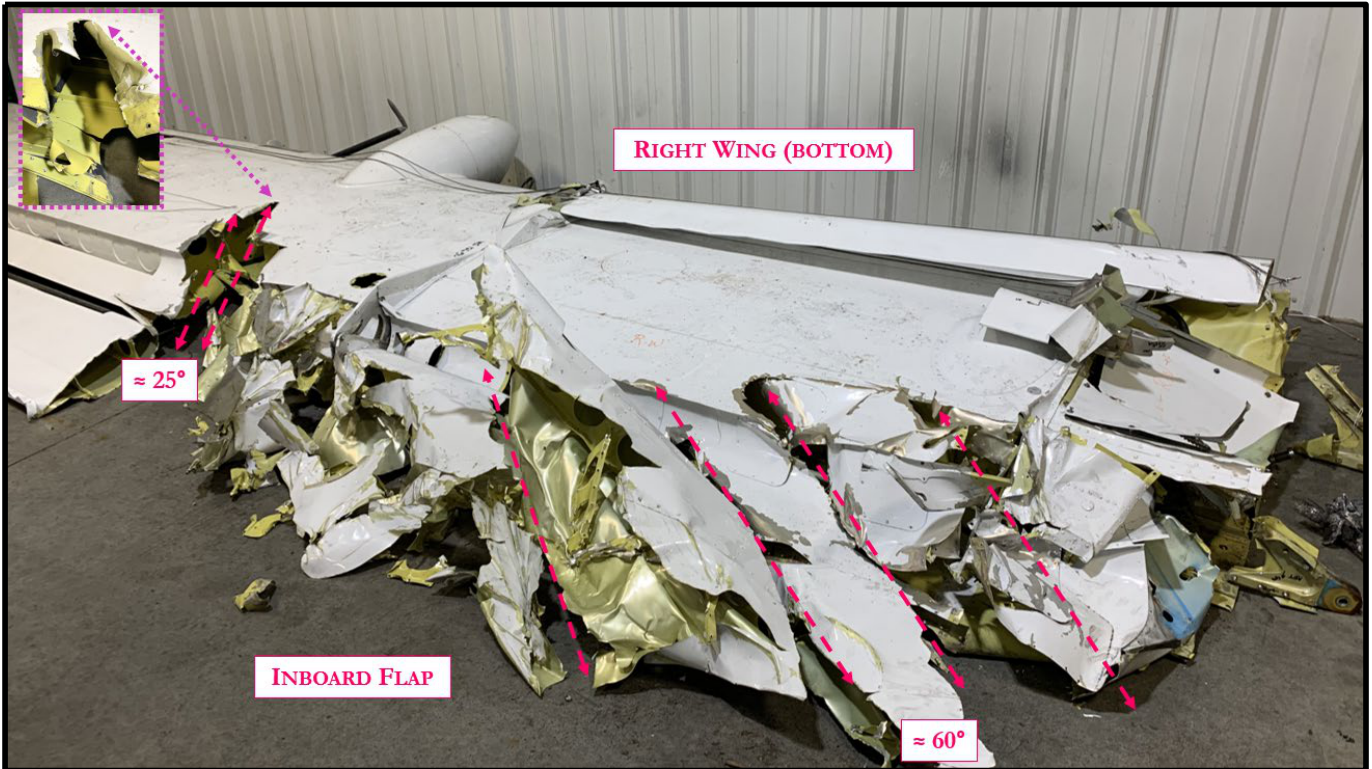
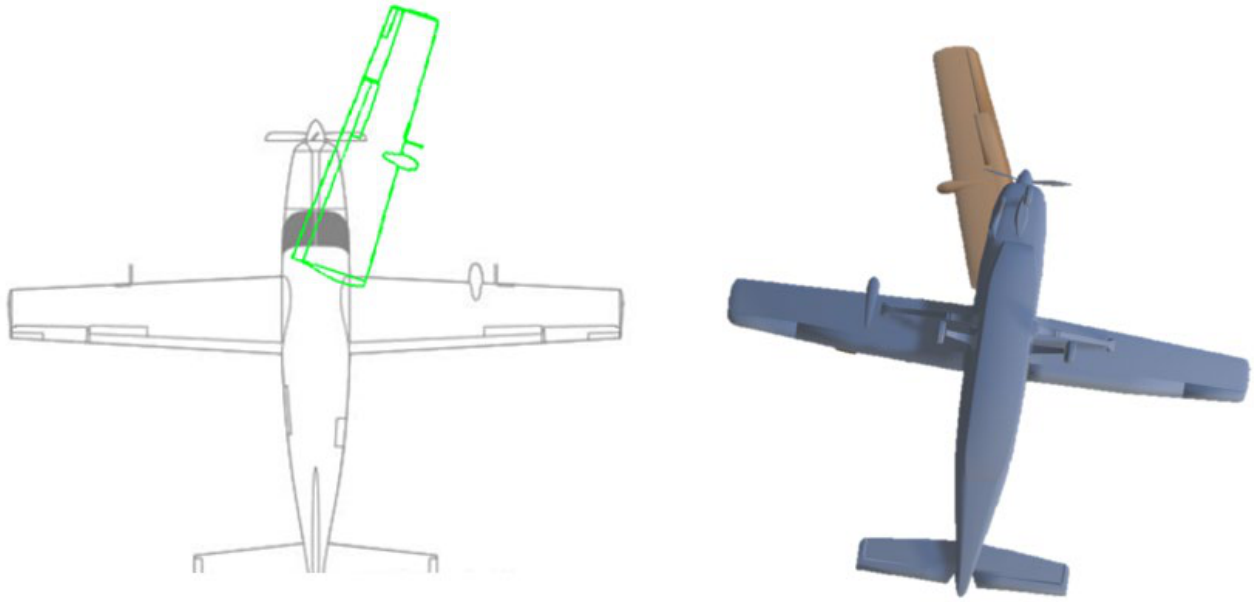
The right wing was relatively intact, with the aileron and trim tab both attached and undamaged. Diagonal buckling was observed on the upper wing skin, along with distinct parallel mechanical cuts displaying upward-curved edges and black paint transfer. Similar cuts were noted near the wing root, also exhibiting upward curling and paint transfer, consistent with mechanical impact. The most forward and outboard cuts were jagged and consistent in shape with the propeller blade tip.

Figure 16: Right wing's upper surface

Figure 17: Right wing's bottom surface and flap

Figure 18: Left: top view; Right: bottom view (showing match with propeller slashes)

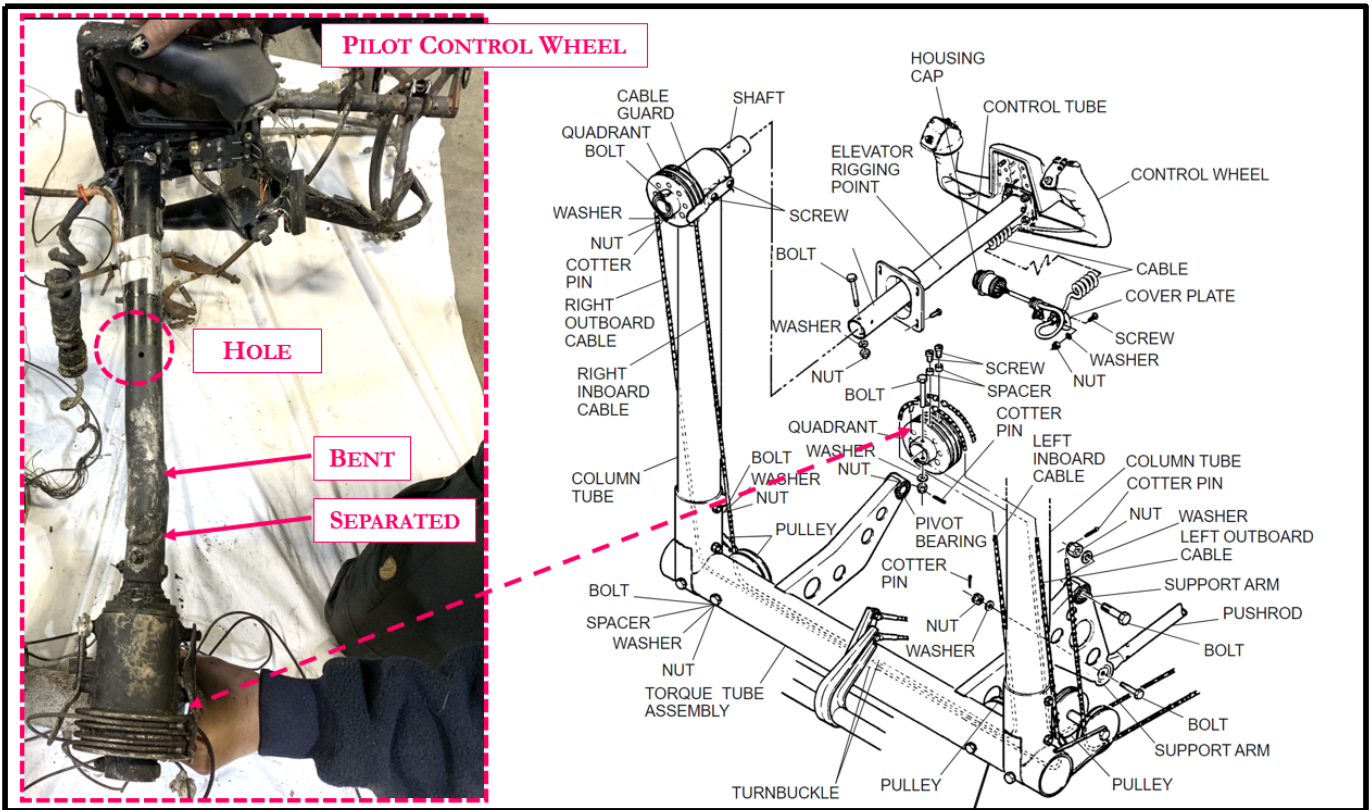
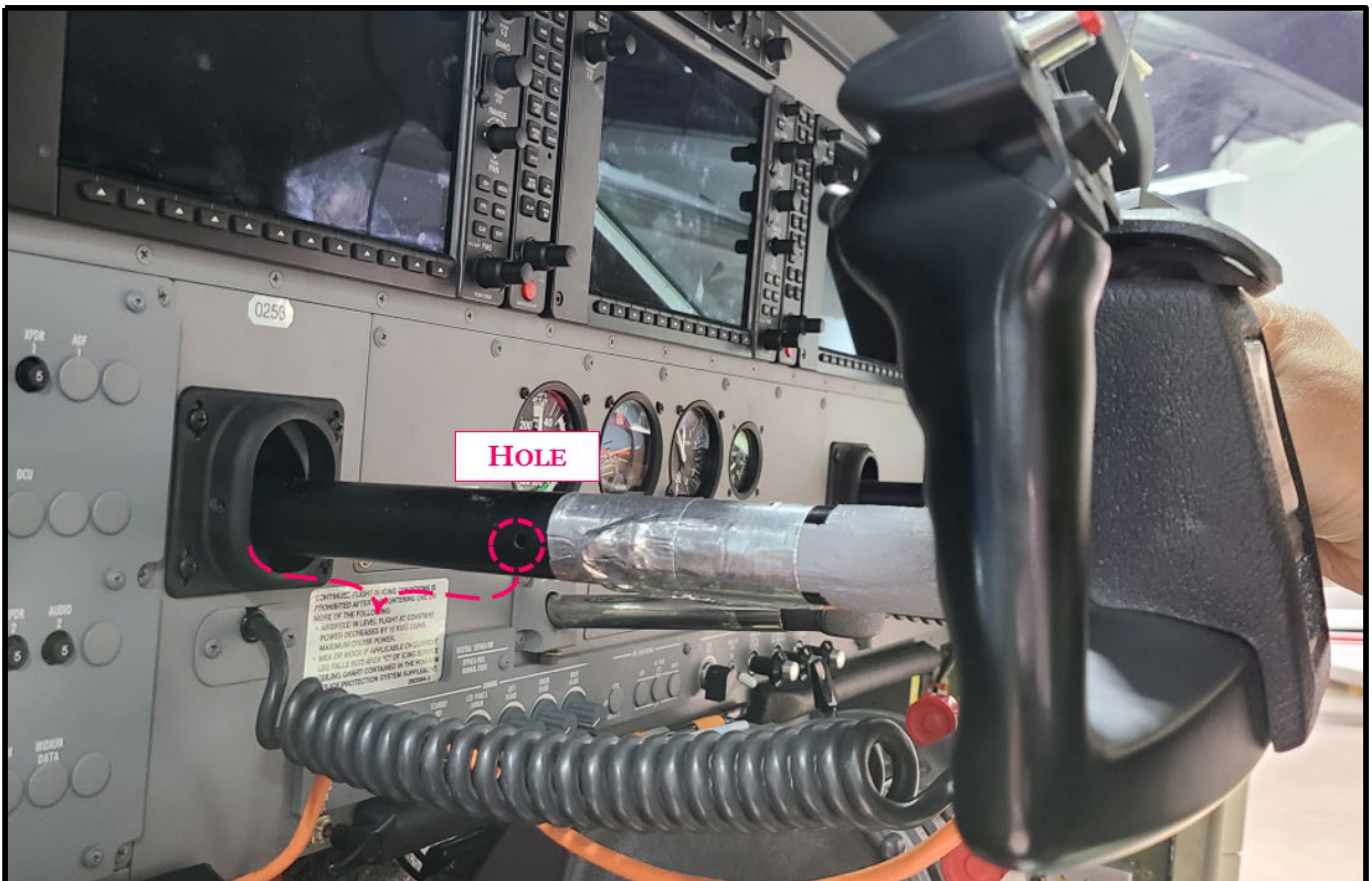
The left control column had separated due to thermal damage, though the bolts at the base remained intact. The control column held trapped swaged ends, and the control wheel tube had melted free from its rotating mount. Upon alignment of the melted surface fractures, investigators found the control yoke frozen in a near-vertical alignment, consistent with full left aileron deflection. The left fuselage pulley, attached to a melted piece of the airframe, suffered thermal damage, with no aileron cable present.

Figure 19: Left control column

Figure 20: Control column in full aft position

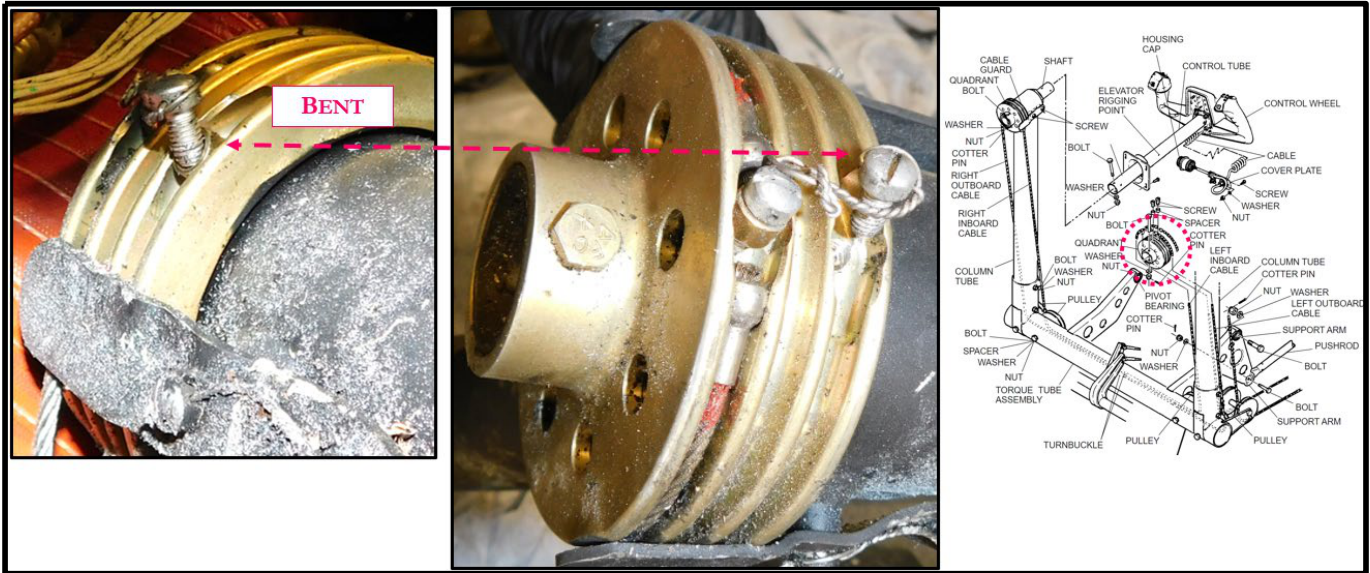
The right control column remained attached, with the pulley unburned. One control cable with two ends was located in the aft channel, while the forward channel contained no control cables, and the screw appeared loose, showing signs of being pulled from the collar. The control yoke tube had broken from its rotating mount, and both control yoke horns were detached from their base. There was no evidence of frictional entrapment on the control yoke tubes, though slight bending was observed aft of the elevator rigging point hole (hole), consistent with the control yokes being fully aft during impact.

Figure 21: Right control column pulley

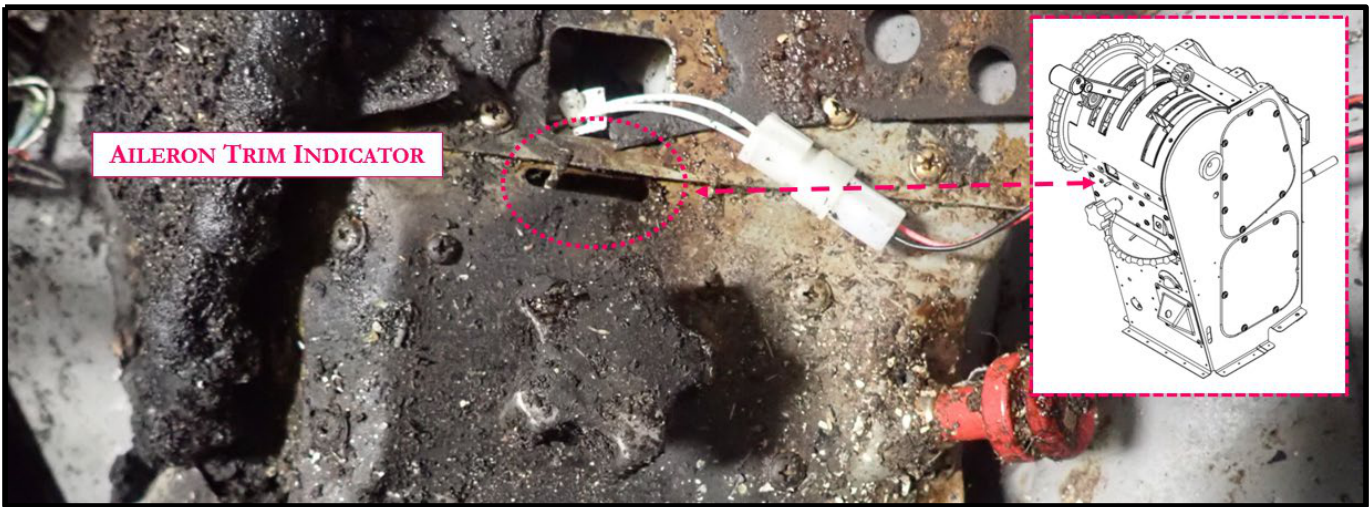
The right aileron remained attached at its fittings, with the trim tab measured at 1 7/8 inches, corresponding to a 5° tab-down position, as noted by a Cessna representative. The trim tab control cables were affixed to the chain ends, which were engaged on the sprockets in the actuator. The trim tab cables continued inboard for approximately 10 feet 11 inches until severed near gashes in the wing, consistent with propeller contact. The aileron trim selector position was in the full left position.

Figure 22: Aileron trim position indicator

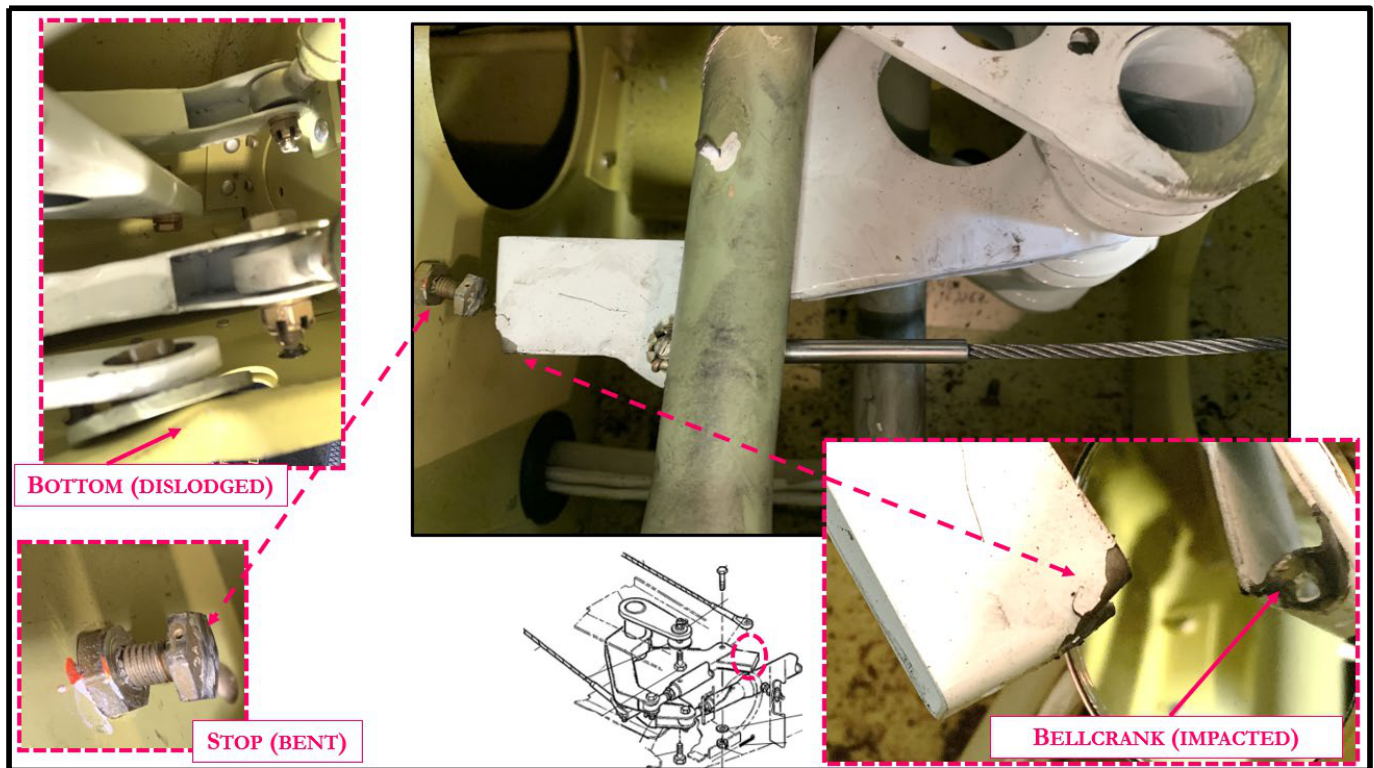
The right aileron attach fittings were intact, and the aileron control tube was continuous to the bellcrank. The bellcrank's upward attach point remained affixed, while the bottom lobe had dislodged from the bearing on the bottom wing skin. The forward and aft aileron control cables were attached to the bellcrank, with the spoiler also attached. The aft bellcrank cable attach point had dislodged from the stop, which showed deformation in an aft direction. The bellcrank stop surface contained a divot consistent with wear from the stop. The aileron cables were continuous inboard to the wing root, where they were frayed and displayed a broom-straw appearance, consistent with overload.

Figure 23: Right aileron bellcrank
